Monmouthshire County Council

Section 19 Flood Investigation Report

Llanwenarth

February 2020

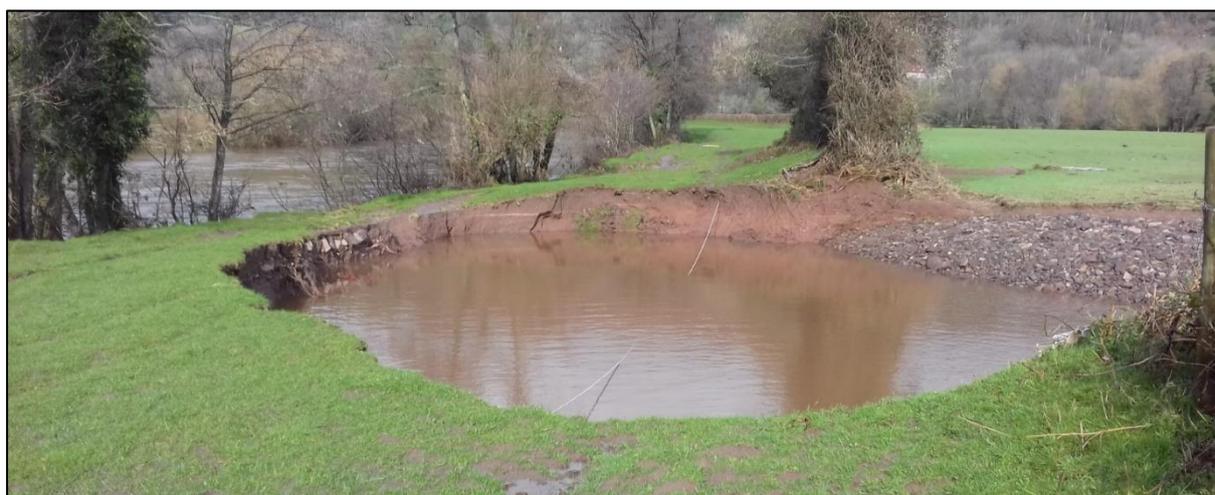
One breach caused the formation of a crater at least 3 m in depth and approximately 40 m in width. It is assumed the crater was formed by turbulence forces during overtopping of the bund. The other breach, some 50 m to the south measured some 80 m in length. At this location a large proportion of the bund was scoured away but no crater was formed. Evidence of a further small amount of localised overtopping, without significant damage, was identified towards the northern end of the embankment, close to the A40.

Photo 1: The crater in the flood embankment.

Alun Griffiths (Contractors) Limited repaired the damaged and destroyed sections of the embankment with imported clay to a design based roughly on works undertaken for NRW on a flood bund at another site.

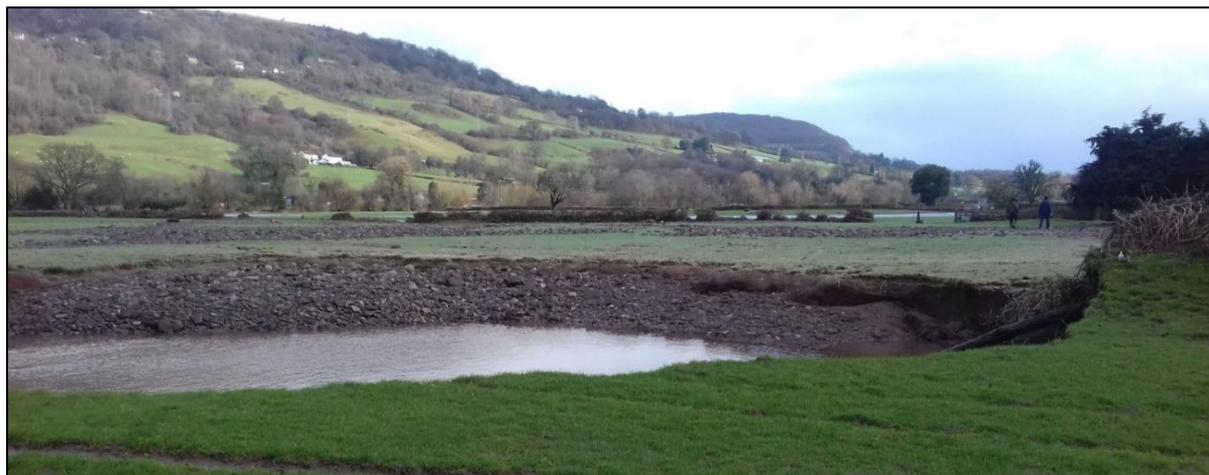
Photo 2: The crater in the flood embankment showing a trail of cobbles running across the field. Buildings of Mardy Farm are obscured by evergreen trees at the right hand side of the picture.

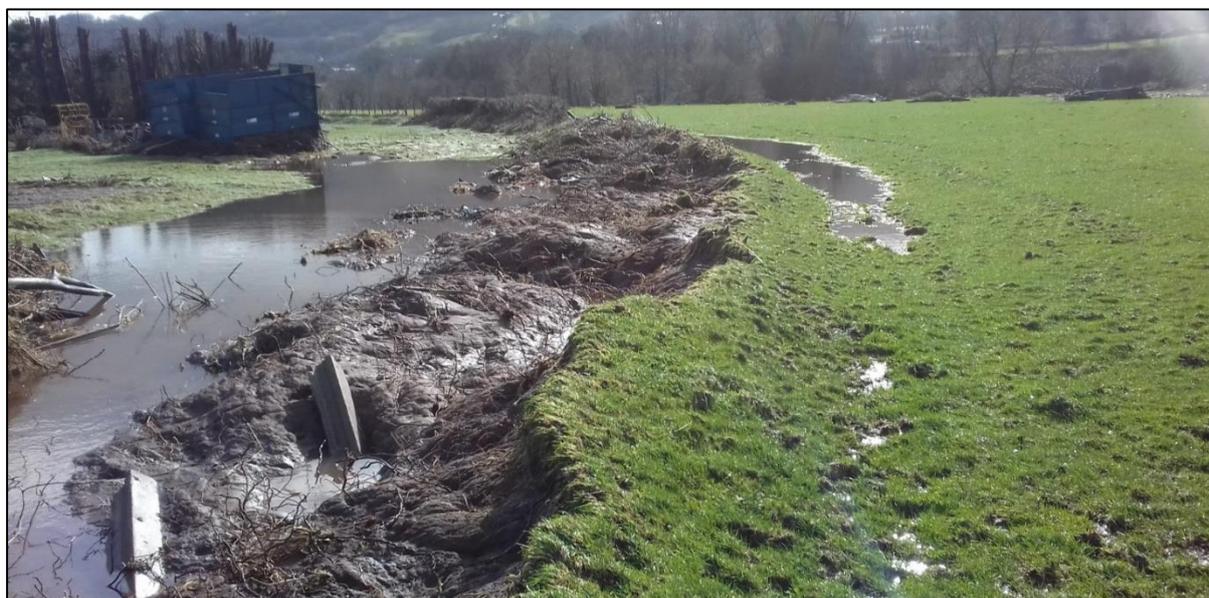
Photo 3: The southern breach in the flood embankment.

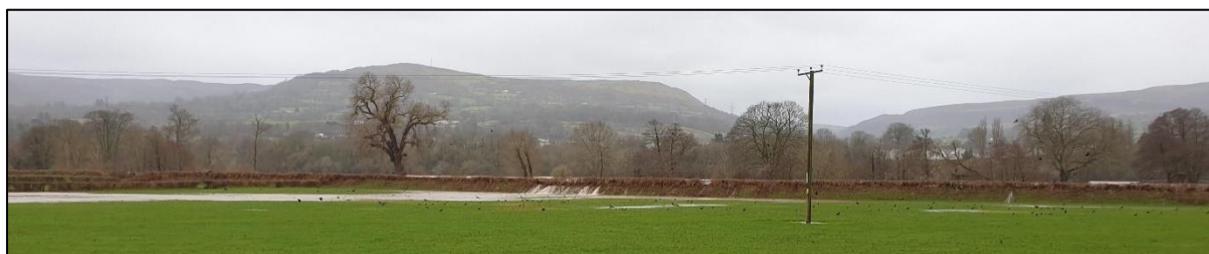
Photo 4: Overtopping of the northern part of the flood embankment continuing at 11:52 am on Sunday 16th February 2020.

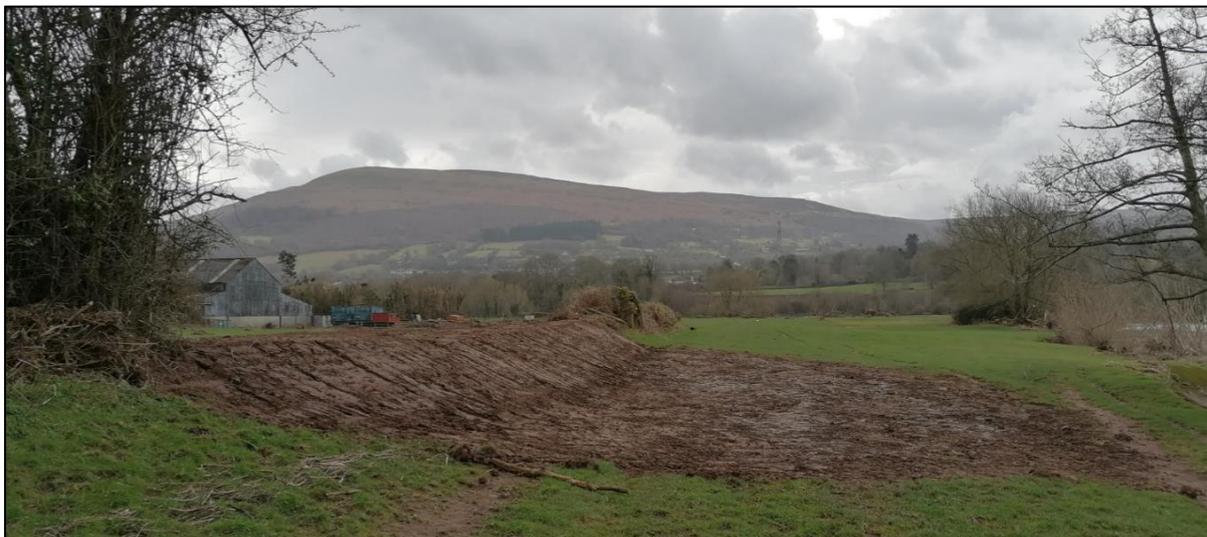
Photo 5: Part of the reinstated embankment on 7th March 2020.

Repair works commenced on 28th February. Works were hampered when shortly after works commenced, on 29th February, the Usk rose again and poured through the hole in the bund, scouring out much of the material which had been placed to fill the crater. The contractors were alert to the rising river level and had moved plant to a safe location so work could start immediately after water levels had receded. Repair works were completed by 5th March.

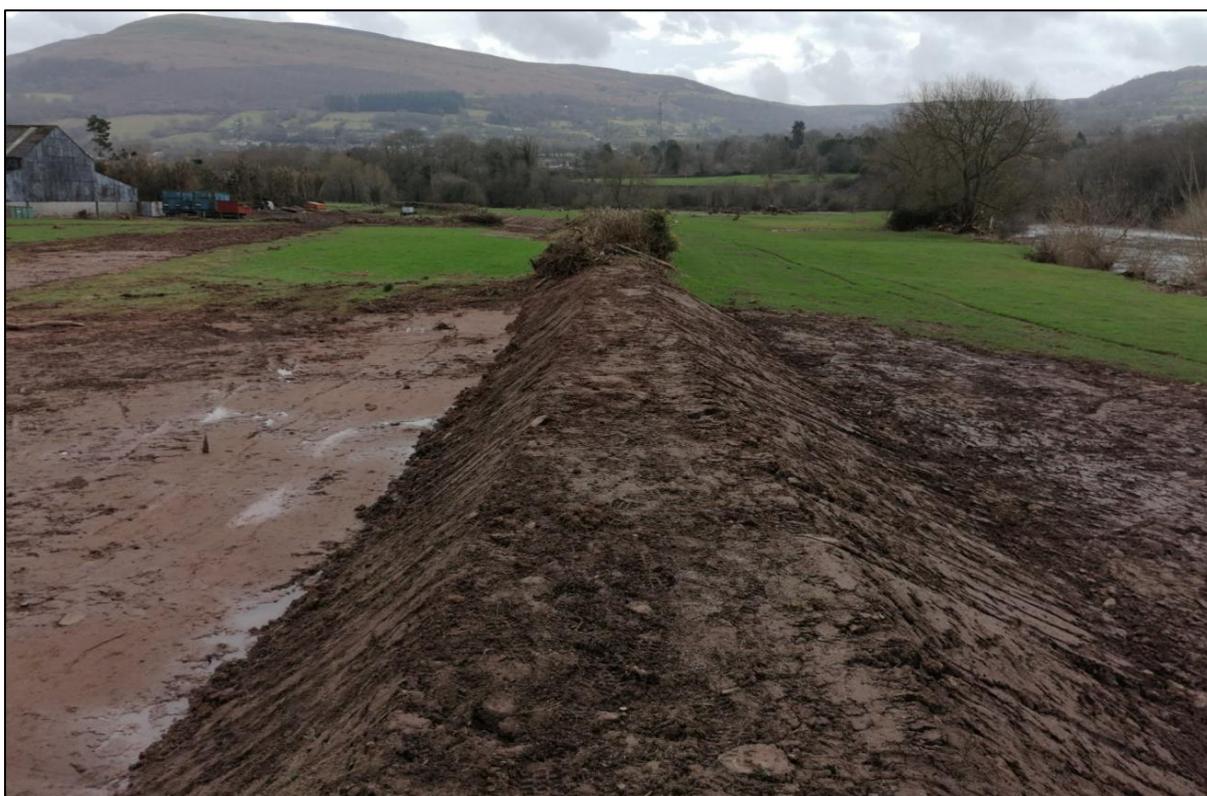
Photo 6: Part of the reinstated embankment on 7th March 2020.

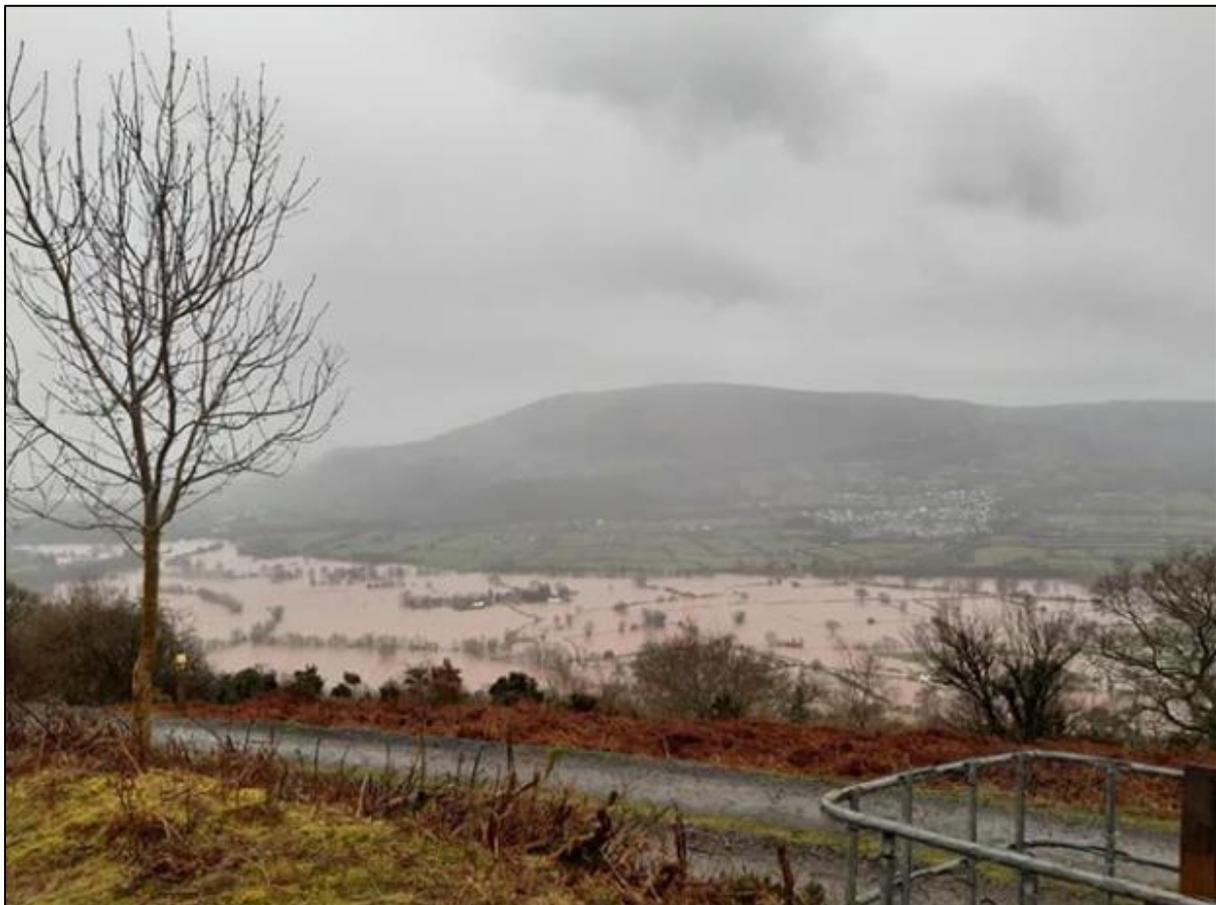
Photo 7: The flooded Llanwenarth Plain viewed from the north.
