Monmouthshire County Council

Section 19 Flood Investigation Report

Llanbadoc, Usk

February 2020

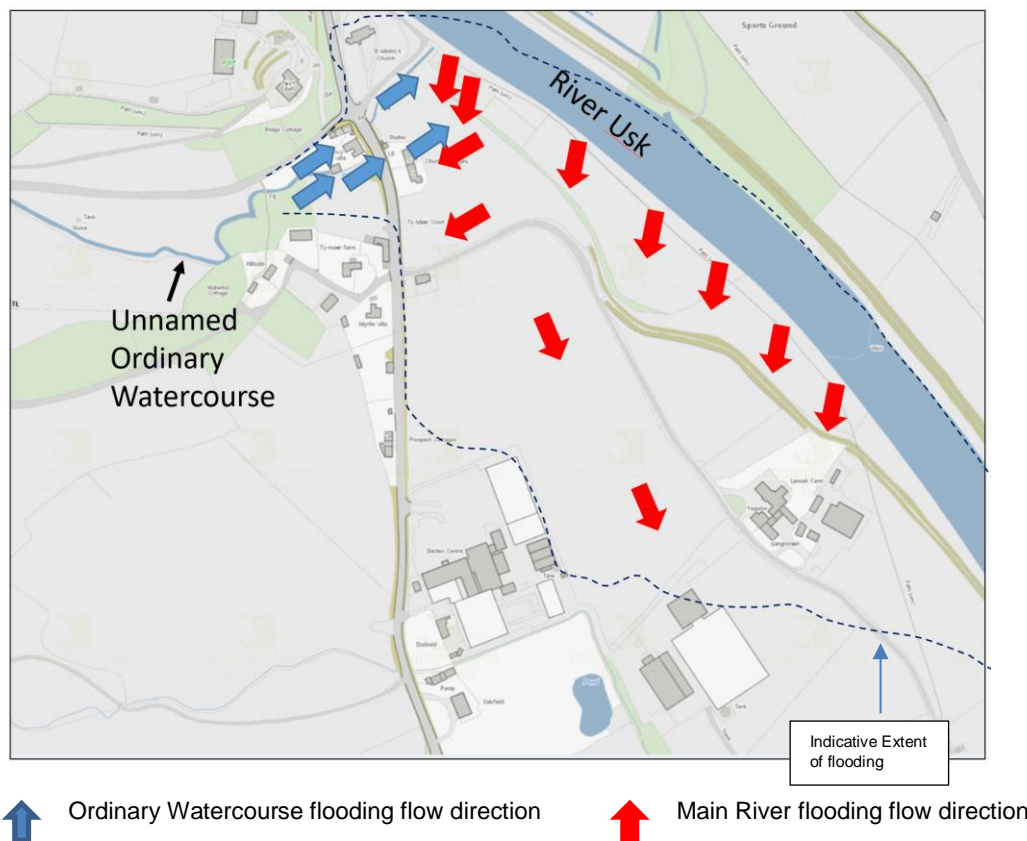
Residents at Lanusk Farm described water as starting to spill over the primary flood defence (See plan in Appendix B) adjacent to the river and pooling between that and a lower bund within the garden. This overtopping caused significant damage to the back of the raised defences. Once the water level in the main channel rose significantly above the defences, the 9 properties, businesses and agricultural barns were inundated quickly to a maximum depth of about three feet throughout. When trying to evacuate the resident also explained about water flowing through a hedgerow between the access driveway (see plan in Appendix B) and the higher field to the rear of Llanbadoc Island Car Park confirming that flow was coming over the top of the River Usk banks at Llanbadoc Island Car Park.

Figure 7 - Flood Flow directions, indicative extents and sources

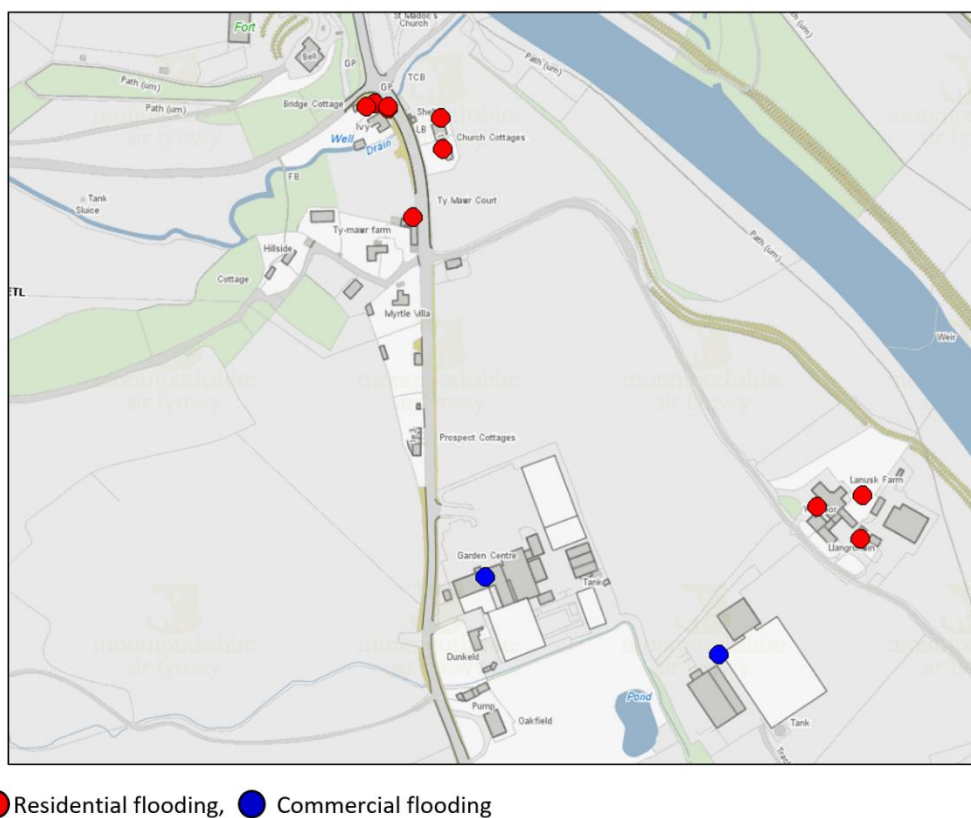
In total nine residential properties, two commercial premise and one church had internal and external flooding and a further two had flooding to gardens or working areas causing damage to properties and disruption to residents and businesses.

Figure 8 - Flooded properties (indicative locations)

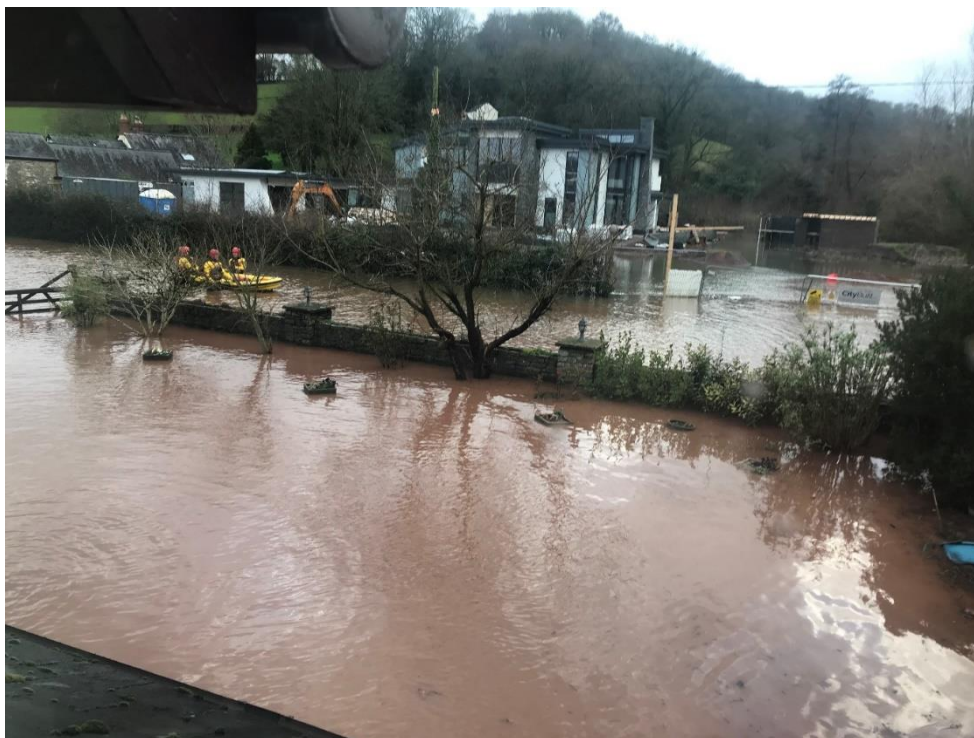
Figure 9 - Rescue crews outside Orchard House standing on the R106 Usk to Caerleon Road - Photo courtesy of Graham Lowe

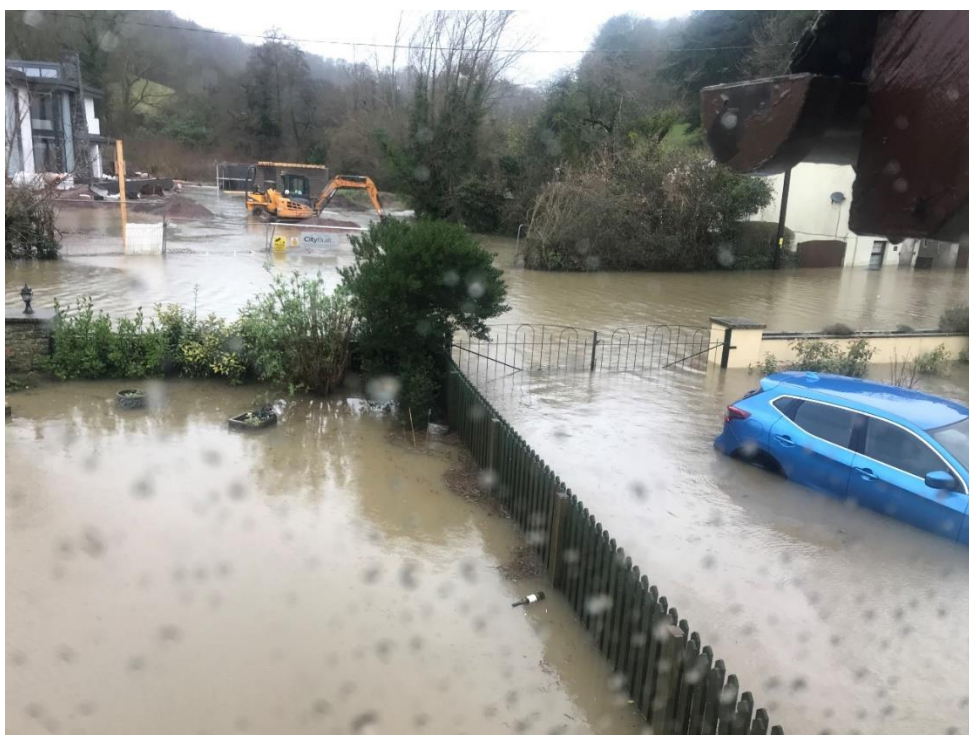
Figure 10 - Flooding between Church Cottages and Orchard House standing on the R106 Usk to Caerleon Road - Photo courtesy of Graham Lowe

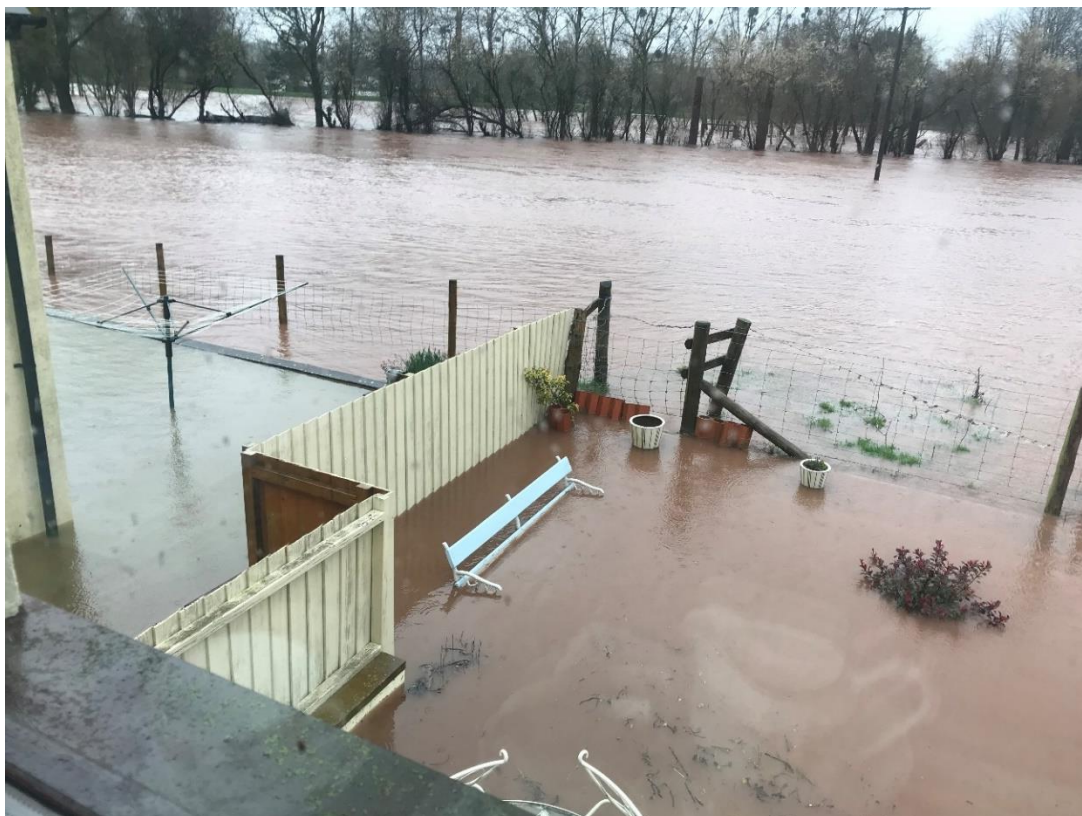
Figure 11 - Flooding between Church Cottages and River Usk beyond tree line

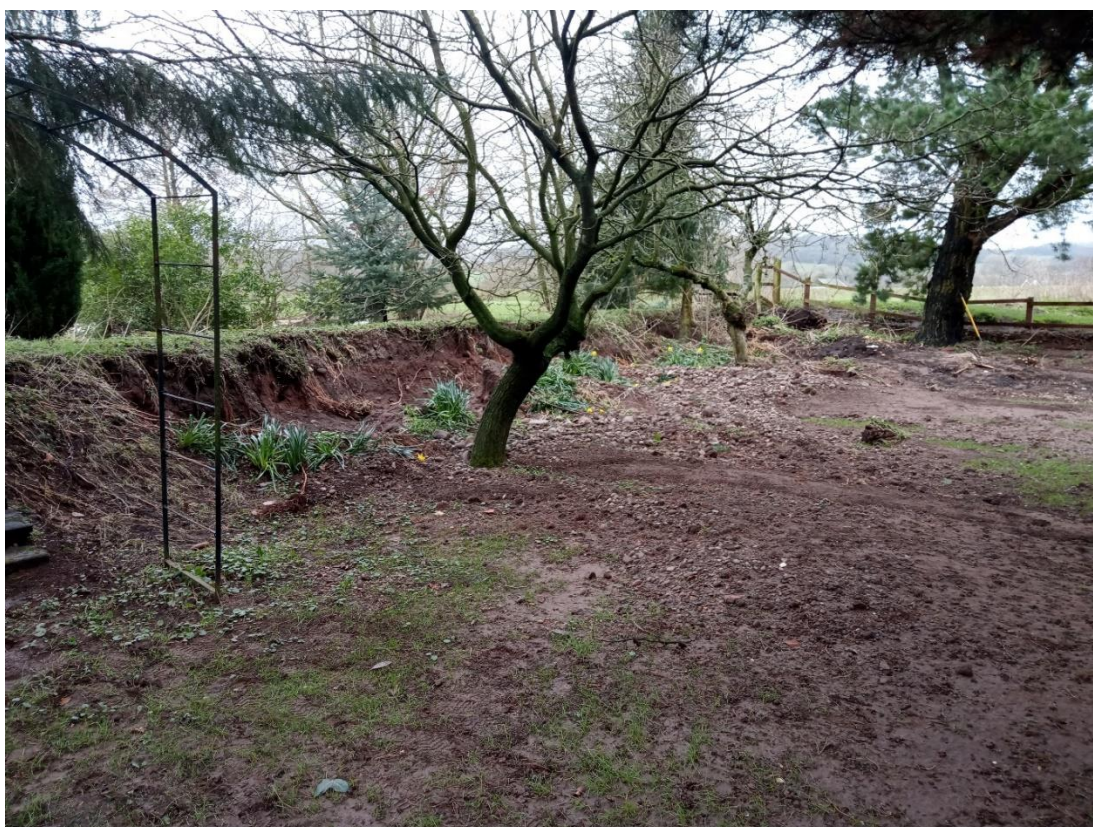
Figure 12 - Damage to rear of Flood Defence Embankment, Llangronwn

In addition, water was noted to be flowing over the defences (previously perceived to be private defences) adjacent to Lanusk Farm causing damage to them. Any further erosion or damage to these defences could have created a serious risk to life.

LB6	NRW to consider future maintenance requirements of existing defences and/or provide specialist advice to riparian owners covering repair and maintenance of the existing flood defence assets	NRW

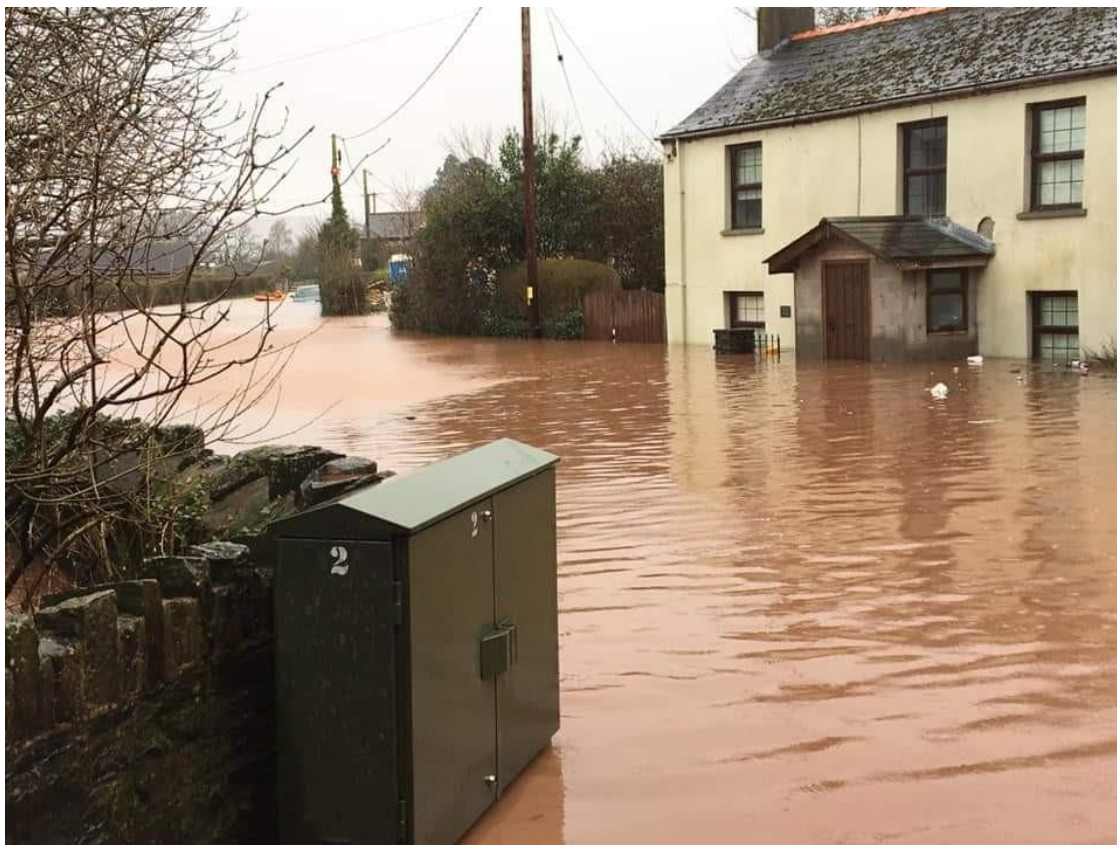
Figure 13 - Extent of flooding, view from Llanbadoc Church across R106

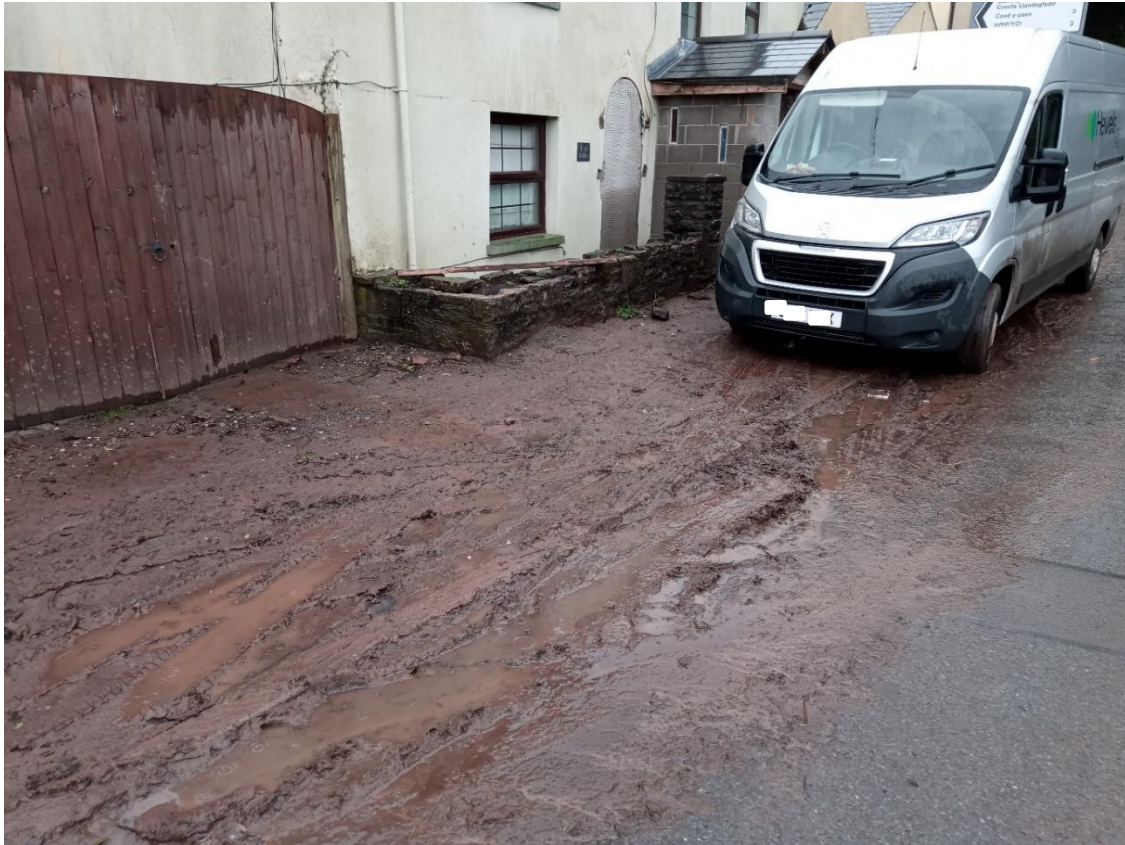
Figure 14 - Silt and Debris outside properties, Water level marks also visible on walls
