Flood and Water Management Act 2010

Section 19 Flood Investigation Report

Caldicot

February 2020

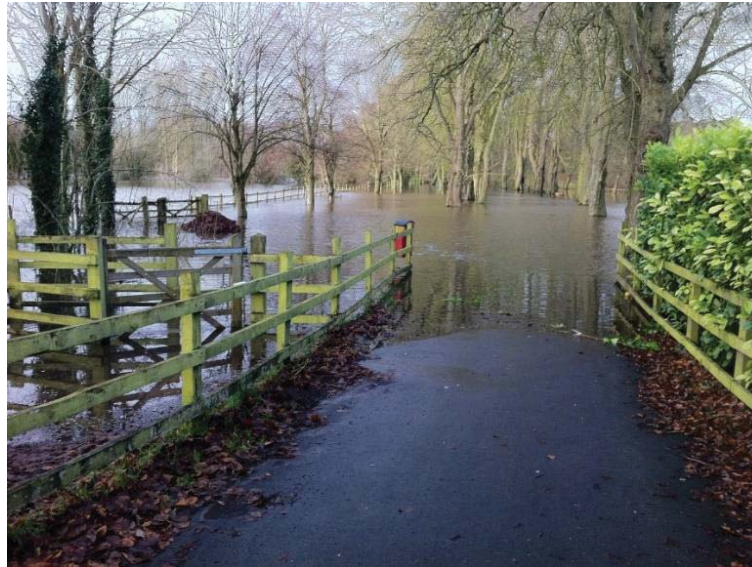
There was another significant event in the December of 2012 affecting parts of Castle Lea and most of the Country Park around the Castle – see Photo 1 below. It is understood that the flooding at Castle Lea was to gardens and outbuildings and not internal. Locally the cause was said to be linked to the sea door - that is the Neddern Brook's outfall into the Severn Estuary either not opening properly or jamming which created a substantial backup of water flooding in upstream areas, but this was never verified.

Photo 1: Showing the Flood Extent in the Country Park December 2012

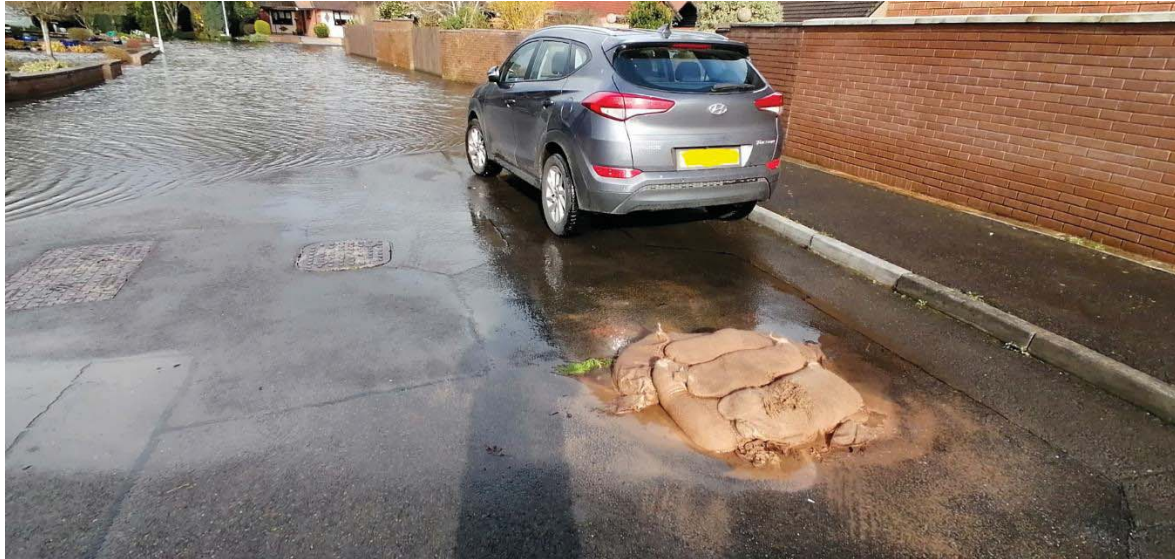
residents here reported flooding issues from late afternoon onwards. Calls to MCC for assistance continued into the afternoon and evening of Saturday and the water levels continued to rise. At Castle Lea it was initially flooding estate roads but then creeping up into out-buildings and then by late evening, into properties. Despite attendance by MCC Officers with deliveries of sandbags and the South Wales Fire and Rescue Service, sandbag delivery comments indicate that it was not possible to prevent the continual flows from the surface water manhole near the junction of Jolyons Court and Castle Lea.

Photo 2: Showing the Surcharging Surface Water Manhole at Castle Lea, taken on 1st March 2020

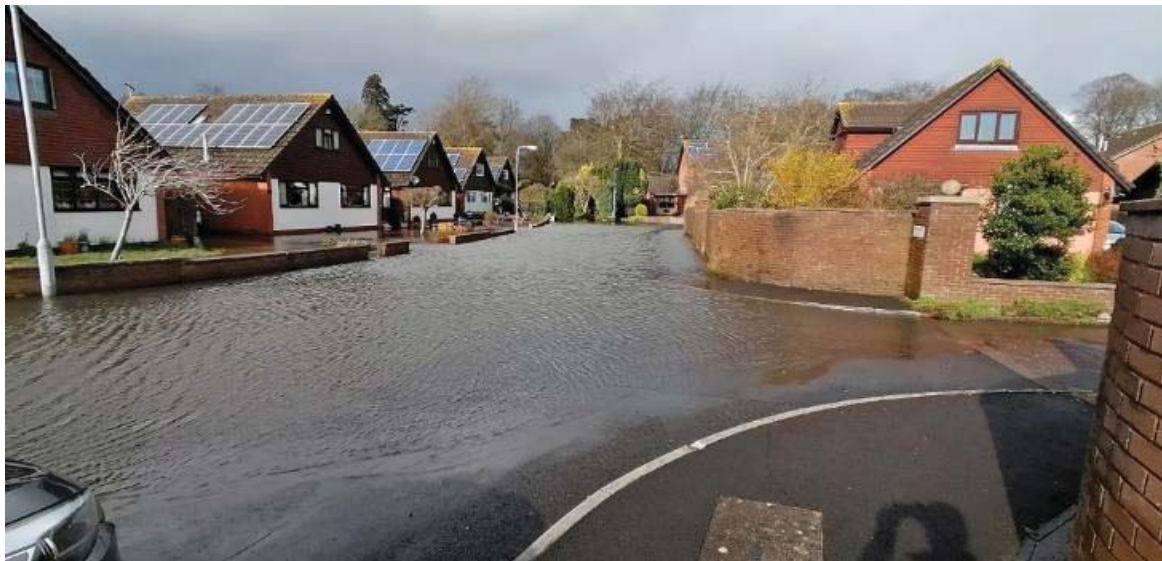
Photo 3: Showing the Flooding Extent at Castle Lea and Jolyons Court, taken on 1st March 2020.

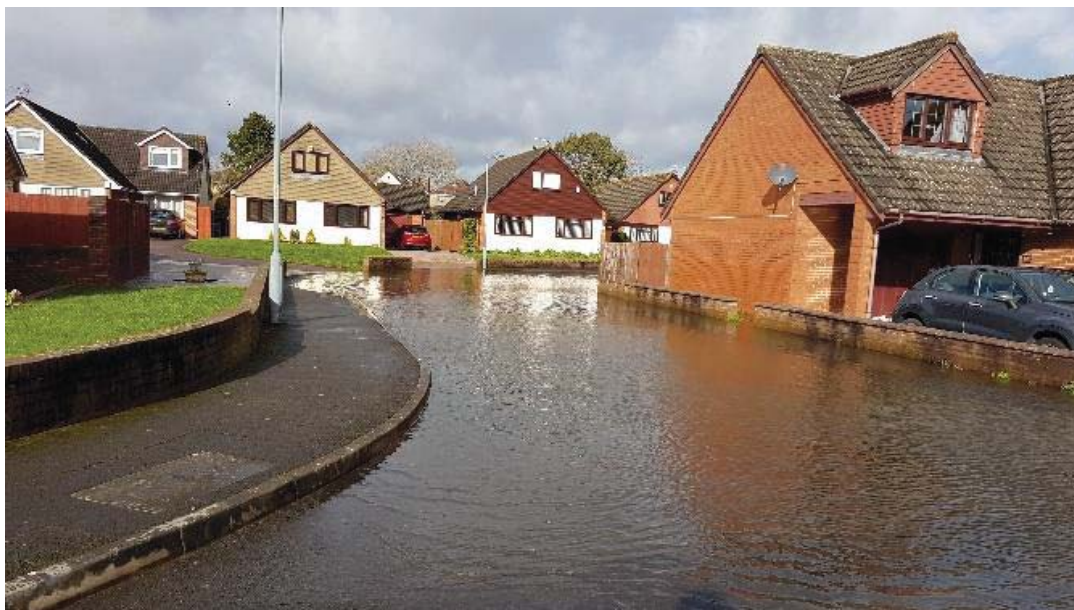
Photo 4: Showing the Flooding Extent at Castle Lea, taken on 1st March 2020.

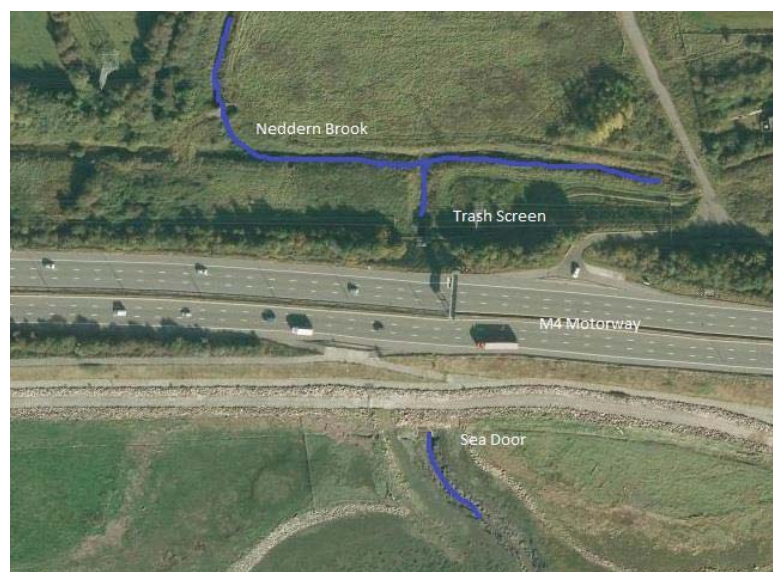
Natural Resources Wales attended the site from around 10.15am on Sunday the 1st March and identified that the trash screen at the entrance to the culvert under the M4 Motorway was clogged with debris. They called Highways England at around 10.45am to attend to deal with the clogged trash screen. The trash screen, culvert and sea door are the responsibility of Highways England as they are associated with the Severn Second Crossing. Highways England (HE) report they received a call at around 11am and their Senior Operations Manager arrived at the site at midday, noting the screen was blocked by debris, mostly with reeds. He considered that the water in the reed was nothing out of the ordinary for this time of year but arranged for a team to attend and then left the site. No records of this team attending have been provided.

Figure 10: Aerial Photograph (2010) of the Culvert under the M4 Motorway

The Senior Operations Manager HE returned at 4pm and explained to several local representatives that were now on site that they were unable to lift the screen for clearing due to the water pressure on the flooded screen. They would need to wait for the next high tide to balance water pressures. Nonetheless the Senior Operations Manager called out a Chargehand / Rigger from HE to join him and they attempted to clear some of the debris manually to relieve the water pressure. An attempt to lift the screen at around 6.30pm failed as the power to the motor cut out. An Electrician from HE attended and restored power but could still not lift the screen and manual clearing continued to around 10pm. The HE staff on site then brought some manual pull lifts from their depot and around 1am on Monday 2nd March they were finally able to lift the screen and flood water dropped significantly. Having cleared the screen of debris it was put back in place. The screen again caught debris and the screen was lifted again, this time by motor about 1.30am on Monday 2nd March and cleared of debris.

From HE's Maintenance Records a full check on the screen and motor was carried out in January 2020 as part of their three monthly visits and all was satisfactory. A further visit was made on 3rd February and they noted that the reed clearing carried out by Natural Resources Wales had left the waterways clear and the screen was clear. There are no further records of attendance until the day of the floods.

Reference	Recommendation	Responsible Risk Management Authority(s)
CA01 (Flood Risk)	Identify and implement any alterations that can be made to the trash screen on the Neddern Brook to ensure it can be immediately cleared at any time and without needing to await a High Tide or sourcing of additional lifting equipment from offsite. Consideration should be given to an automated screen or remote monitoring via a CCTV camera. Such changes may require approval from NRW (Flood Risk Activity Permit) and should be discussed with MCC as Lead Local Flood Authority.	Highways England
CA02 (Flood Risk)	That Highways England review their Maintenance Plan to ensure visits to check that the trash screen is clear during and following major flood warnings being issued and during and after any significant storm events.	Highways England
CA03 (Flood Risk)	Consider the viability of the addition of a gauge or gauge station on the Neddern Brook to aid forecasting and monitoring of water levels with a flood warning system.	NRW

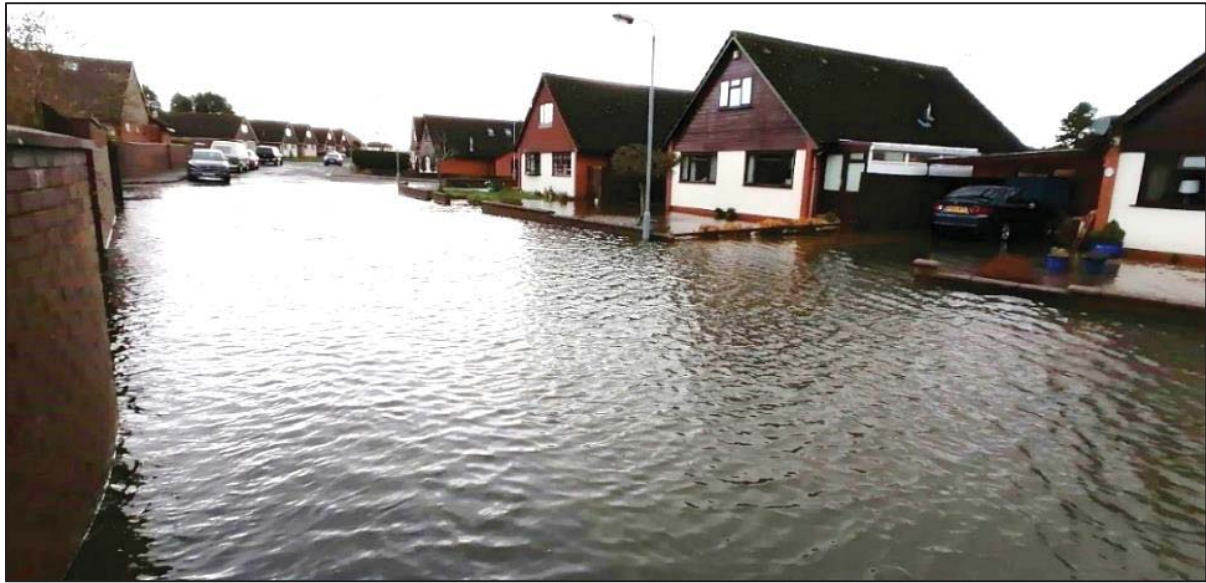
In addition to the restriction of flow caused by the blockage at the HE screen, local reports have suggested that excessive vegetation and raised invert levels between the Castle grounds and the M4 culvert have reduced the channel's capacity over time and further restrict flow. Consideration should be given to undertaking a detailed assessment of the channel's capacity, invert levels and structures along its length to identify any significant restrictions to flow along this stretch of the Neddern Brook.

Photo 7: Showing the Flooding Extent at Castle Lea Looking South from Jolyons Court taken on 1st March 2020

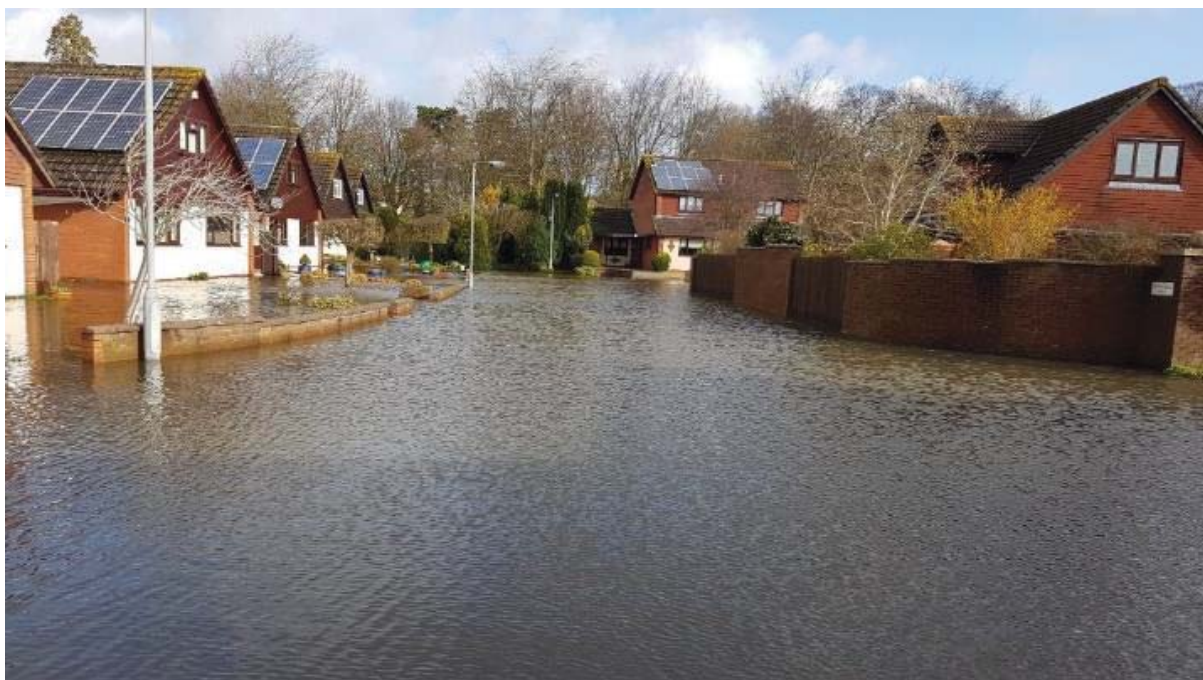
Photo 8: Showing the Flooding Extent at Castle Lea Looking North from Jolyons Court, taken on 1st March 2020.

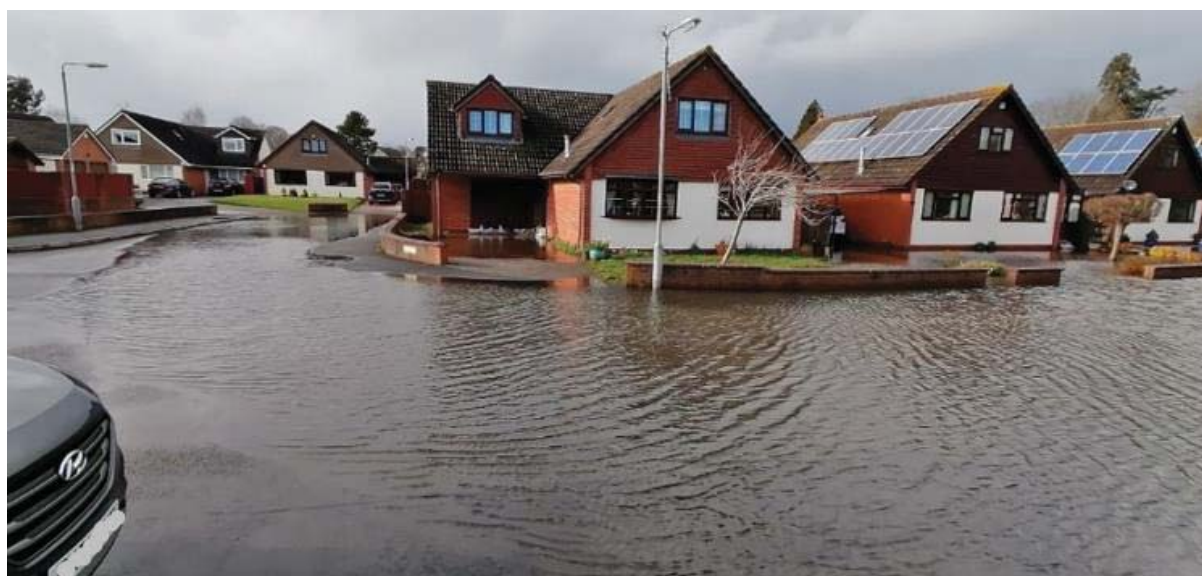
Photo 9: Showing the Flooding Extent at Castle Lea Looking West, taken on 1st March 2020

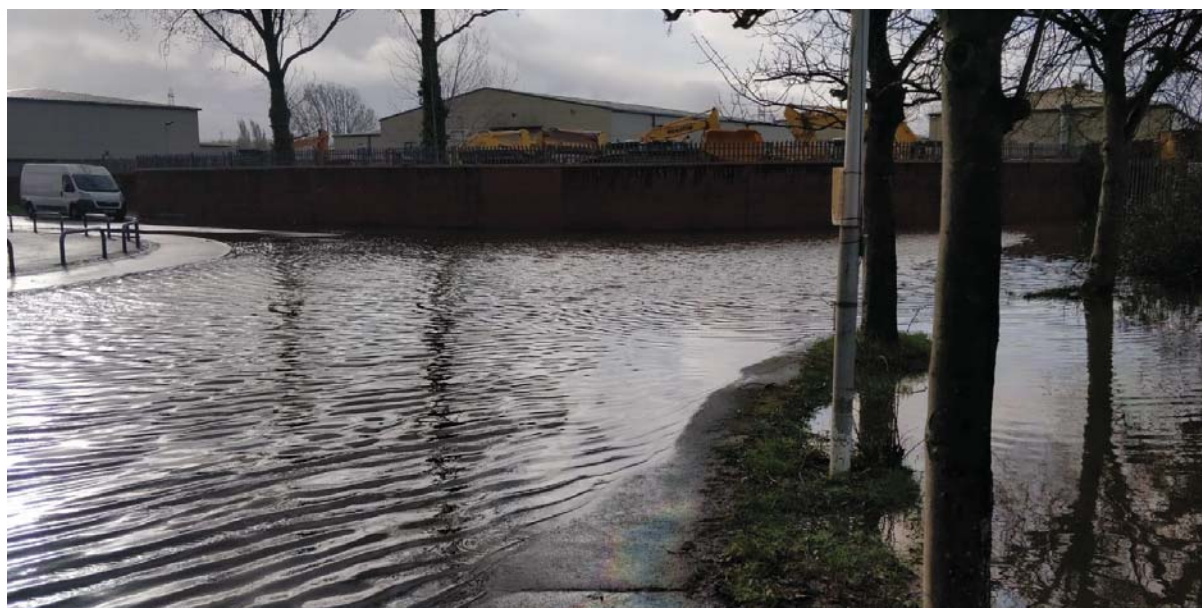
Photo 10: Shows Flooding Levels on Sunday 1st March 2020 in the Commercial Area

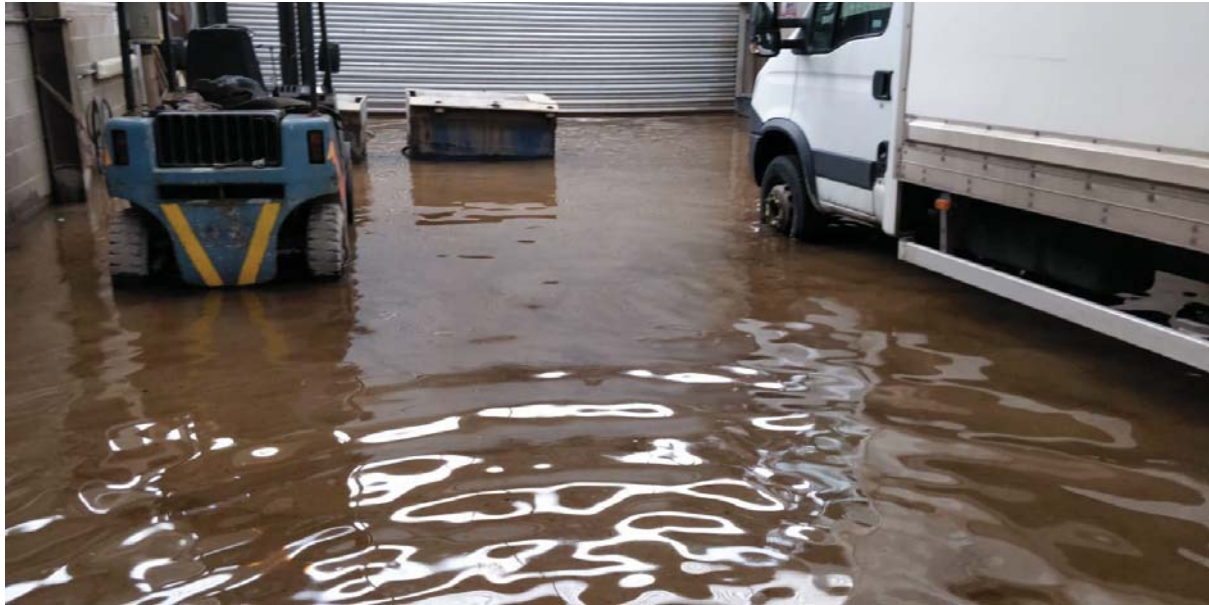
Photo 11: Shows Flooding Levels on Sunday 1st March 2020 in the Commercial Area

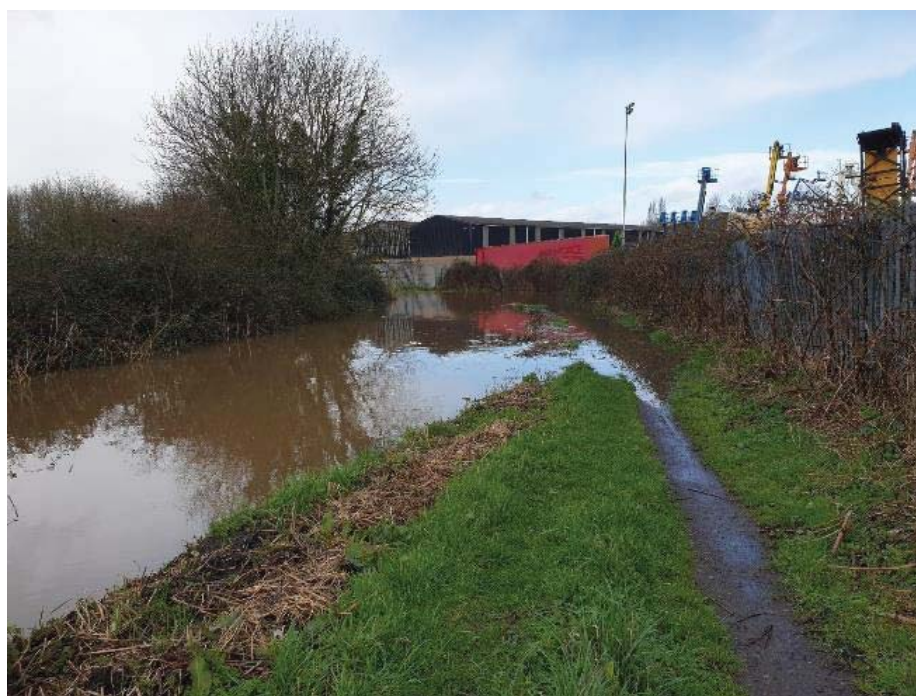
Photo 13: Shows Water Level in Neddern Brook Looking North on Sunday 1st March 2020 Adjacent to Symondscliff Way

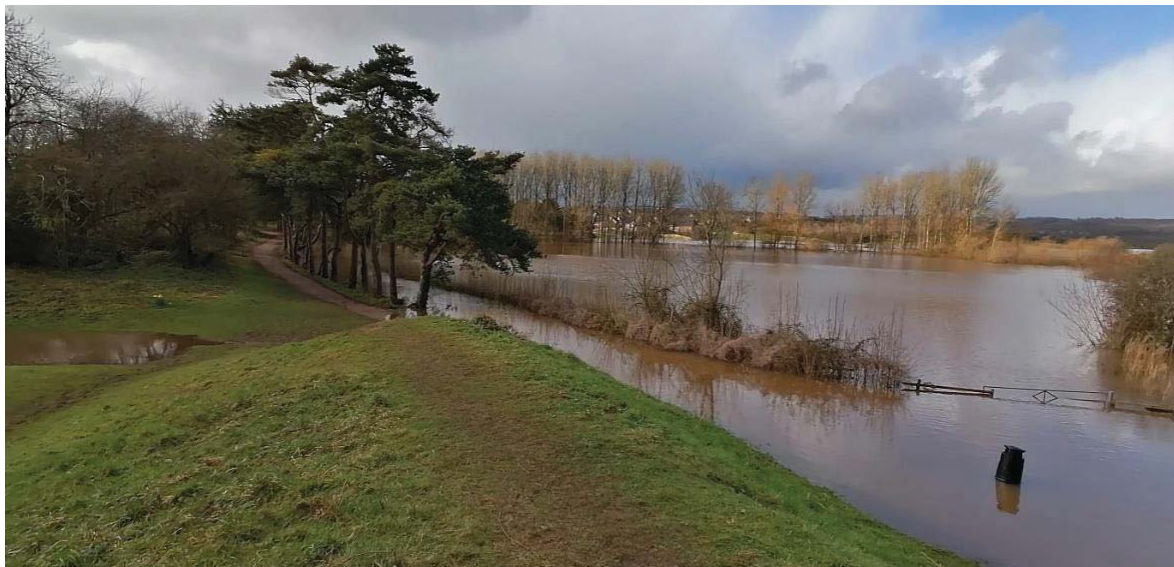
Photo 14: The Neddern Brook in Flood taken Saturday 1st March 2020

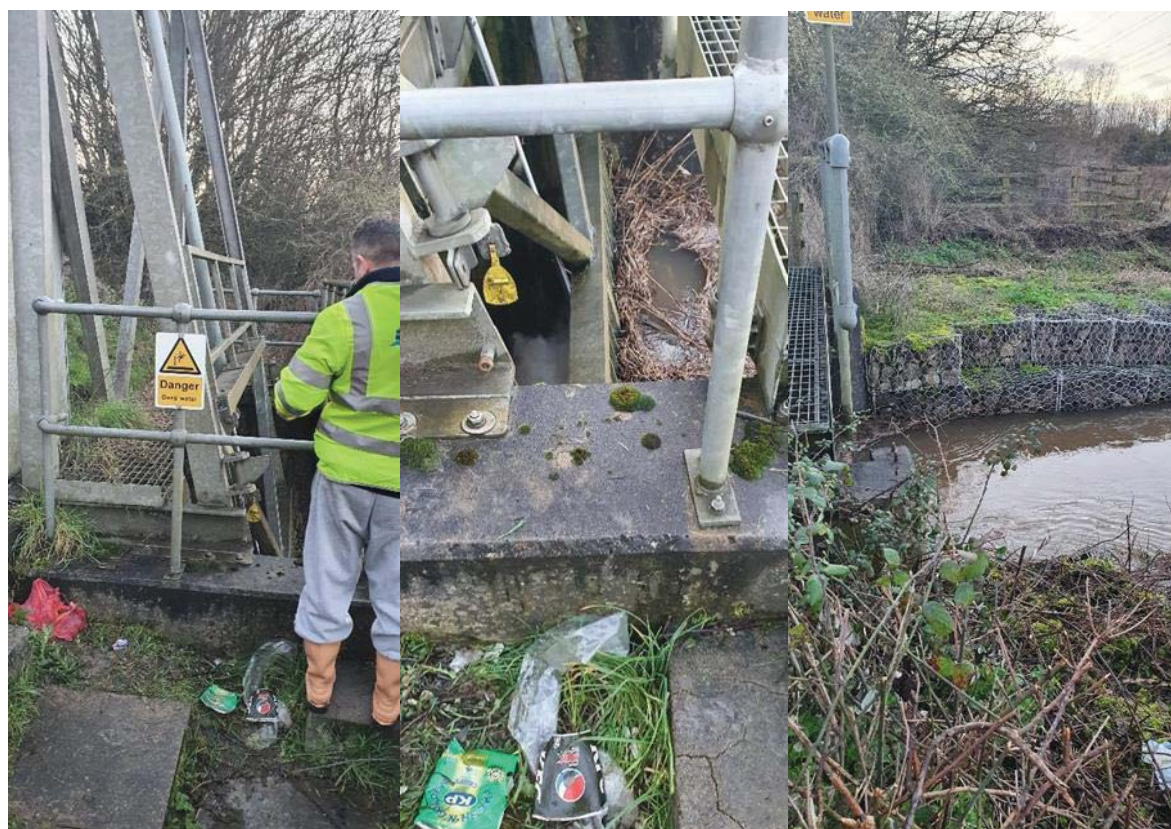
Photos 15, 16 and 17: Shows Highways England staff at the Trash Screen in March 2020 also showing some of the Debris

Whilst the groundwater element and surface water discharges to the Neddern Brook added to the flooding, the relative rapidity of the flood level reductions once the trash screen was lifted and cleared reinforce the conclusion that the clogged trash screen had a significant impact on the upstream levels. It is noted that there are no reported HE visits made between the 3rd February and the 1st March during which time there had been three major storms, with little doubt that each generated substantial debris which would have been caught by the trash screen.

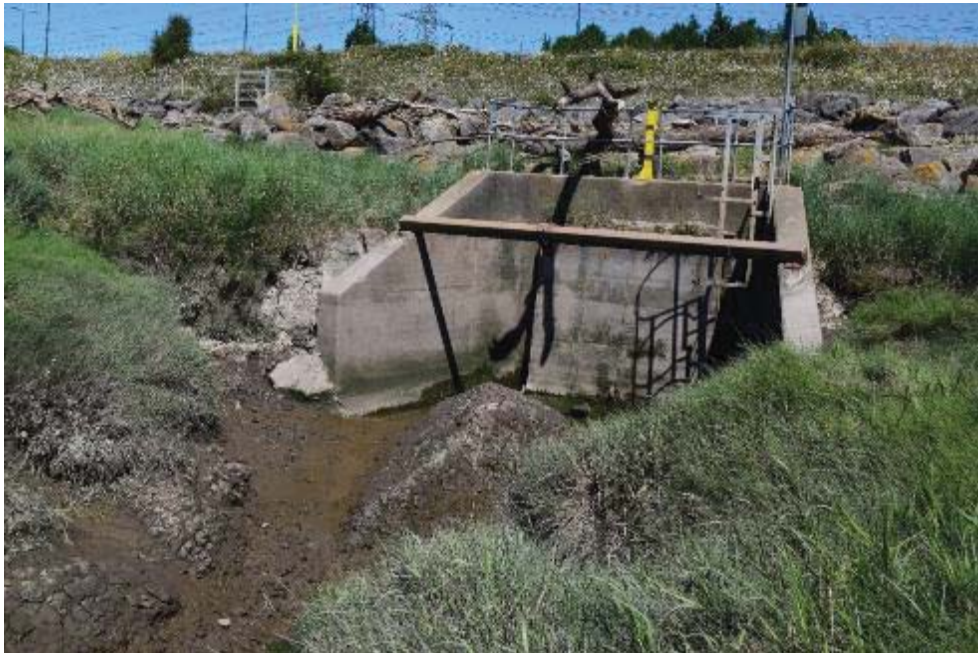
**Photo 19: The Sea Door where the Neddern Brook Outfalls into the River Severn
taken June 2020**

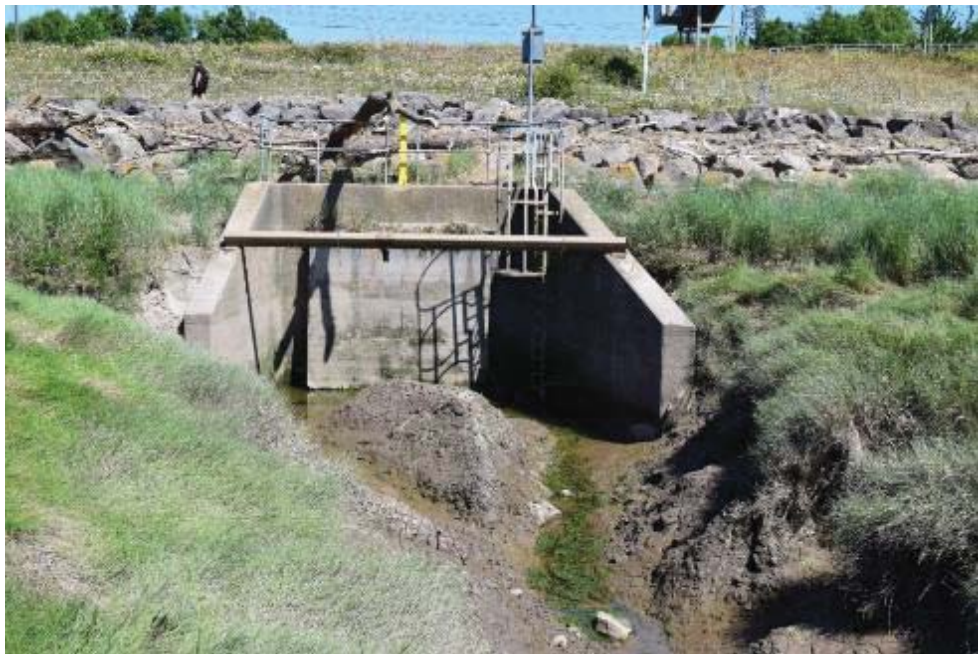
**Photo 20: The Sea Door where the Neddern Brook Outfalls and Shows Silt Deposit in
Front of Door taken June 2020**

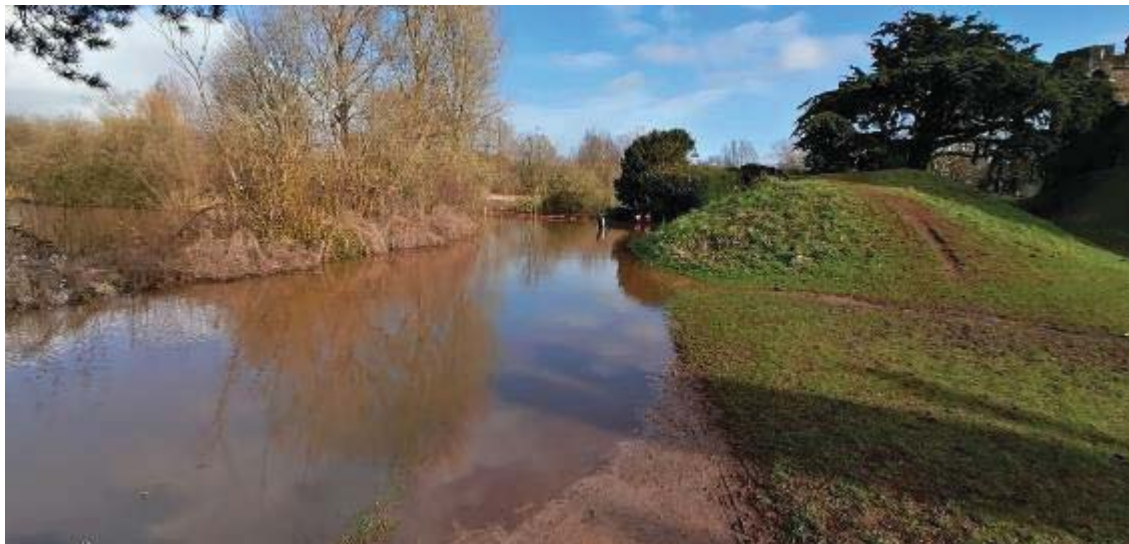
Photo 22: Showing the Flood Levels in the Neddern Brook, taken on 1st March 2020 in the Country Park

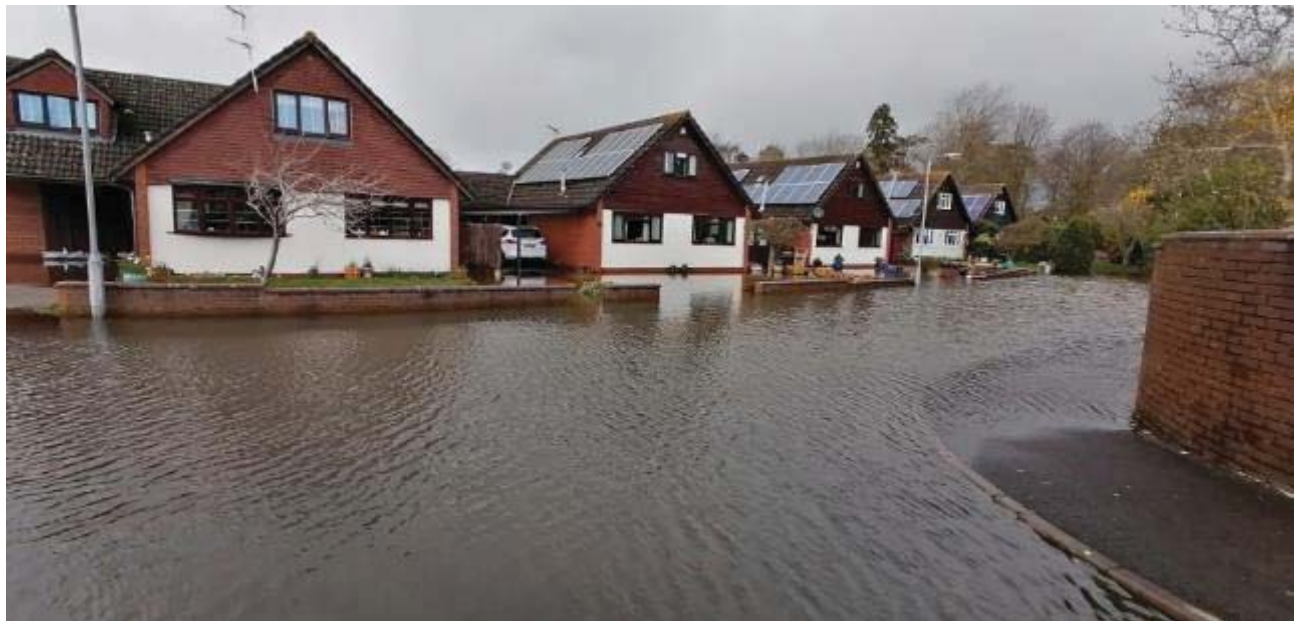
Photo 24: Showing the flooding at Castle Lea looking North from Jolyons Court on Sunday 1st March 2020

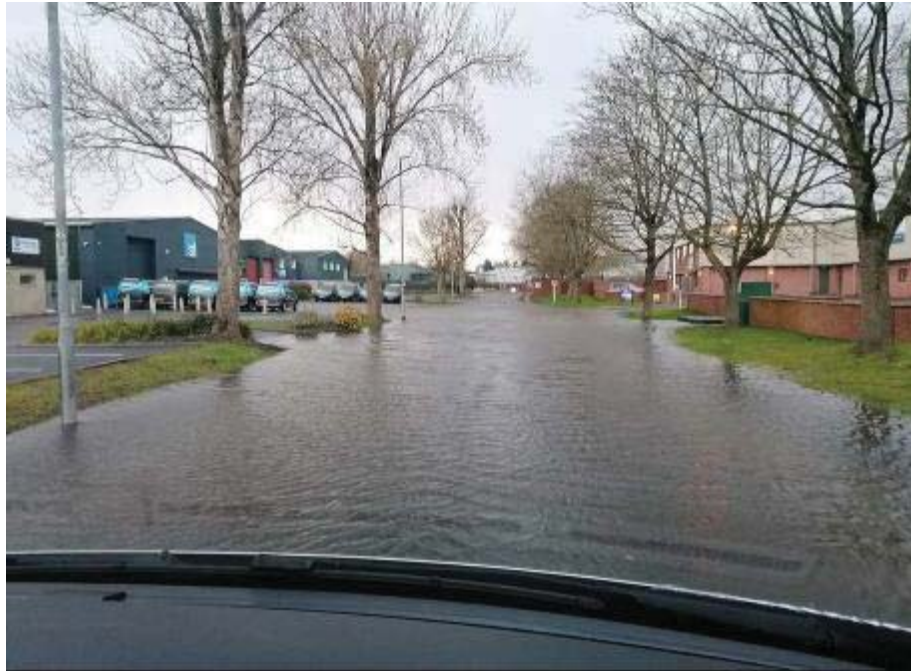
**Photo 25: Shows Flooding at Normans Way Looking West towards the Neddern Brook, Sunday 1st March
courtesy of SD sealants**

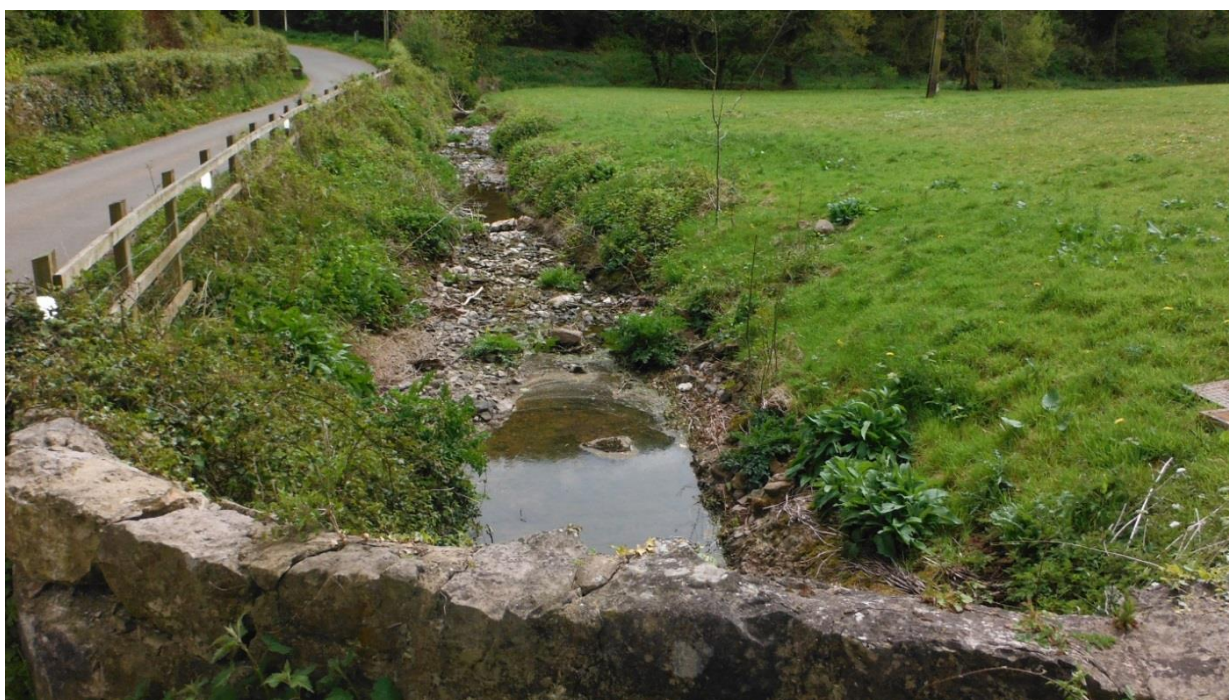
The concrete river channel was installed to minimise water loss to ground and to reduce flow to the Great Spring. It was constructed in just a few months between August and October 1883, (Walker, 1888). The channel was constructed on the upper part of the Nedern Brook from the Cwm (ST4591093175) and Rodge Farm (ST4609509461) for a distance of 3 km. There are no concrete sections within the wetland SSSI boundary. Haskoning UK Ltd (2013) recommended that a survey was undertaken to assess the state of the concrete channel. Although this was not done during this project a similar survey had been undertaken for Environment Agency Wales as part of the Great Spring work (Lawrence et al 2013). The survey showed that the concrete channel was still visible over much of the original 3 km reach however the concrete bed 'is now in a poor state of repair and it is considered unlikely to prevent recharge to the aquifer from the Castrogi or Nedern Brooks' (Lawrence et al 2013). The Nedern Brook is known to have a discrete sink at the 'Cwm' (Figure 12) and will also dry up along much of its lower reach (Figure 13).

Figure 12 Nedern Brook sinking to the base of the river, at the Cwm (1.5.2015). The concrete river channel is still visible however it does not restrict the water from sinking to ground. (P915235) © BGS NERC.
