Cyngor Sir Fynwy

### Adroddiad Ymchwilio Llifogydd Adran 19

# Cil-y-coed

Chwefror 2020

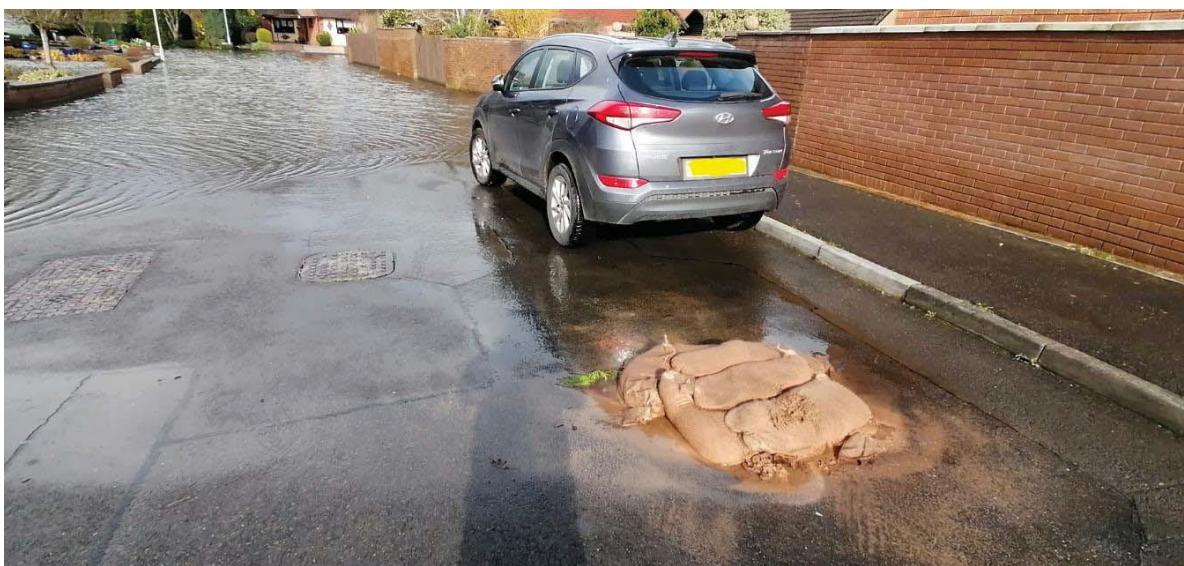
y cam hwn roedd y llifogydd yn Castle Lodge Crescent yn dod o Nant Nedern. Mae adroddiadau preswylwyr yn sôn am broblemau llifogydd o 9.30am ymlaen. Roedd llifogydd yn Castle Lea yn dod o dwll gwaith oedd yn gorlifo dŵr wyneb a soniodd preswylwyr am broblemau llifogydd o ddiwed y prynhawn ymlaen. Parhaodd galwadau i Gyngor Sir Fynwy am gymorth i'r prynhawn a gyda'r nos ar y dydd Sadwrn ac fe wnaeth y lefelau dŵr barhau i godi. Yn Castle Lea roedd y llifogydd i ddechrau ar ffyrdd y stad ond yna yn ymledu i adeiladau allanol ac yna erbyn yn hwyr gyda'r nos, i mewn i anheddu. Er presenoldeb Swyddogion Cyngor Sir Fynwy yn dosbarthu bagiau tywod a Gwasanaeth Tân ac Achub De Cymru, mae sylwadau am ddosbarthu bagiau tywod yn dweud nad oedd yn bosibl atal y lifodd parhaus o dwll gwaith dŵr wyneb ger cyffordd Jolyons Court a Castle Lea.

Ffotograff 2: Yn dangos y twll gwaith yn gorlifo dŵr wyneb yn Castle Lea, a dynnyd ar 1 Mawrth 2020

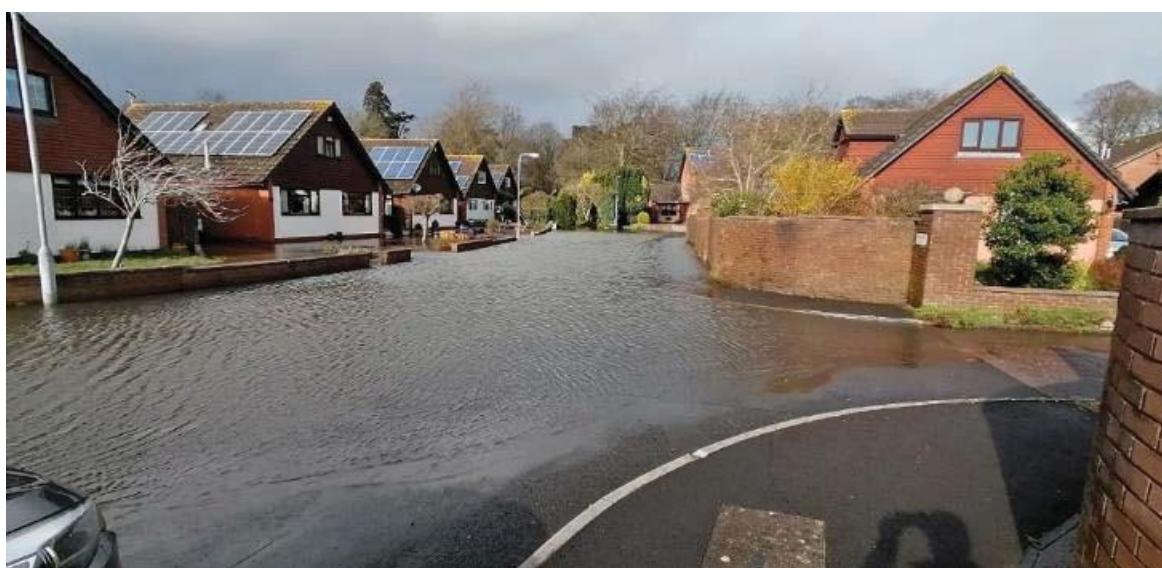
Ffotograff 3: Yn dangos maint llifogydd yn Castle Lea a Jolyons Court, a dynnyd ar 1 Mawrth 2020.

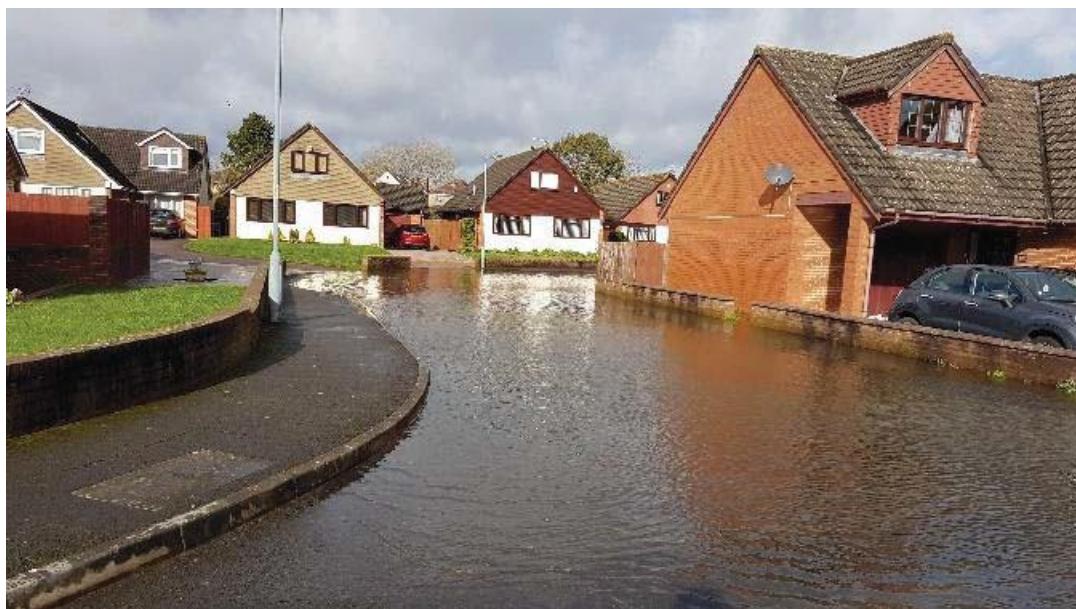
Llun 4: Yn dangos maint y llifogydd yn Castle Lea, a dynnwyd ar 1 Mawrth 2020

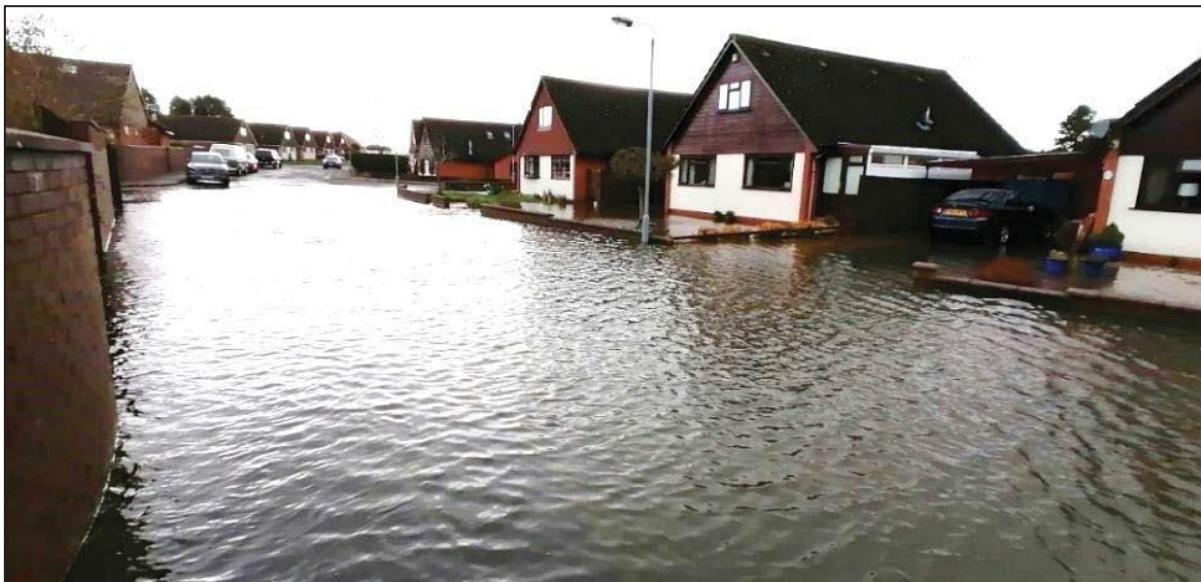
Yn ogystal â'r cyfyngiad ar y llif a achoswyd gan y blociad yn sgrin Highways England, mae adroddiadau lleol wedi awgrymu fod tyfiant gormodol a lefelau gwrthdro uwch rhwng tiroedd y Castell a chwl fert yr M4 wedi gostwng capasiti y sianel dros gyfnod ac yn cyfyngu'r llif ymhellach. Dylid ystyried cynnal asesiad manwl o gapasiti'r sianel, lefelau gwrthdro a strwythurau ar ei hyd i ddynodi unrhyw gyfyngiadau sylweddol i'r llif ar hyd y darn yma o Nant Nedern.

**Ffotograff 7: Yn dangos maint y llifogydd yn Castle Lea yn edrych o'r de o Jolyons Court a dynnyd ar 1 Mawrth 2020**

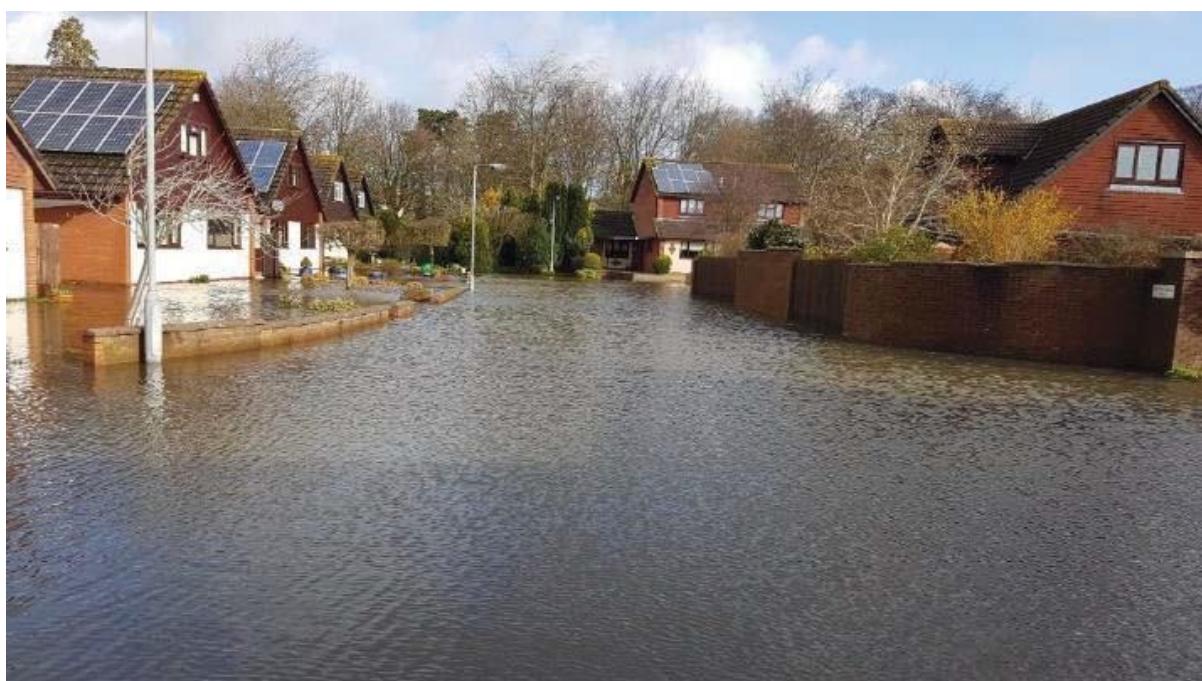
**Ffotograff 8: Yn dangos maint y llifogydd yn Castle Lea yn edrych i'r gogledd o Jolyons Court, a dynnyd ar 1 Mawrth 2020.**

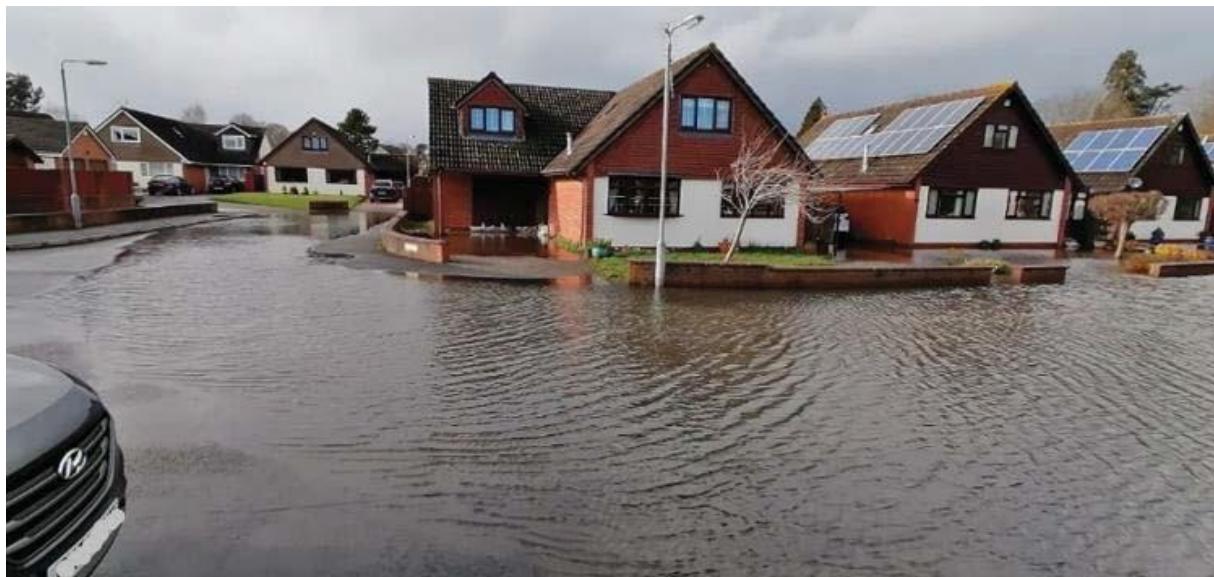
Ffotograff 9: Yn dangos maint y llifogydd yn Castle Lea yn edrych i'r gorllewin, a dynnwyd ar 1 Mawrth 2020

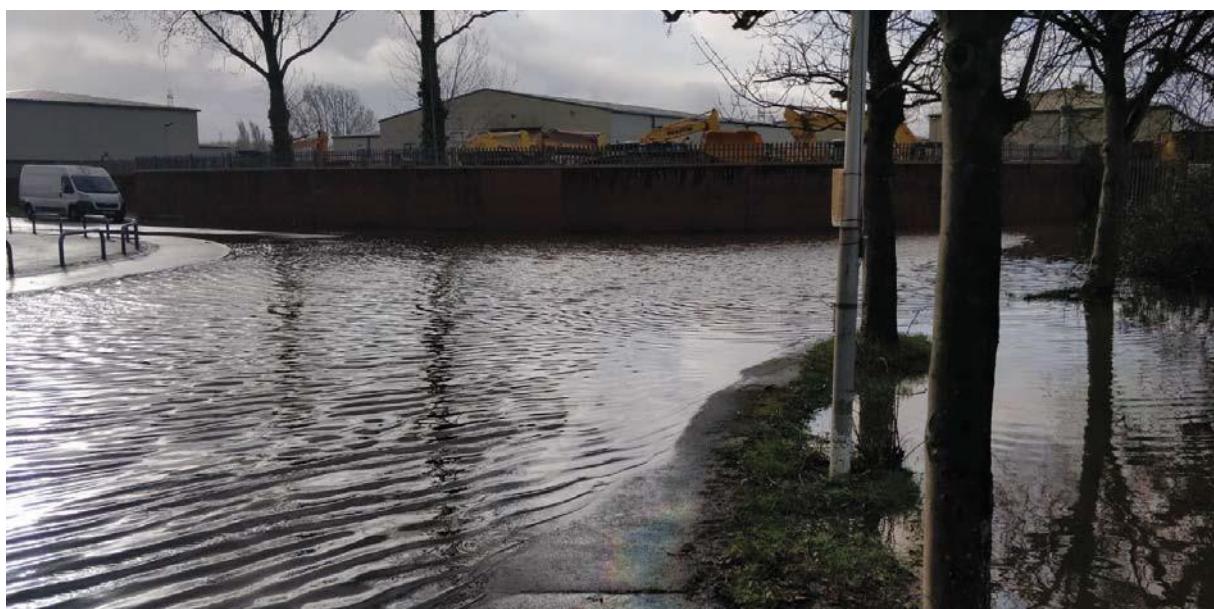
Ffotograff 10: Yn dangos lefelau llifogydd ddydd Sul 1 Mawrth 2020 yn yr ardal fasnachol

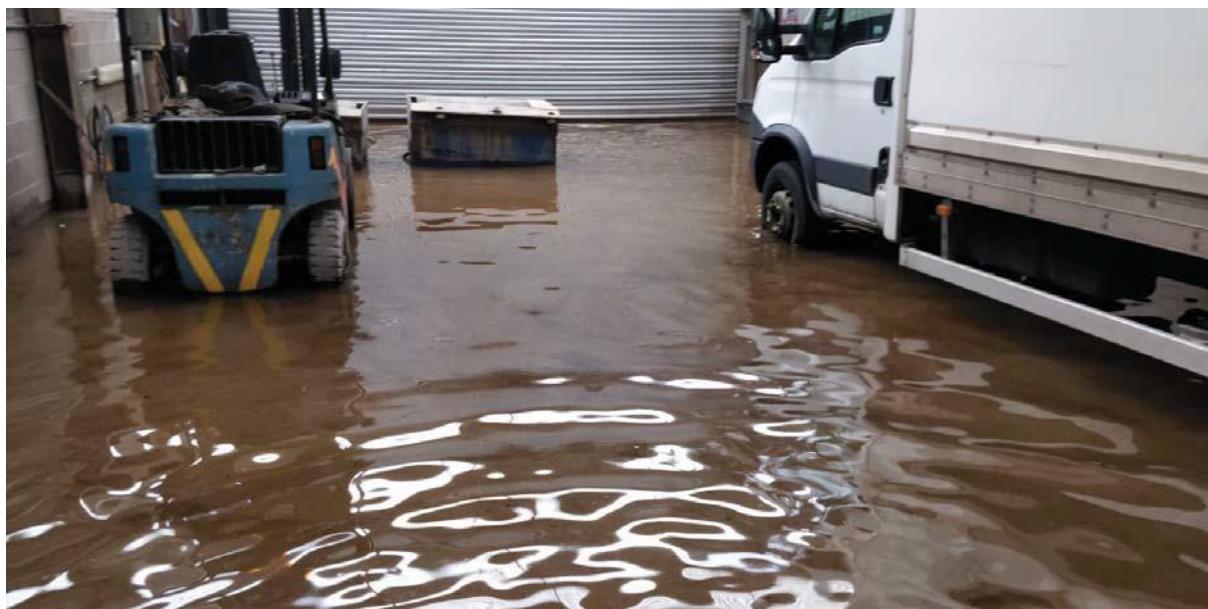
Ffotograff 11: Yn dangos lefelau llifogydd ddydd Sul 1 Mawrth 2020 yn yr ardal fasnachol

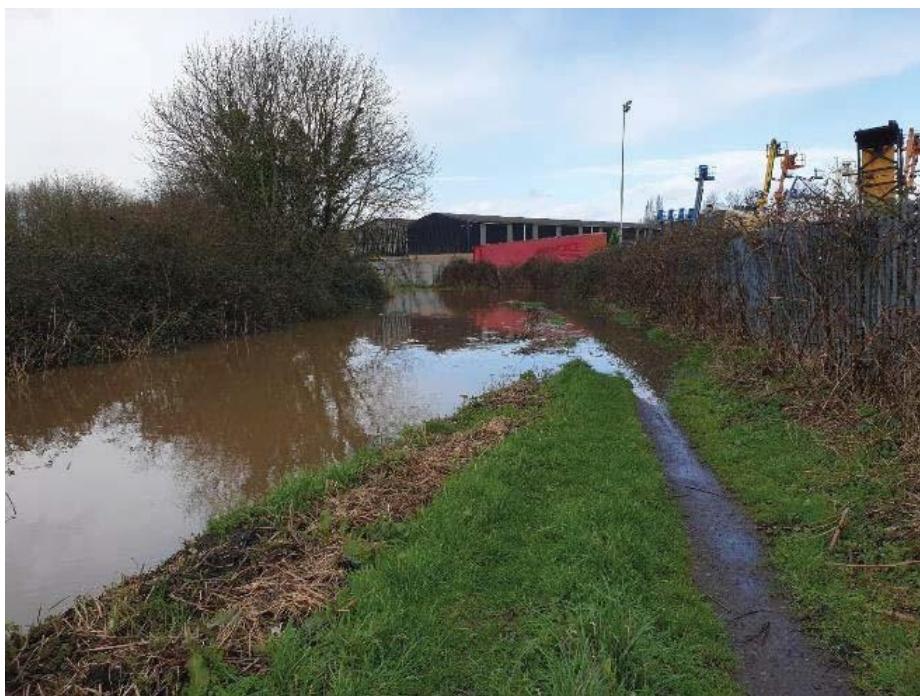
**Ffotograff 13:** Yn dangos lefel dŵr yn Nant Nedern yn edrych i'r gogledd ddydd Sul 1 Mawrth 2020 ger Symondscliff Way

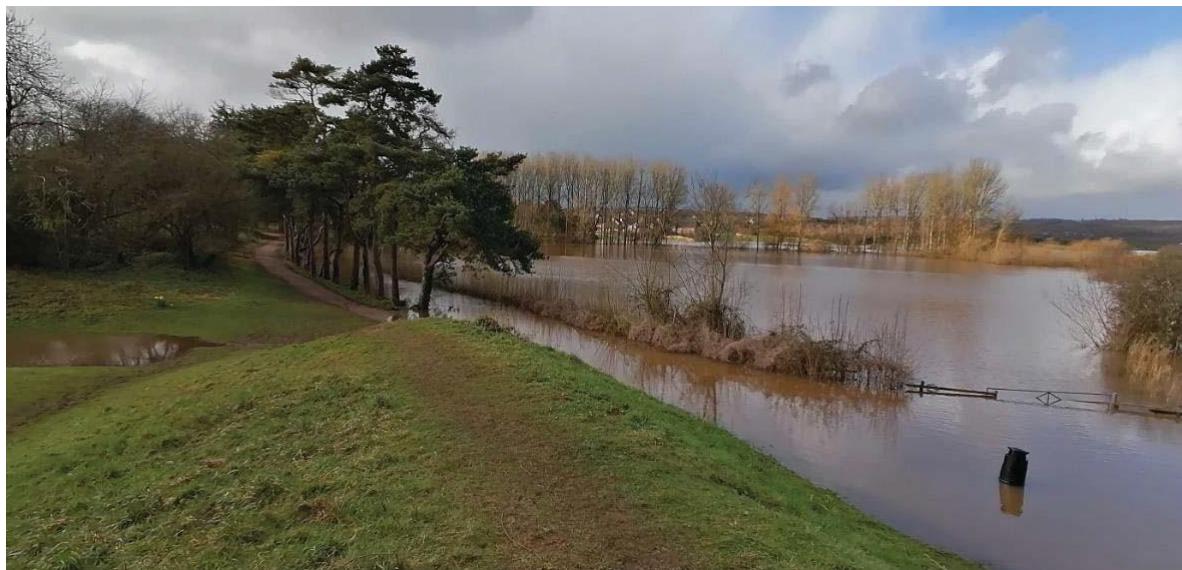
Ffotograff 14: Nant Nedern mewn llifogydd a dynnwyd ddydd Sadwrn 1 Mawrth 2020

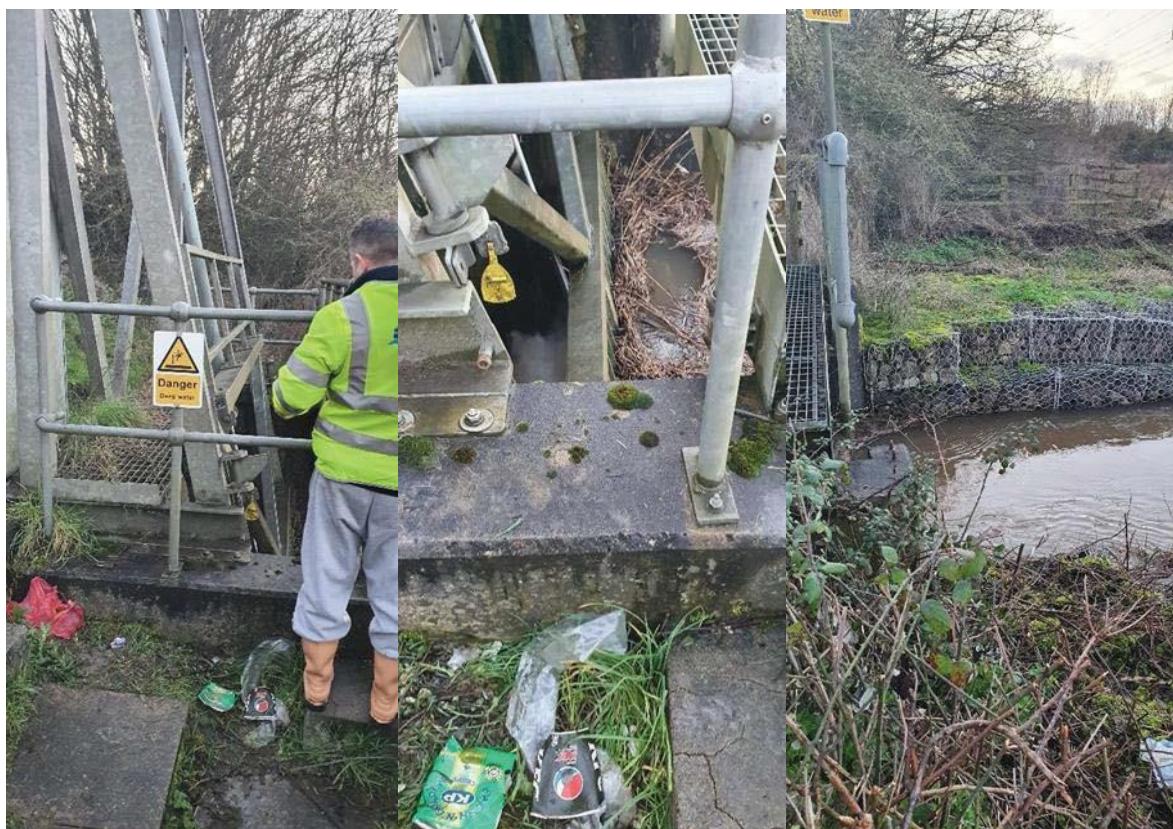
Ffotograffau 15, 16, a 17: Staff Highways England wrth y Sgrin frigau ym mis Mawrth 2020 hefyd yn dangos peth o'r malurion

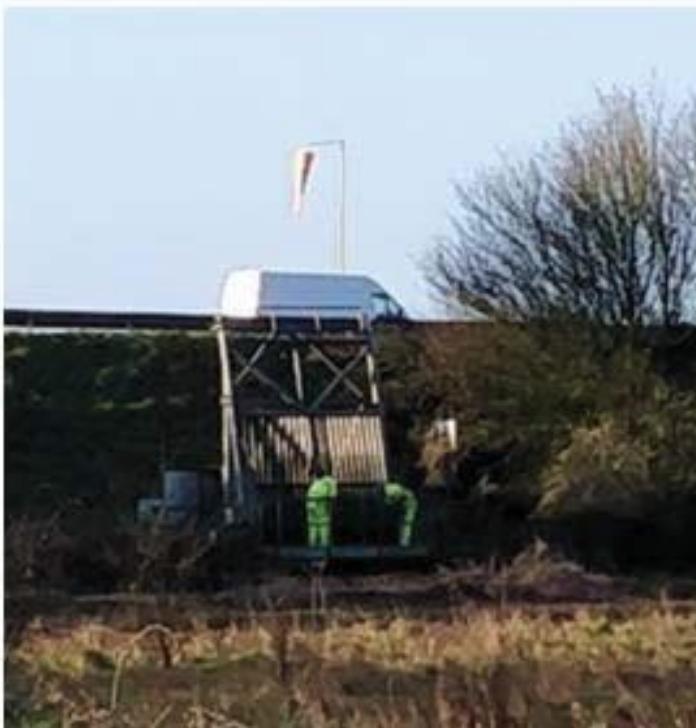
Ffotograff 18: Y sgrin wrth y fynedfa i'r cwlfert dan draffordd yr M4, i'r de o'r ardaloedd masnachol, a dynnwyd ddydd Sul 1 Mawrth 2020

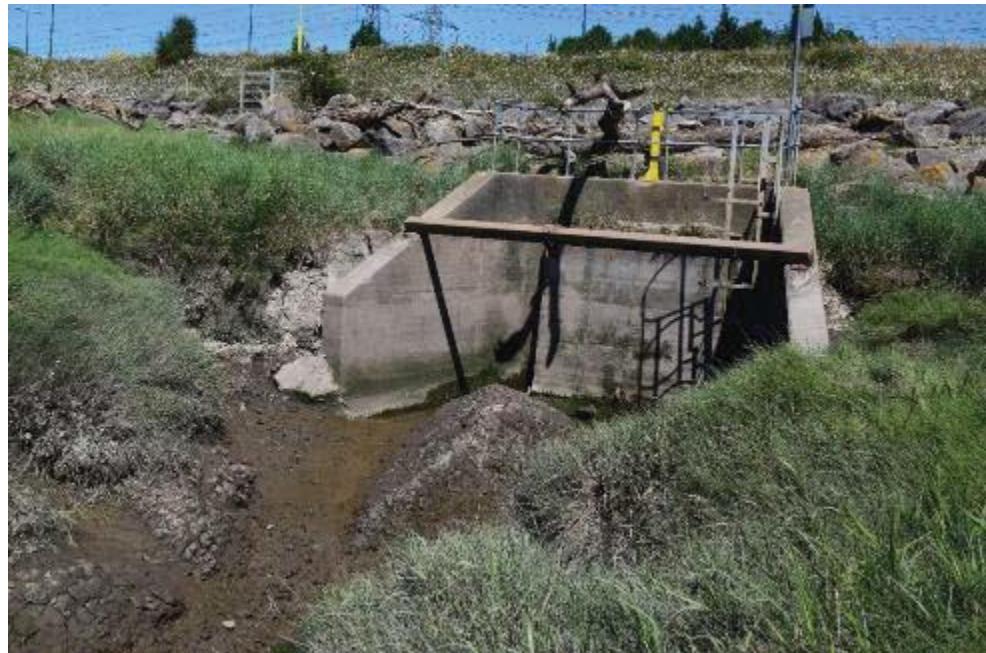
Ffotograff 19: Y drws môr lle mae Nant Nedern yn arllwys i Afon Hafren, tynnwyd  
Mehefin 2020

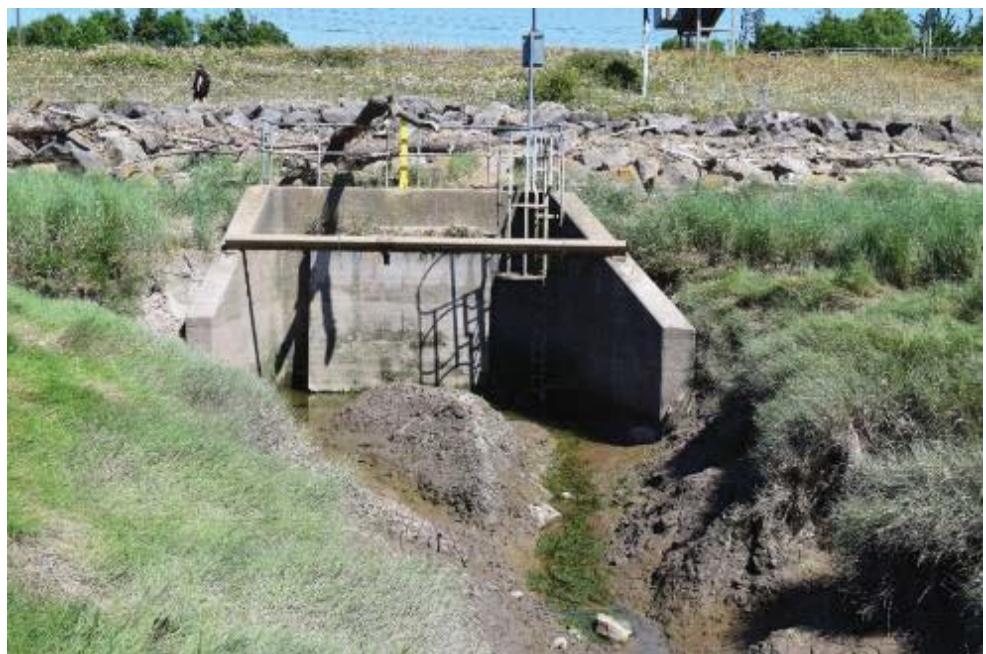
Ffotograff 20: Y drws môr lle mae Nant Nedern yn arllwys ac yn dangos gwaddod  
llaid o flaen y drws, tynnwyd ym Mehefin 2020

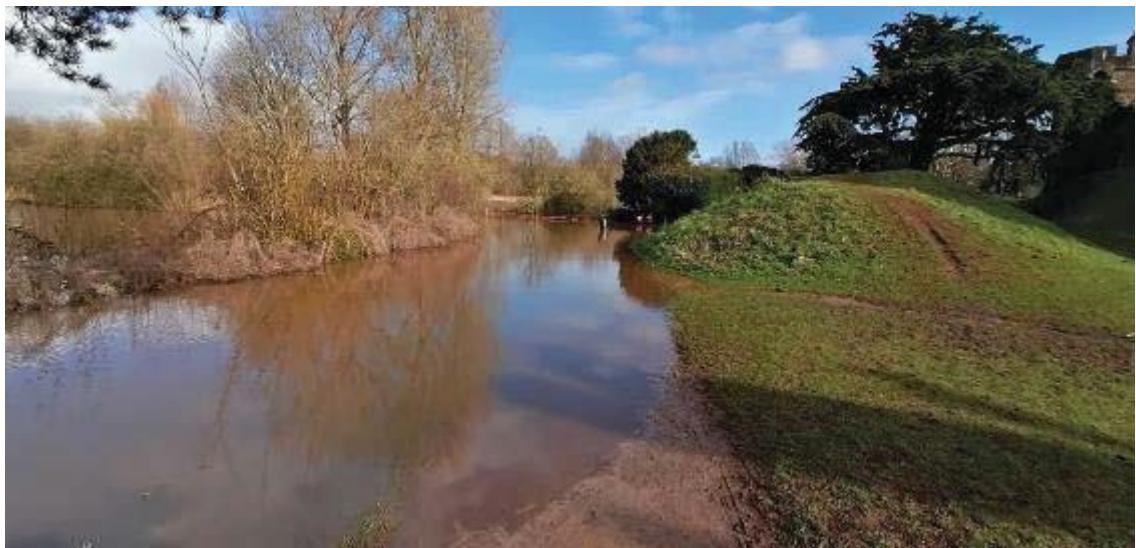
Ffotograff 22: Yn dangos lefelau llifogydd yn Nant Nedern, a dynnwd ar 1 Mawrth 2020 yn y Parc Gwledig

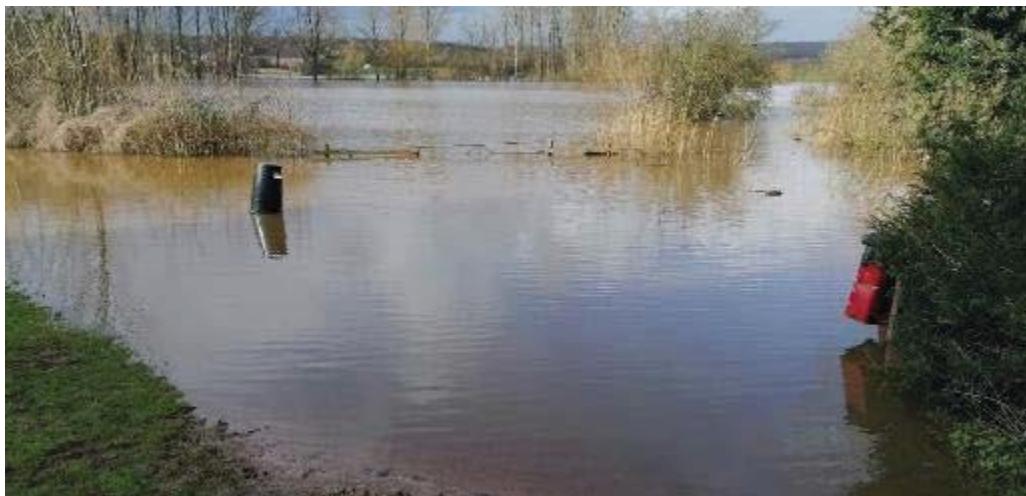
**Ffotograff 23: Yn dangos lefel y llifogydd yn y Parc Gwledig, tynnwyd ar 1 Mawrth 2020**

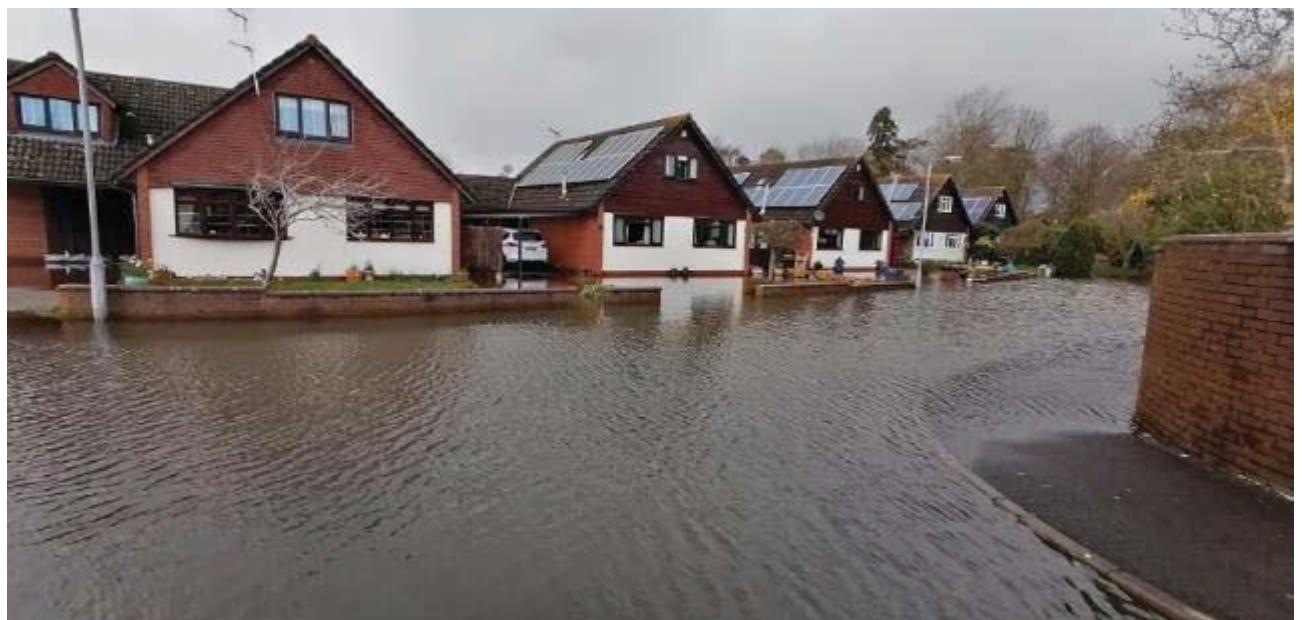
**Ffotograff 245: yn dangos y llifogydd yn Castle Lea yn edrych i'r gogledd o Jolyons Court ddydd Sul 1 Mawrth 2020**

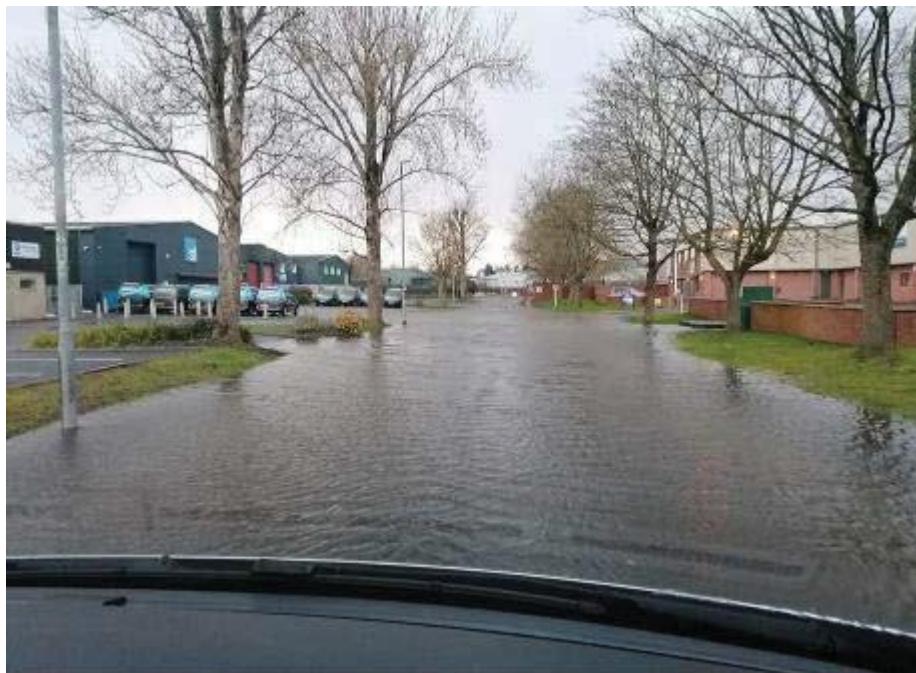
Ffotograff 24: Yn dangos llifogydd yn Normans Way yn edrych i'r gorllewin tuag at Nant Nedern, dydd Sul 1 Mawrth, diolch i SD Sealants

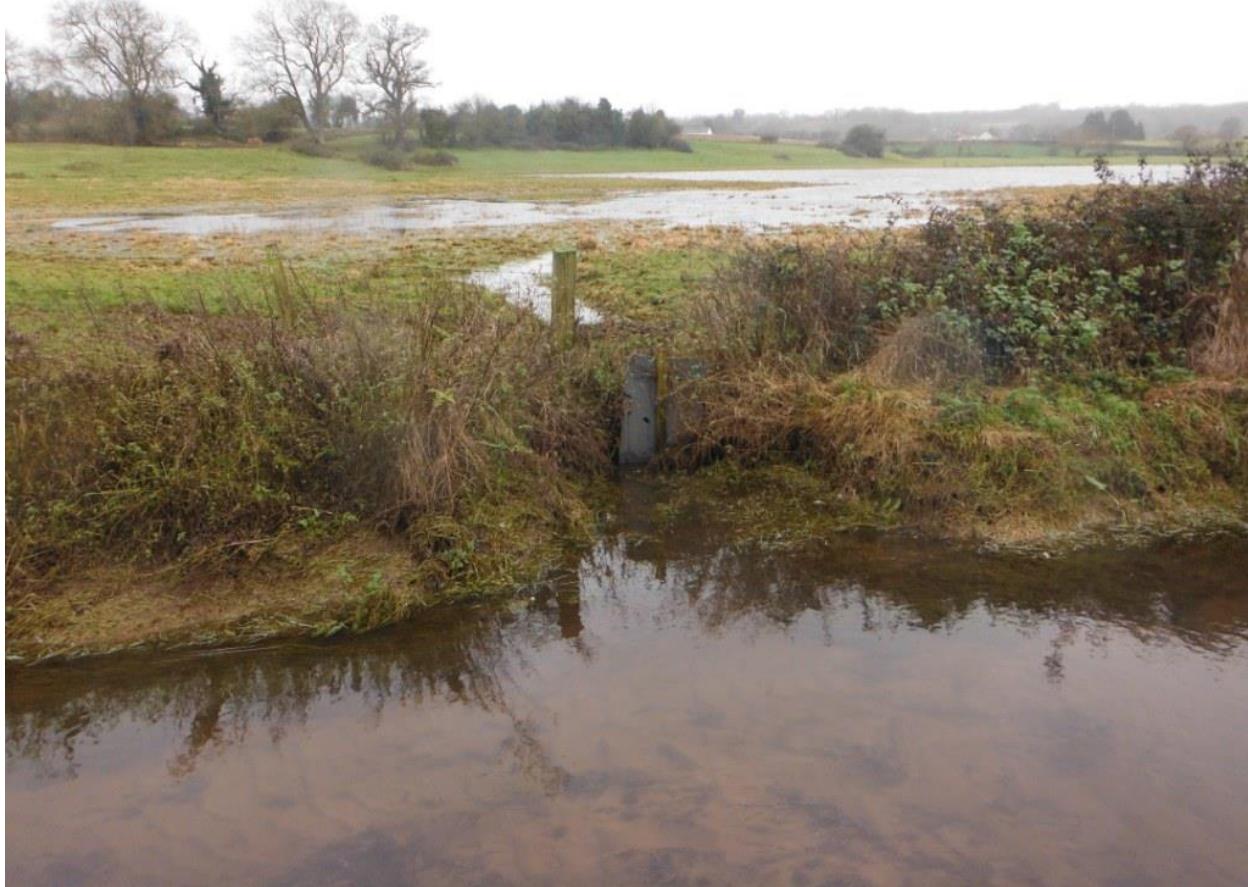
**Figure 4 Flooding initiated on the banks and floodplains drains into the Nedern Brook (P915242) © BGS NERC.**

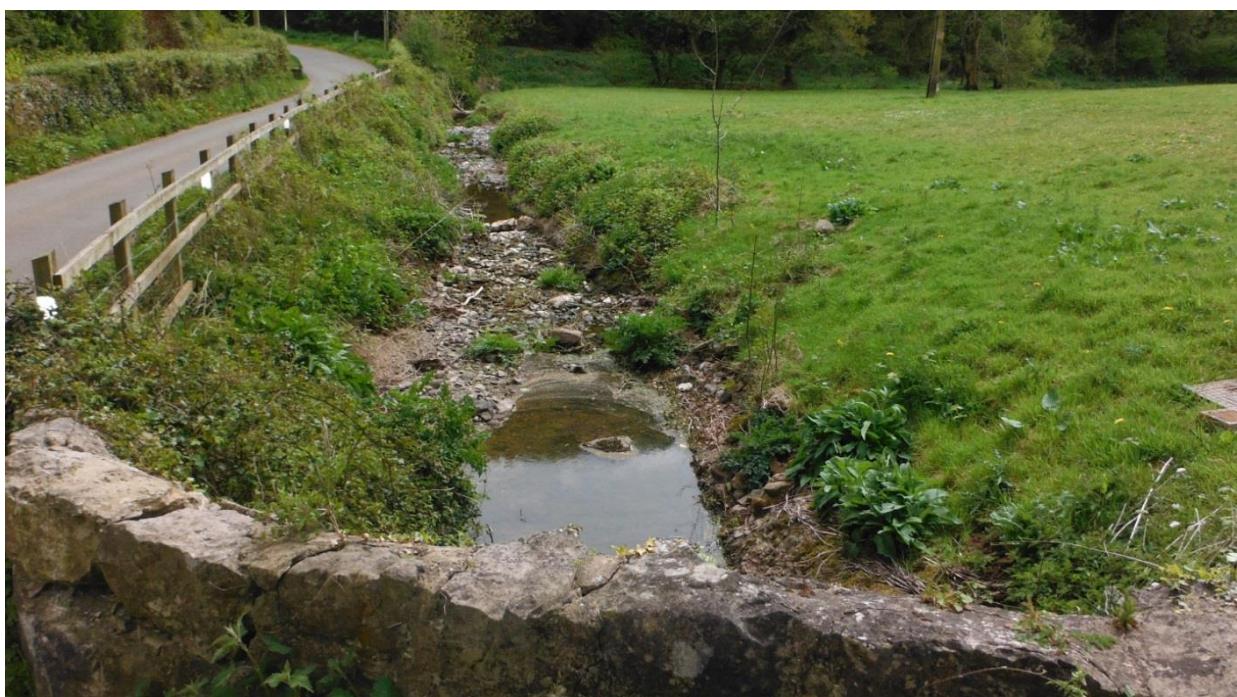
The concrete river channel was installed to minimise water loss to ground and to reduce flow to the Great Spring. It was constructed in just a few months between August and October 1883, (Walker, 1888). The channel was constructed on the upper part of the Nedern Brook from the Cwm (ST4591093175) and Ridge Farm (ST4609509461) for a distance of 3 km. There are no concrete sections within the wetland SSSI boundary. Haskoning UK Ltd (2013) recommended that a survey was undertaken to assess the state of the concrete channel. Although this was not done during this project a similar survey had been undertaken for Environment Agency Wales as part of the Great Spring work (Lawrence et al 2013). The survey showed that the concrete channel was still visible over much of the original 3 km reach however the concrete bed ‘is now in a poor state of repair and it is considered unlikely to prevent recharge to the aquifer from the Castrogi or Nedern Brooks’(Lawrence et al 2013). The Nedern Brook is known to have a discrete sink at the ‘Cwm’ (Figure 12) and will also dry up along much of its lower reach (Figure 13).

**Figure 12 Nedern Brook sinking to the base of the river, at the Cwm (1.5.2015). The concrete river channel is still visible however it does not restrict the water from sinking to ground. (P915235) © BGS NERC.**

- A walkover of the Nedern and Castrogi Brook showed that the Victorian concrete lined channel was in a poor state of repair and is very unlikely to prevent surface water loss into the aquifer.

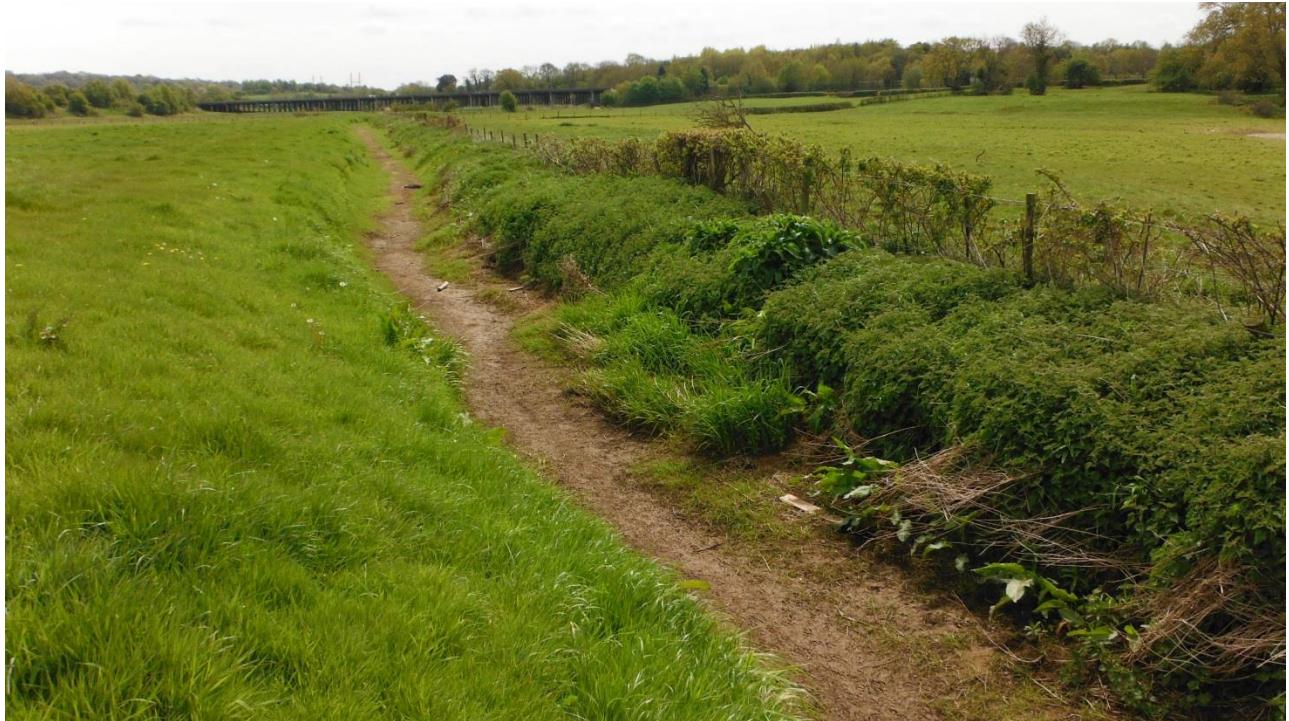
**Figure 13 Nedern Brook (dry) looking south towards the M48 road bridge 1<sup>st</sup> May 2015. © BGS NERC. P917085.**
