R1 Cwmyoy Landslip

Geotechnical Inspection Report

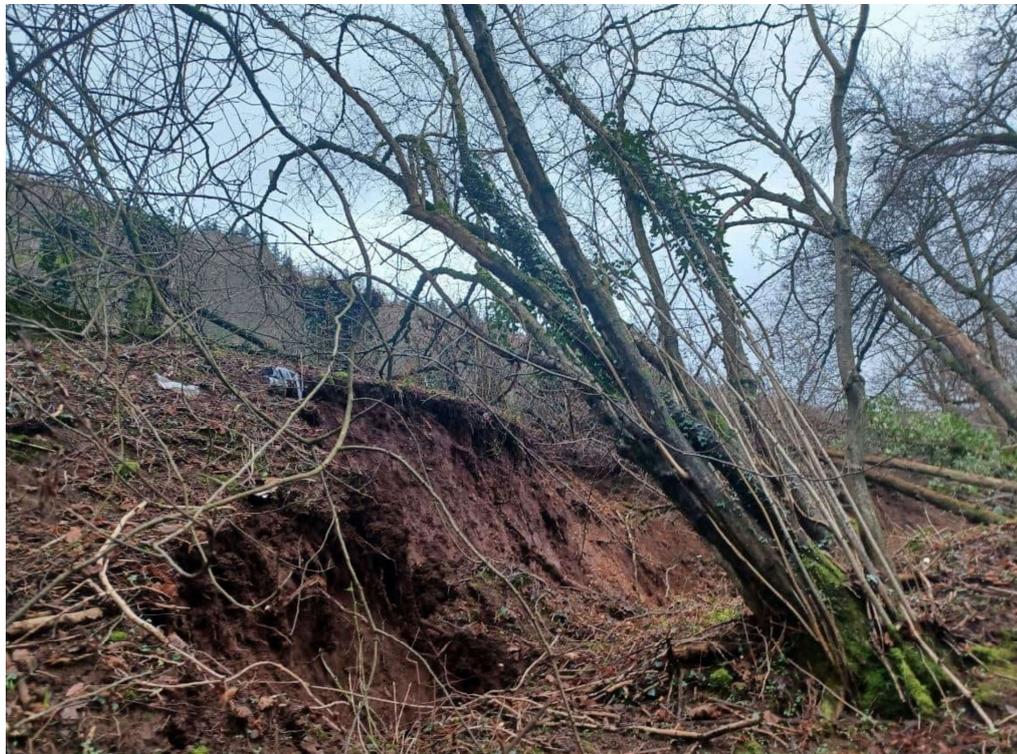
During the initial inspection the backscarp was approximately 1m from the edge of the carriageway at the rear of the hedge and fence. A number of trees had fallen across the road which were being removed at the time of the inspection (cut off to the hedge line).

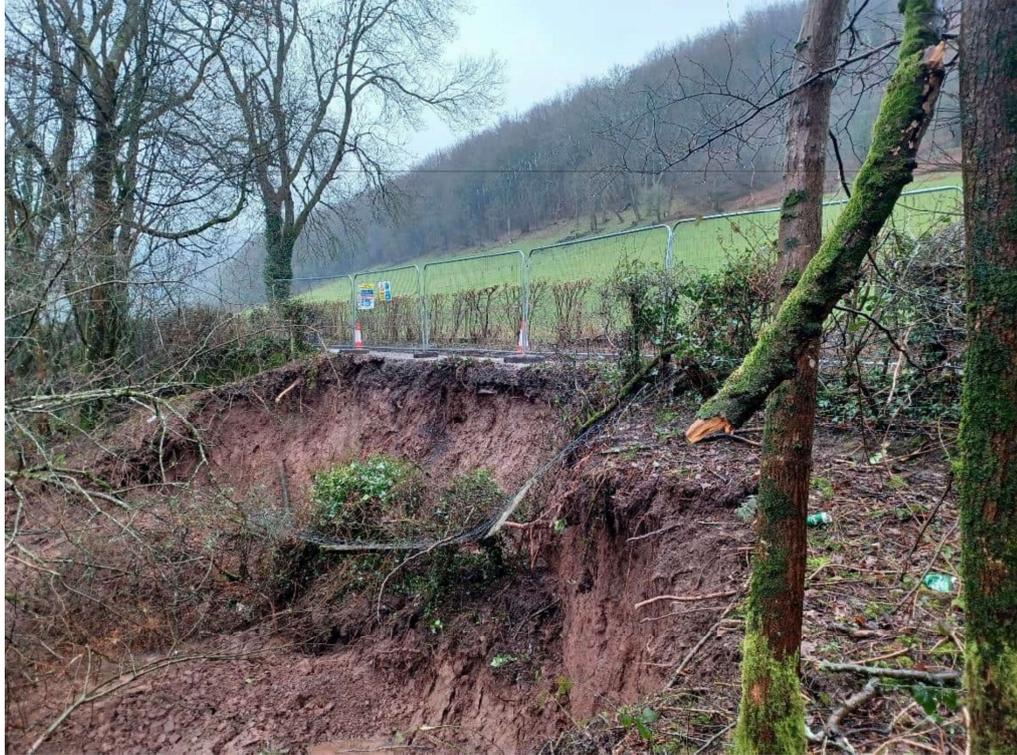
During the second inspection undertaken on 03/02/2026 the backscarp had regressed to the edge of the carriageway, totally removing the fence and hedge line.

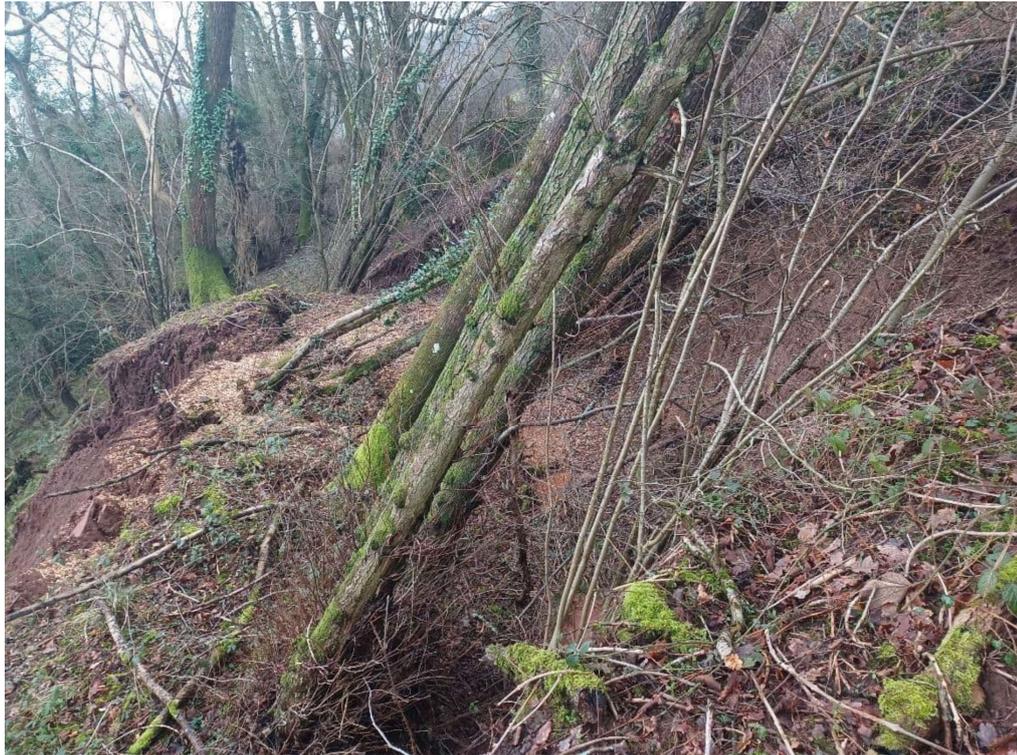
During the first visit the slip bowl contained a significant mass of saturated slipped debris containing large trees which had the potential to impact the road.

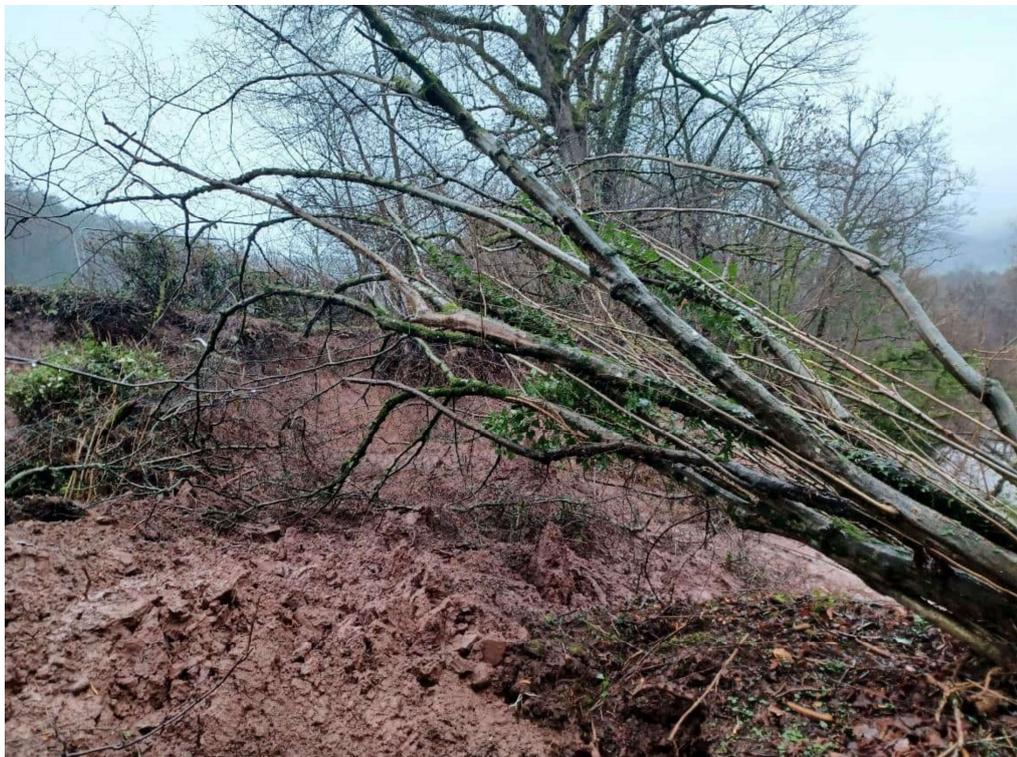
During the second visit, a significant amount of this slipped debris, including the majority of the trees had failed downslope into the river.

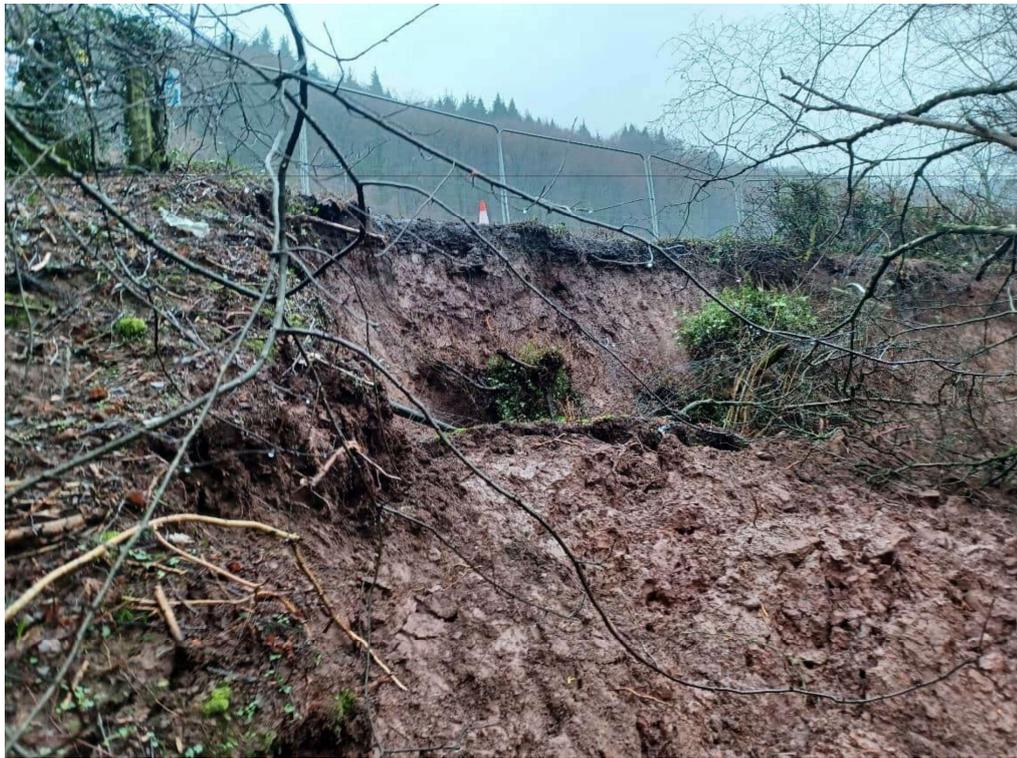
Below the edge of the carriageway there is a 3m vertical drop where some saturated debris remains in the slip bowl.

Due to the steep vertical face under the existing road edge, it is essential that vehicles and pedestrians are excluded from the area as a failure of the slope will continue to regress and undermine the road surfacing.

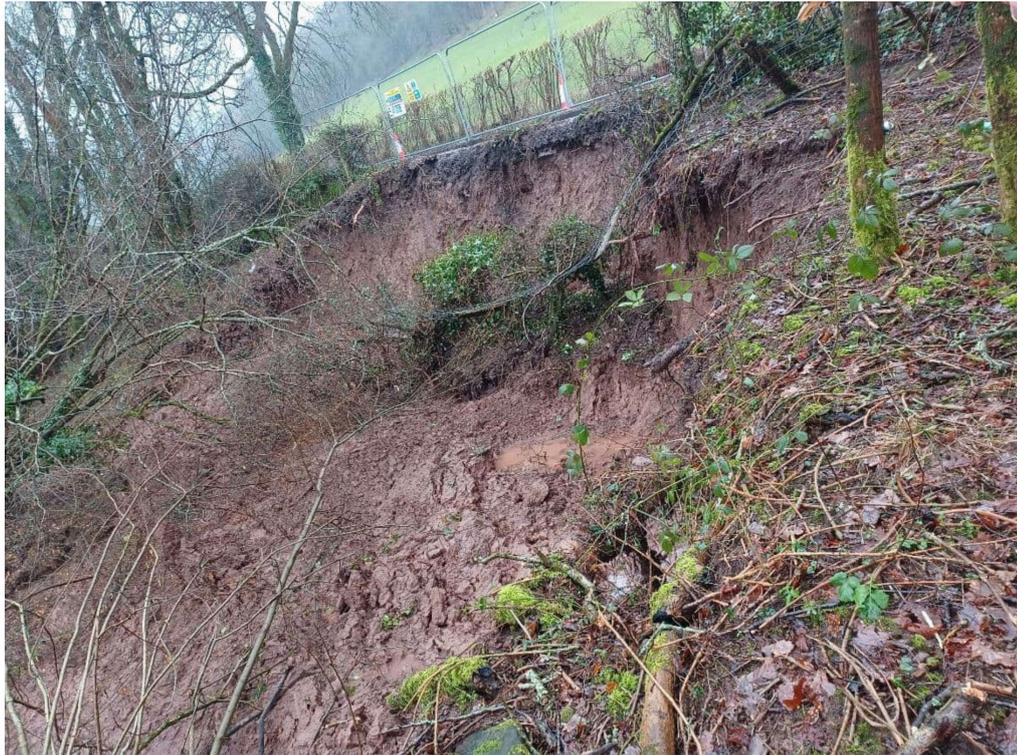
The backscarp has exposed road surfacing and slightly undermined the road in places overlying weathered mudstone materials. Water was noted issuing from the backscarp particularly on the upstream side.

Active water issues were noted in the backscarp, which were continuing to saturate debris remaining within the slip bowl suggesting water ingress from the crest was likely to be a contributing factor. No drainage features (pipes) were identified in the area of the failure. Surface water flows were also forming scour channels through the materials on the slope (gully features).

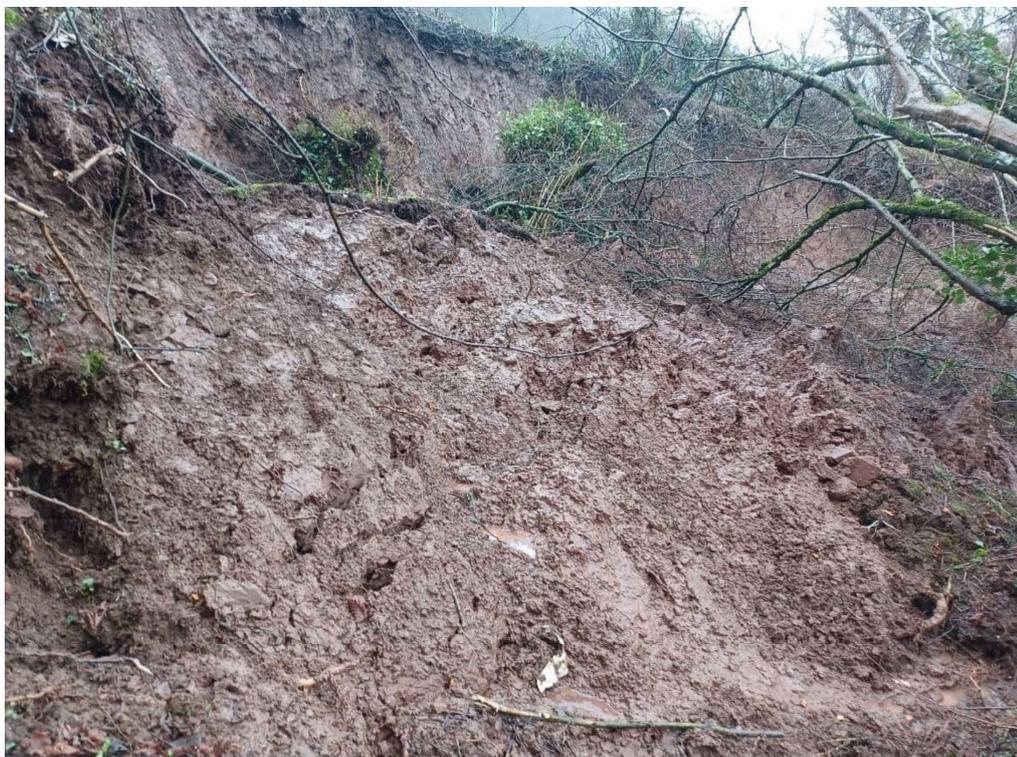
Below the vertical failed section, a slacker slope exists, where some of the slip debris has remained. This material is saturated (very soft, no strength) and has significant tension cracking throughout.

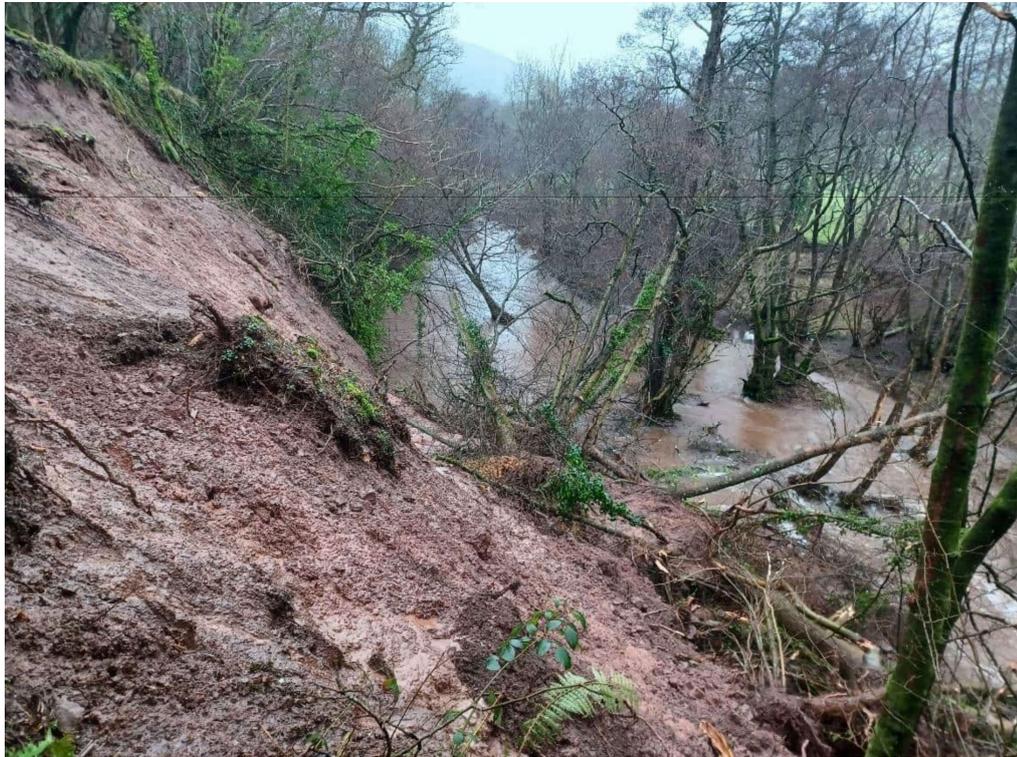
Below the mid slope, less steep section, the slip continues very steeply (estimated around 70 degrees) for around 25m down to the river.

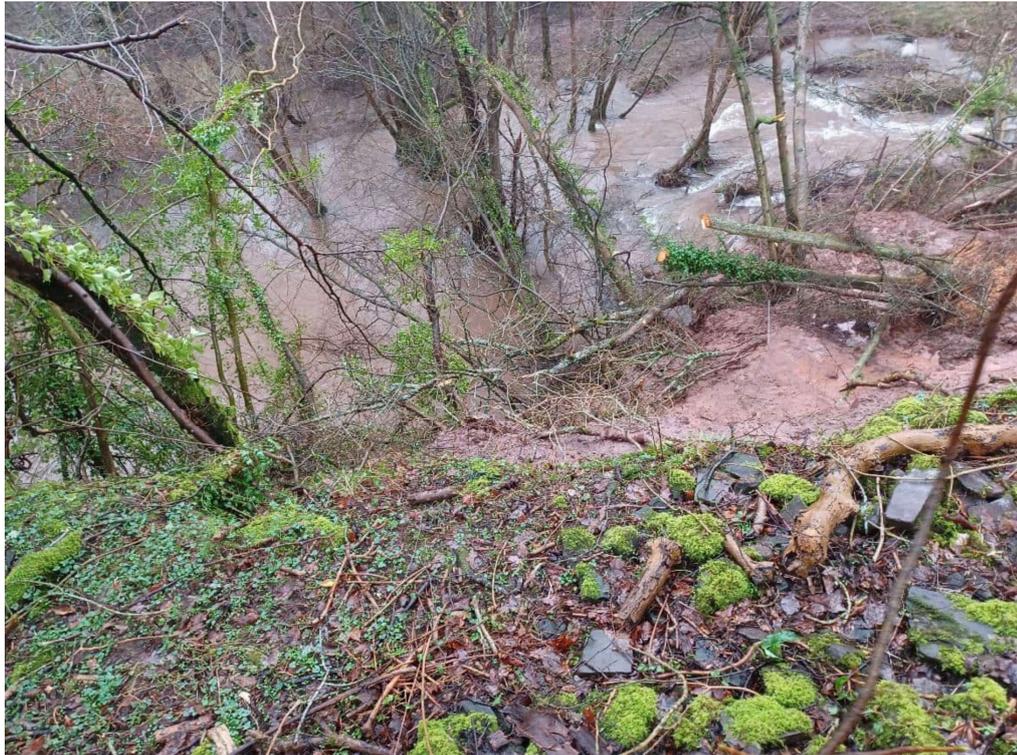
The slip debris width increases below the crest, reaching 30 to 40m at the toe. It was evident that the slip widens below a break in the slope, generally extending upstream of the upper slip bowl. It was also evident during the inspection that tension cracks extended into a flat area immediately adjacent to the slip (break of slope), which from historical records looks like a potential former road alignment, located at a lower level than the existing.

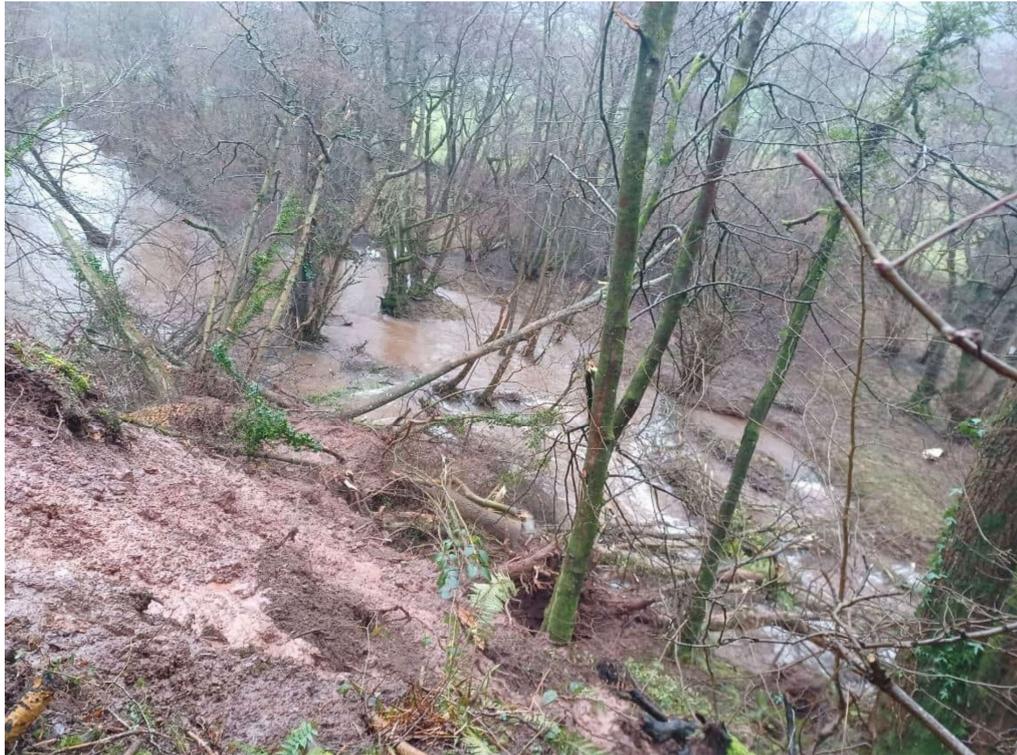
Immediately following the slip, debris would have formed a toe in the river channel, which would have restricted the channel in this area and subsequently has been eroded removing support for the remaining slip debris on the slope. This mechanism continues keeping the landslip active.

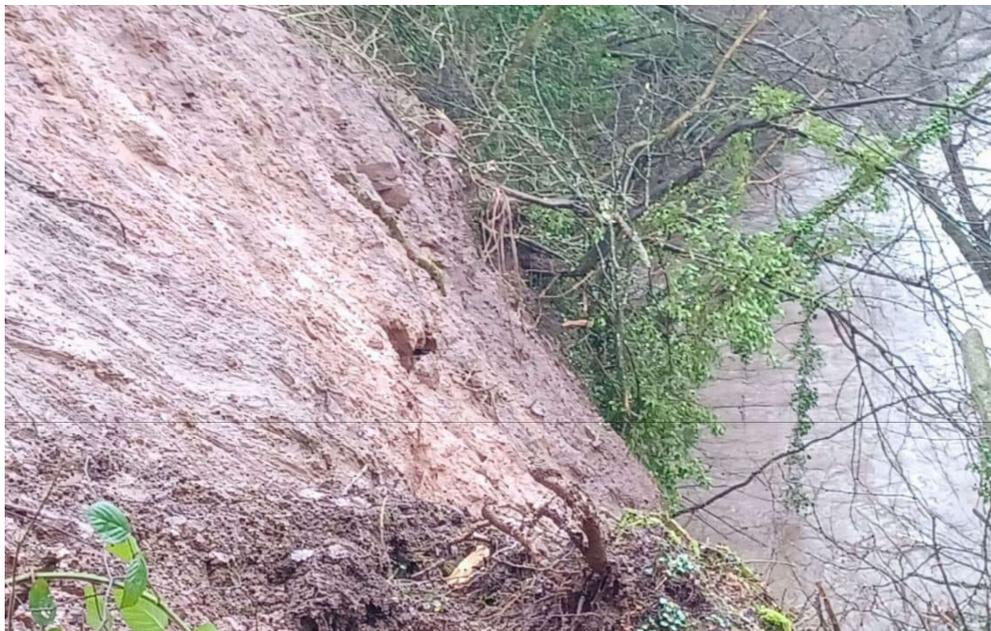
During the inspection a more competent sandstone band was visible in the face of the slip, slightly below the break in slope.

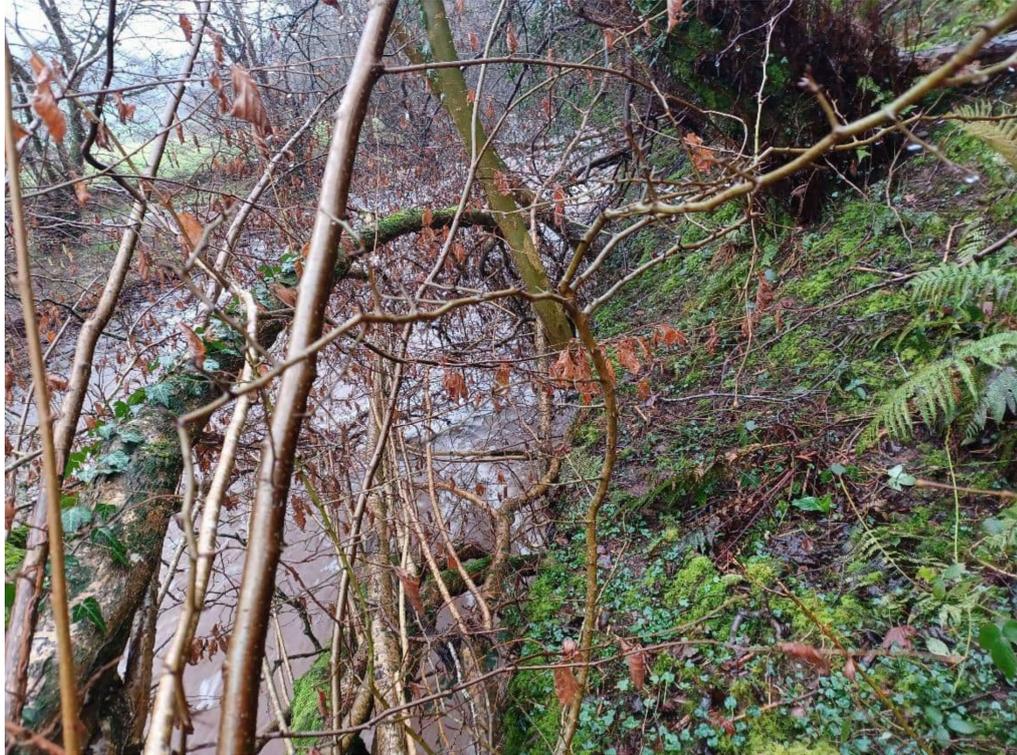
On the downstream side of the debris flow, a “wall” structure is present at the toe of the slope along the edge of the river, but no access was possible to definitely confirm the extents of any damage and or scour. It

should be noted that there was no evidence of a wall at the base of the slipped section.

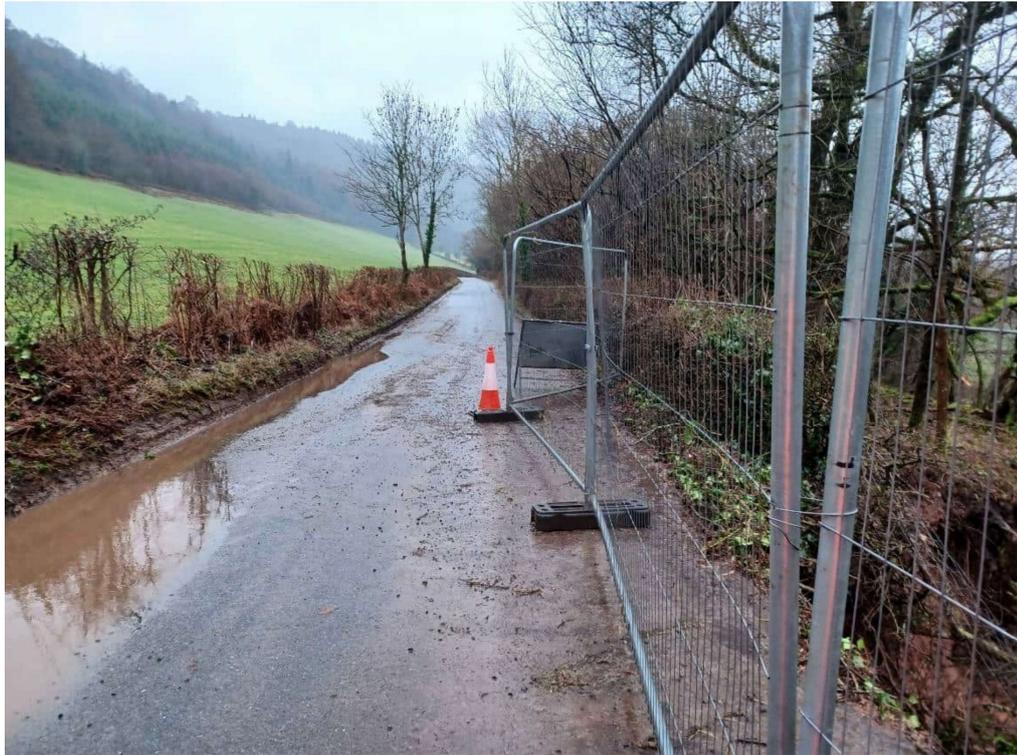
The carriageway along the failed section is located in topographical low and standing water was noted on the uphill side, during the inspection water was actively flowing across the road into the slip bowl further saturating and destabilising the slip debris below.

It is recommended that a line of sand bags are placed along the crest of the slip at the edge of the road to stop surface water from the highway overtopping.

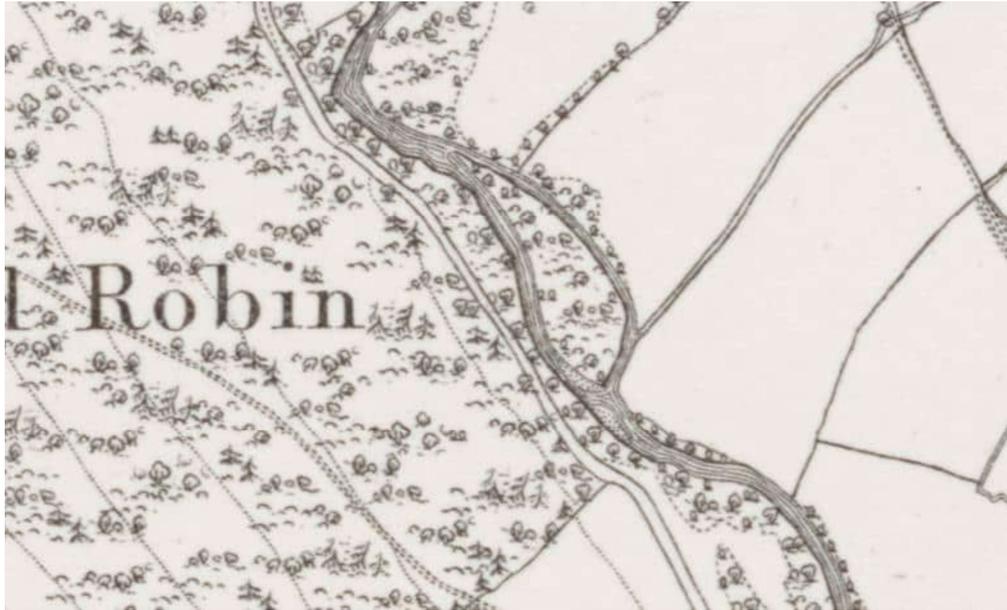
Historical OS mapping available online from the National Library of Scotland shows the site to be slightly different on the 1887 OS six inch map, the highway shown appears to have more bends and be located to the east of the current alignment.

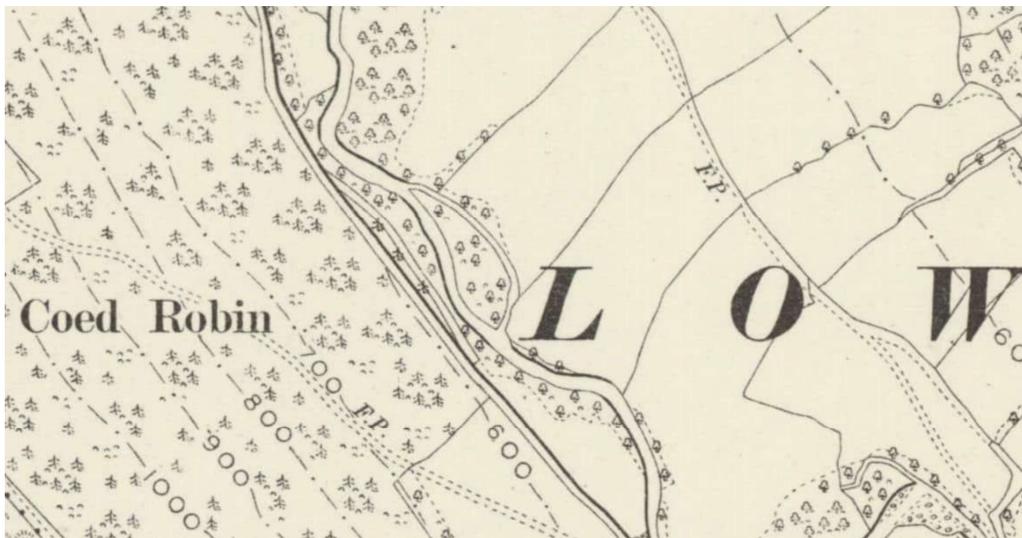
The 1902 OS six inch map shows a new straight road alignment and a further track (abandoned?) to the east side of the new alignment. This suggests that there may have been an issue with this section of the road, and the road realigned.
