# OLD WYE BRIDGE – COMPLETE CLOSURE UPDATE

PRESENTATION TO MONMOUTHSHIRE COUNTY COUNCIL

Presented to MCC | 31<sup>st</sup> March 2026

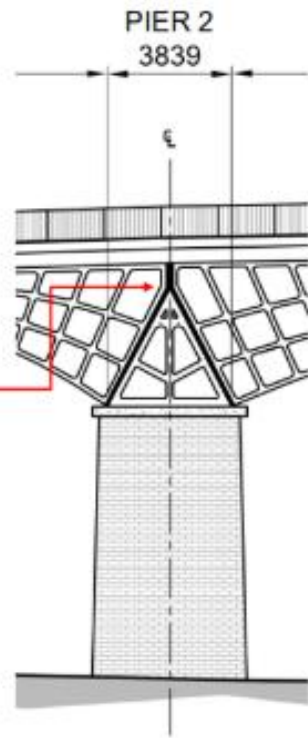
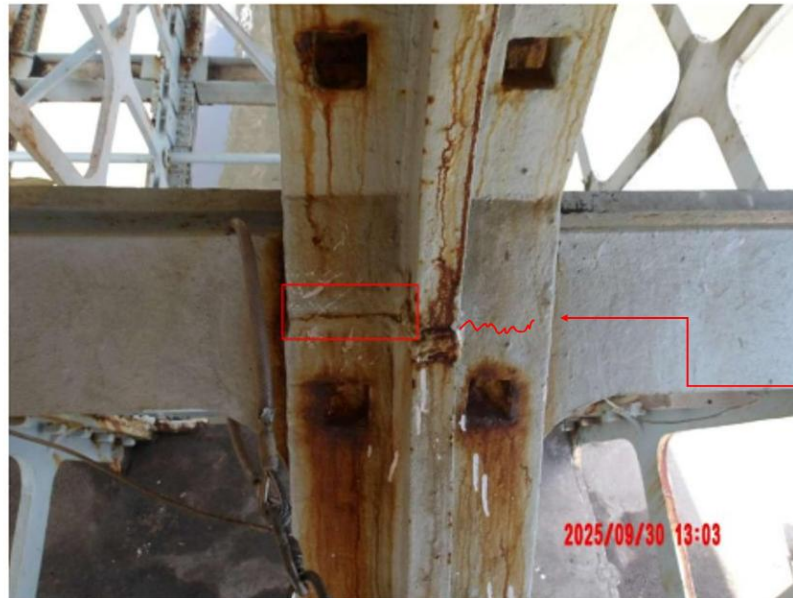
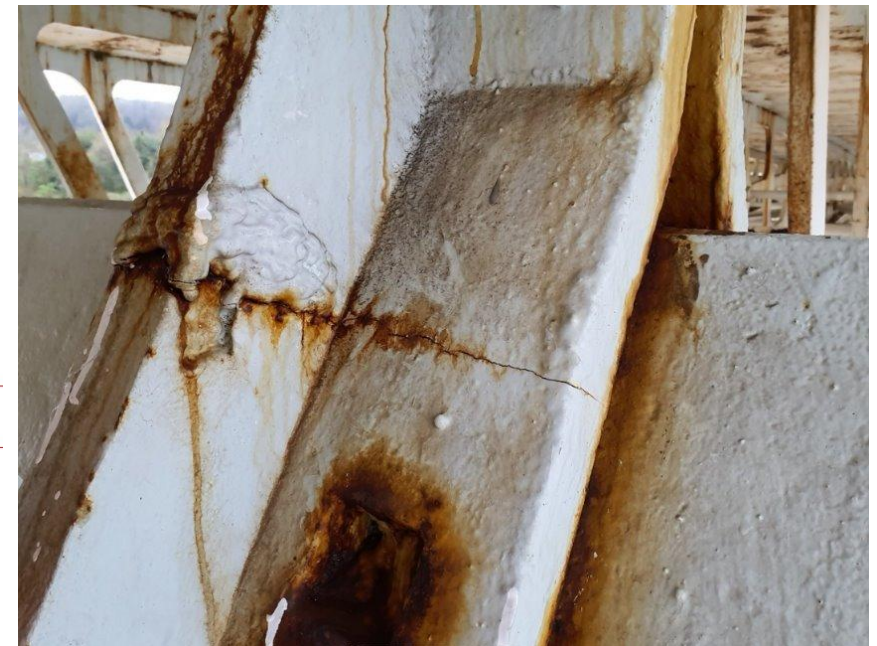
# New Defect (No.1) – Pier 2, Girder 2

Existing crack propagating

- New cracks are most likely to have occurred as the bridge contracted during cold weather over the winter, with the cracks discovered in Oct 2025 due to expansion in hot weather over the summer.

- Cast iron is susceptible to fatigue, so cycles of load/stress from temperature changes and vehicle loads will have accumulated damage in the metal. This means that cracking can occur even at loads that the bridge has previously supported without cracking.

- Install real-time monitoring and cameras under the bridge, so that we can ensure that cracking has not progressed to a point where the capacity of the bridge is compromised. (currently inspections are every 6 months and require costly roped-access teams).
- Calculations of the local stability of support to the road / footway around the cracks.
- Investigation of the concrete slab on the bridge to understand whether this is strong enough to bridge over the damaged components.

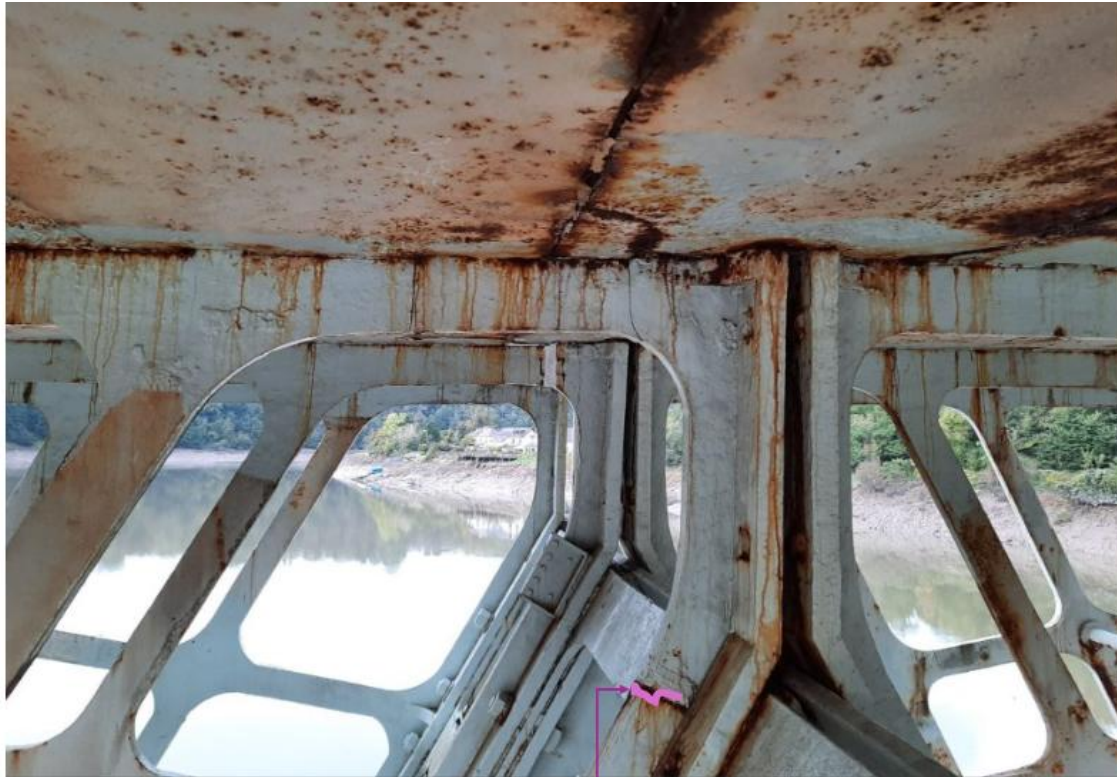
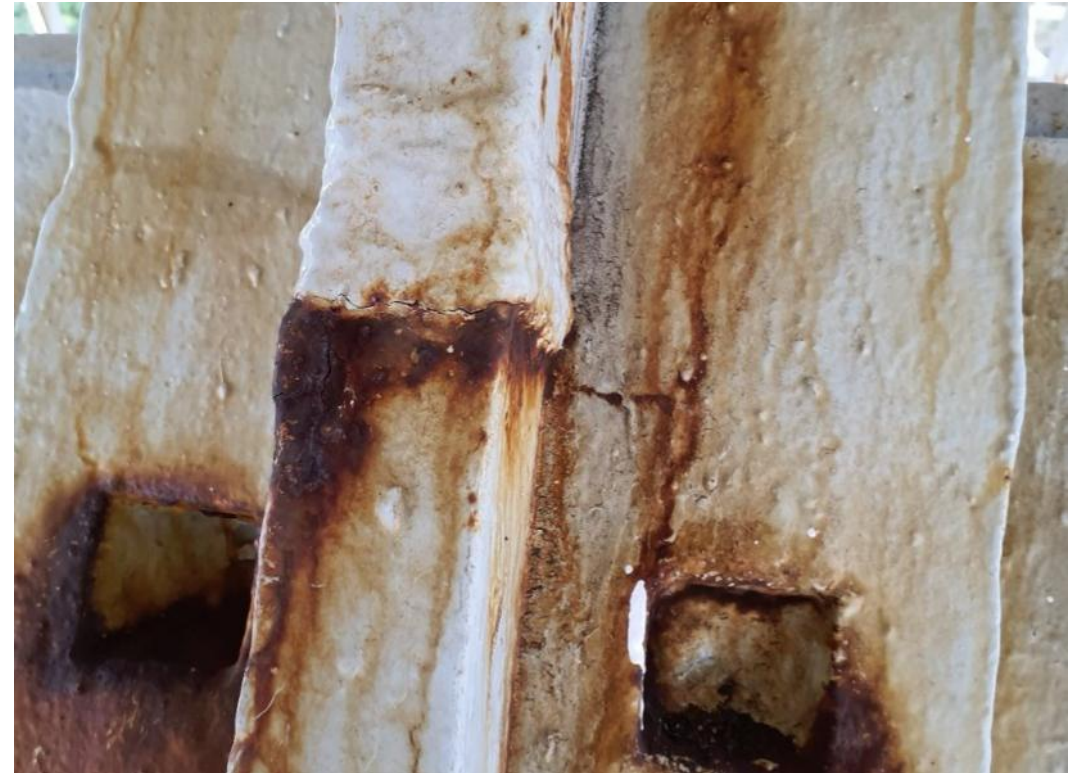
# New Defect (No.2) – Pier 2, Girder 3

New crack location

- The new cracks at Piers 2 and 4 leave a section of the cast iron structure that is disconnected from the bridge by cracks. These sections support cast iron deckplates, that in turn support the road and footways. This results in a loss of support to the deck plates and there is a concern that three of the deck plates in the area over Pier 2 and two deck plates near Pier 4 have a loss of support and that therefore the road/footway in these regions doesn't have adequate support.

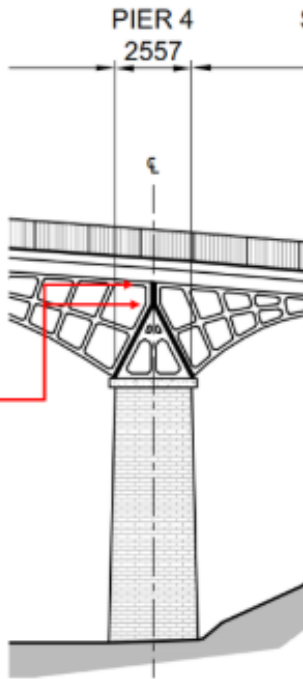
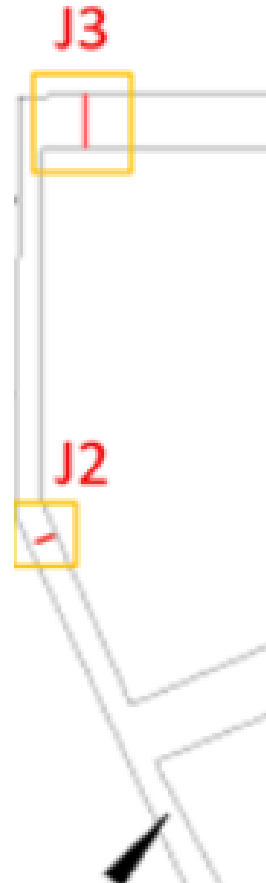
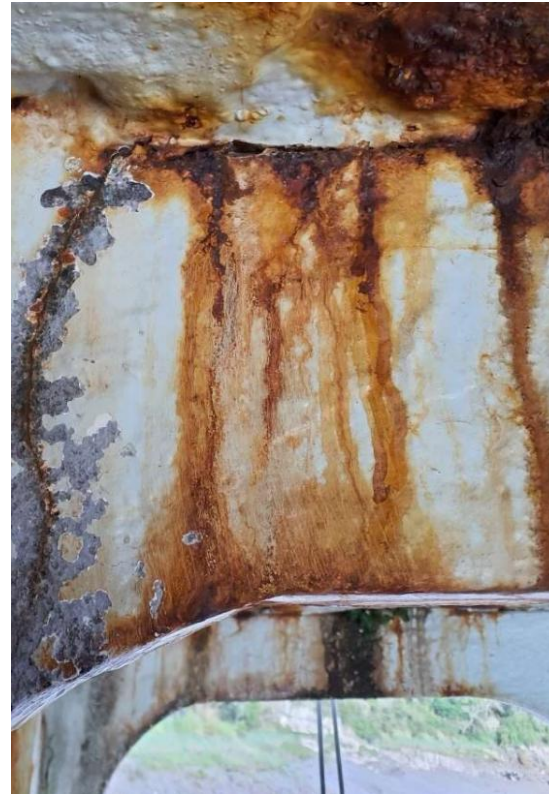
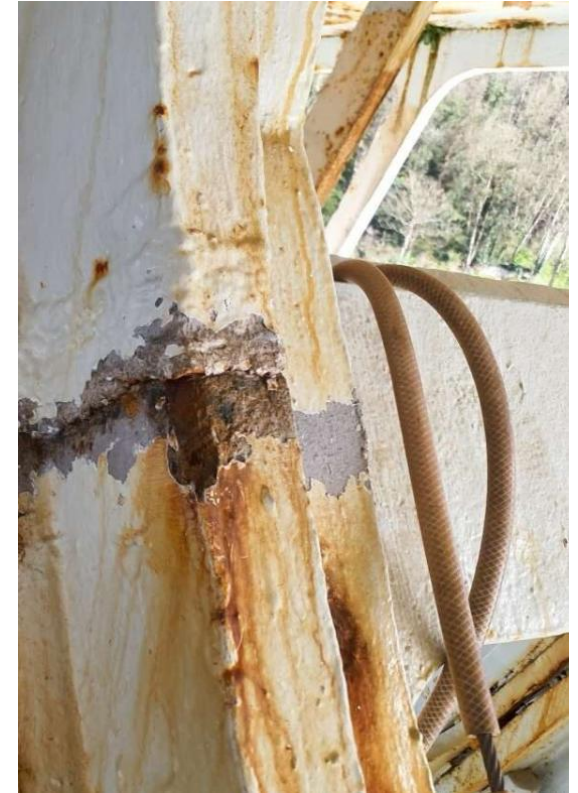
# New Defect (No.3&4) – Pier 4, Girder 2

Areas where new cracks located on welded repairs
