### **Section 19 Flood Investigation Report**

# Woodside, Usk

### February 2020

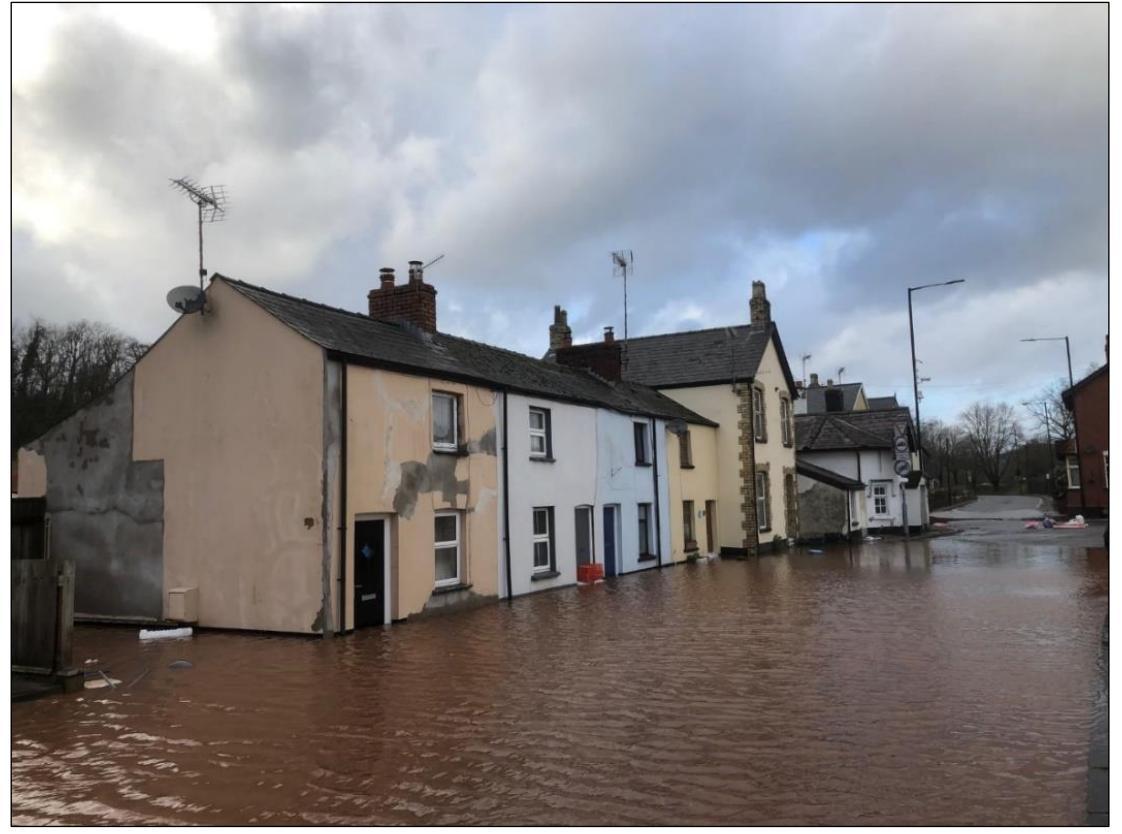
Photo 1: Flooding of Road Outside Nos 11-15 Woodside Taken 16<sup>th</sup> Feb 2020 Courtesy of a Local Resident.

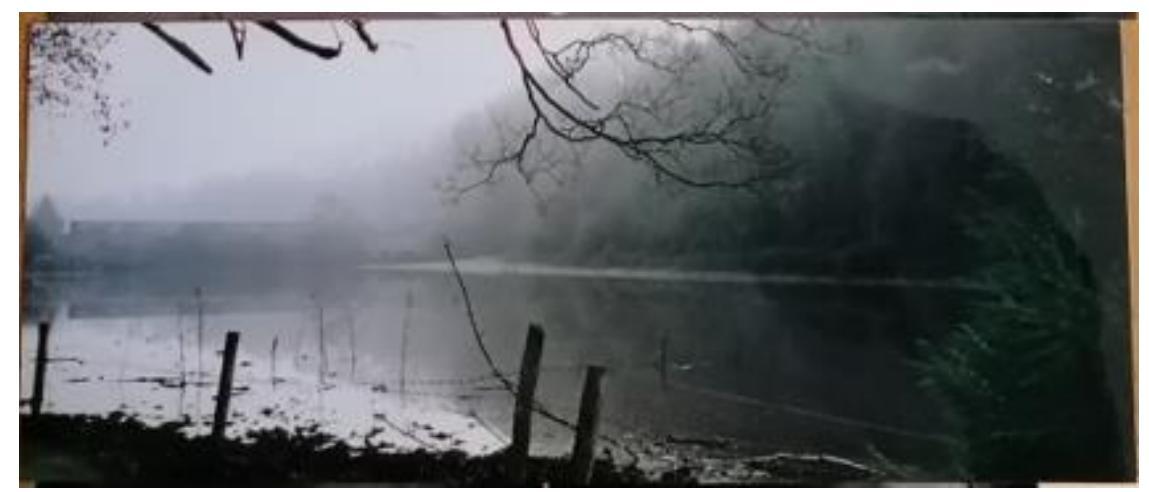
Photo 2: A view of the flooding in the low lying are to the rear of the Glen Yr Afon

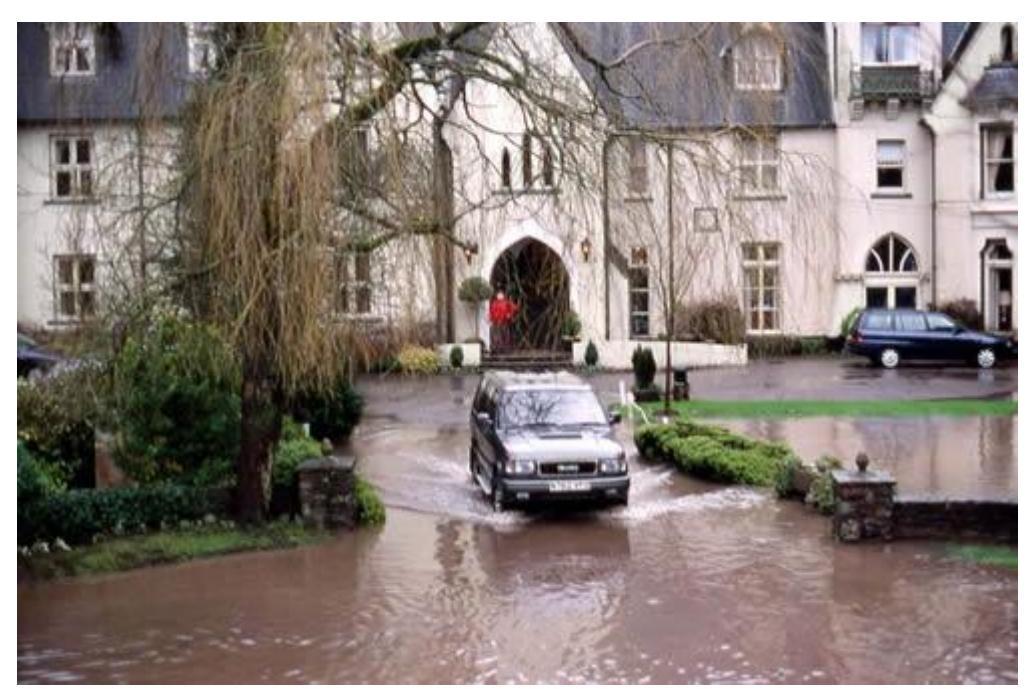
Photo 3: Flooding at the Glen Yr Afon Hotel in 2002, courtesy of John Tallet of Usk

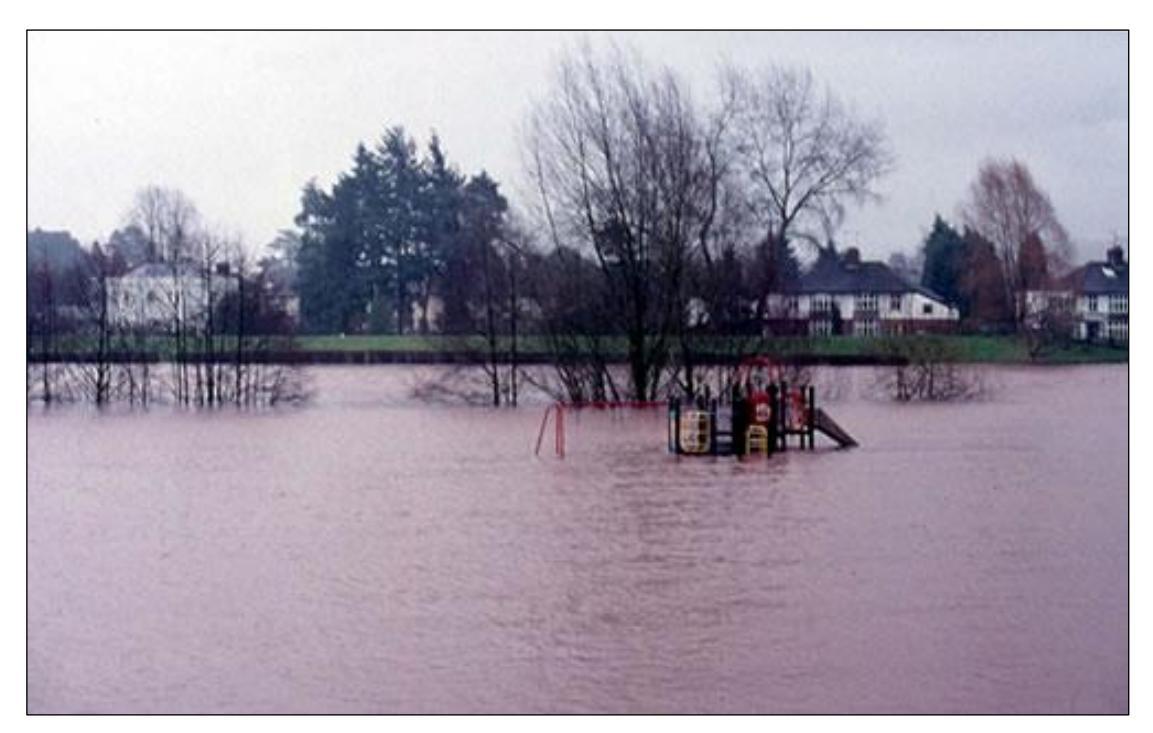
Photo 4: Flooding of the Playing Field at Usk in 2002, Courtesy of John Tallet of Usk

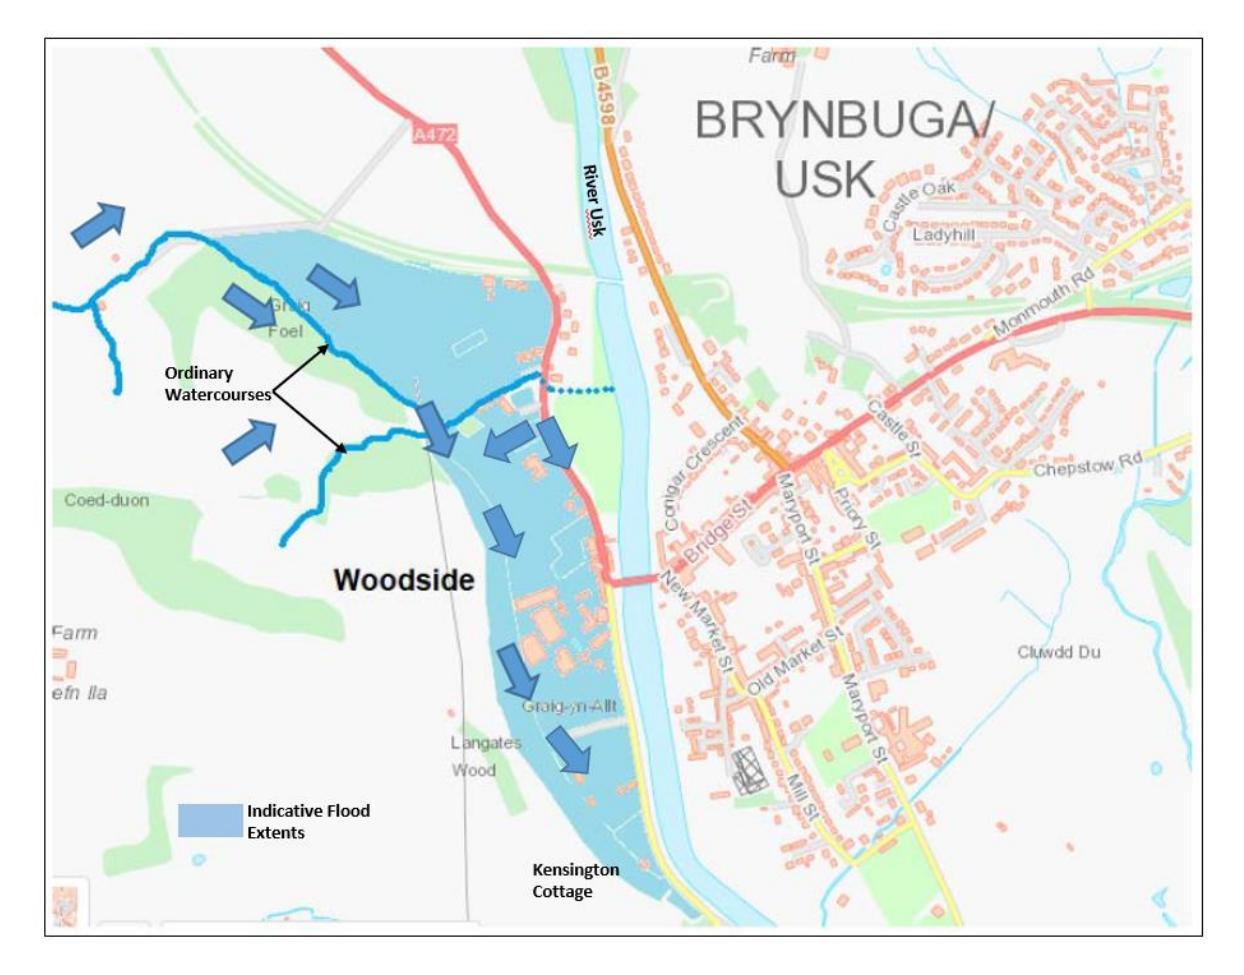
As flows in the unnamed stream ceased to discharge to the river the A472 began to flood with some flows moving south down the road towards the Usk Bridge. Some flows went off to the west in a low area just north of the Glen Yr Afon Hotel. These flows then continued on to flood the lower lying areas west of the properties and then further south to the industrial area.

Residential properties at Woodside Court and Mayfield were flooded internally and two properties were surrounded by floodwater about 200mm deep. One of these properties avoided internal flooding by pumping via the Fire Service. Three properties had internal flooding in the Woodside Court area and three others had flooded gardens or were surrounded by flood water. Two commercial properties at the Old Goods Yard site were also surrounded by flood water around 300mm deep.

Figure 4: Plan Showing Indicative Flow Paths and Flood Extents

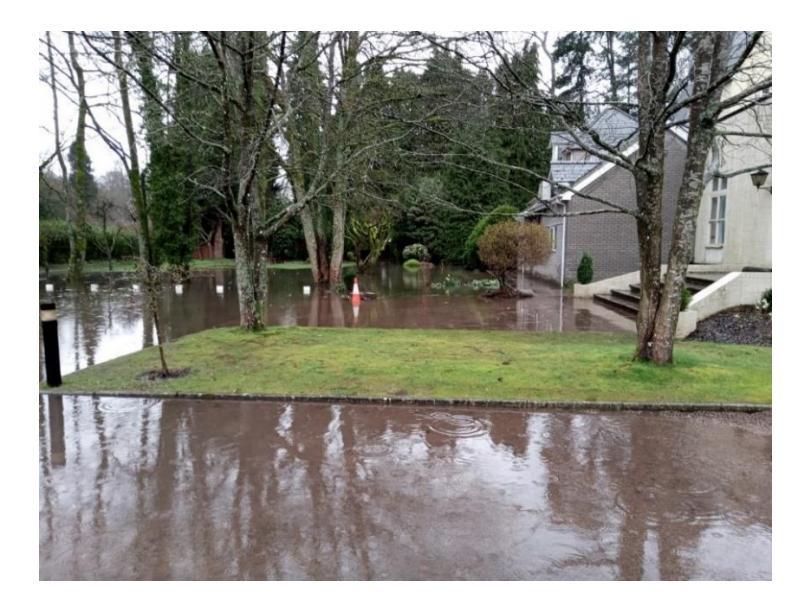
The kitchen area of the Glen Yr Afon Hotel, which is at the rear of hotel the was reported to have been flooded from the lower lying land at the rear as were some of the terraced houses on the west side of the A472 north the Usk bridge. A number of residential properties on the east side of the A472 near the bridge were also affected and these may have been flooded from their outfalls to the river, possibly due to flap valves being lifted by flood waters in the River Usk, (See Photo 9 below). Water also flowed through the masonry wall at the south west side of the bridge where there are visible cracks in a short length of the wall here, (See Photo 6 below). It is possible these cracks were there prior to the flood, as these walls have been subject to traffic damage from large vehicles.

Photo 5: Flooding at the Rear of the Glen Yr Afon Hotel

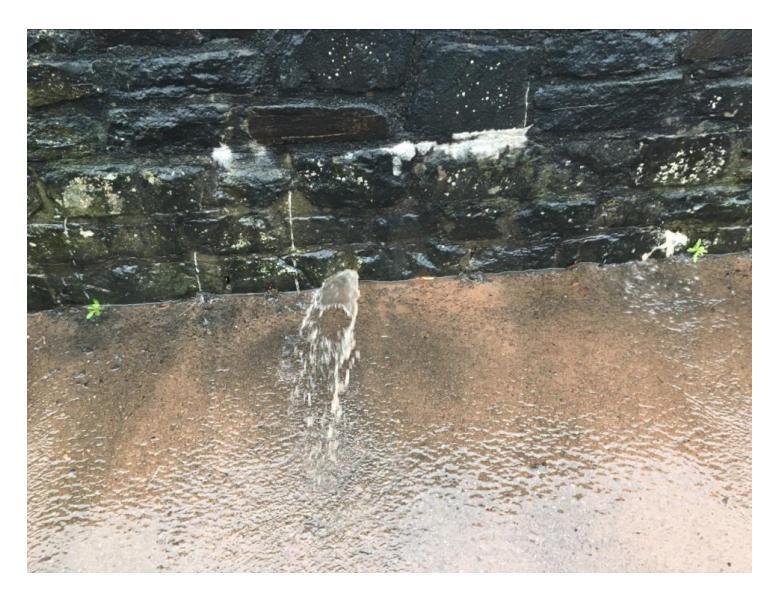
Residents of the cottages just south of the bridge were badly affected by the water seeping through the bridge wall at the front to around 200mm and by much deeper water at the rear and commented that flooding commenced around 7am on the 16<sup>th</sup> and rose very quickly during the morning to around one metre deep internally.

Photo 6: Water Flowing through Usk Bridge Parapet Wall - West Side.

In addition, water was noted to be flowing through the bridge wall at the south west corner of the River Usk bridge and cracks are evident. It is unclear whether these were there before the flooding, as these walls are subject to damage from traffic movements.

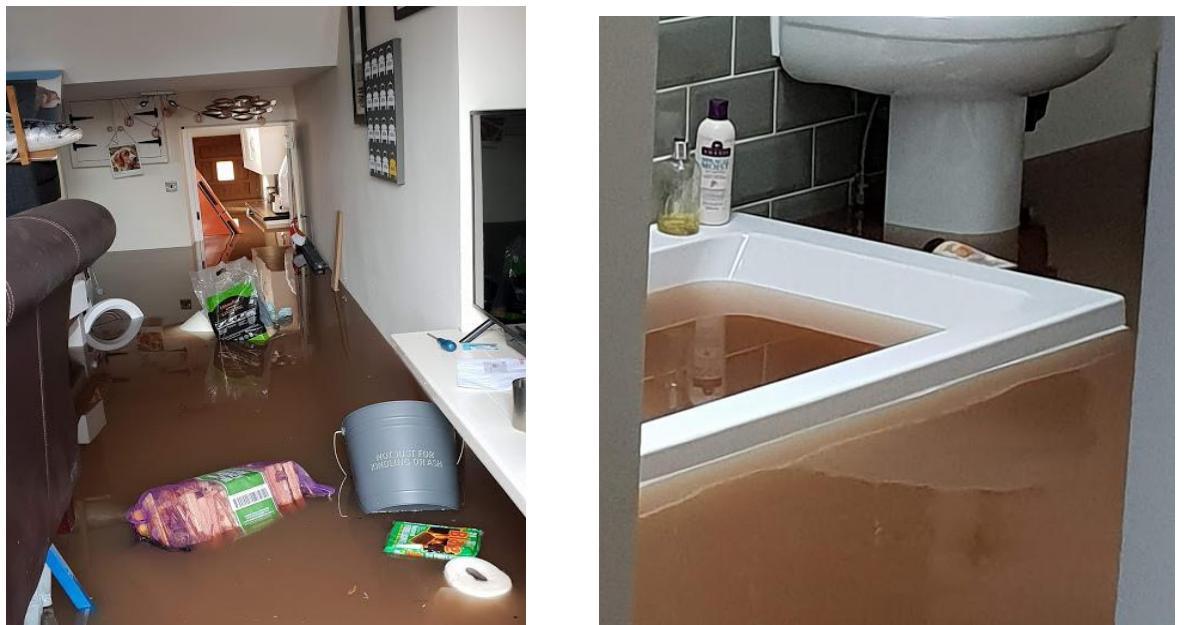
Photos 7 and 8: Showing Internal Flooding to Cottages South of the Bridge, Courtesy of Local Residents

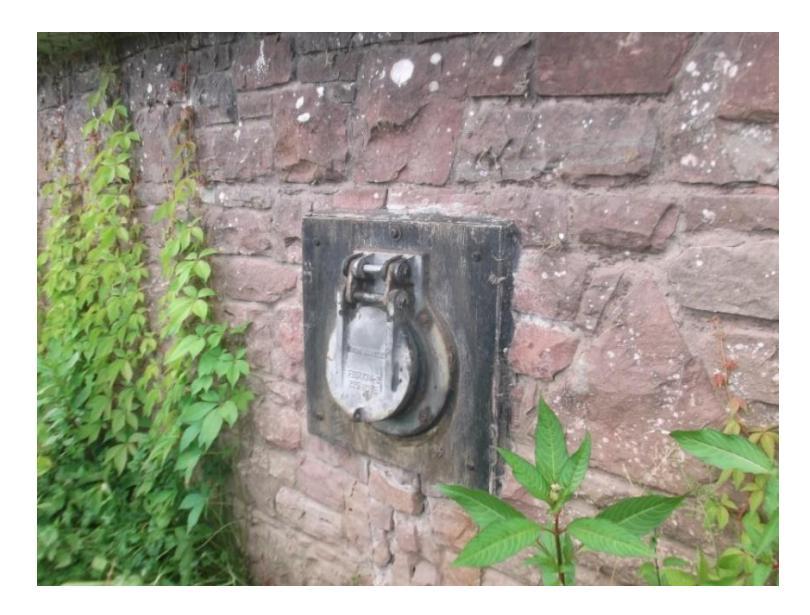
Photo 9: Example of Outfall with Flap Valve, taken July 2020

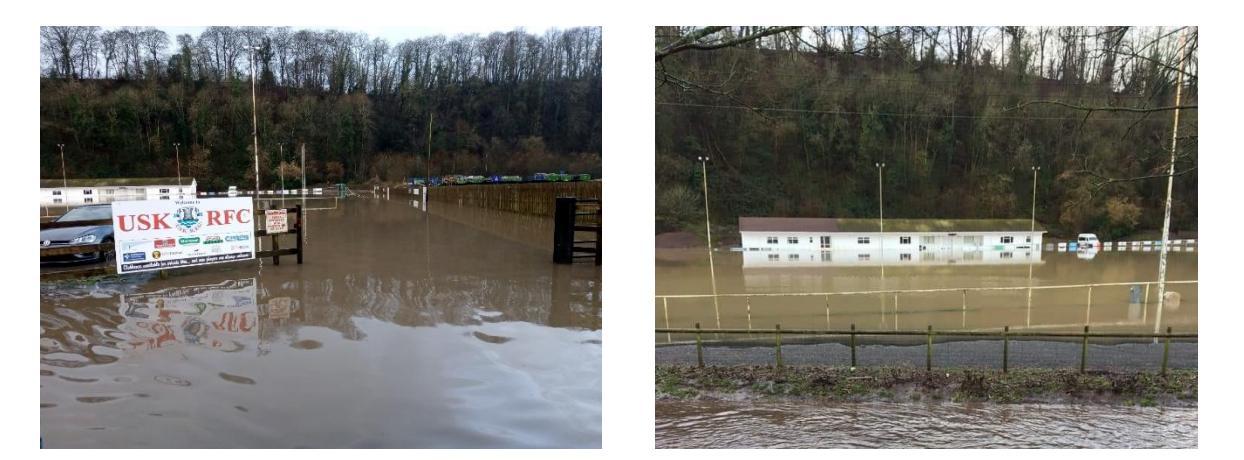
The rugby field and its pavilion buildings were badly affected with water up to the serving bars, several feet deep in the pavilion. It is noticeable that the A472 falls as it travels south from the Old Goods Yard to the bridge and continues on the minor road, R106, to the rugby pitch by some two metres which would have hampered clearing the flood water once the flood locking cleared. This also partly accounts for the deeper flood water at the southern part of the Woodside area.

Photos 10 & 11: Flooding at the Rugby Club, taken on Sunday 17th

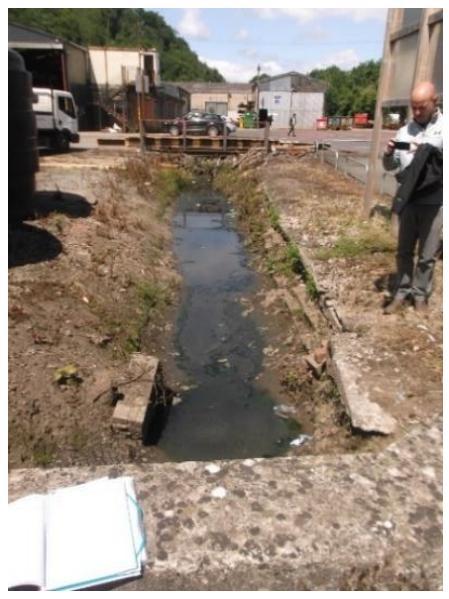
Photo 12: The Open Ditch on the Industrial Estate taken July 2020

There is a very limited system of land drainage with the brook, and one notable open ditch in the centre of the industrial area. Parts of the unnamed brook were noted to have quite an amount of debris and silt when visited in June 2020, this may well be from the February floods. Land owners will be notified to clear their sections of the brook to maintain an unobstructed water course.

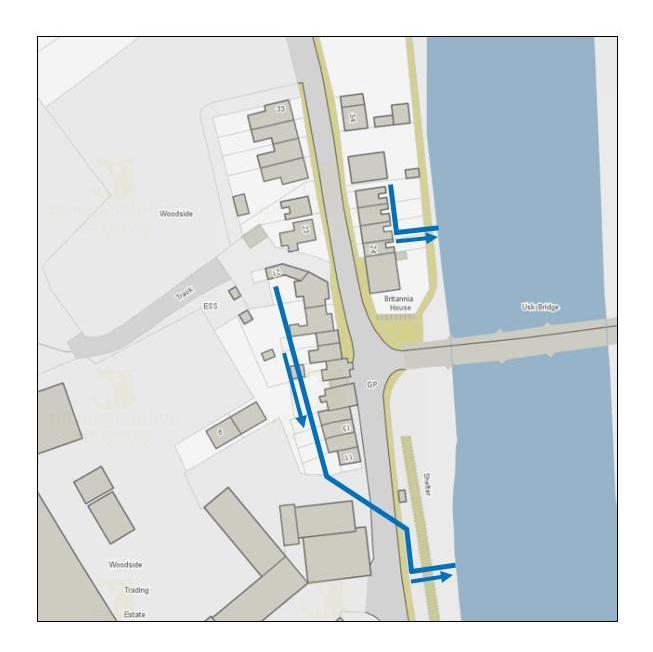
Figure 9: Indicative locations of Foul Sewerage Systems at Woodside

West of the bridge there is a short sewerage system along the rear of the cottages at numbers 11 to 21 Woodside which was overwhelmed by the flood waters. This would have mixed foul sewage with flood water and some residents have reported that floodwater came up through their sinks and bathrooms. North of the bridge and east of the A472 there is also a short sewerage system for numbers 22, 24, 26, 28, 30 & 32 Woodside and both systems discharge to the River Usk.

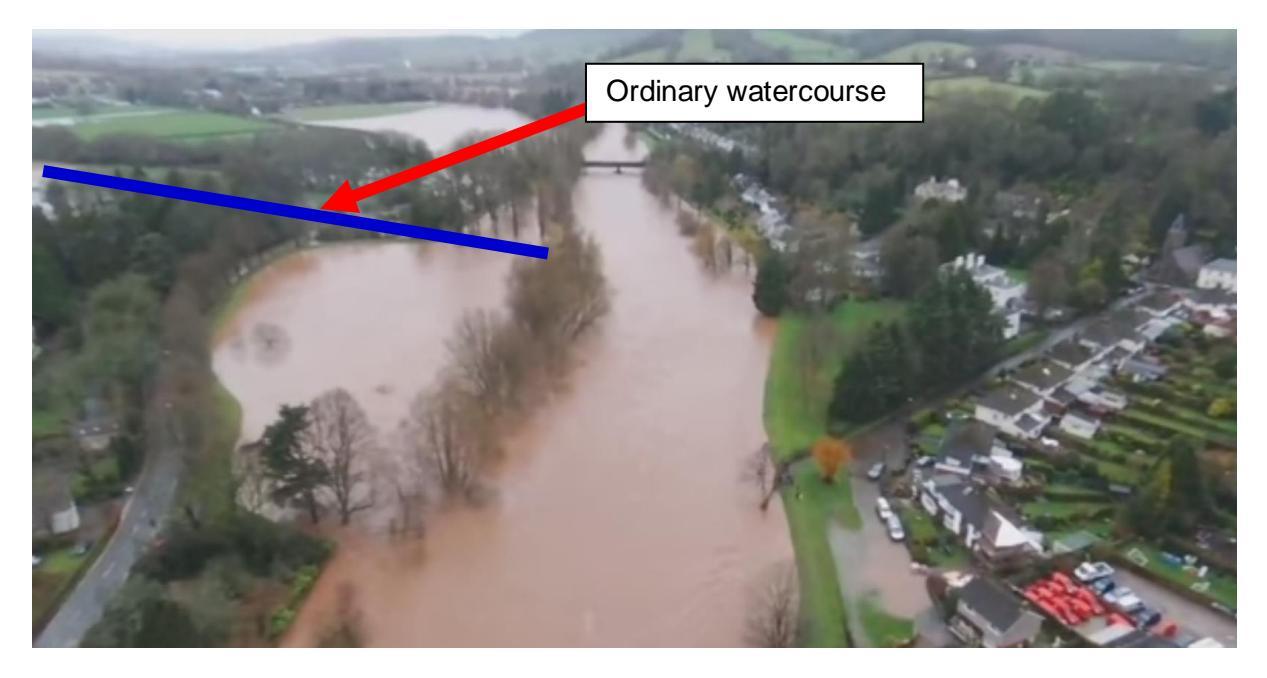
Photo 13: River Usk looking upstream. Surcharged ordinary watercourse is located in top left of photo

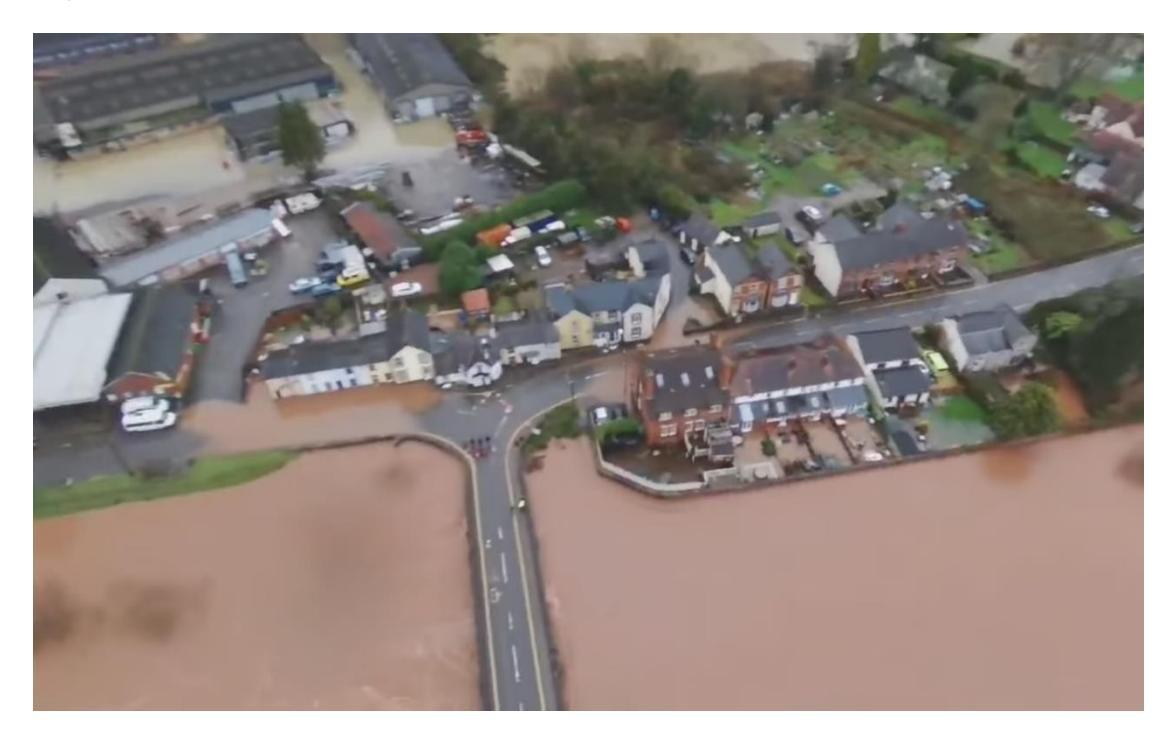
**Photo 14:** Usk Town Bridge, note flooding to carriageway adjacent to Woodside Cottages and flooding to industrial estate at top of photo. Difference in colour of water indicates flooding from 2 difference sources (ordinary watercourse light colour, River Usk brown darker colour)

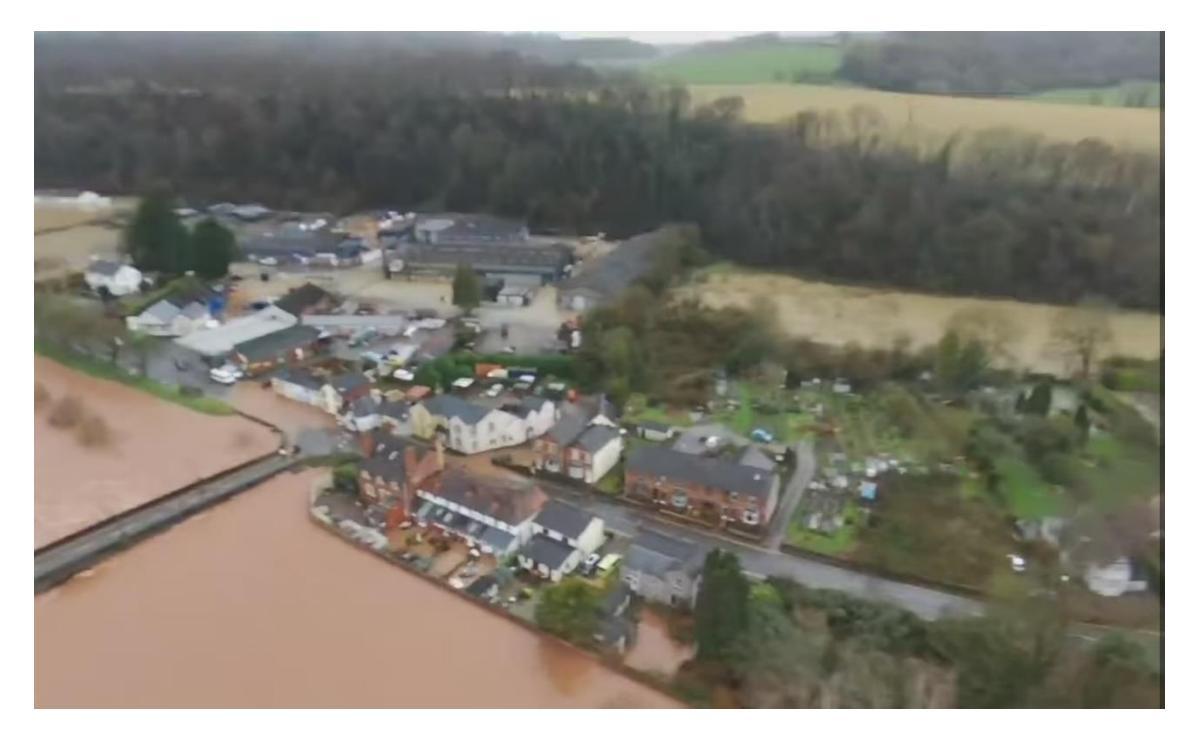
**Photo 15**: Flooding from ordinary watercourse running right to left in top of photo, through Woodside Industrial Est. and on to Usk Rugby Club

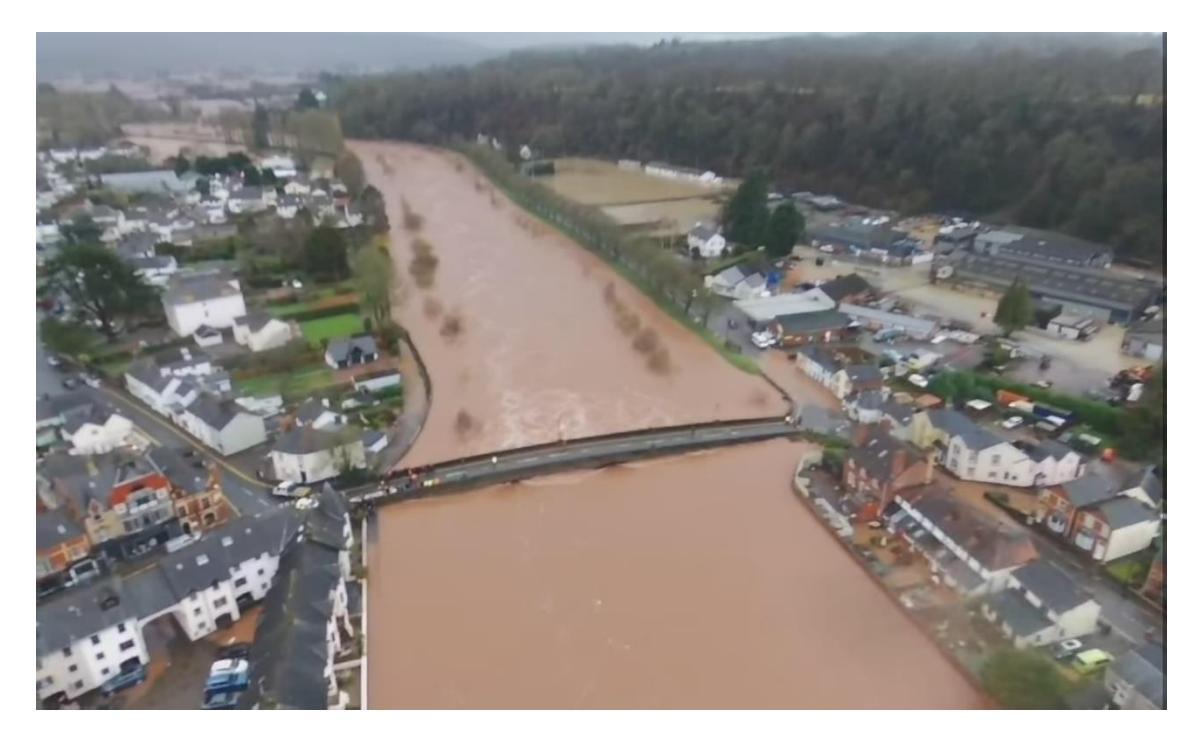
Photo 16: Extensive flooding to Woodside Industrial Est. and rugby club on right
