**Monmouthshire County Council**

**Flood and Water Management Act 2010**

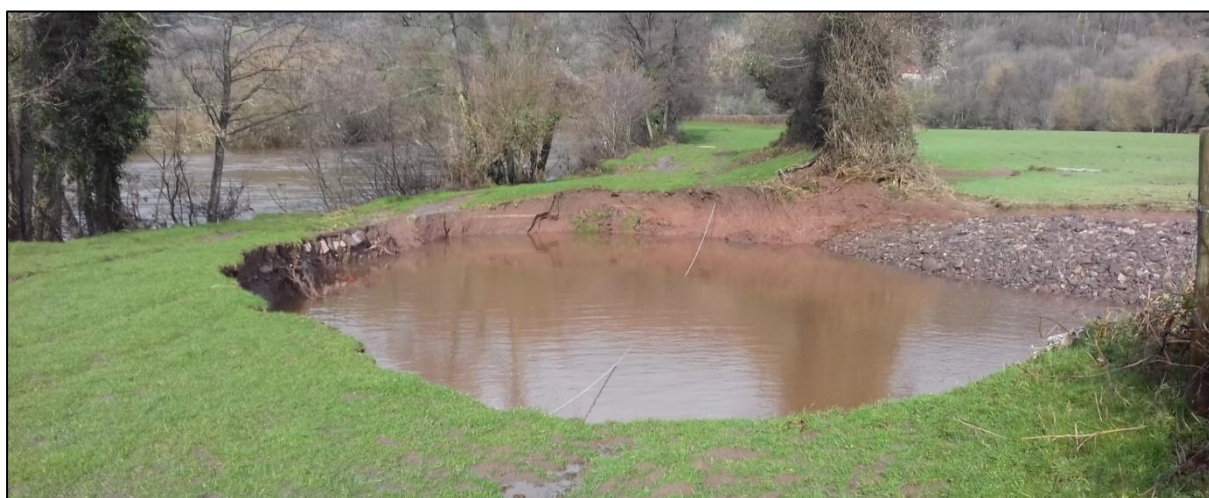
Photo 1: The crater in the flood embankment.

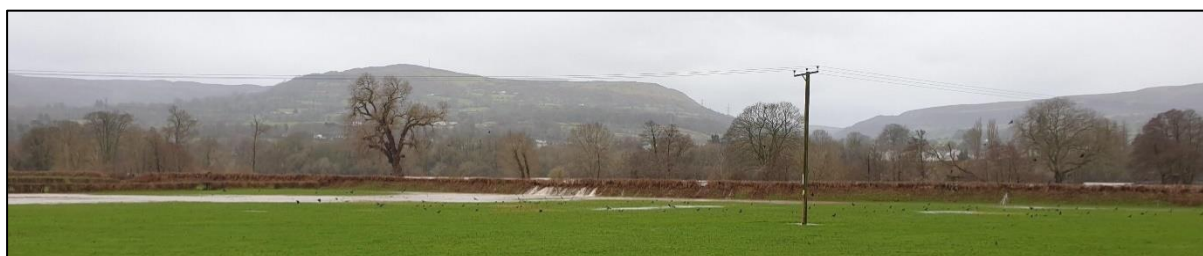
**Photo 4: Overtopping of the northern part of the flood embankment continuing at 11:52 am on Sunday 16<sup>th</sup> February 2020.**

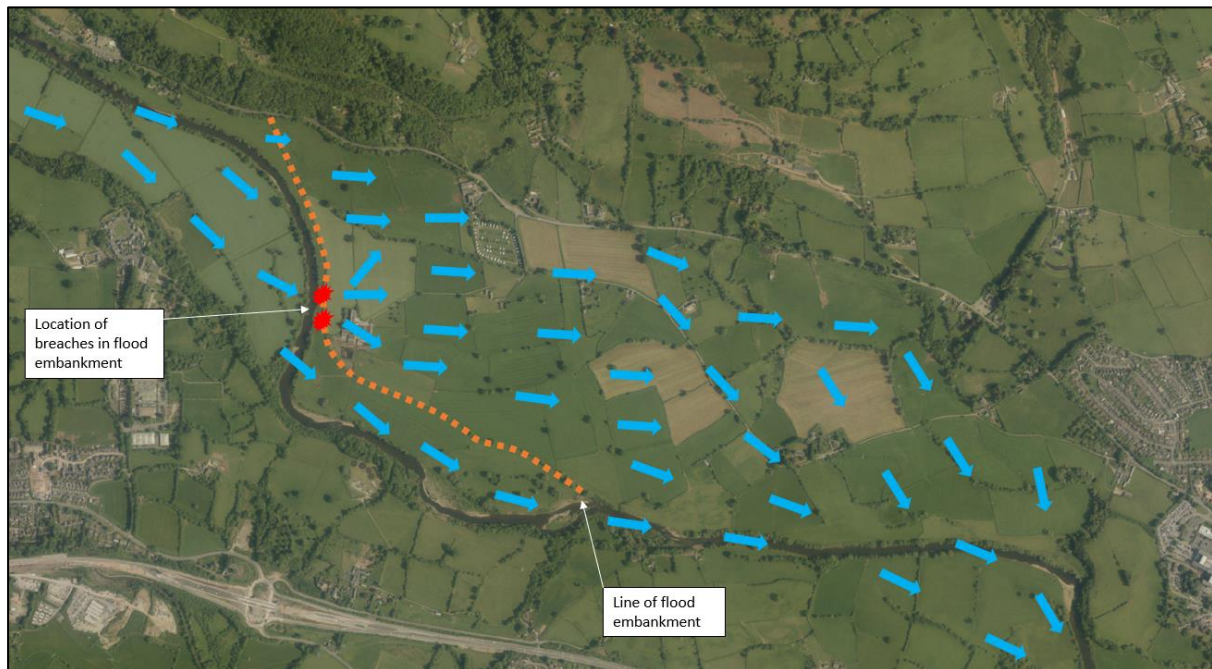
**Figure 7: Indicative overland flow path based on evidence obtained by the LLFA. This diagram is highly conjectural as no modelling taking into account the flood embankment has been undertaken.**

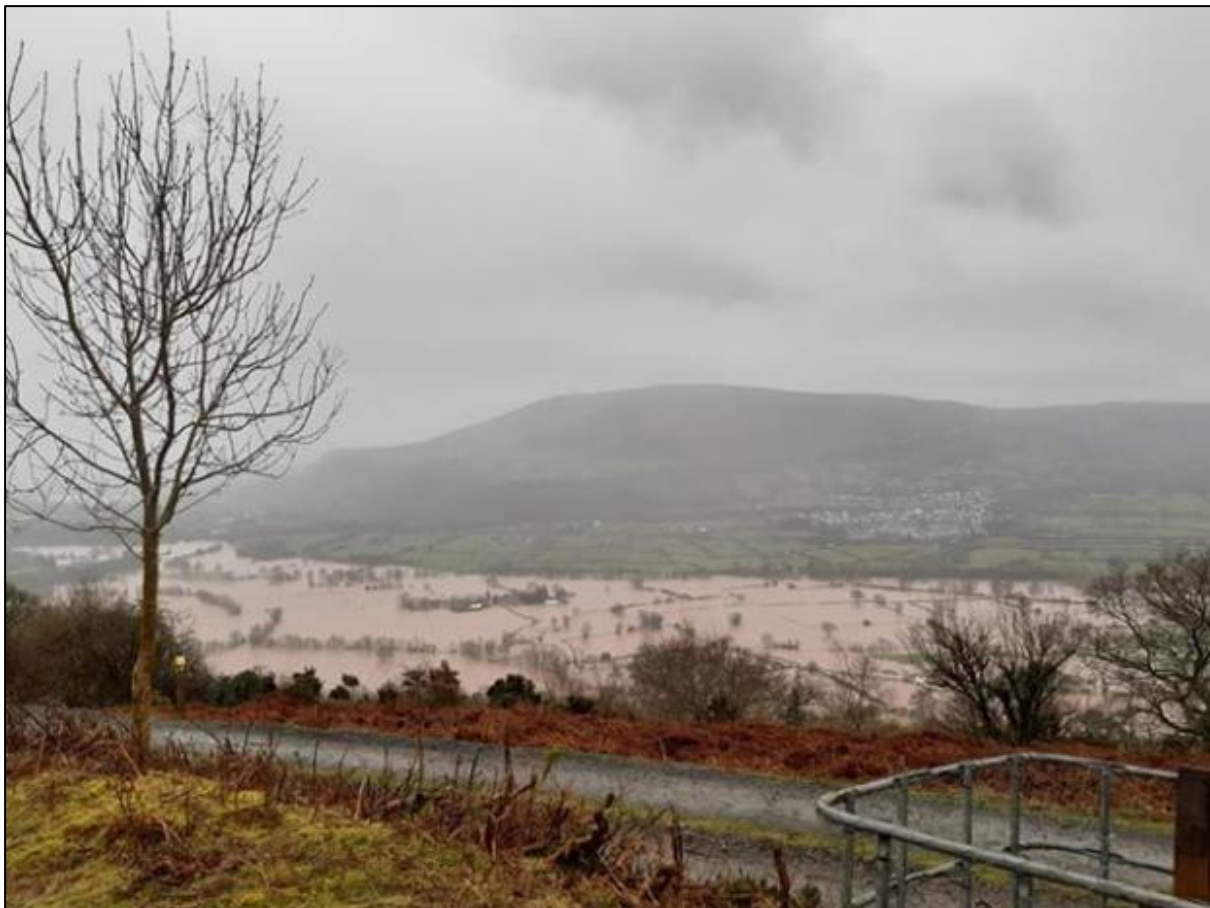
Photo 7: The flooded Llanwenarth Plain viewed from the north.
