# **LAND AT CAE MELIN, LITTLE MILL, PONTYPOOL, MONMOUTHSHIRE**

### **Technical Note – Drainage Statement**

231107-KTN-TN-01-A

26<sup>th</sup> January 2024

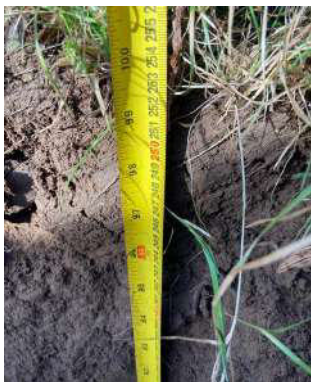
| Client | Site Address | Project No |
|---|---|---|
| ground excavated down to 250cm deep. No highly permeable layers of soil found. Bedrock not hit. Water table was not hit in 250cm deep excavation. | | |

| Ground water level check - Photos | |
|---|---|
| <p>depth of pit</p> | <p>soil profile of ground water check pit</p> |

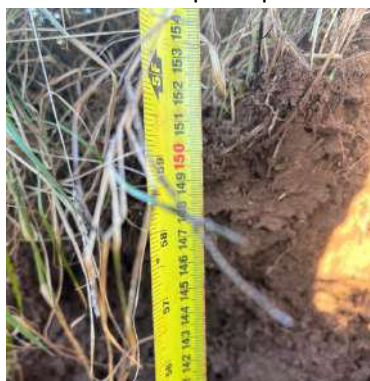
excavated pit depth

**PIT A (north)**

The following day 16/01/24 at 8:26am 65cm of water still remaining in pit A.

Testing aborted due to extremely slow draining pits and unfavourable results.

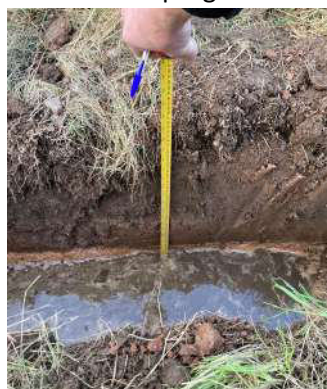
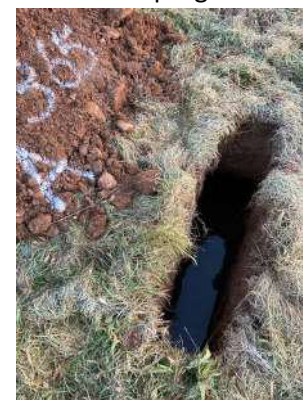
Test in progress

test in progress

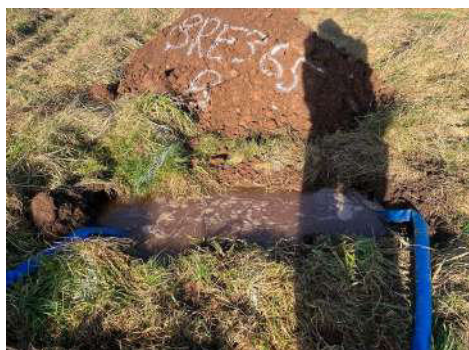
full pit - start of test

Following day 16/01/24 at 08:27, 40cm water still remaining in pit B .

Testing aborted due to extremely slow draining pits and unfavourable results.

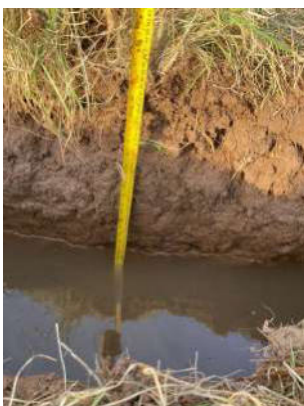
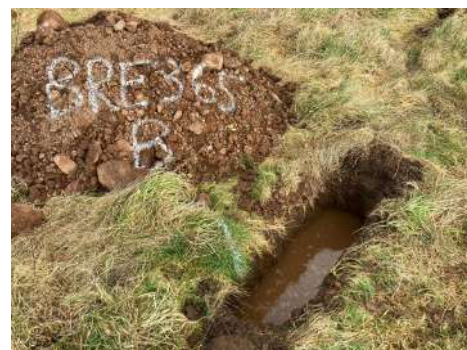
test in progress
