Grosmont

*Conservation Area
Appraisal &
Management Proposals*

Report Title: Grosmont Conservation Area Appraisal & Management Proposals
Client: Monmouthshire County Council
Project Number: 2009/089

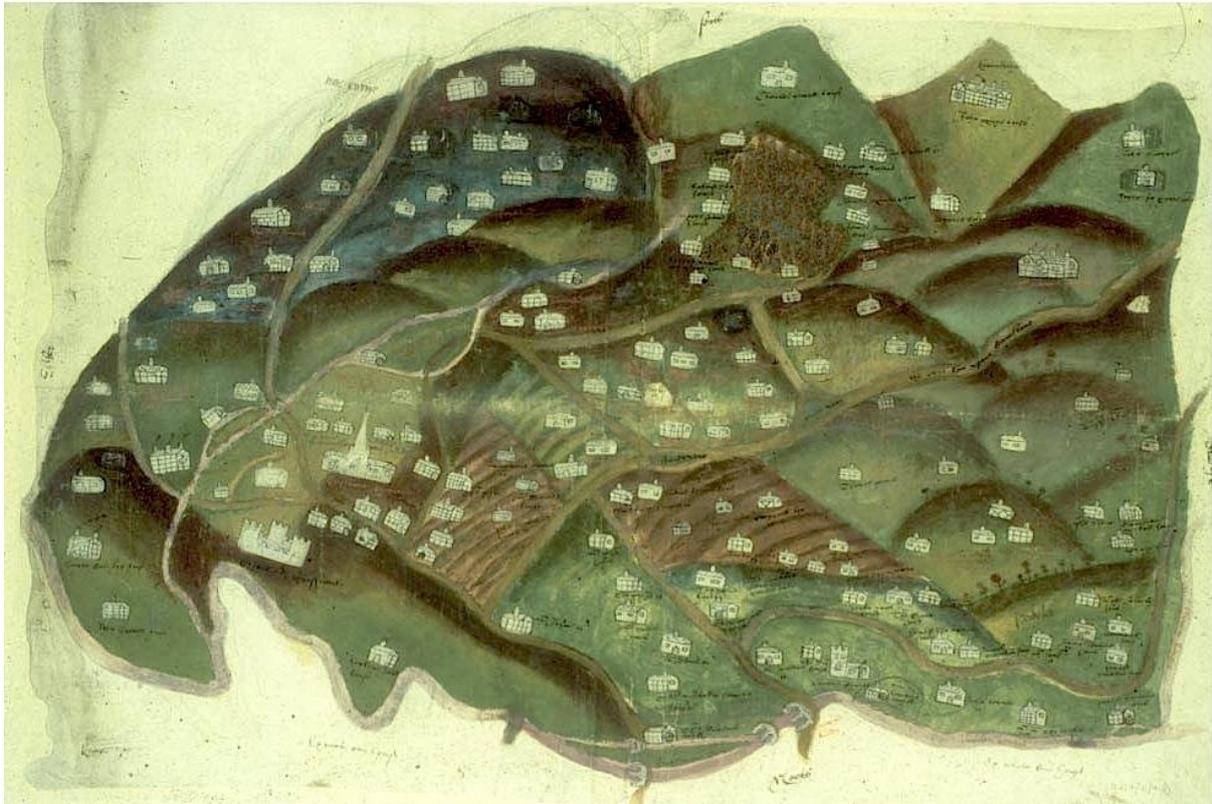
Fig.3 Duchy of Lancaster estate map of 1588

6.1.8 The castle, church and old roadways (now often footpaths or abandoned sections) are all identifiable on a Duchy of Lancaster estate map of 1588 (**Fig.3**). The map, a landscape view drawn from Garway Hill looking south, was created to settle a dispute over corn mills on the Tresenny Brook. This very unusual map depicts the entire manor of Grosmont of 17 square miles with 143 houses, 6 watermills, other buildings and bridges. The map does not depict barns or other separate agricultural buildings. The houses comprise a wide range of timber-framed buildings with thatched or stone-slate roofs. The map provides a graphic impression of the countryside in the Elizabethan period as an area of farms or smallholdings working relatively heavy soils, largely utilised for pasture rather than for arable land, together with some woodland (Palmer, 2009). The position of the mills can be identified by the

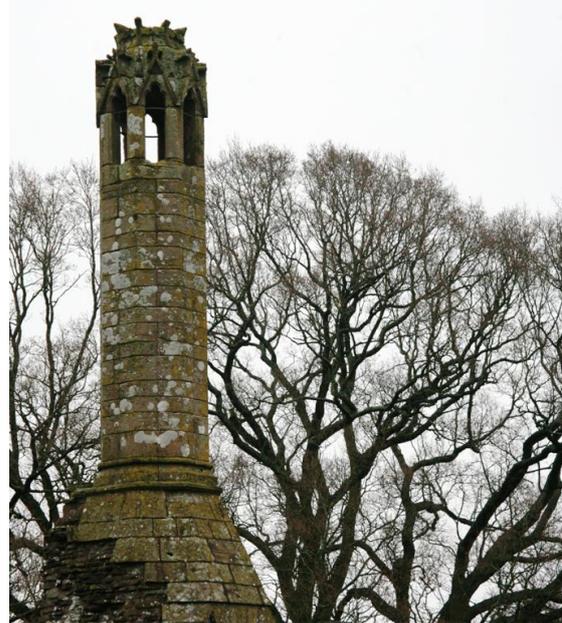
Fig.6 The prominent and distinctive octagonal 14th century chimney stack, a rare survival at Grosmont Castle

south-west tower, west tower, north block, hall block, inner ward and curtain walls (**Fig.6**). One of the most prominent features is the striking 14th century octagonal chimney that served the fireplaces in the two upper chambers of the north block (**Fig.7**). This chimney, with its fine gabled and coroneted top, demarked the high status rooms within the castle. The castle is surrounded by mown grassland and groupings of deciduous trees. Its Norman earthworks are visible in places, extending west into the village. There are archaeological traces of a medieval building in what was the outer ward.

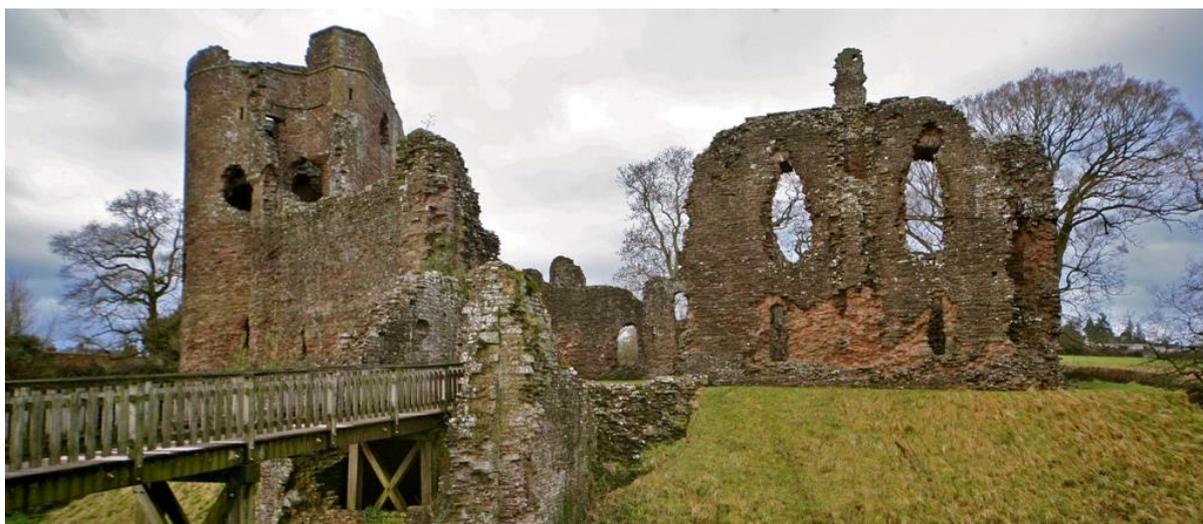
Fig.7 The ruins of the castle from the south set in its dry moat

7.3.5 The castle is constructed of coursed rubble masonry of local Old Red Sandstone. Ashlar detailing was used in the north block and in the south-west tower, which has fireplaces with chamfered jambs of pale cream ashlar. A red brick garden wall bounds the outer court of the castle forming the boundary wall of gardens to houses on the main road including Rock Villa, The Steppes, Whitney Villa, Howells House and Castle View (**Fig.8**).

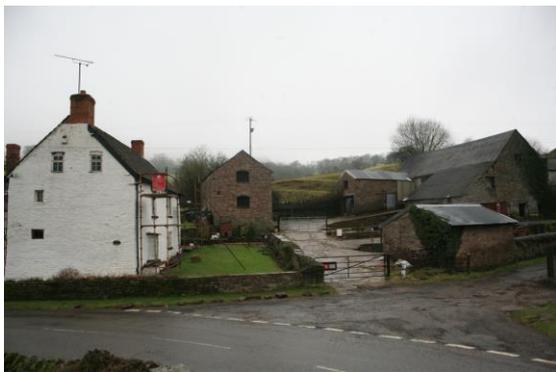
Fig.41 Lower Tresenny farmstead

7.3.31 Lower Tresenny comprises a multi-phase two-storey farmhouse of 16th-century origins with parlour wing and east wing. To the south-west is a granary above a cow house and to the west is a large six-bay cruck-framed threshing barn of c.1550 with attached lofted cow house (**Fig.41**). There are additional stone outbuildings within the yard and large steel framed 20th century sheds to the west and opposite the road to the north-west.

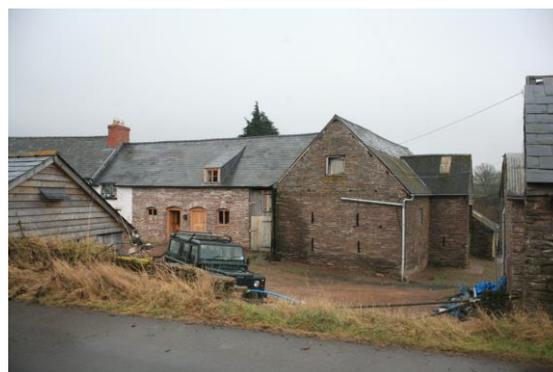
Fig.42 Stables and barn attached to the farmhouse at Great Tresenny make up an important farmstead group

probably for a threshing machine. This collection survives well as a traditional farmstead complex (Fig.42). Lower Tresenny, despite the construction of practical steel-framed buildings, retains a great deal of its original character with multi-phase farmhouse, granary and corn barn. The cruck-framed barn is an extremely rare and well-preserved example (Fig.43).

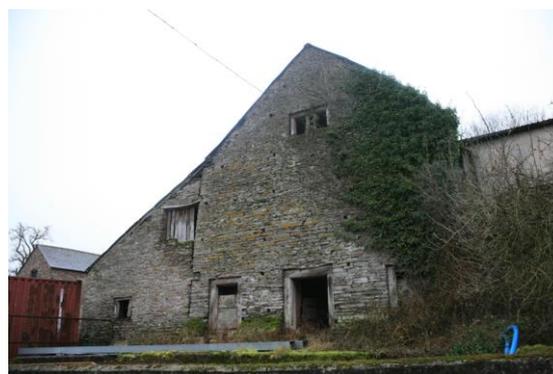
Fig.43 End gable of the cruck-framed barn, Lower Tresenny Farm

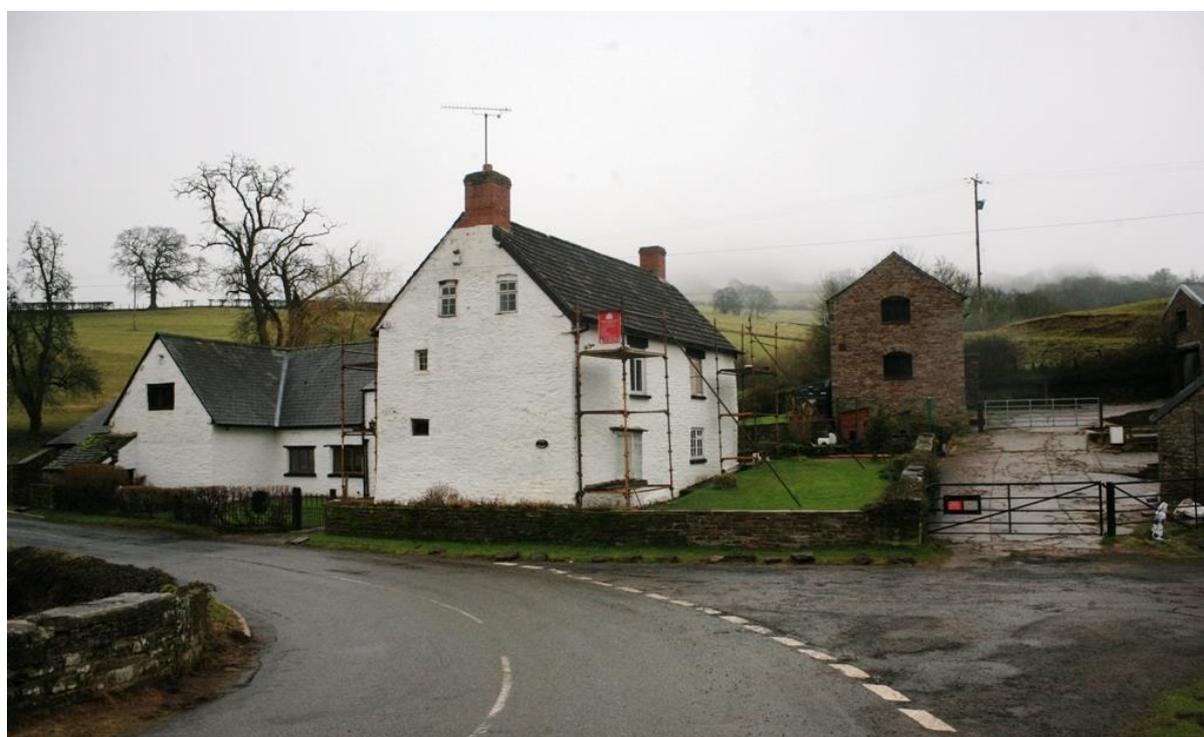
Fig.44 White-washed Lower Tresenny farmhouse

7.3.33 Buildings are generally coursed local rubble stone, Great and Lower Tresenny farmhouses both white-washed (Fig.44). Outbuildings are also stone, some with oak weatherboarding, such as the oak cruck-framed barn at Lower Tresenny. Roofs are natural slate with corrugated iron roofs to some outbuildings. Houses have red brick end stacks. Detailed features include 16th and 17th century timber diamond mullions to outbuildings, timber shutters, and contemporary plank doors with strap hinges. Great Tresenny features an 18th century, 12-pane, iron framed window and sunk-chamfered mullions while Lower Tresenny has casements and a 19th-century bay window.

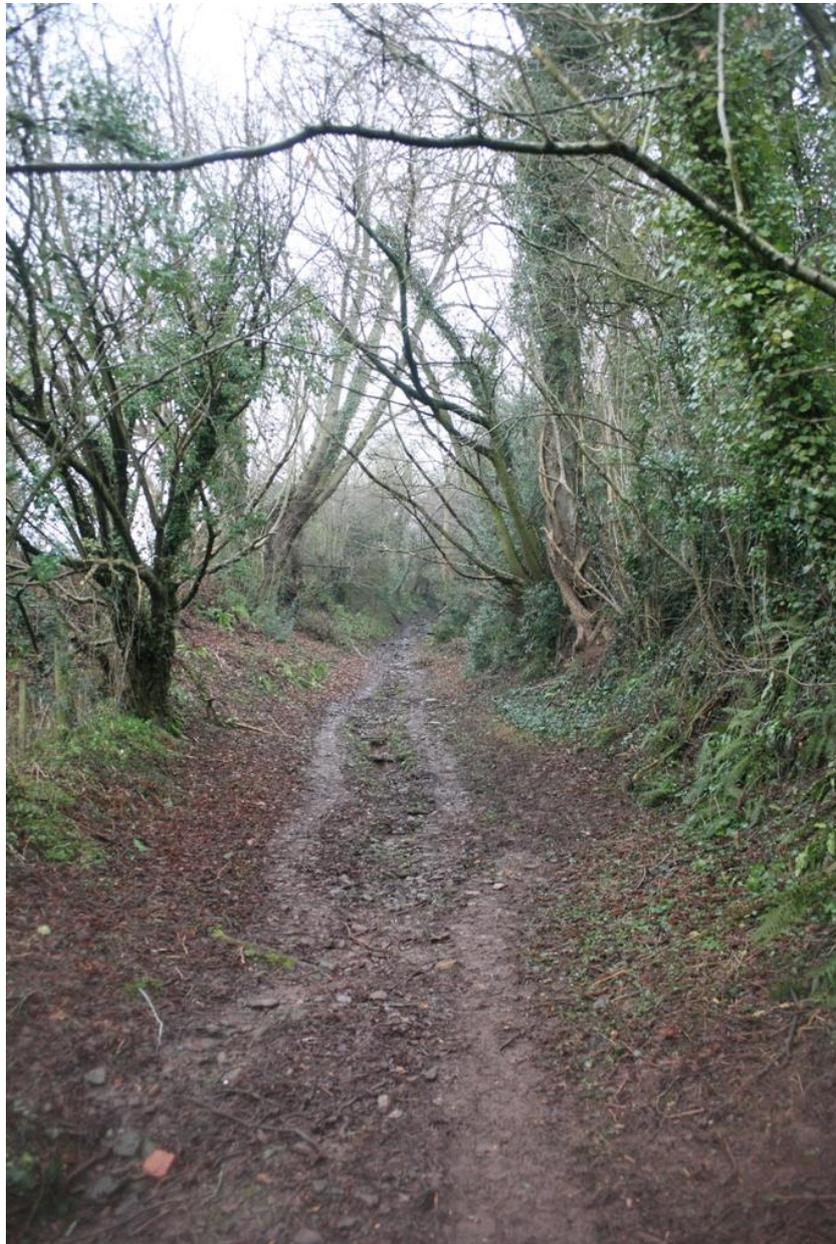
Fig.47 The sunken trackway, formerly a route into the medieval town

7.3.35 Local features include the old roadway leading north to the church, now a sunken track (Fig.47), stone remains within the Tresenny Brook and the stone arched bridge over the brook at Lower Tresenny. The historic farmsteads with farmhouses and traditional outbuildings are excellent examples of the use of the local stone, a defining characteristic of this area. The farmsteads, important both historically and architecturally are good examples recalling the village's former agrarian history and its strong relationship with the open countryside, both defining characteristics of the conservation area.

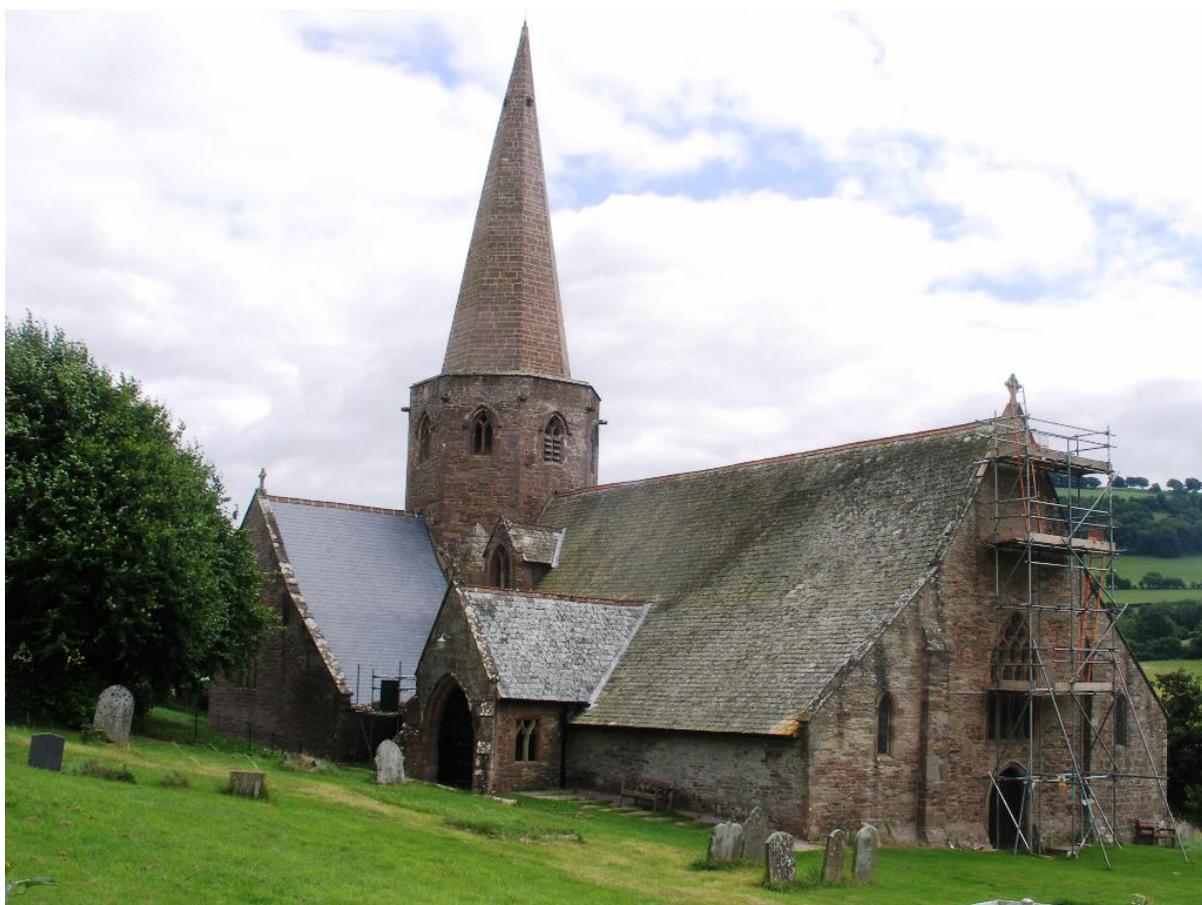
Fig.48 St Nicholas Church from the north-west, showing the barn-like sweep of its nave and transept roof, uninterrupted by clerestory windows. The octagonal tower topped by its spire enhances the significance of this important church

7.4.4 The octagonal central tower and spire were added in the 14th century, following the completion of the crossing. This construction caused structural problems which were rectified in the Victorian restoration. The crossing now acts as the 'nave' of the church by accommodating the seating for the considerably smaller congregation than the church was originally built for. A Victorian screen separates this part of the church from the unused part of the nave.

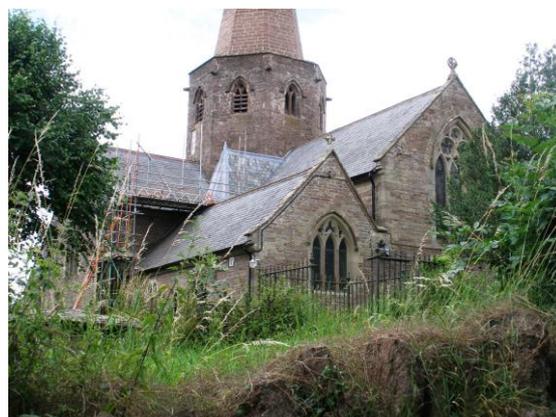
Fig.49 St Nicholas Church from the south-east showing the Victorian rebuilding and restoration of the chancel and chapel

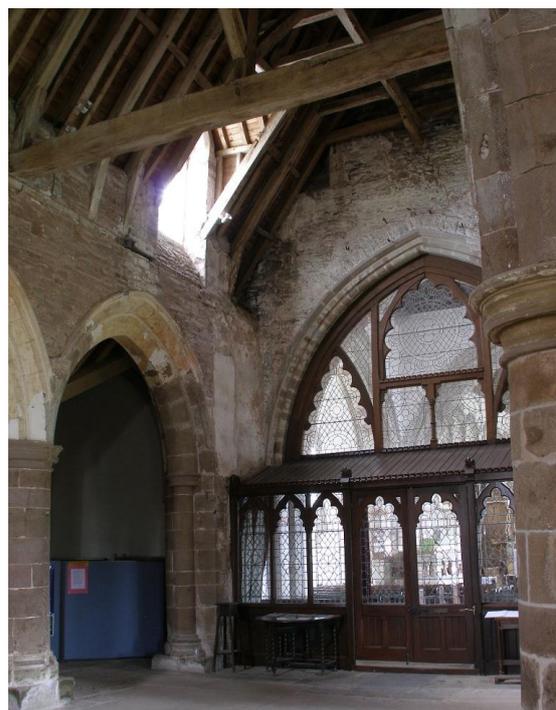
Fig.50 St Nicholas Church from the unfurnished nave looking towards the 19th century screen and the restored crossing and chapel beyond. The single dormer window seen is effective in providing light to the screen area.

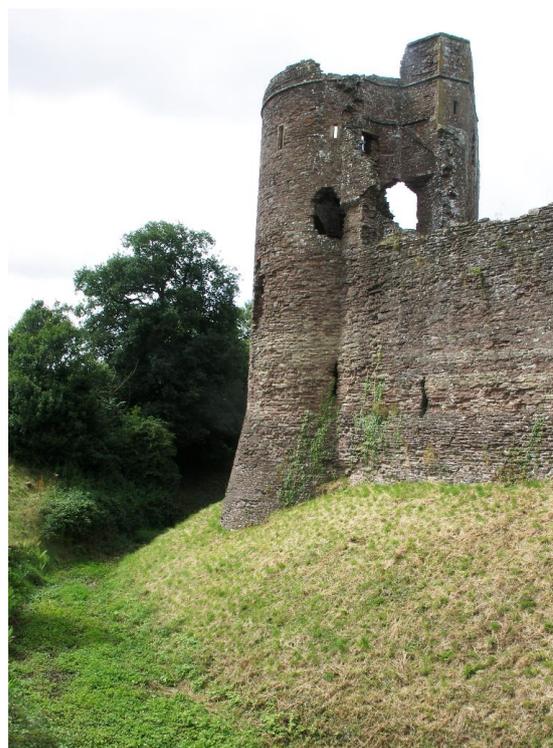
Fig.52 Grosmont Castle. One of the powerful towers on its south-west side looking towards the town. The steep sides to the moat are apparent here.

7.4.8 Despite the height of the towers and its commanding position overlooking the bend of the River Monnow, the continuous frontage of the High Street and the considerable tree cover to the east of the castle, mean that it is only glimpsed from the town and is obscured in some wider landscape views towards the town. The castle is now in the care of Cadw.

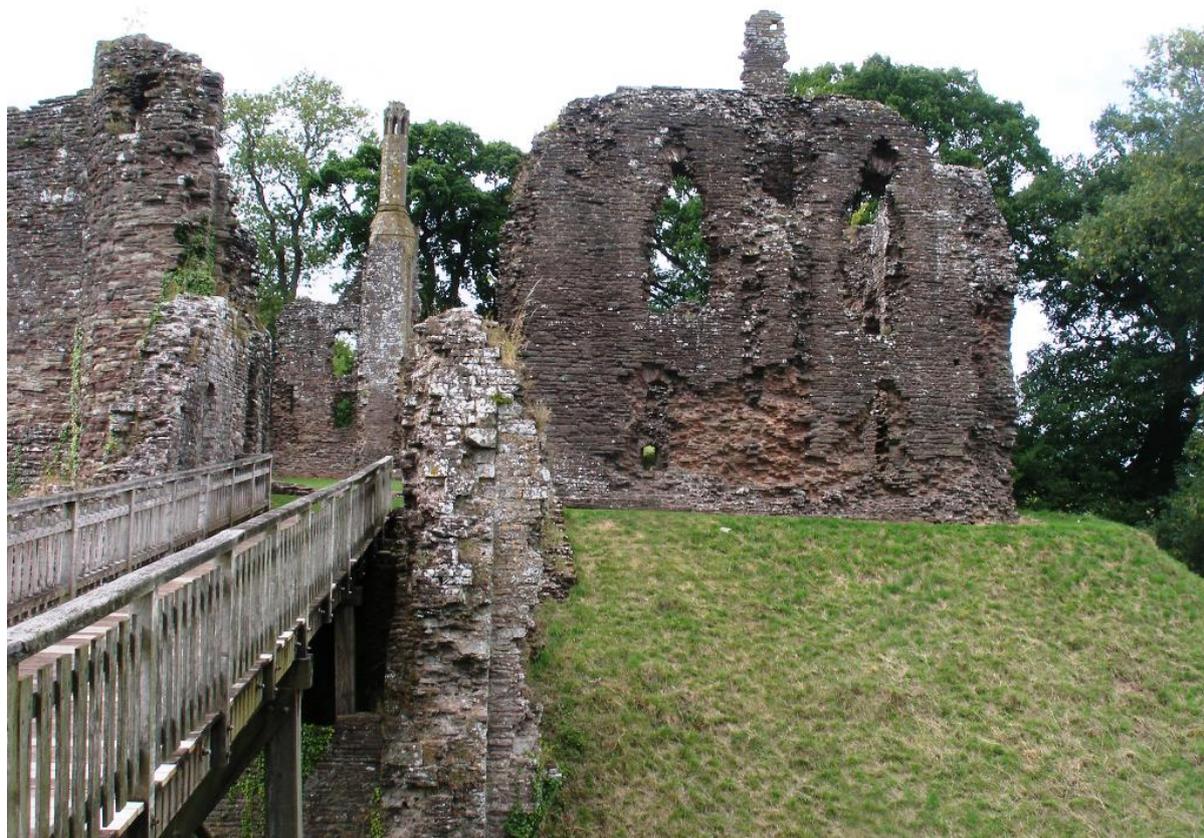
Fig.51 Grosmont Castle from the entrance bridge spanning the moat. The remains of the Great Hall are to be seen to the right.

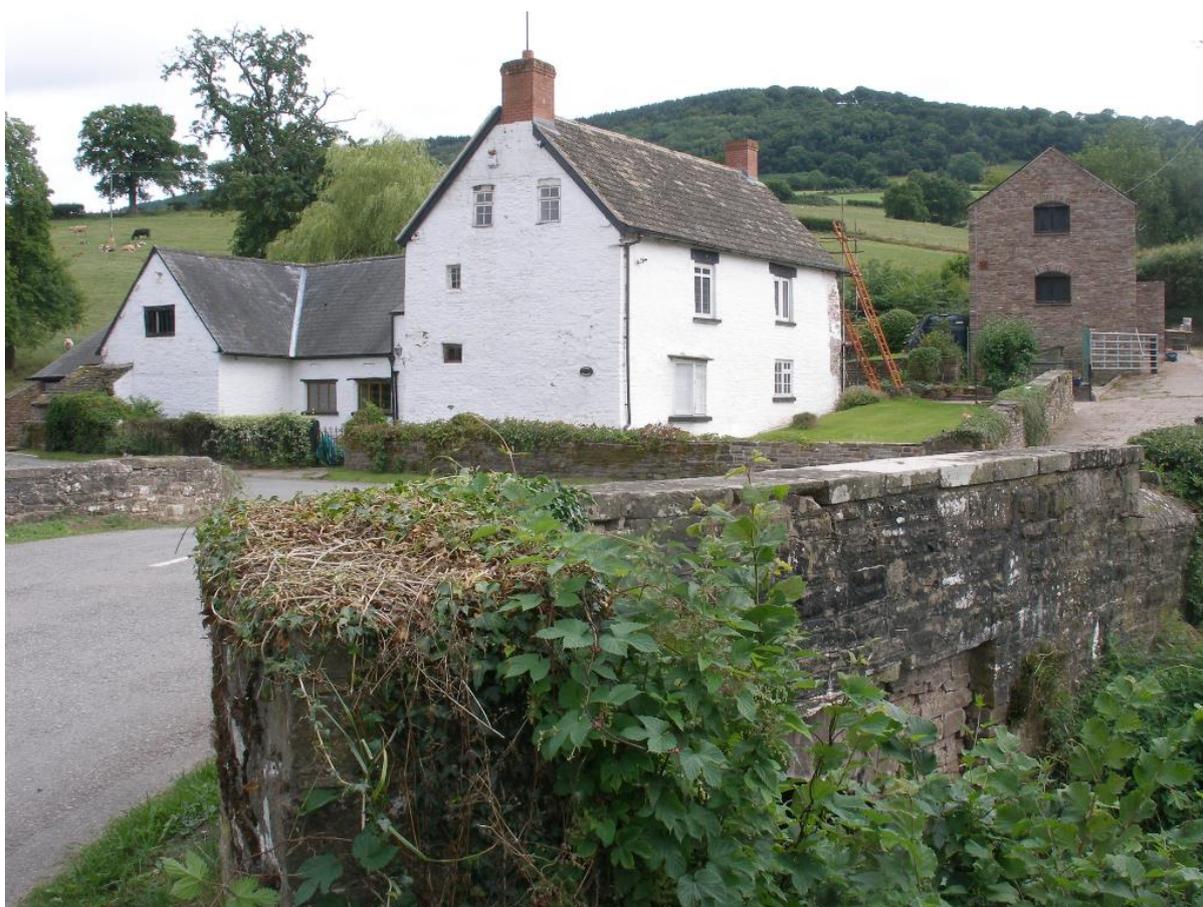
Fig.53 Lower Tresenny Farmhouse. The earliest part dating from the 16th century is the low wing between the cross wing to the left and the two-storey 'parlour wing' to the right.

7.4.10 Lower Tresenny Farmhouse (Grade II listed, **Fig.53**) also has 16th century origins. The earliest portion of the central low wing is presumably the original hall. The two-storey (plus attic) 'parlour' wing, set at right angles, was added a short time later, with the one storey with attic wing to the left being a 17th century addition. The most significant features are to be found internally, including a cruck truss, indicating that the present two storey building was once a full height hall, later subdivided. External features of this painted rubble stone building with brick stacks include the round arched entrance door, a dripstone on the gable head, mullioned casement windows and deep timber lintels.

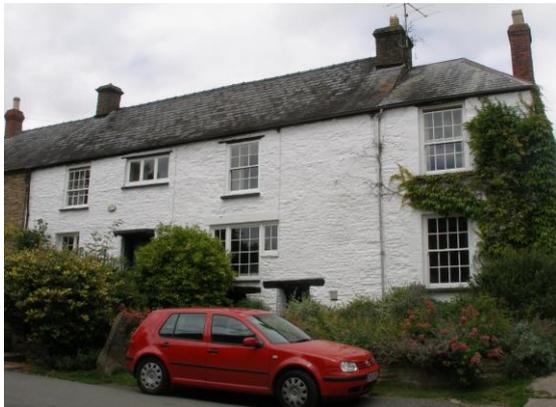
Fig.54 Howells House. This 17th century town house retains an original mullioned window and planked front door in the centre. By the 19th century sash windows had been inserted and an extension built on the right.

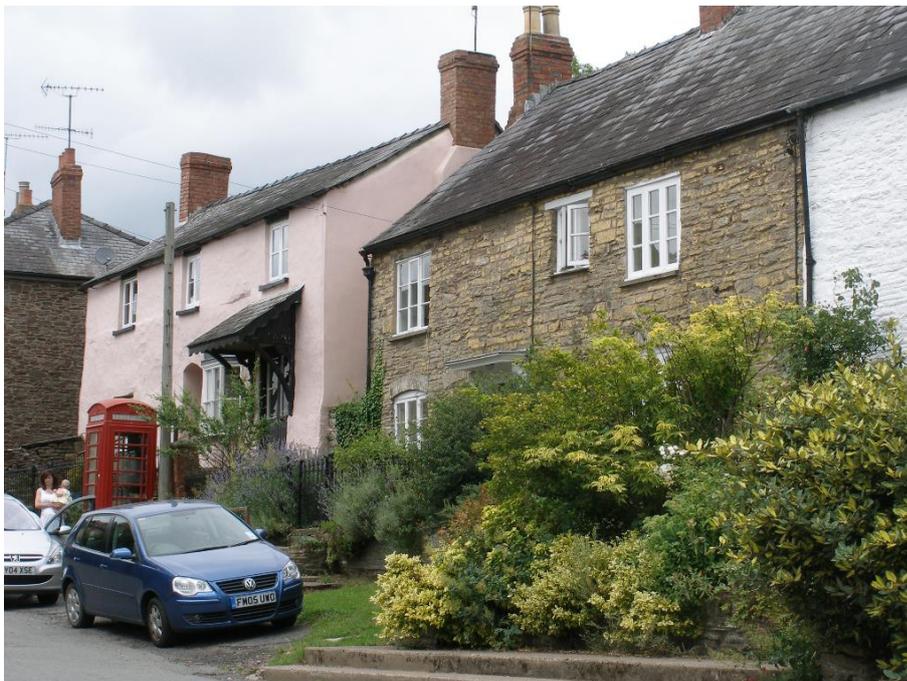
Fig.55 Whitney Villa (to the right) and The Steps (to the left), although altered, retain their broad fronted 17th century character.

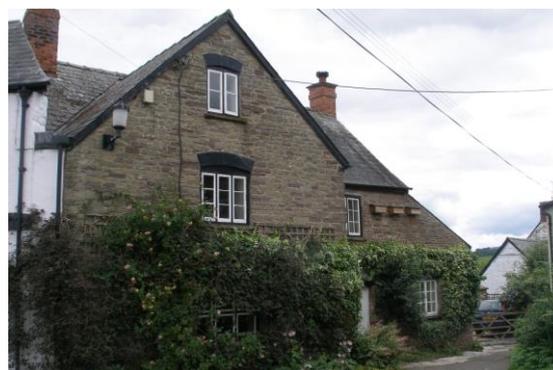
Fig.56 The former Greyhound Inn. The large gable was added somewhat later to this simple wide fronted 17th century town house.

7.4.14 The Old Greyhound (Grade II listed, **Fig.56**) stands at the junction of the High Street and the narrow lane leading to the Town Farm. This former inn is also a two unit cross passage house. However, it differs from those discussed above as it had a slightly projecting gable wing added on its left hand side not long after it was built. The gable accommodates an attic storey above the first floor. A three light mullioned and transomed window at the ground floor of the gable wing can be glimpsed through the ivy.

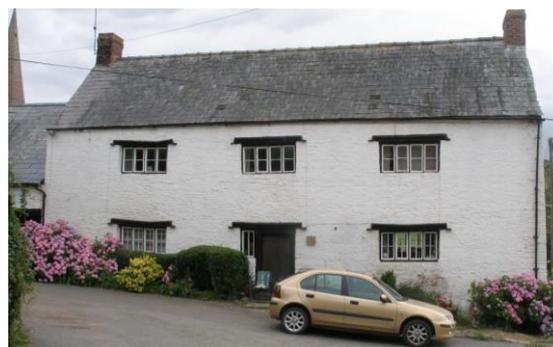
Fig.57 Town Farm House. This remarkably well preserved building of the 17th century retains its symmetrical façade design of five mullioned windows and central front door. The gable end stacks are a typical feature

7.4.16 Farm buildings of particular note were constructed in Grosmont in the 17th century. The Town Farm (Grade II* listed, **Fig.57**) has a remarkably intact front elevation with a symmetrical composition of five mullioned windows arranged around the central front door. Each window has three mullions and is topped by characteristic dripmould lintels. The front door is of plank and batten construction with the frame dated 1673. The only slight interruption to the strict symmetry of the two storey elevation is a narrow side window on the left side of the front door.

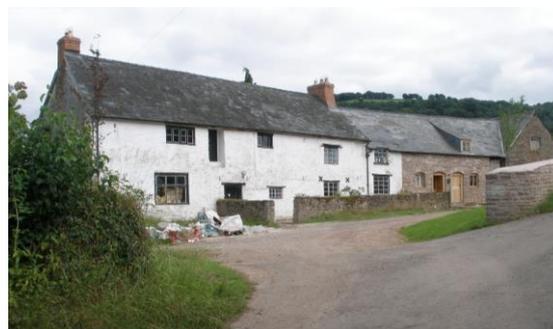
Fig.58 Great Tresenny Farm. The brick stacks mark the extent of the early 17th century farmhouse with its hall on the left. Subsequent extensions have created a fine range of farm buildings.

7.4.17 Great Tresenny Farmhouse (Grade II listed, **Fig.58**) constructed in the early years of the 17th century is remarkably unaltered although it has been extended to the south, making a long narrow range facing the road across the farmyard. The brick end stacks mark the extent of the original farmhouse. The plank door opens to the cross passage, with

the original hall to the left and the parlour accommodation to the right. The windows are mainly mullioned, with a very small arched window lighting the fireplace stair. Later additions and alterations include a loading door on the first floor and an 18th century iron framed window on the ground floor to the right.

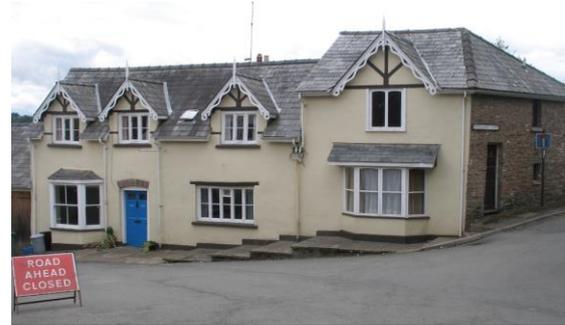
Fig.59 York House was altered and extended (to the right) in the 18th century. The decorative bargeboards are probably a later feature.

7.4.19 Nevertheless existing buildings were extended, for example Howells House and the former Old Duke of York Inn, now York House (**Fig.59**), and others had the newly fashionable sash windows inserted.

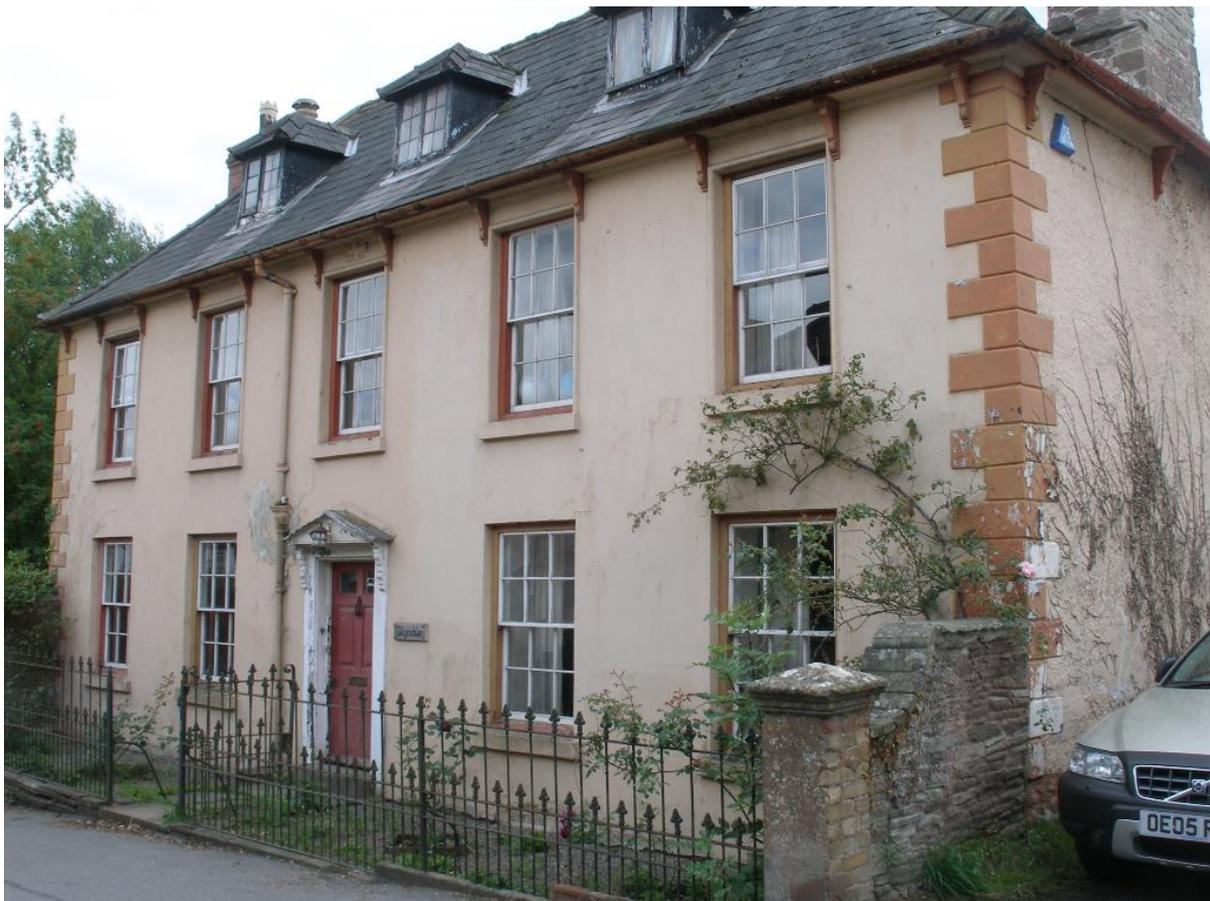
Fig.60 Glyndwr House is a typical renaissance style building, symmetrical, with five bays of sash windows. Pronounced quoins and the steeply pitched roof are typical of the first half of the 18th century. Here, as in many houses in Grosmont, front boundary railings are an attractive element in the streetscape.

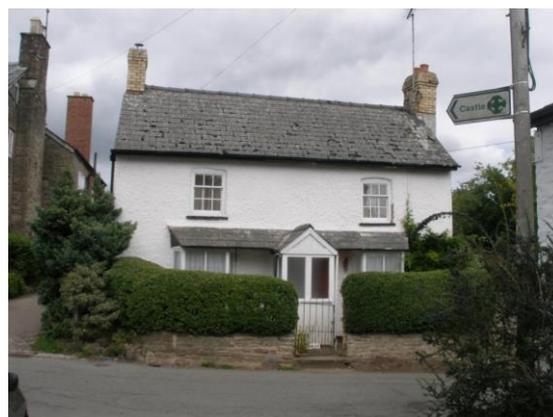
Fig.62 Woodview Cottage. Its simple 18th century design is enhanced by 19th century bay windows and continuous canopy.

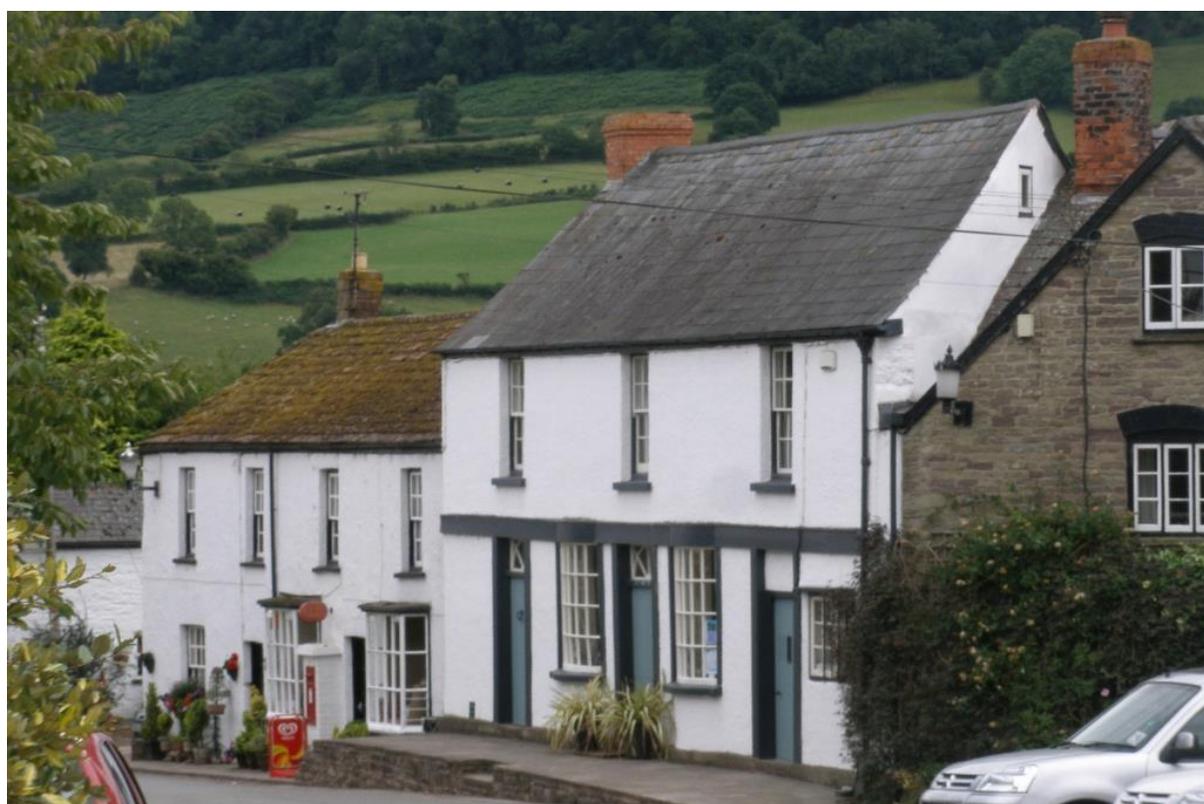
Fig.61 'Gentle Jane' (centre). A town house with a symmetrical front. The subtly curved bow windows suggest that it dates from the late 18th century.

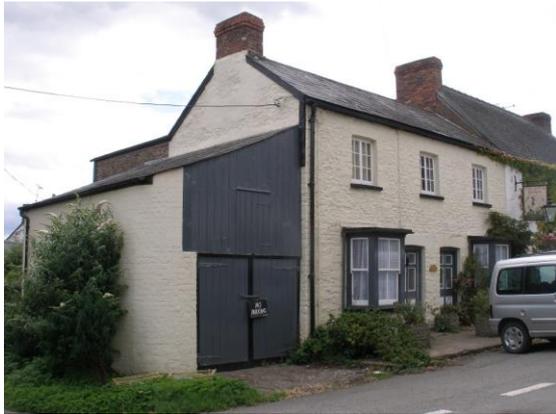
Fig.63 Angel Cottage, adjoining the Angel Inn, built in the 19th century as two cottages, creates a successful range with the Angel Inn. Typical Victorian sashes are evident in the bay windows.

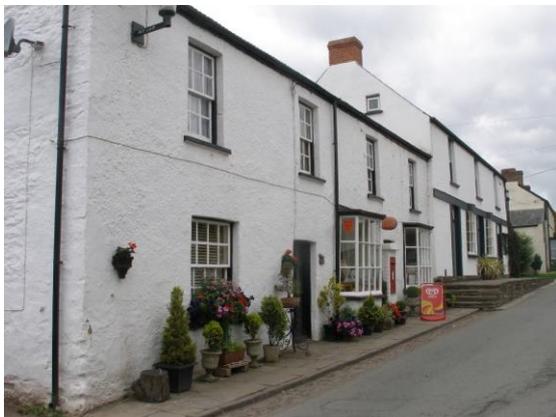
Fig.64 The Post Office, adjoining 'Gentle Jane' steps down the High Street. Its windows are late Georgian in design and the early shopfronts are of particular interest

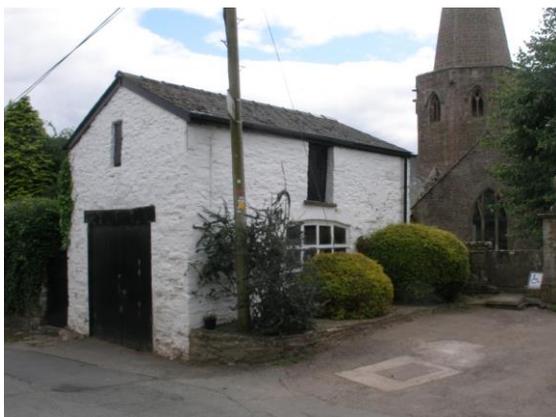
Fig.65 The Coach House to the Post Office. A well preserved simple everyday vernacular building which, like that in Fig.68 are heritage assets contributing to the character of Grosmont.

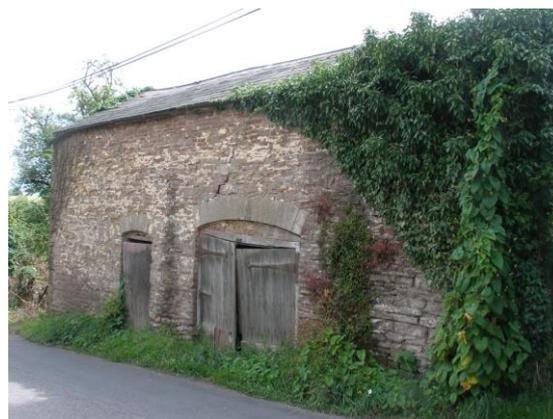
Fig.66 A disused farm building distinguished by well formed voussoirs, stands at the roadside opposite the Old Tan House. Traces of original paintwork can be detected on the rubble walls.

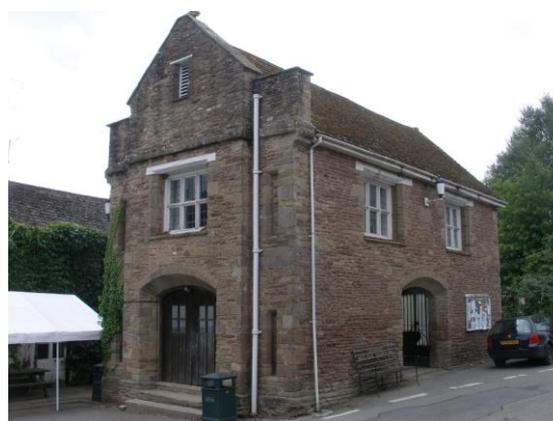
Fig.67 The Town Hall. This was rebuilt in 1831-2 in a hybrid style, recalling 17th century characteristics, especially with the mullioned and transomed windows. As usual with these buildings, it served as a market hall on the ground floor.

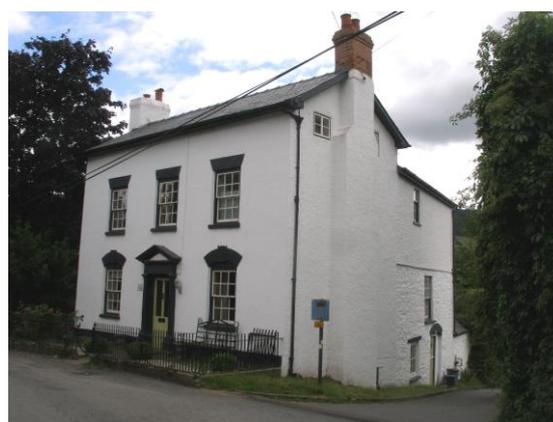
Fig.68 Alma House, an urbane late Georgian double fronted house with windows and railings intact. It fronts an earlier building to the rear.

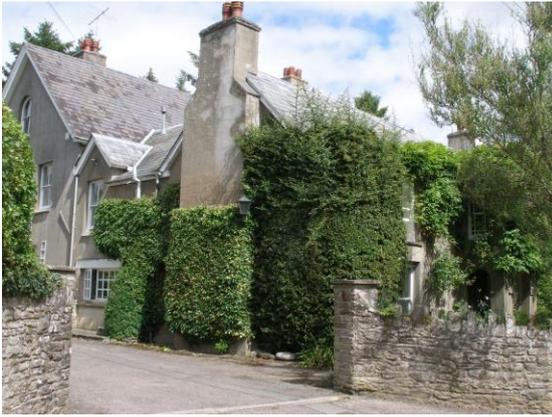
Fig.69 'Athelstan'. The original 16th century house is to the front, partially clad in ivy, and denoted by its prominent gable stack. The extensive Victorian additions can be seen to the rear.

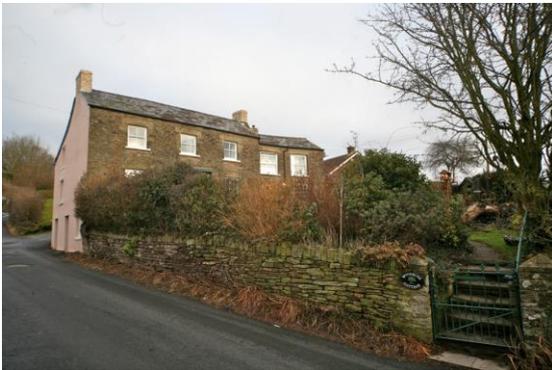
Fig.70 Woodbine Cottage. A mid-19th century large cottage featuring rubble stone, slate roof and brick end stacks.

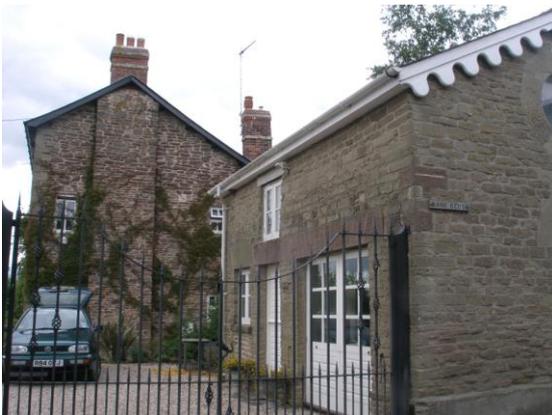
Fig.71 Bank House, with its three-storey mid-Victorian main elevation situated perpendicular to the High Street, looks south towards the church and market place.

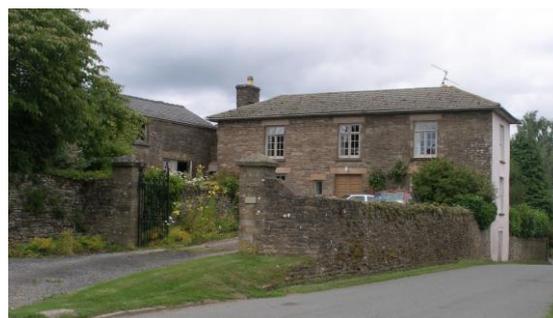
Fig.72 Belgrave House, towards the northern edge of the town, is sited at right angles to the High Street. This broad fronted Regency house has a characteristic low-pitched hipped roof.

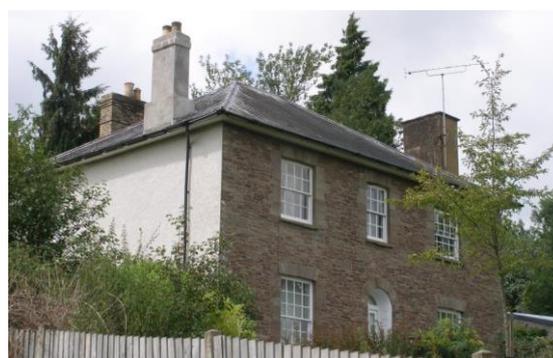
Fig.73 The Old Tan House. Another Regency style house with typical hipped roof, elegant sash windows and semicircular door head.

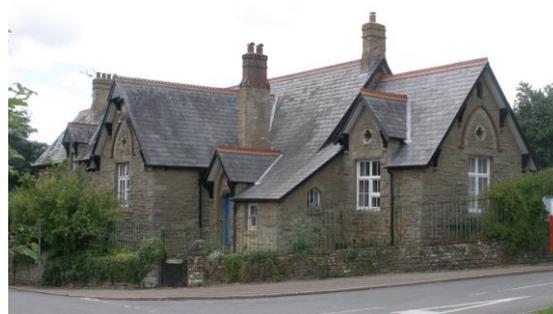
Fig.74 The Old School. The profusion of steeply pitched roofs, tall chimneys and Gothic details such as the quatrefoil vents in the gable ends typify this Victorian Gothic Revival building.

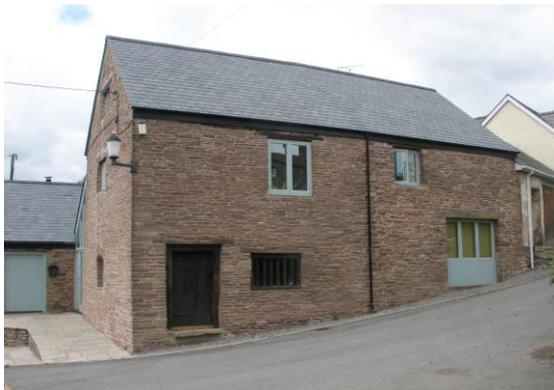
Fig.75 Stable range to Town End Barn is a recent conversion to residential use. Existing openings are utilised, and the simplicity of the original building is retained.

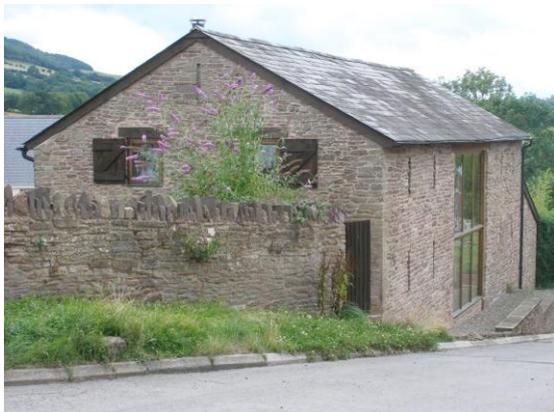
Fig.76 Town Barn. A residential conversion where existing openings, in this case the large cart doorway and the slit vents, have been retained and new windows inserted.

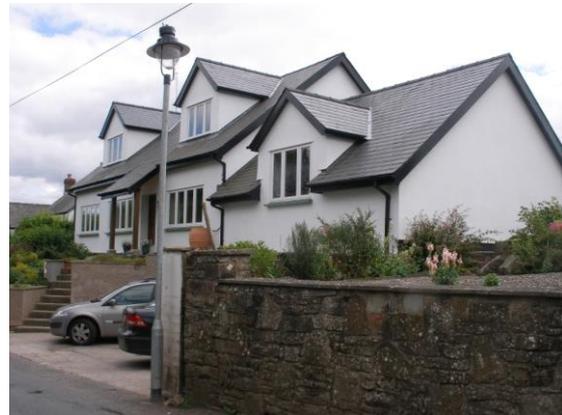
Fig.77 A new wide-fronted house retains the linear building form so characteristic of Grosmont. The subservient wing in the foreground is appropriate in reducing its bulk or repetitive effect. The mullioned windows are also appropriate. Perhaps the dormers could have been slightly less dominant.

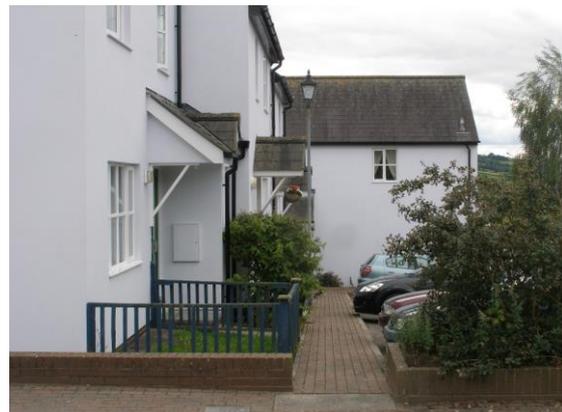
Fig.78 Bevan Court. A courtyard development with appropriate sense of enclosure and massing. The elevations are simple yet have variety. The parking space is well overlooked but not dominant.

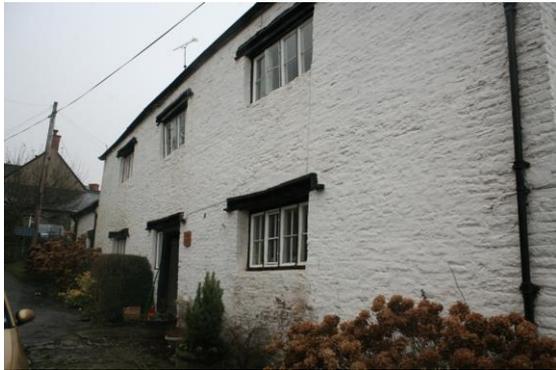
Fig.80 Traditional limewash to Town Farm

7.7.2 Walls are sandstone rubble laid in courses with many buildings white-washed or painted (**Fig.80**). Some stone buildings are rendered and incised to look like ashlar (Athelstan). Occasional buildings have stucco quoins (Glyndwr). Others use rock-faced stone (Rock Villa, Old School) (**Fig.81**) or have dressed stone (Bank House, see **Fig.71**). Openings in walls to 16th and 17th century properties are small with casements or mullions. Later 19th century re-frontings have larger openings to accommodate timber framed vertical sliding sashes.

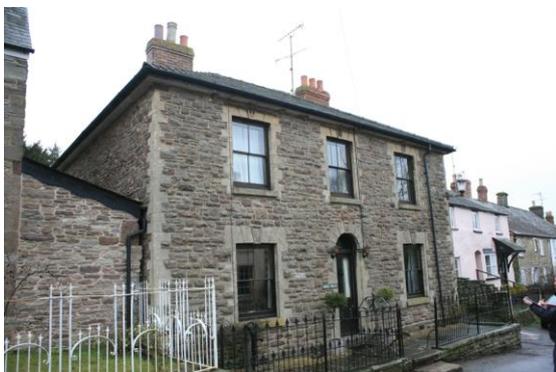
Fig.81 Rock Villa: use of Rock-faced sandstone

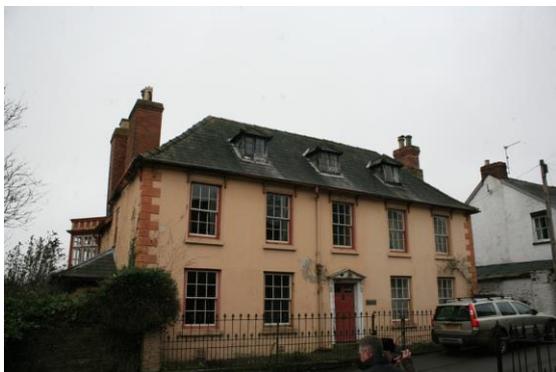
Fig.82 Glyndwr with its distinctive hipped roof and symmetrical frontage

7.7.3 Roofs are predominantly gable roofs, but there are occasional hipped roofs (**Fig.82**). Most are natural slate with the very occasional use of clay tile to outbuildings. Cement fibre slate and concrete interlocking tile is seen on some older buildings and 20th century infill. A range of sheeting material including corrugated asbestos and corrugated iron is found on some outbuildings.

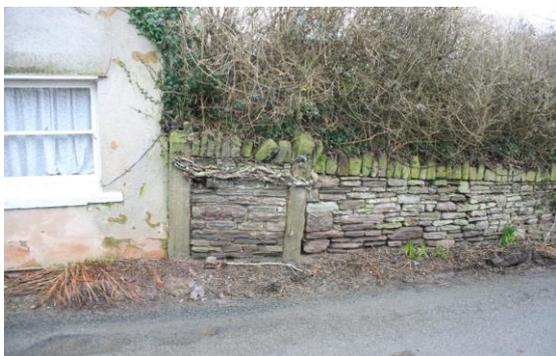
Fig.83 Drystone wall with blocked gateway to Woodbine Cottage

7.7.4 Boundary walls are local rubble stone, some with coping stones (**Fig.83**). Low stone plinths often form a base for decorative iron railings to roadside properties.
