Flood and Water Management Act 2010

Section 19 Flood Investigation Report

Skenfrith

October 2019

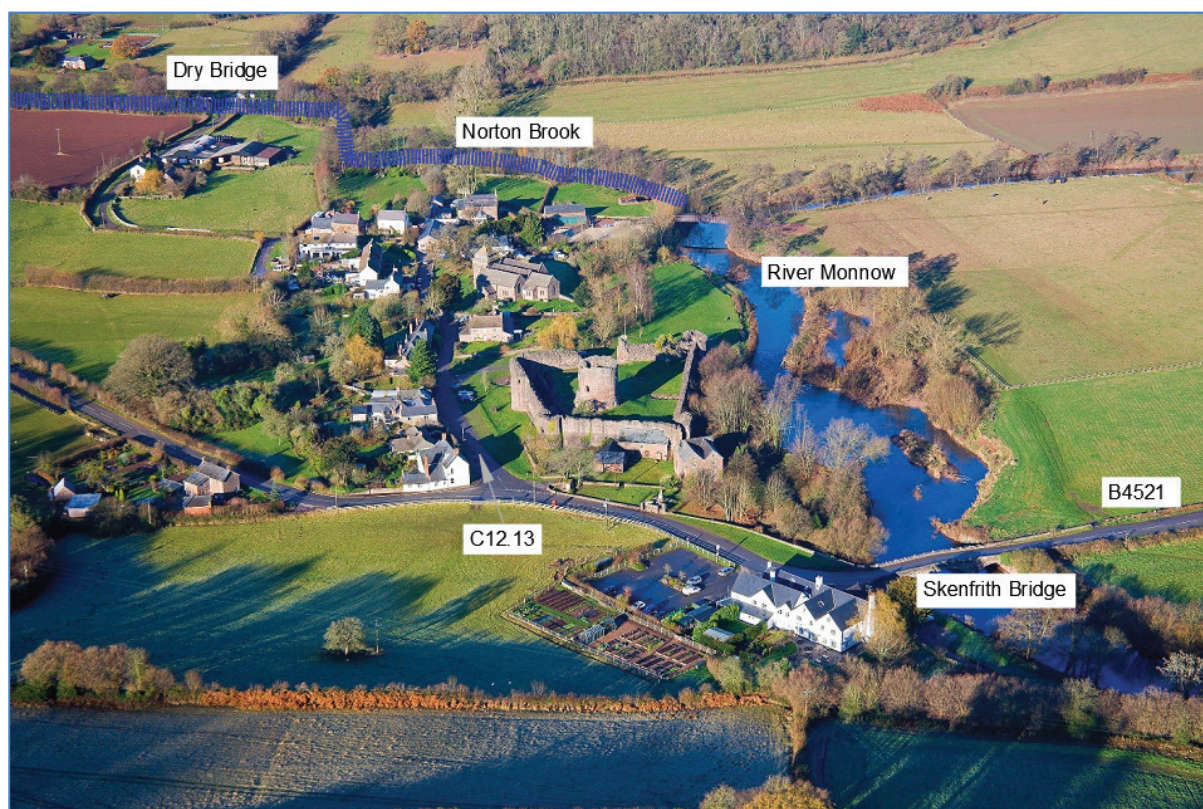
Figure 2: Skenfrith and local rivers / road network

Natural Resources Wales (NRW) flood maps show Skenfrith as being at High risk of flooding from the River Monnow and Norton Brook, and Medium - High risk from surface water flooding as shown in Figures 2 and 3 below.

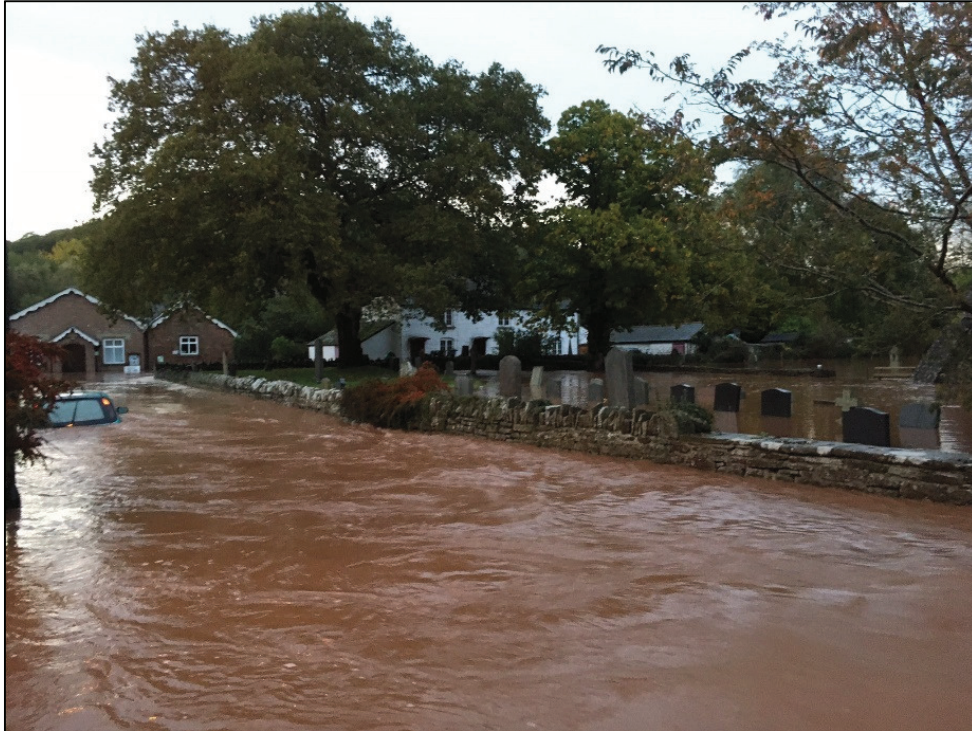
Photo 1: Significant flooding in the centre of the village and church grounds

A post event inspection identified eighteen residential properties that were very badly affected with levels of internal flooding typically 300-600mm deep, but up to approximately 1.0m in some instances. The local pub, village hall and church also suffered significant flooding.

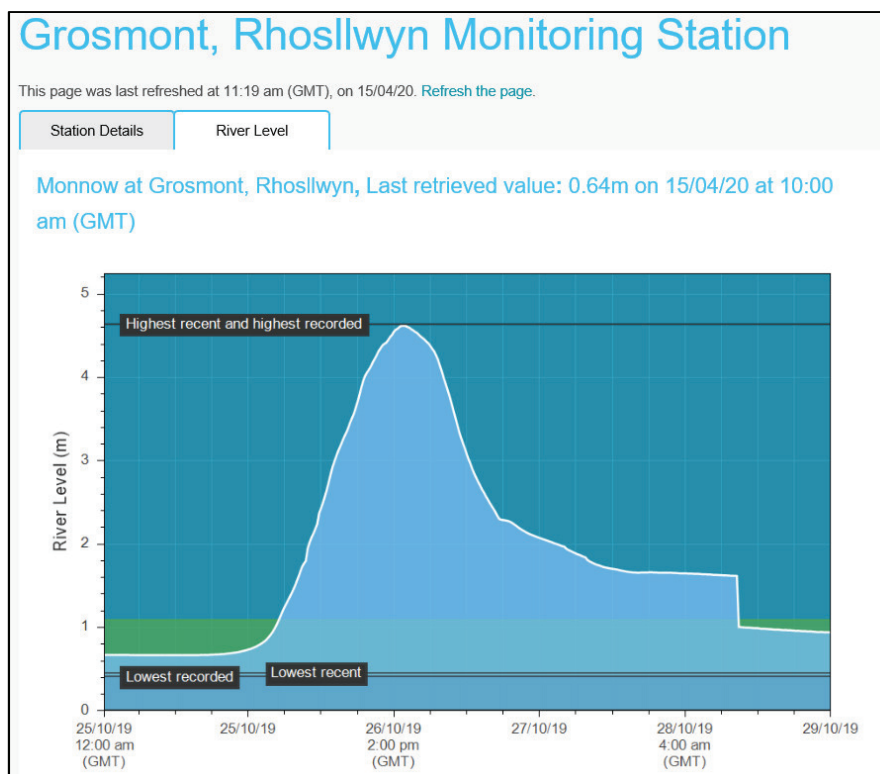
Figure 6: An extract from Natural Resources Wales' River Monitoring Gauge at Grosmont (4 day view)

Record levels along the River Monnow were recorded at NRW's Grosmont and Skenfrith gauge stations. A peak level of 4.62m was recorded at Grosmont at 3.00pm on Saturday 26th October, with the peak reaching 4.84m at Skenfrith approximately 2 hours later between 5.30-6.30pm.

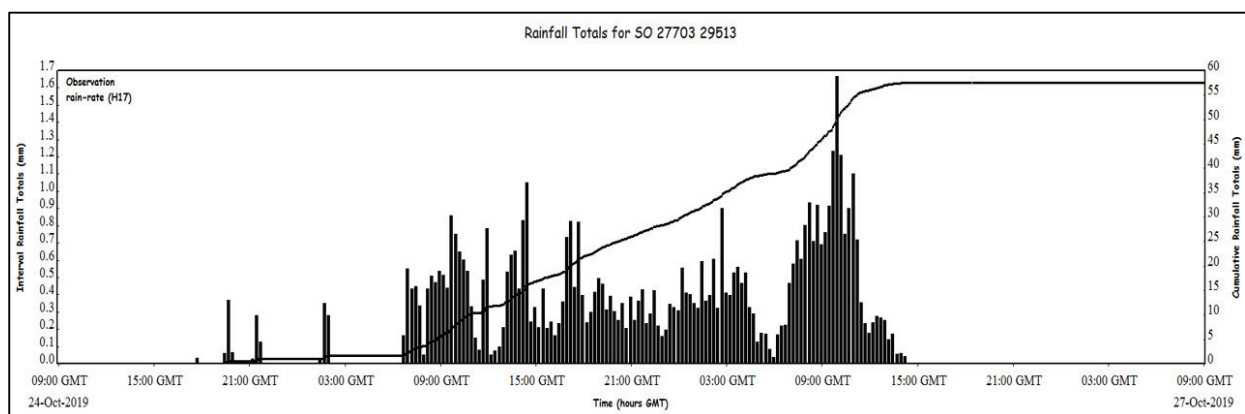
Figure 10: Tafalog Gauge Station, 85mm in two days peaking at 50mm in 12 hours on the 26th October.

At the western edge of the River Monnow catchment a NRW rainfall gauge located at Tafalog, Llanthony, recorded a 24hr rainfall total of 84.4mm, which equated approximately to a 1 in 26 year return period. The peak rainfall was recorded on the morning of 26th October.

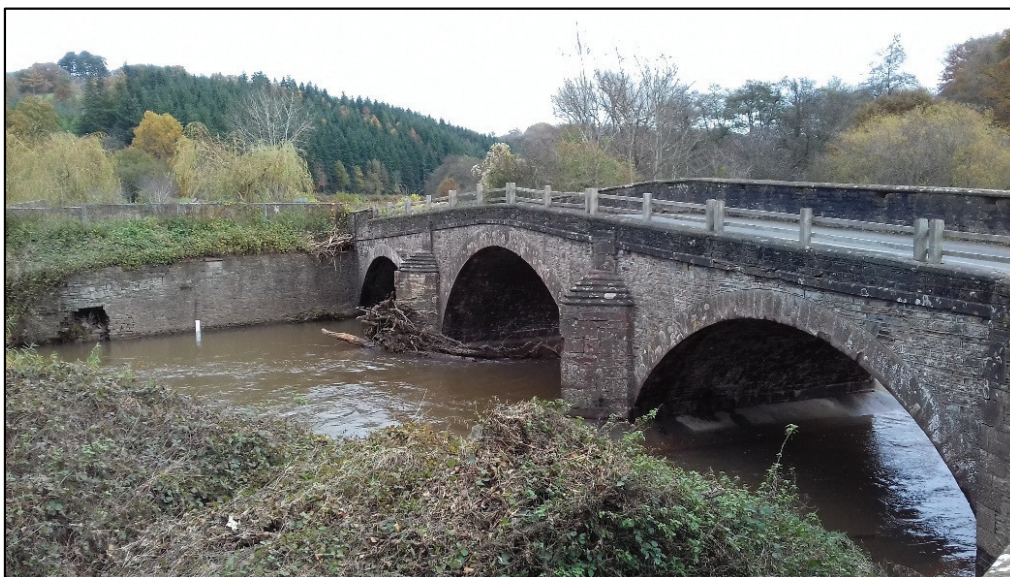
Photo 2: Skenfrith Bridge with a small accumulation of woody debris on the far cutwater post event

During the flood event, no major blockages or impediments to flow were reported within the watercourses or at Skenfrith Bridge, which carries the B4521 over the River Monnow at the downstream end of the village. Significant overland flows were reported across fields to the east of the village which then overtopped the B4521. After the event, debris accumulations were visible along the top of fences and gates suggesting the depth of water at this location was in excess of 1m.

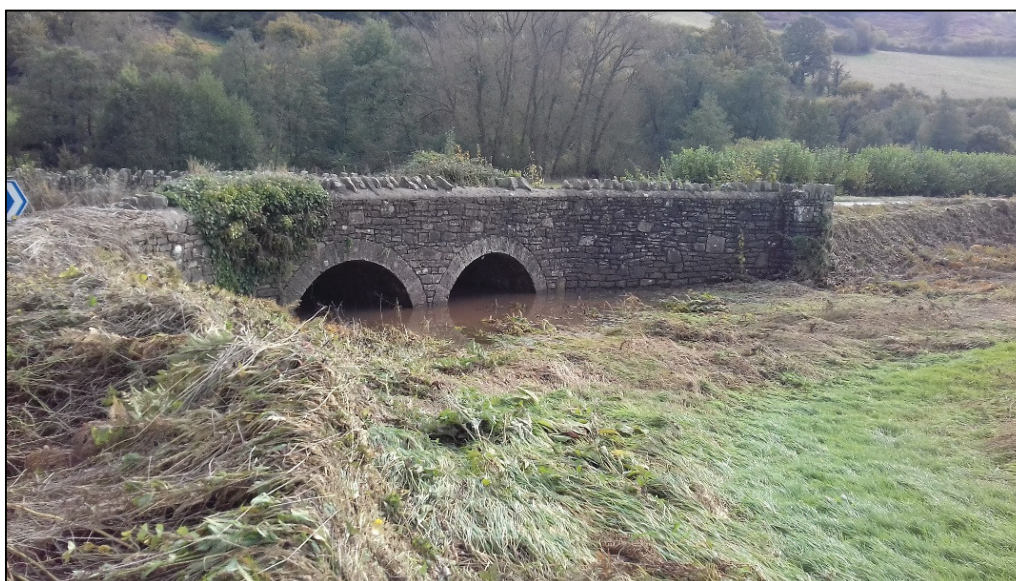
Photo 3: Flood relief aches at the B4521/R23 Junction

The Easter 1998 flood report suggests this section of the B4521 carriageway, which crosses the flood plain to the east of the village, was raised in 1960 in order to improve access over Skenfrith Bridge for larger vehicles. The carriageway was overtopped in places during this event causing damage to hedges and fencing. The raised section has been described as a “causeway” type structure that has created a barrier to overland flow during extreme flood events. There is a twin masonry arch relief structure at the far end of the “causeway” adjacent to the B4521/R23 junction, which is of insufficient capacity to convey the overland flow beneath the B4521. Photos of this structure and other key drainage features can be found in Appendix B. Further investigation and hydraulic modelling would be required to ascertain what affect this section of raised carriageway has on overland flow and if it is significant enough to affect flood levels within the village.
