Monmouthshire County Council

Section 19 Flood Investigation Report

Mayhill, Monmouth

February 2020

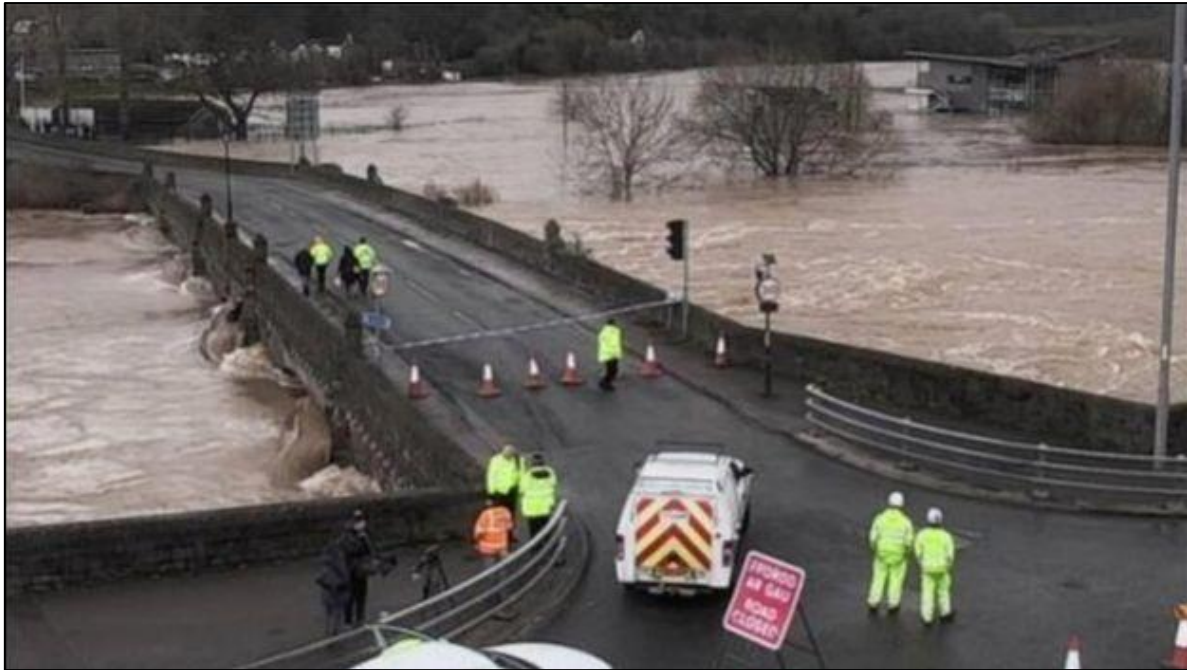
Photo 2: Showing the Wye Bridge looking east to Mayhill.

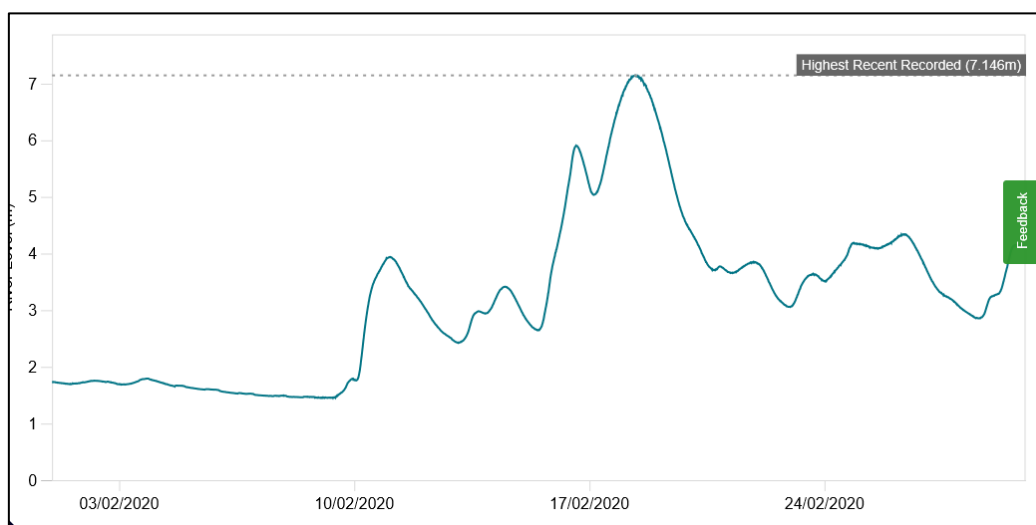
Figure 6: River Wye Gauge Readings for February 2020

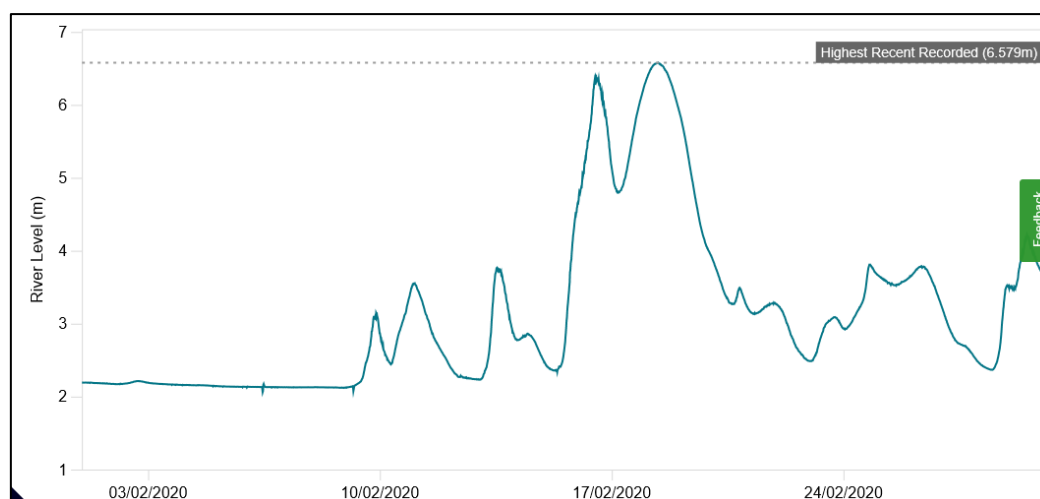
Figure 7: River Monnow Gauge Readings for February 2020

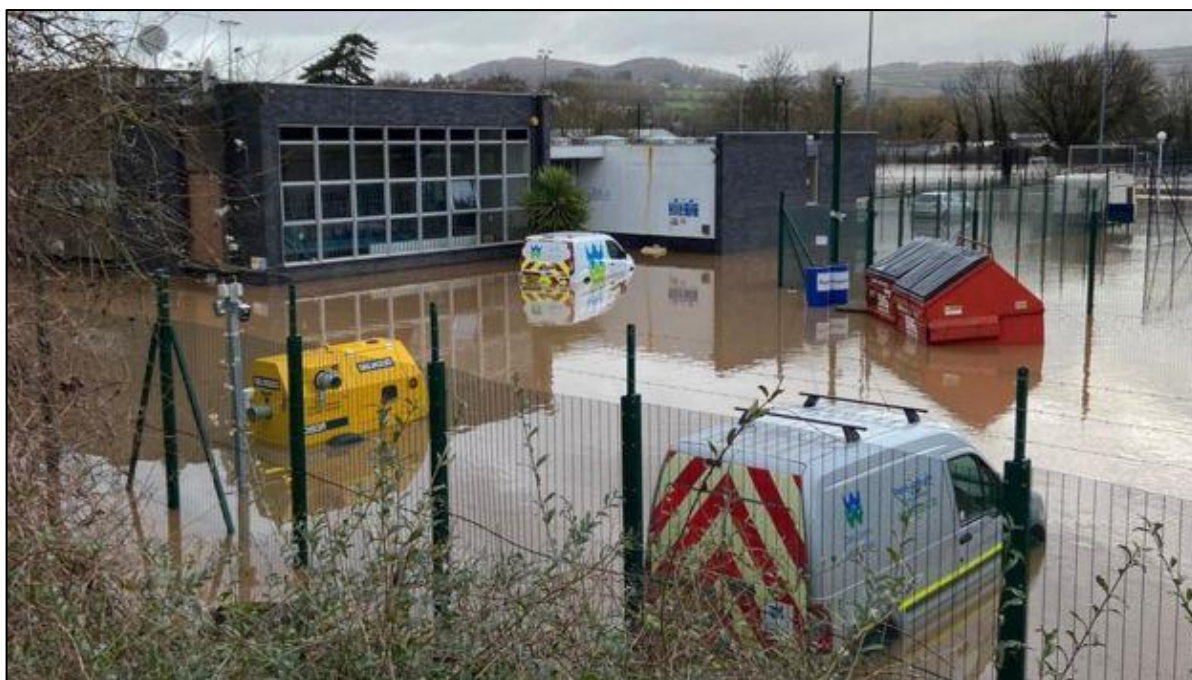
Photo 3: The Welsh Water Mayhill Water Treatment Plant

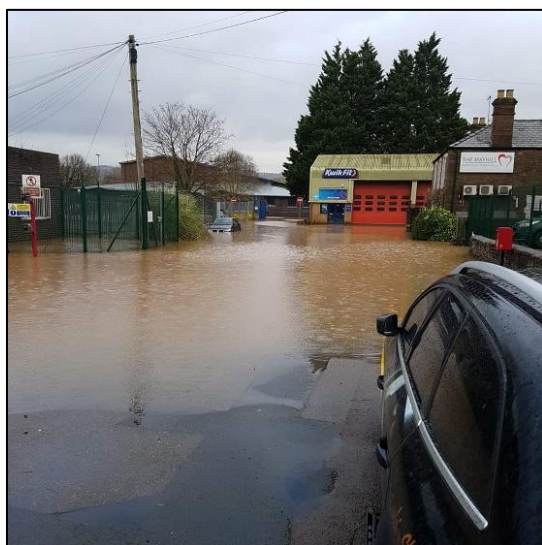
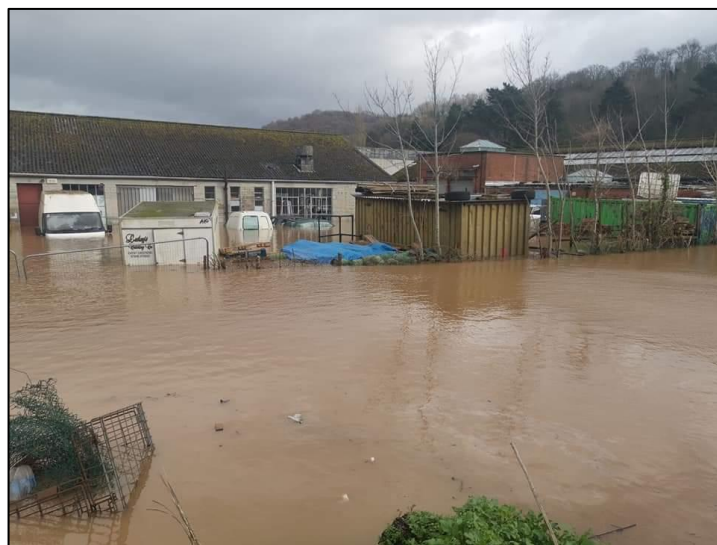
Photos 4 & 5: Flooding of the Industrial Estate Area

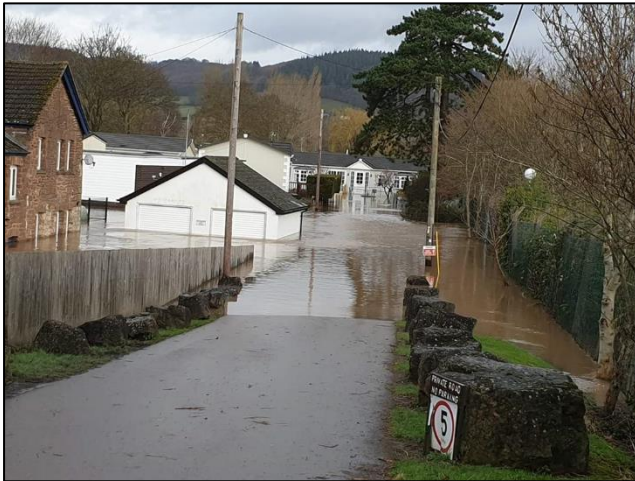
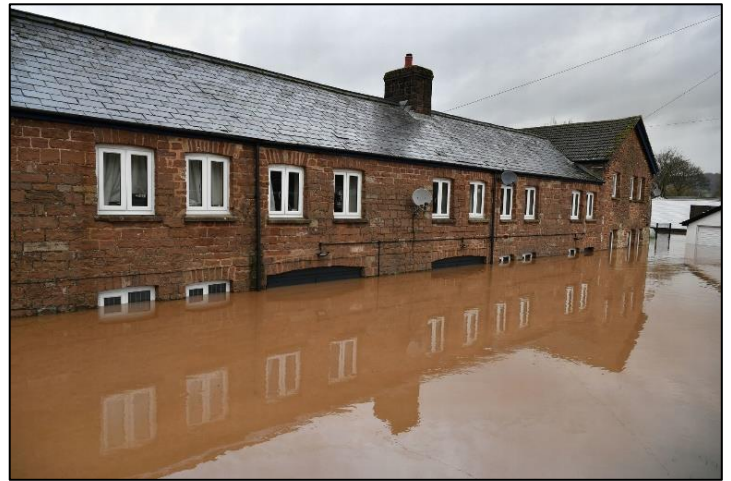
Photos 6 & 7: Left - Flooding to Riverside Park Access, Right - Flooding of Wyebriidge Cottages, Courtesy of Gloucestershire Live.

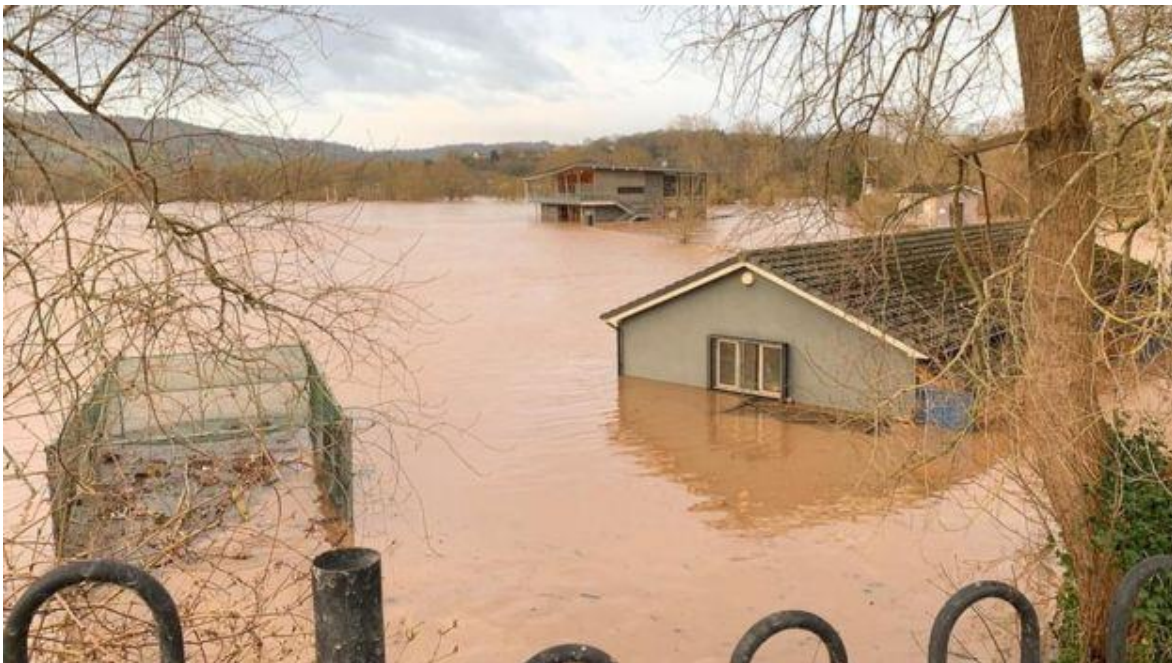
Photo 8: The view downstream of Wye Bridge showing the flooding of the Monmouth Boys School Playing Fields, sports complex and buildings

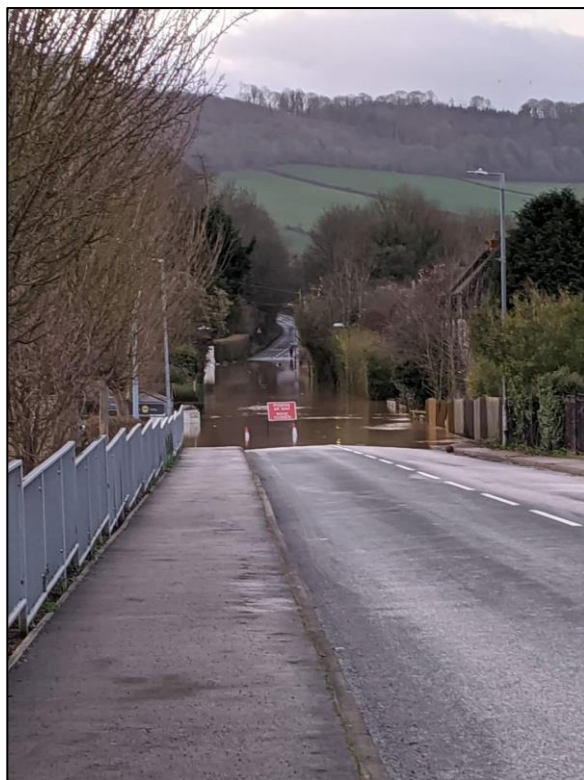
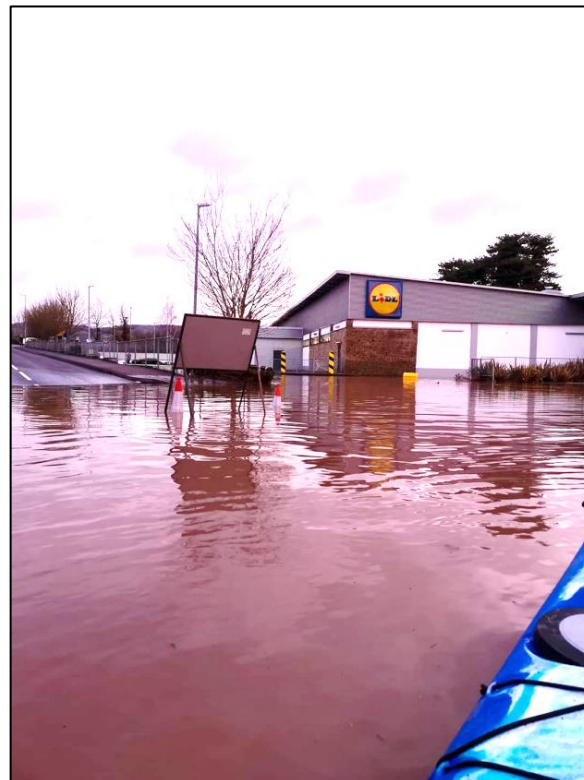
The A466 Redbrook Road on the eastern side of the Wye Bridge was also flooded during this period. The flooding was of sufficient depth to prevent traffic use. The closure meant that travel to the Forest of Dean, Chepstow and Monmouth itself was severely restricted for residents who live in the Wyesham area, causing considerable difficulties over the four days of the flood.

Photos 9 and 10: Showing the flooding on the A466 Redbrook Road

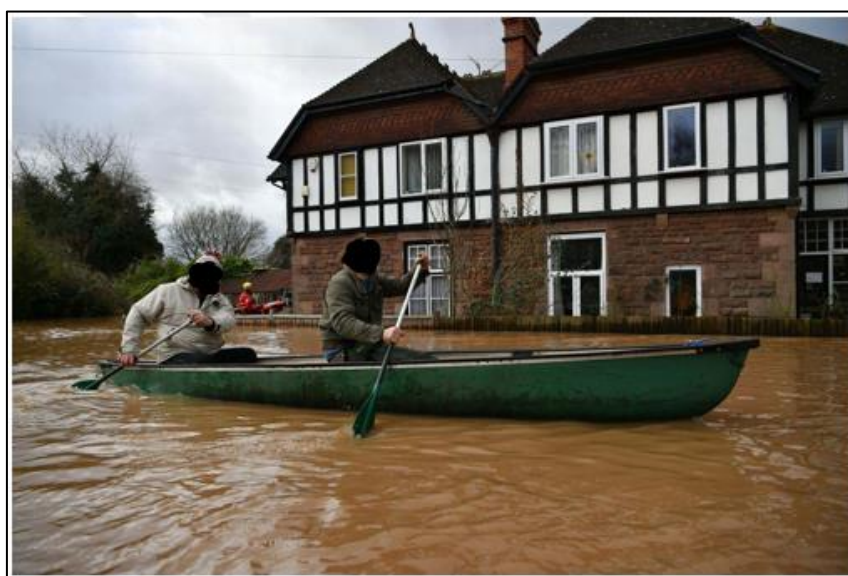
Along the A466 Redbrook Road, the old railway embankment runs parallel to the road. There is a break in the bank for an access onto the Monmouth Boys School playing fields where the flood levels were such that water came through and over the sandbagging and flooded Redbrook Road and local areas. This included a number of residential properties as well as the car park of the Lidl store.

Photo 11: Flooding along Redbrook Road, Courtesy of Gloucestershire Live

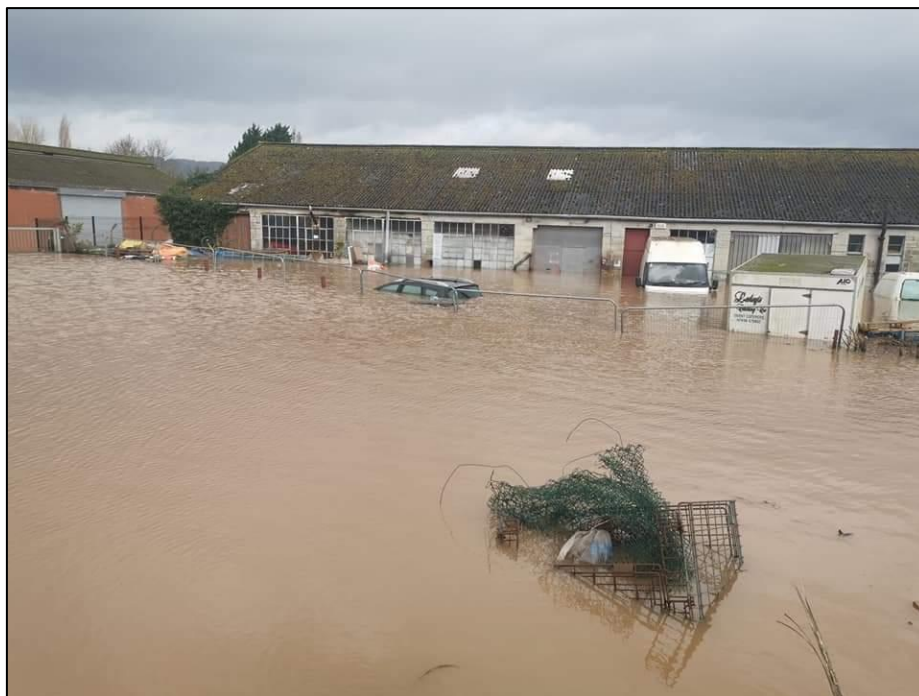
Photo 12: Flooding off Hadnock Road and the Industrial Estate

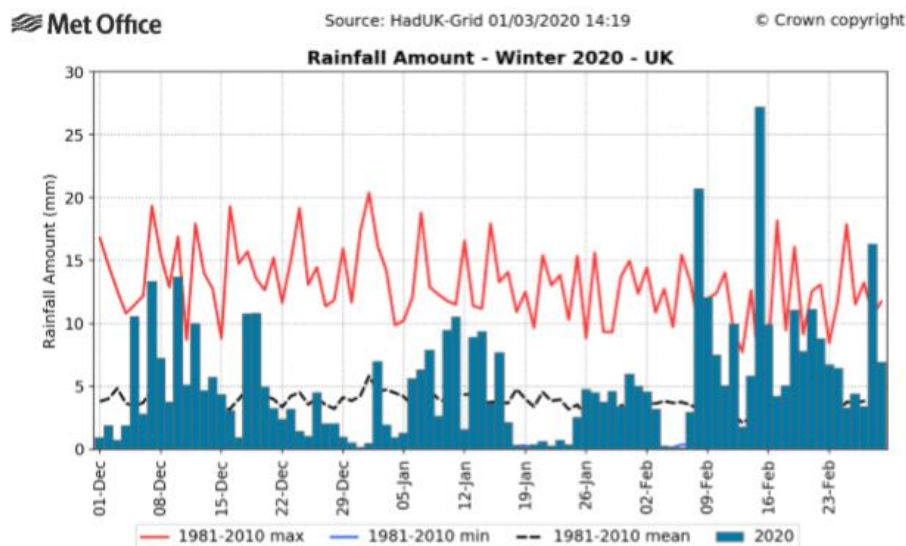
Figure 9: Met Office Rainfall Data December 2019 to February 2020.

This also shows daily rainfall totals through February 2020, with particularly wet days from Ciara (8th), Dennis (15th) and Jorge (28th).

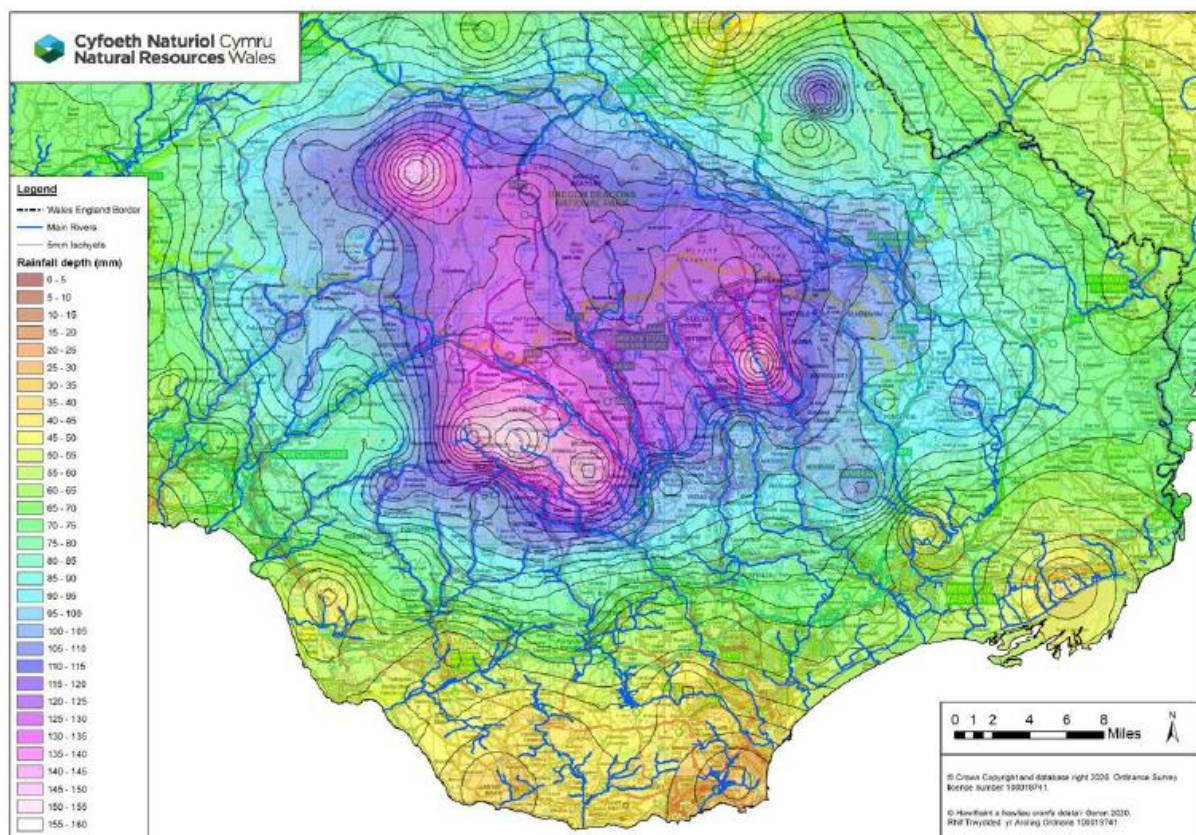
Figure 12: Rainfall Isohyet Map showing rainfall over a 48-hour period during Storm Dennis in South Wales (produced by NRW).

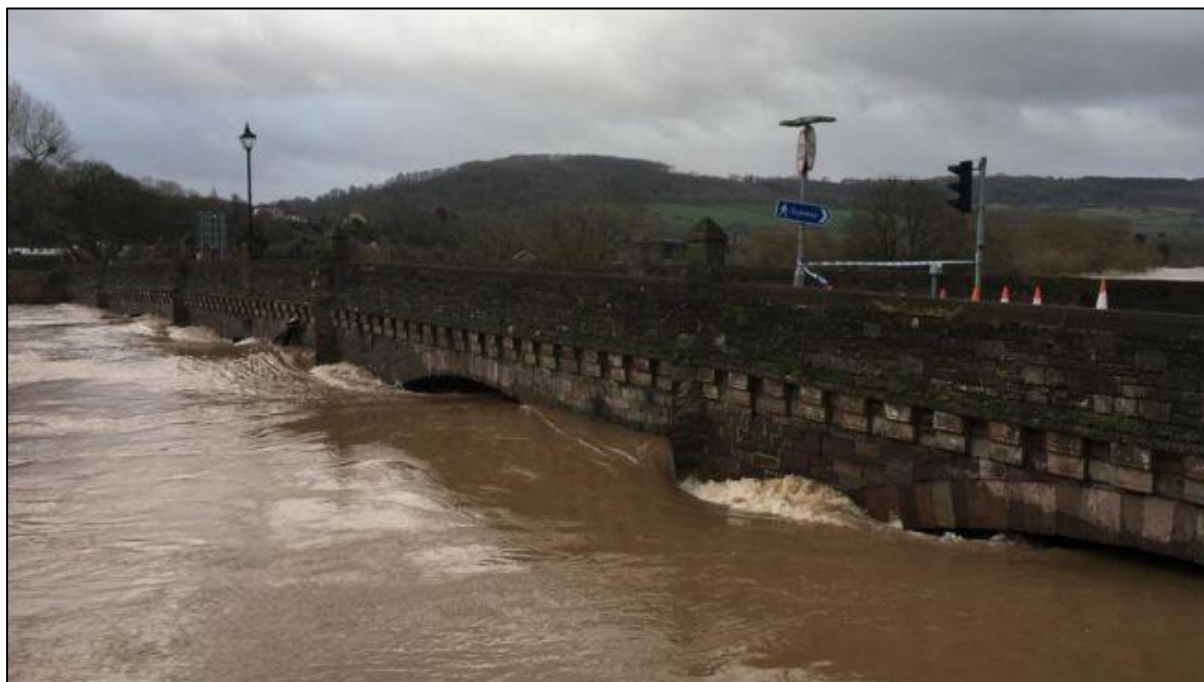
Photo 12: View of high water levels upstream of Wye Bridge, courtesy of ITV News

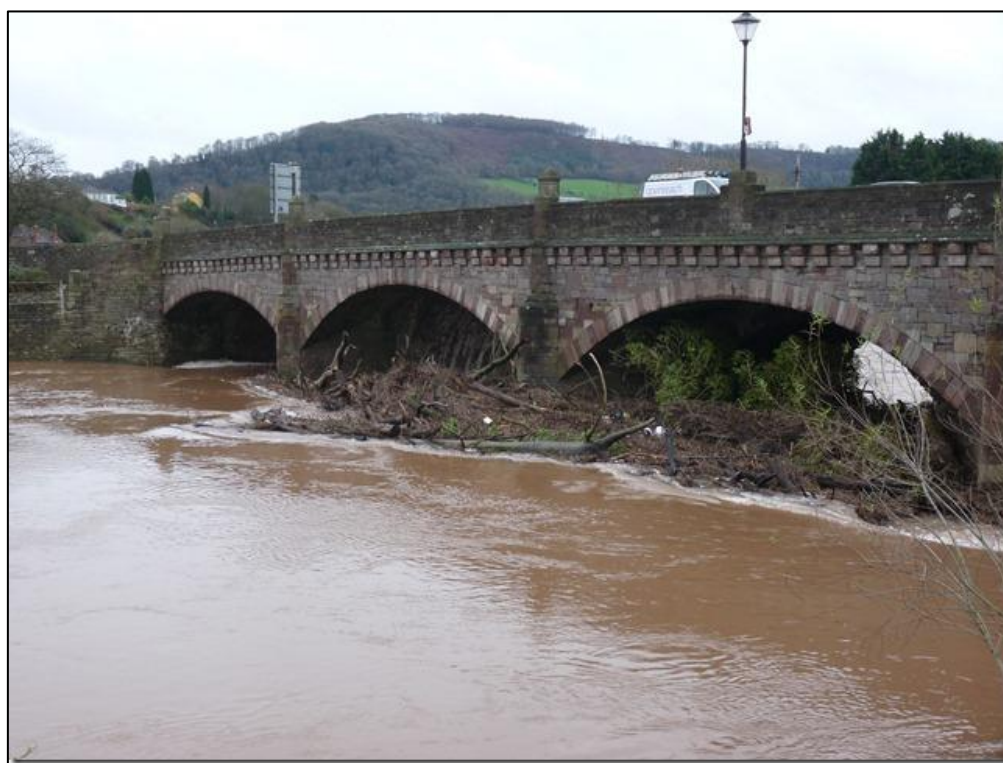
Photo 13: Debris build up on the upstream side of Wye Bridge as a result of the flood event

A number of masonry arches beneath the road on the Mayhill side are used as storage and have higher ground on the downstream side. Clearing these may improve conveyance of flood waters as these are likely to have been originally intended as flood relief arches. Consideration should be given to investigating whether these could be cleared and whether it would improve flows.

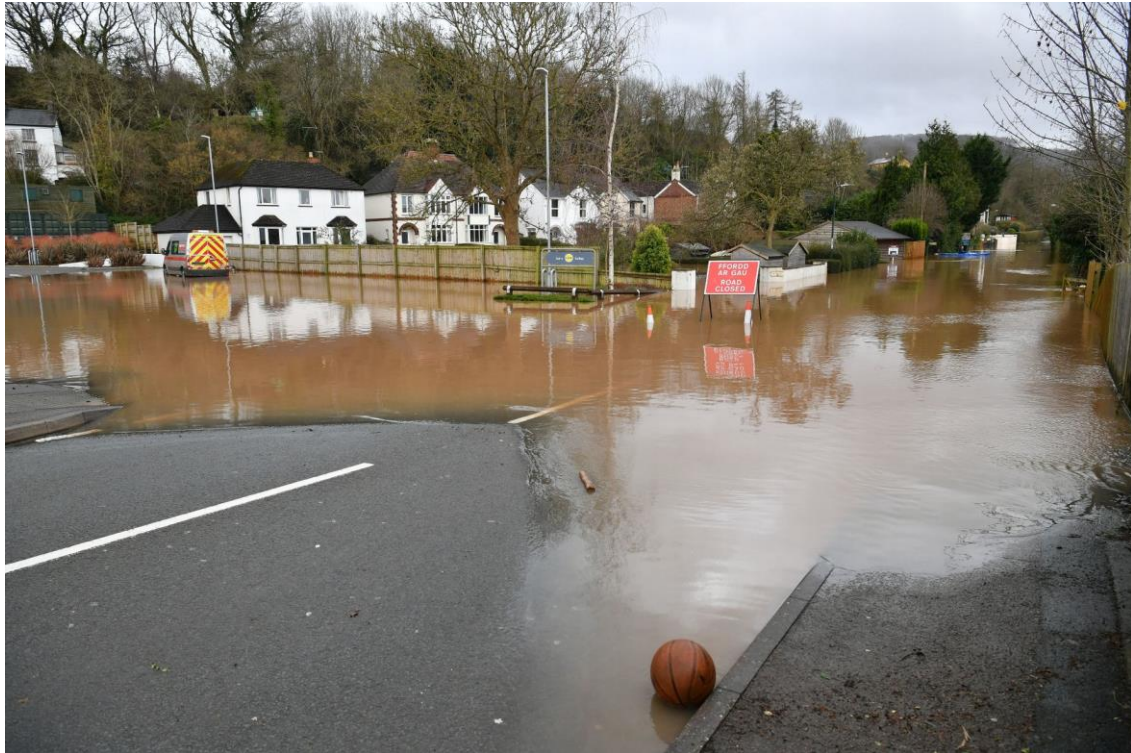
Photo 14: A466 Redbrook road looking south, Lidl car park visible on the left, From Gloucestershire Live

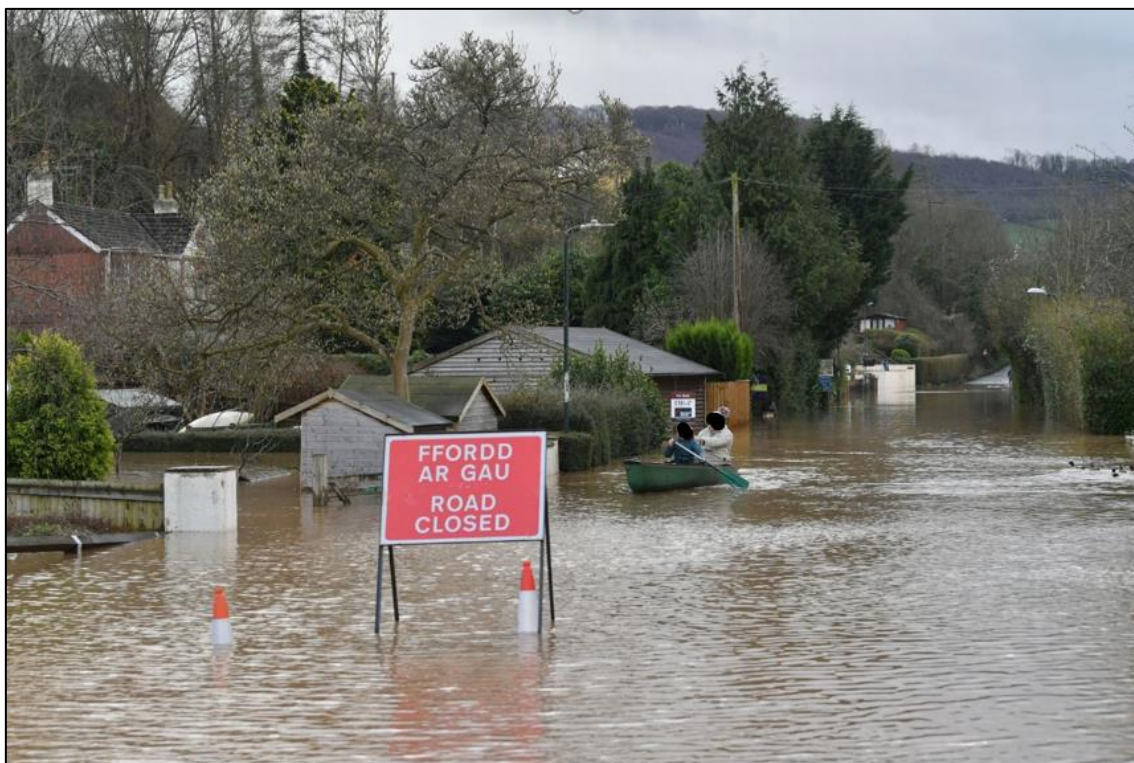
Photo 15: A466 Redbrook Road adjacent to Lidl's car park, From Gloucestershire Live

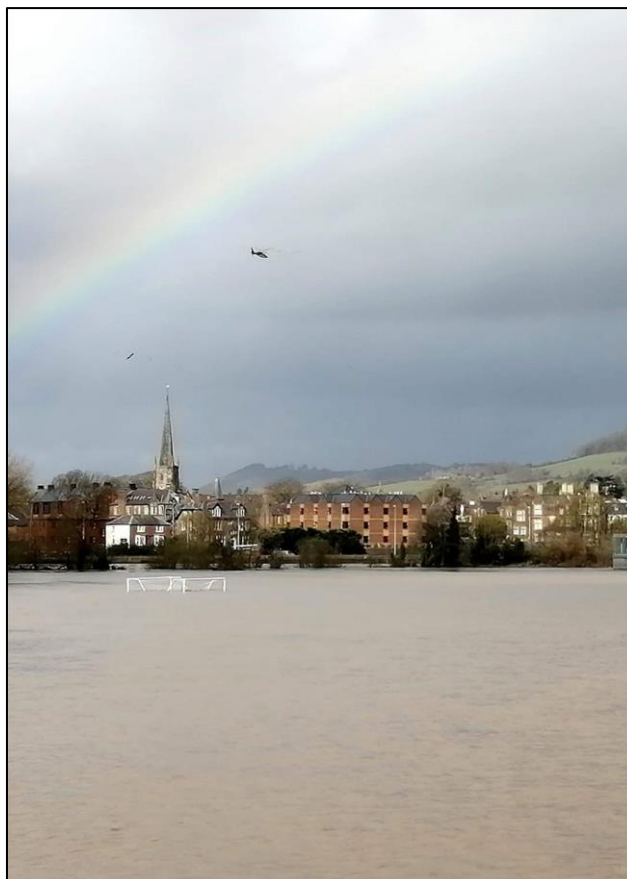
Photo 16: View across Monmouth Boys School sports pitches with the main river channel in the distance and pavilion building on the right

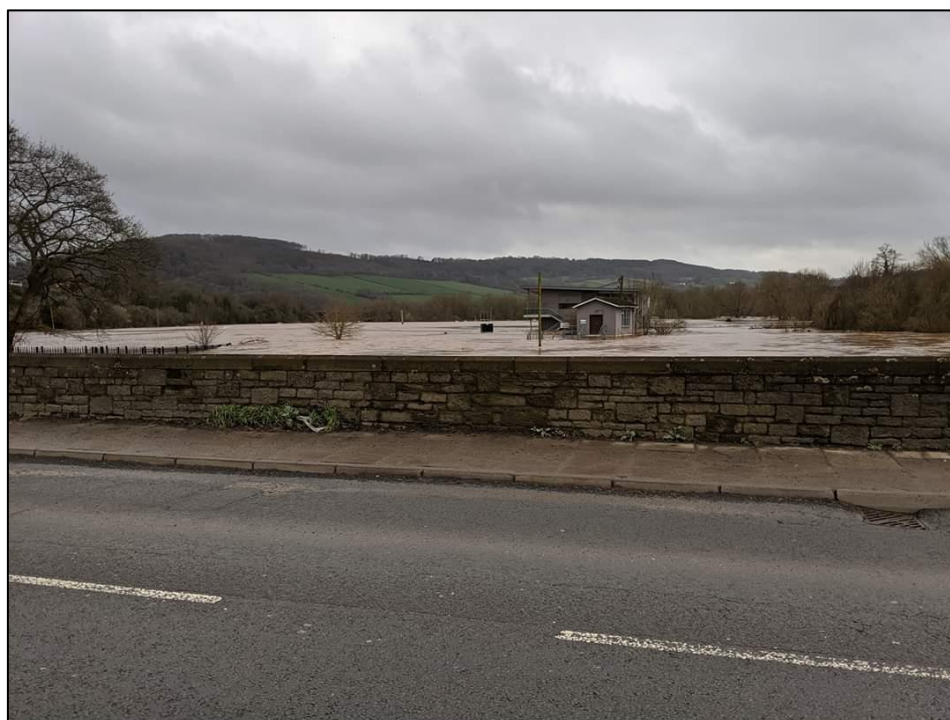
Photo 17: View from Wye Bridge looking downstream to the Monmouth Boys School sports pavilion
