**Monmouthshire County Council**

**Section 19 Flood Investigation Report**

**Forge Road, Monmouth**

**Storm Dennis  
February 2020**

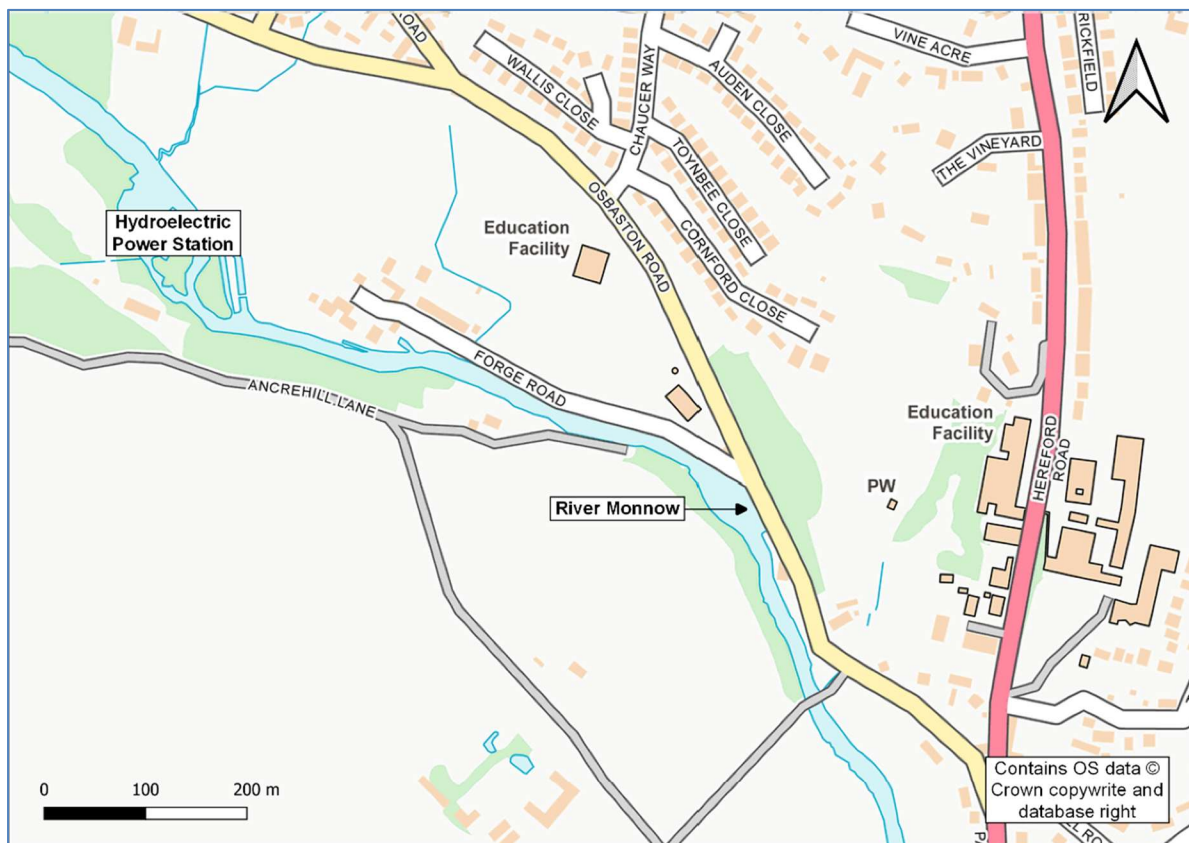
Figure 2-2. Flood Investigation Area location plan

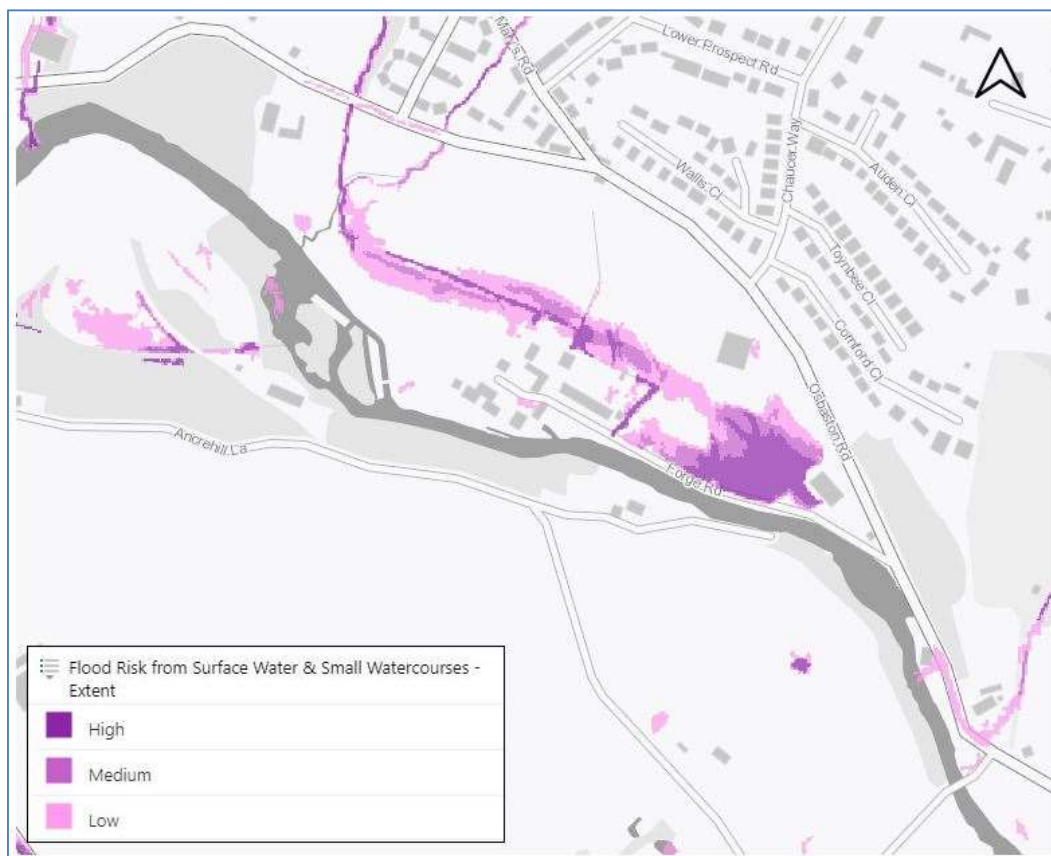
NRW flood maps show Forge Road is at high risk of flooding from the River Monnow, and at some low surface water flood risk, see Figure 2-3 and Figure 2-4.

*Figure 2-4. Extract from Natural Resources Wales, Risk of Flooding from Surface Water*

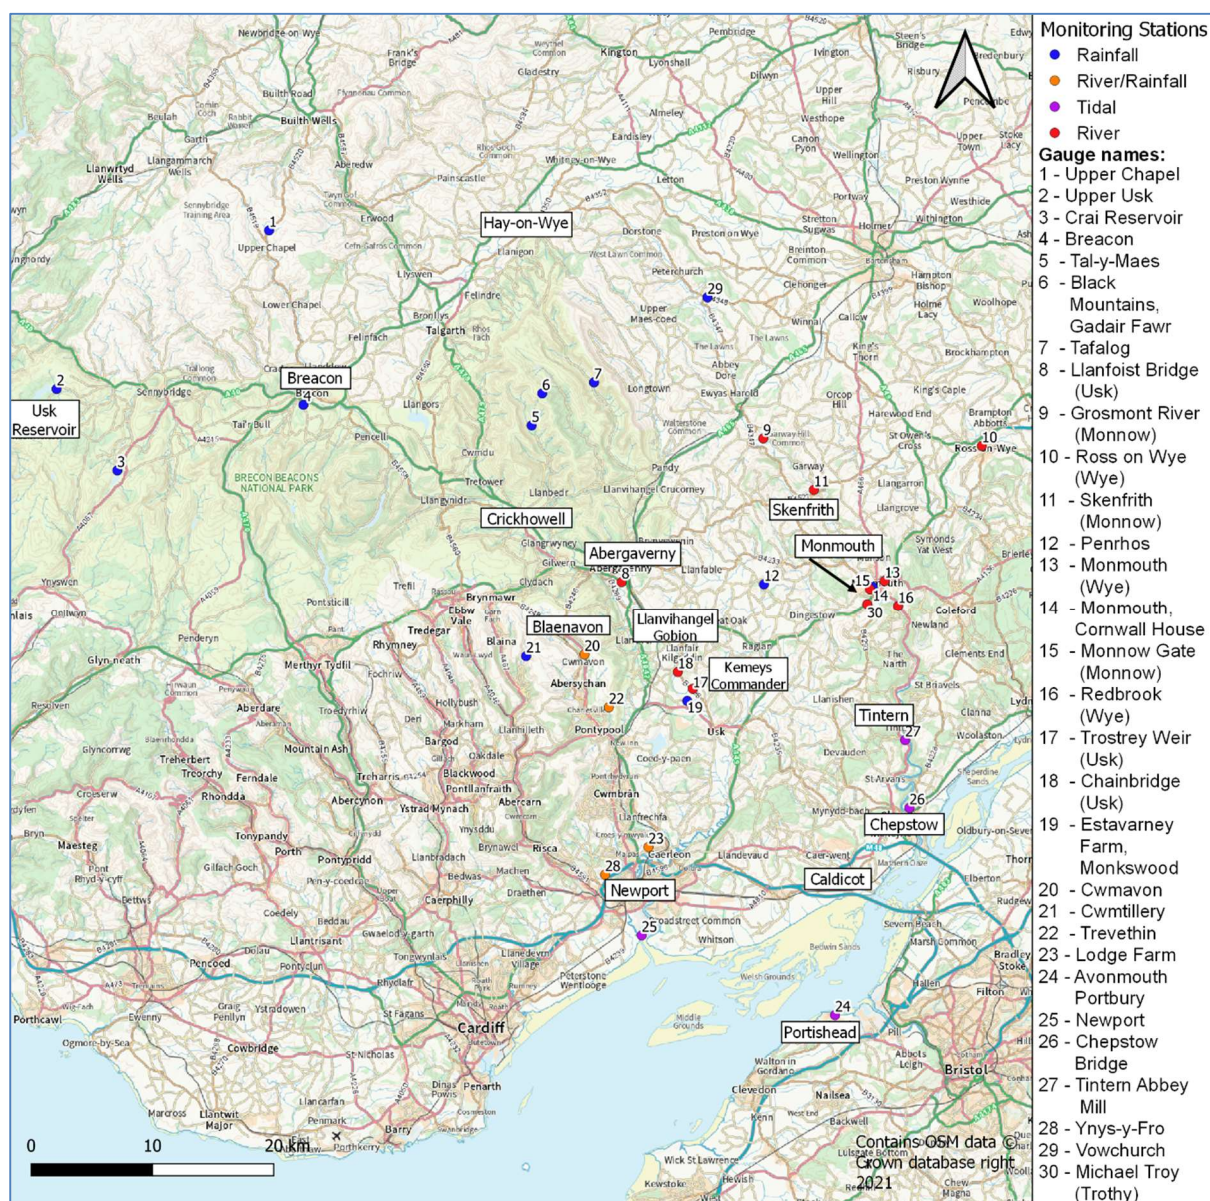
The location of nearby NRW and EA river, rain, and tidal gauges are shown in Figure 3-2.

All gauges are NRW except Vowchurch rain gauge, Ross on Wye river gauge, and Avonmouth Portbury tidal gauge which are EA. All the listed river and tidal gauges are telemetered. Rain gauges are a mixture of telemetered and logger.

Figure 3-2 Local rain, river, and tidal gauges<sup>12</sup>

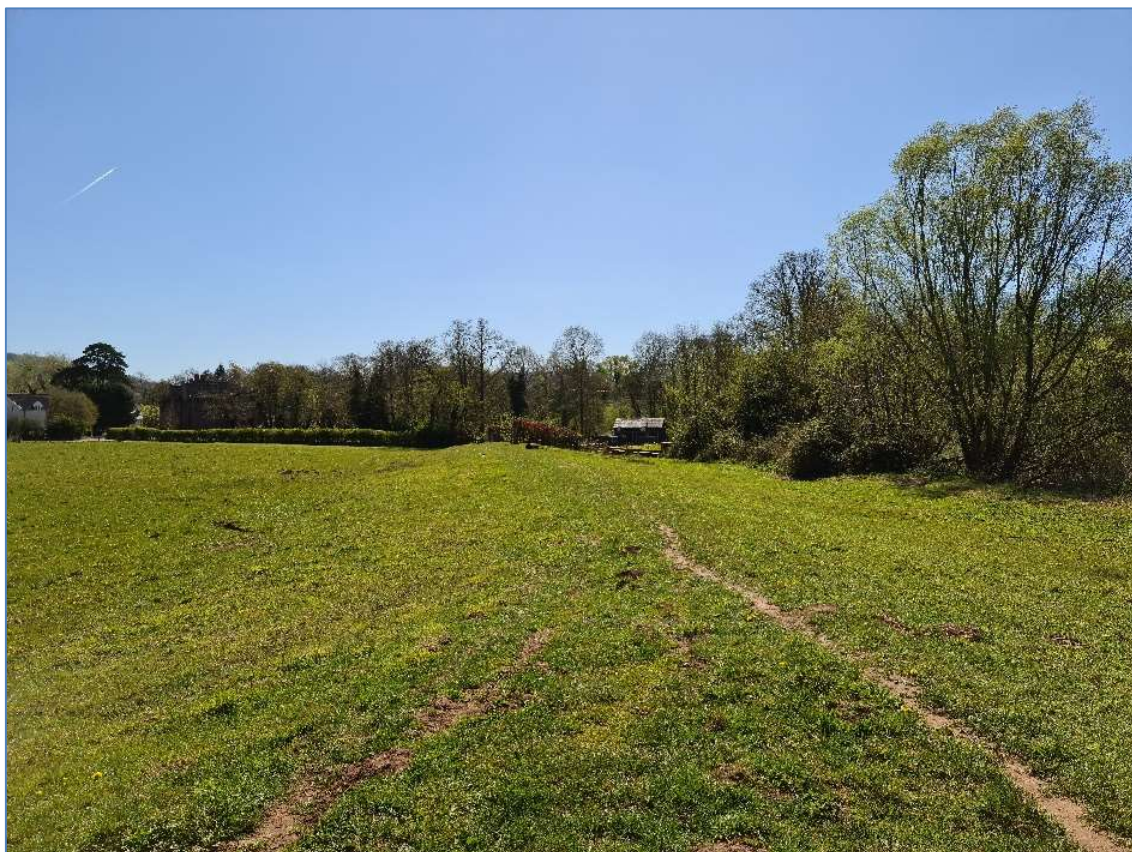
*Figure 4-2. Forge Weir embankment, site visit May 2021*

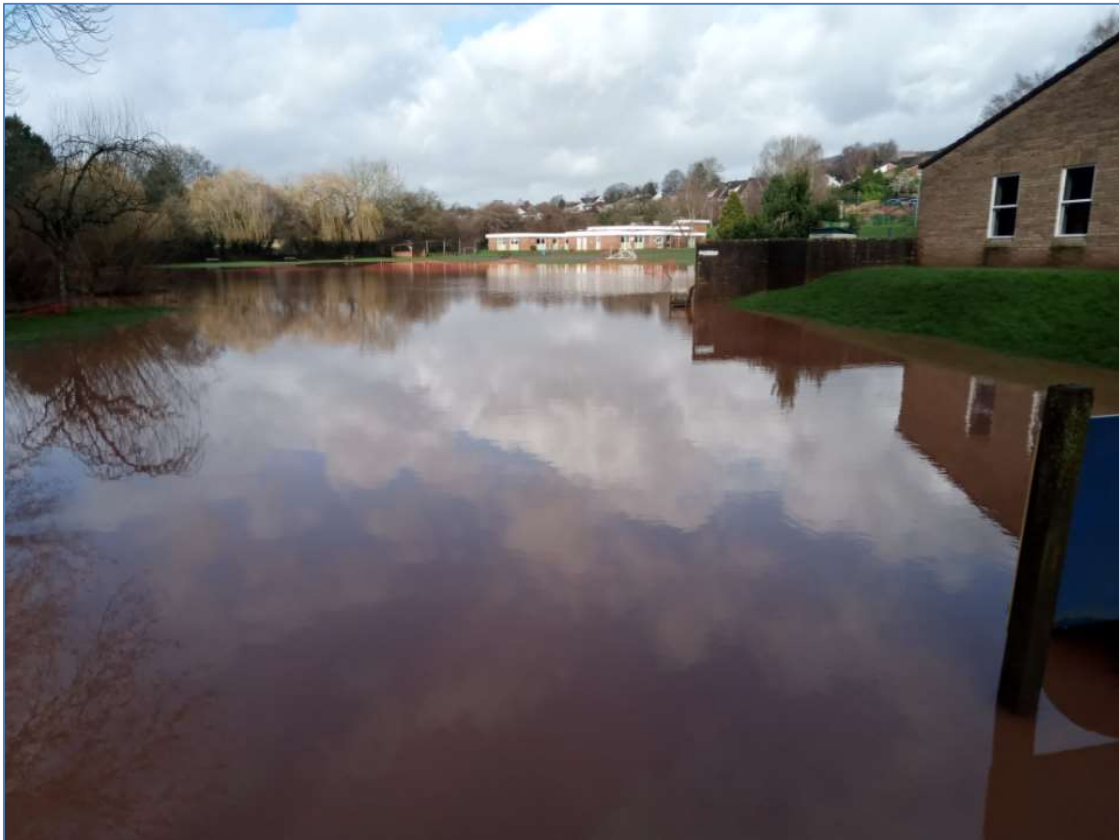
*Figure 4-3. Flooding in school grounds at Forge Road, Storm Dennis February 2020*

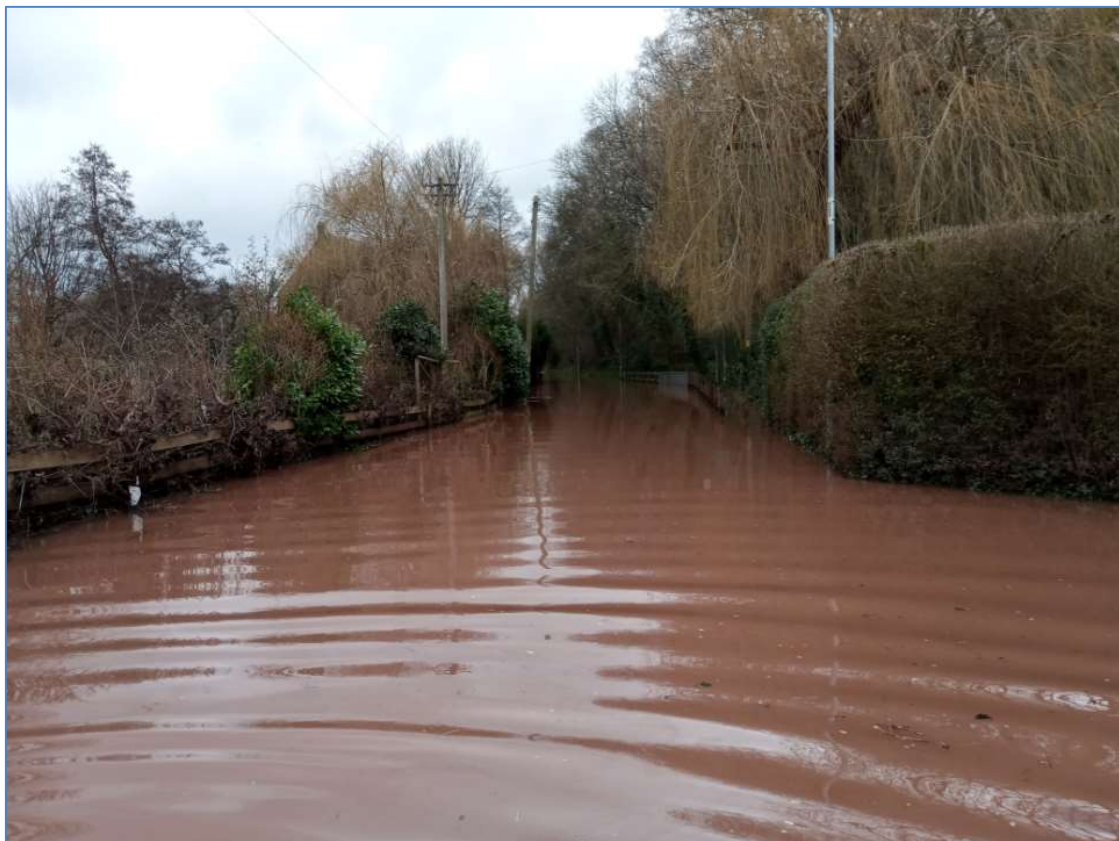
*Figure 4-4. Flooding at Forge Road, Storm Dennis February 2020*

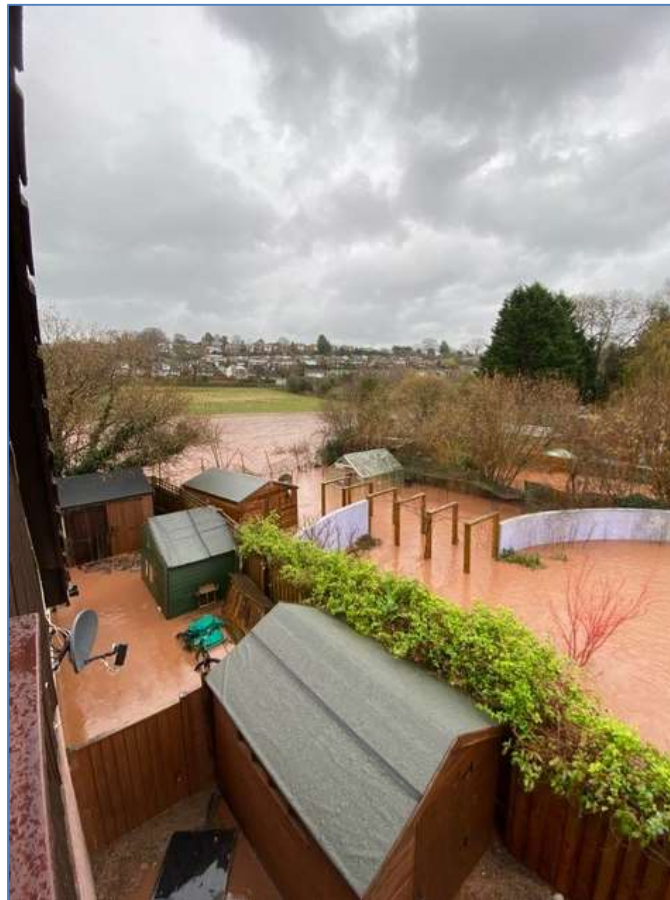
*Figure 4-5. Flooding at rear of Forge Road looking north-west, Storm Dennis February 2020*

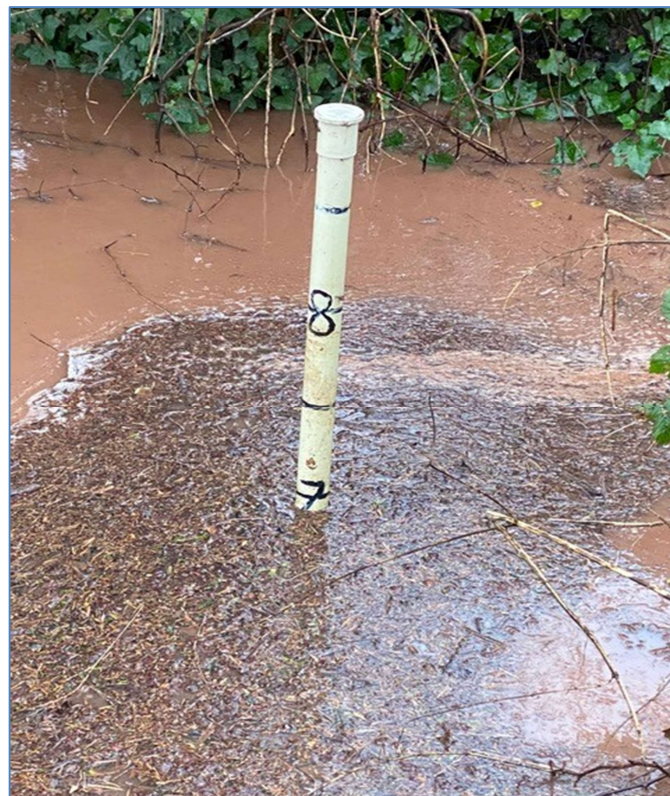
*Figure 4-6. Resident's gauging pole on the ordinary watercourse adjacent to Forge Road, historical flooding*

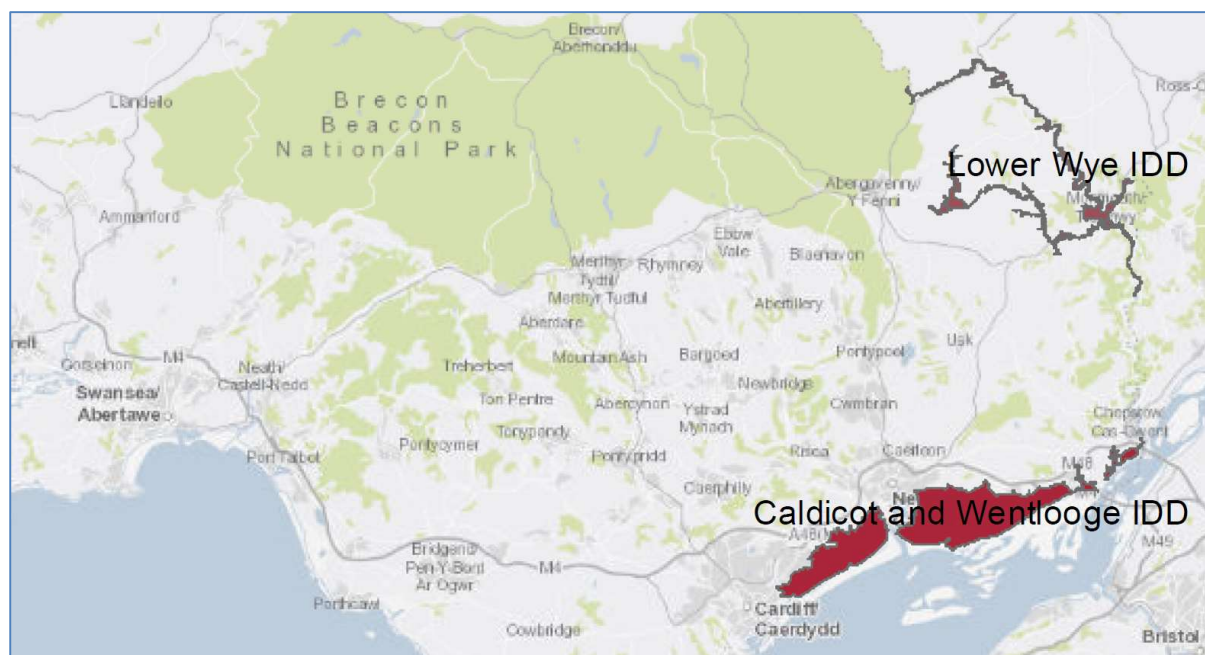
Forge Road is in the Lower Wye IDD as shown in Figure 5-1 and Figure 5-2.

*Figure 5-1. IDD boundaries within South Wales*

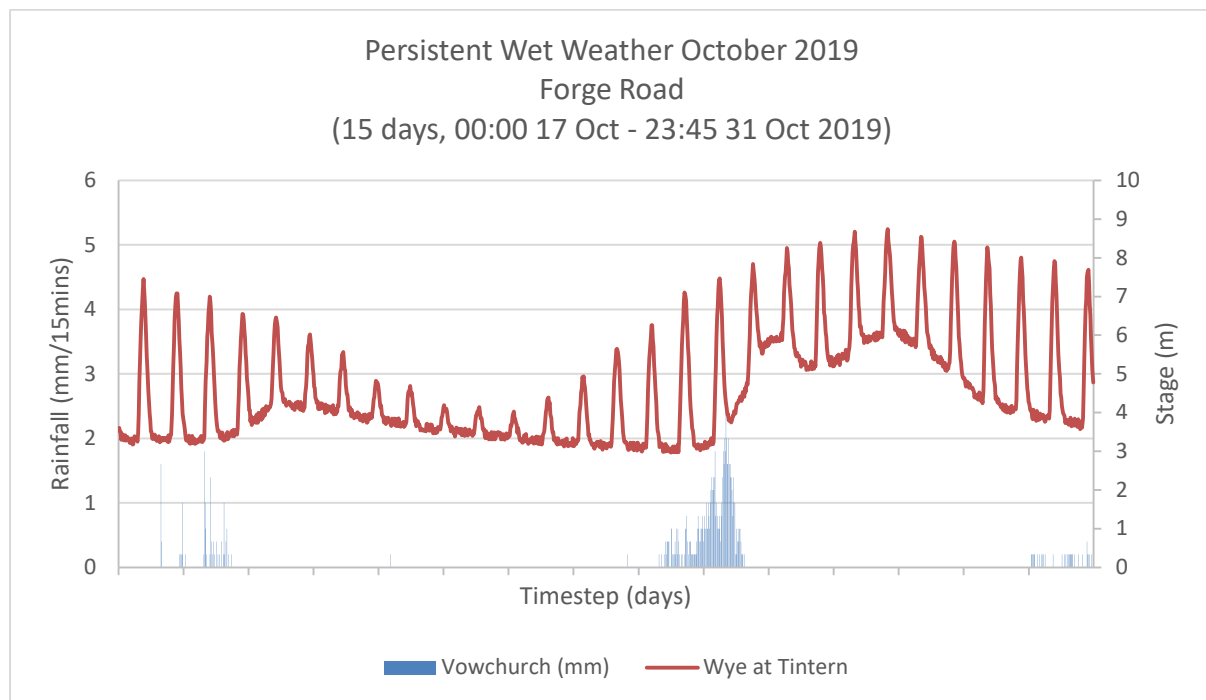
Figure 0-8. Persistent Wet Weather October 2019 - Tidal levels for the Wye at Tintern Abbey for the 15-day period 17 to 31 October 2019
