Monmouthshire County Council

Section 19 Flood Investigation Report

Forge Road, Monmouth

**Persistent Wet Weather
October 2019**

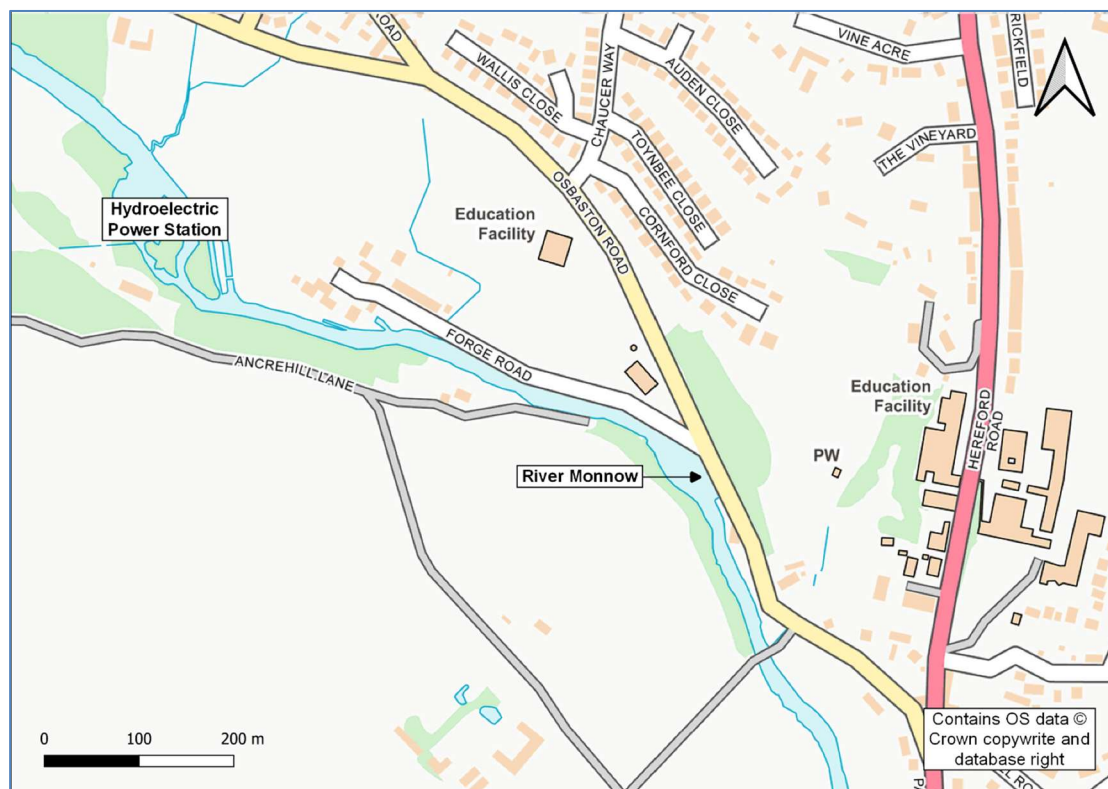
Figure 2-2. Flood Investigation Area location plan

Figure 2-2 is a plan of the flood investigations area.

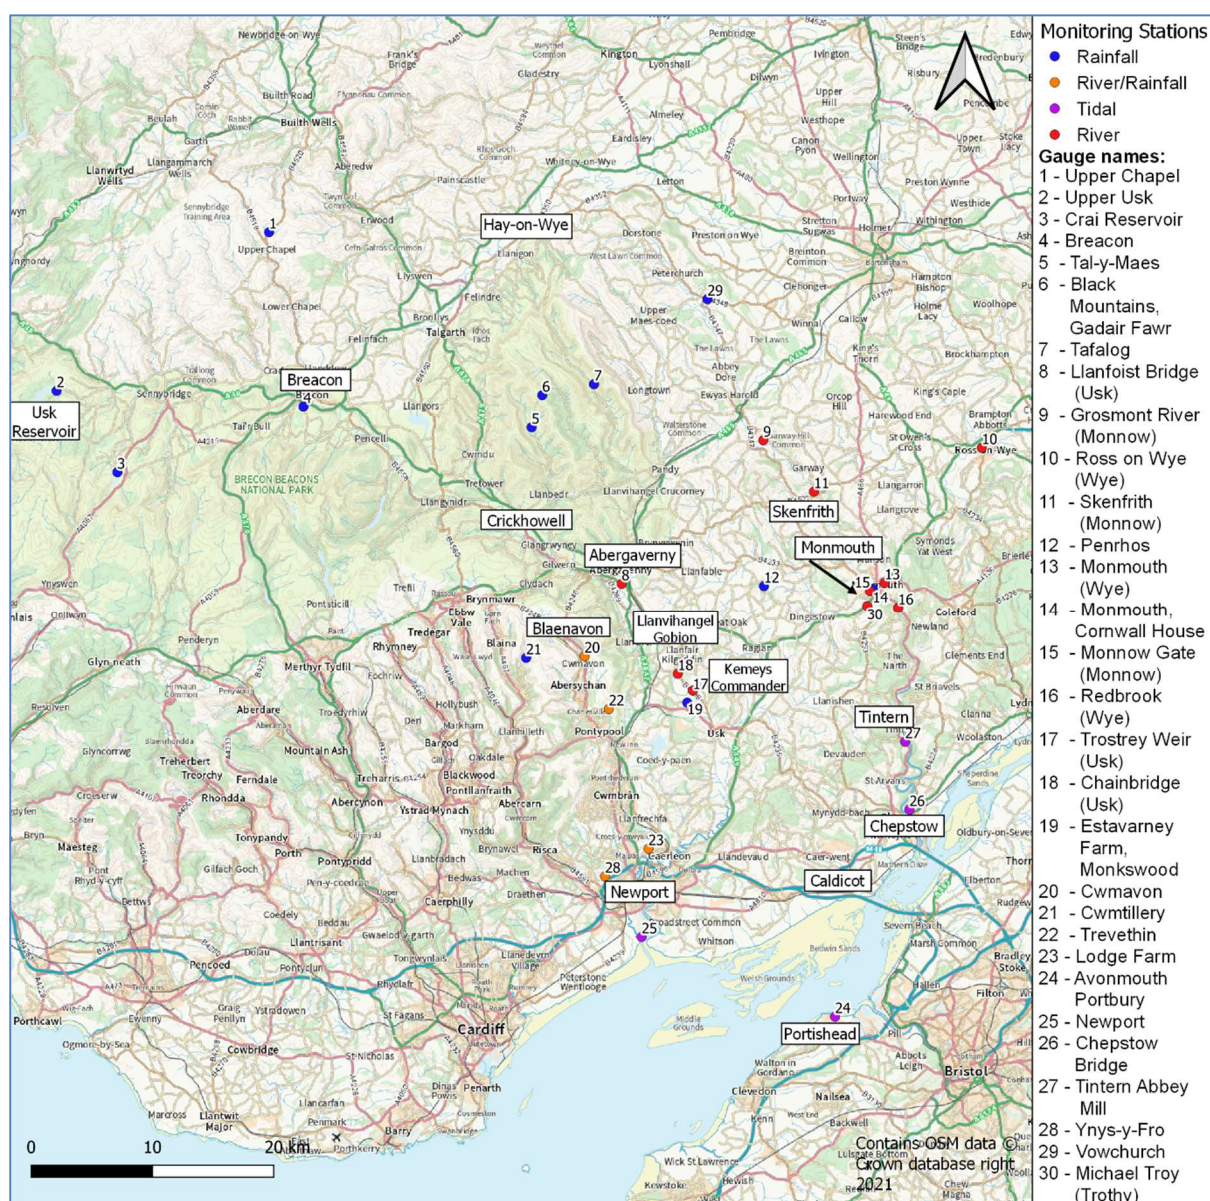
Figure 3-2. Local rain and river gauges¹²

The location of nearby NRW and EA river, rainfall, and tidal gauges are shown in Figure 3-2.

All gauges are NRW except Vowchurch rain gauge, Ross on Wye river gauge, and Avonmouth Portbury tidal gauge which are EA. All the listed river and tidal gauges are telemetered. Rain gauges are a mixture of telemetered and logger.

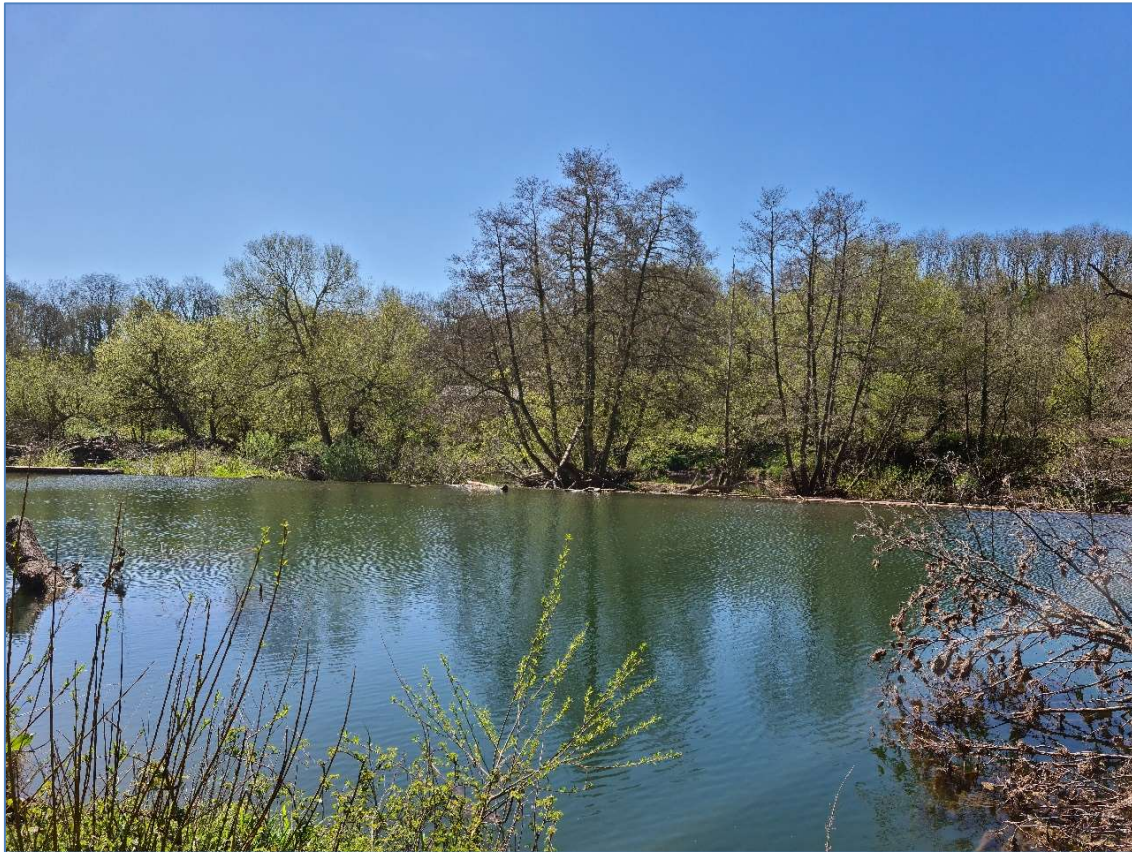
Figure 4-1. Forge Weir, site visit May 2021

Anecdotal reports state that from the onset of internal property flooding, within 2 to 3 hours internal flood depths were 0.61m. After the Monnow overtopped at Forge Weir there was a very rapid rise in flood depths from 0.46 to 0.91m. The flooding occurred from the evening of 25 October into the morning of 26 October 2019.

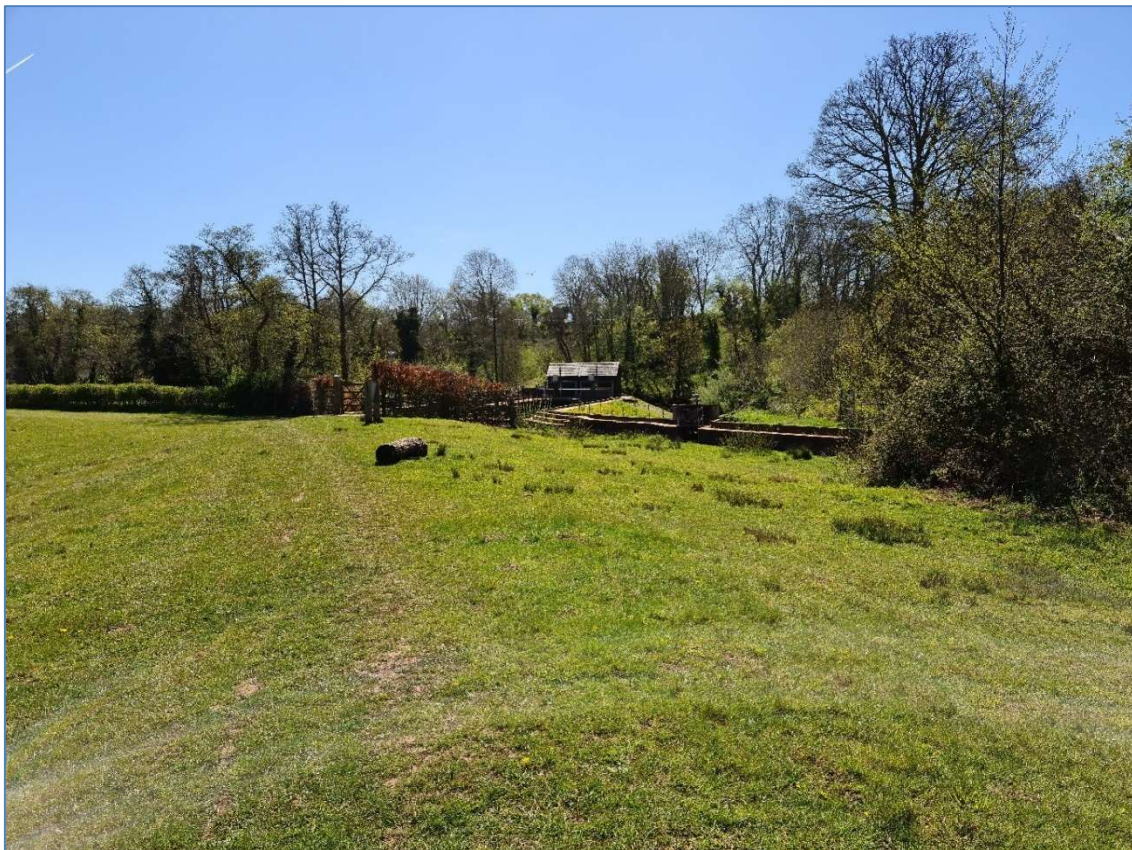
Figure 4-2. Flood embankment adjacent to Forge Weir on the left bank of the Monnow, site visit May 2021

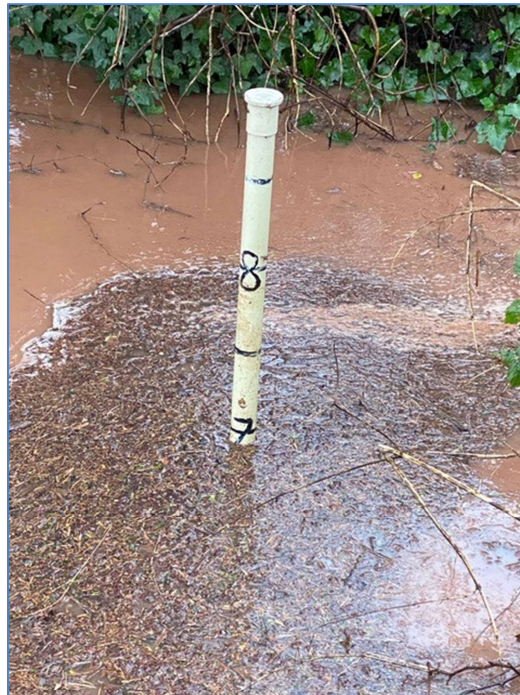
Figure 4-3. Resident's gauging pole on the ordinary watercourse adjacent to Forge Road. Photo taken during February 2020 flood event

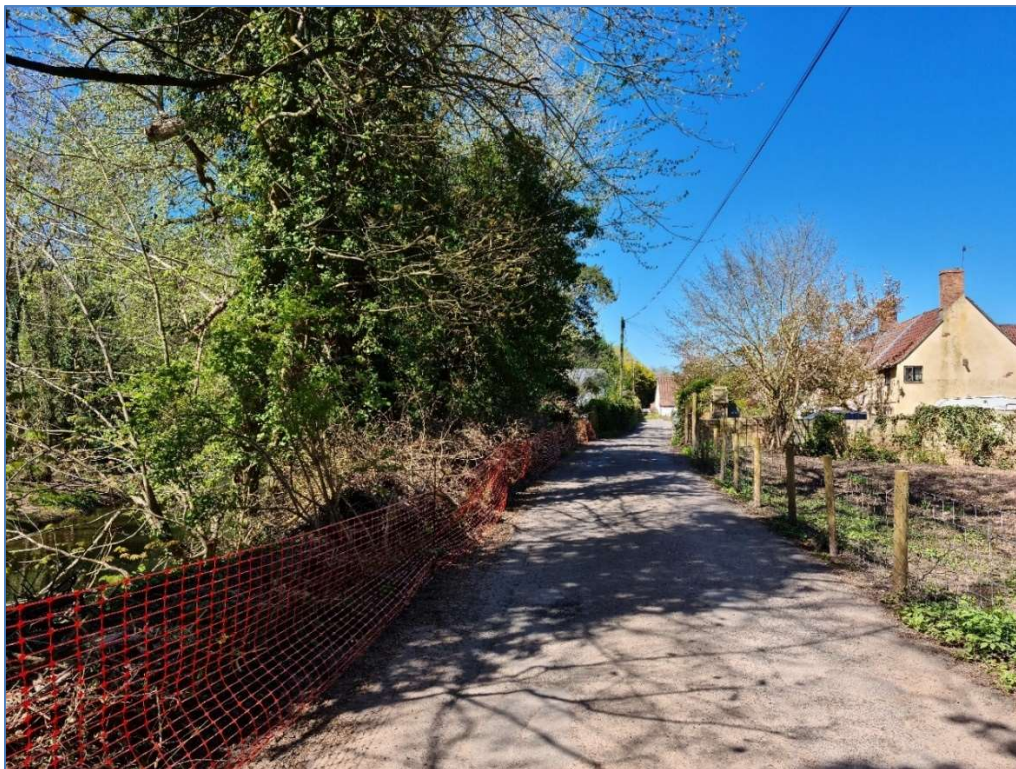
Figure 4-5. Picture looking northwest along Forge Road, the River Monnow runs parallel to left of Forge Road in this image. Photo taken site visit May 2021

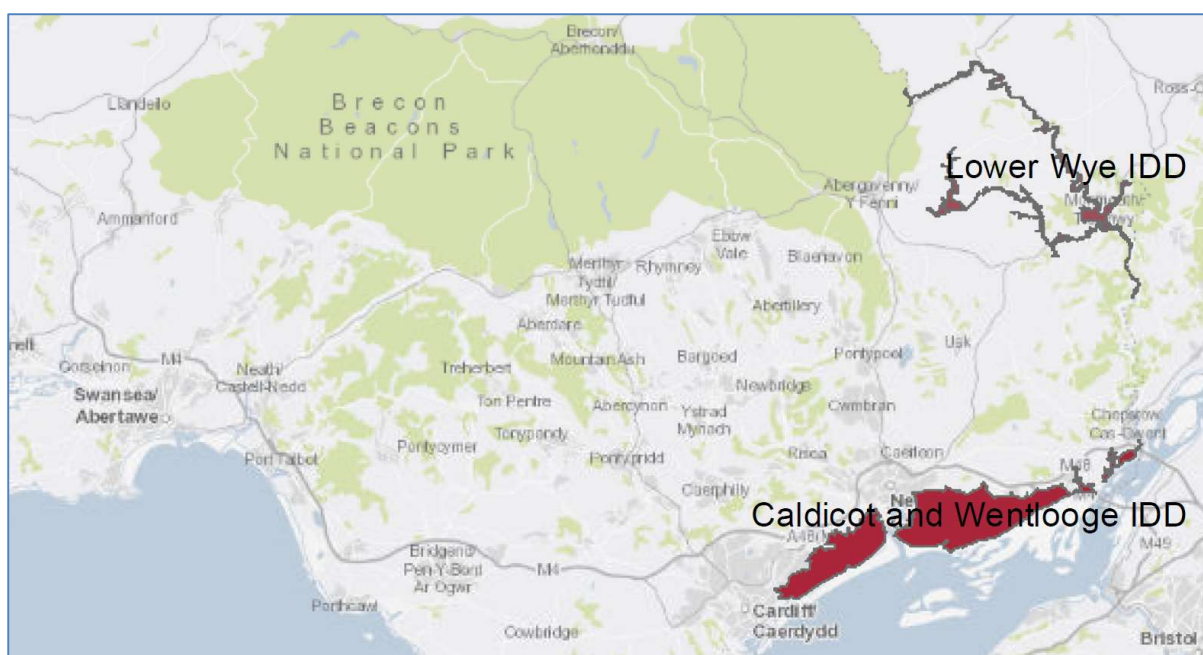
Figure 5-1. IDD boundaries within South Wales

Forge Road is in the Lower Wye IDD as shown in Figure 5-1 and Figure 5-2.

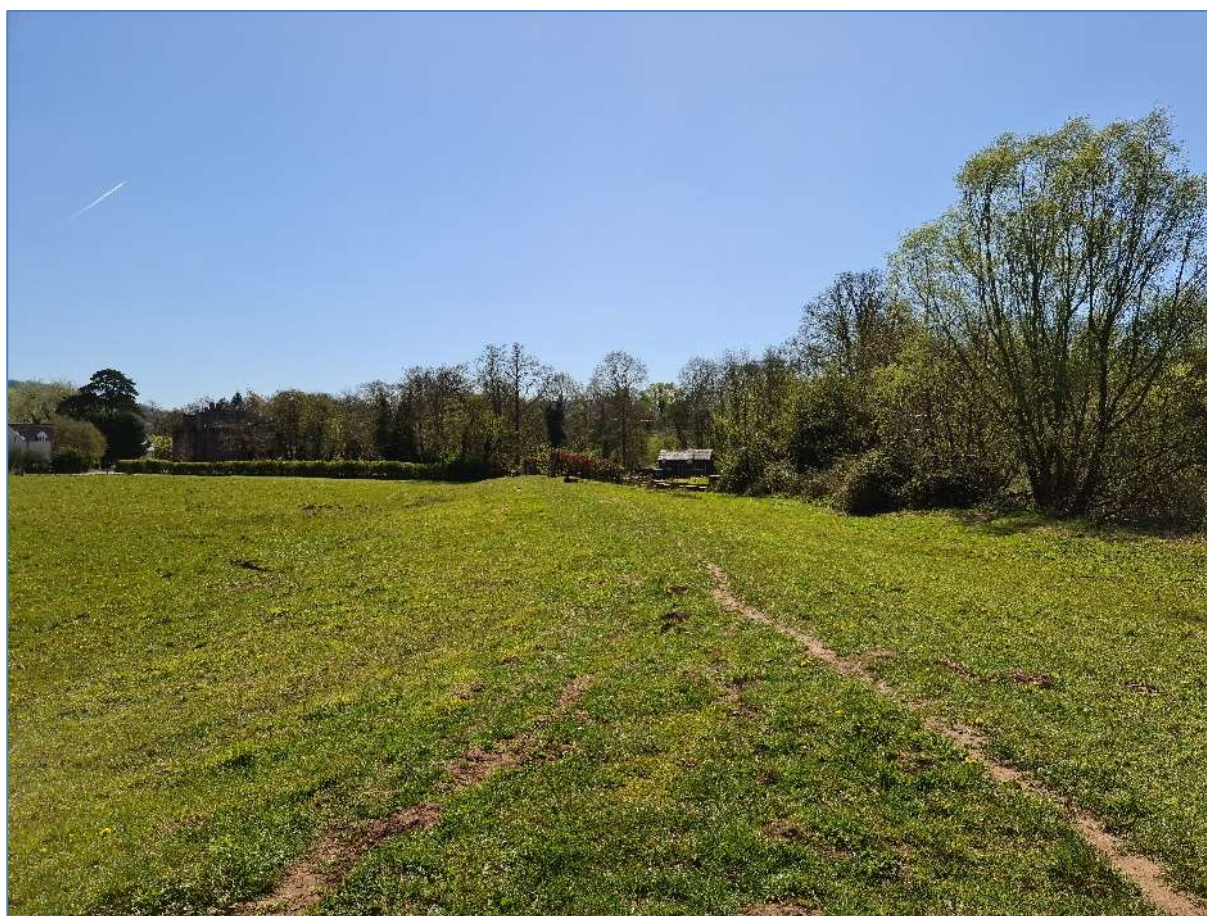
Figure 7-1. Forge Weir embankment, site visit May 2021

Date	Scheme details
1992	The <i>EA Easter Floods Report 1998</i> details proposals to defend Forge Road against flooding in the Monmouth Flood Alleviation Scheme, the proposed dates of the historical works were 1990 to 1992, however the works were deemed economically unviable and were not delivered. Relatively moderate works were carried out including construction of an embankment adjacent to Forge Weir to prevent flood water overspilling during low return period events see Figure 7-1. The flood embankment prevented flood water from prematurely breaking out of the side stream opposite the weir. The flood embankment terminates just downstream of the weir and is not designed to prevent flooding of the River Monnow just downstream.

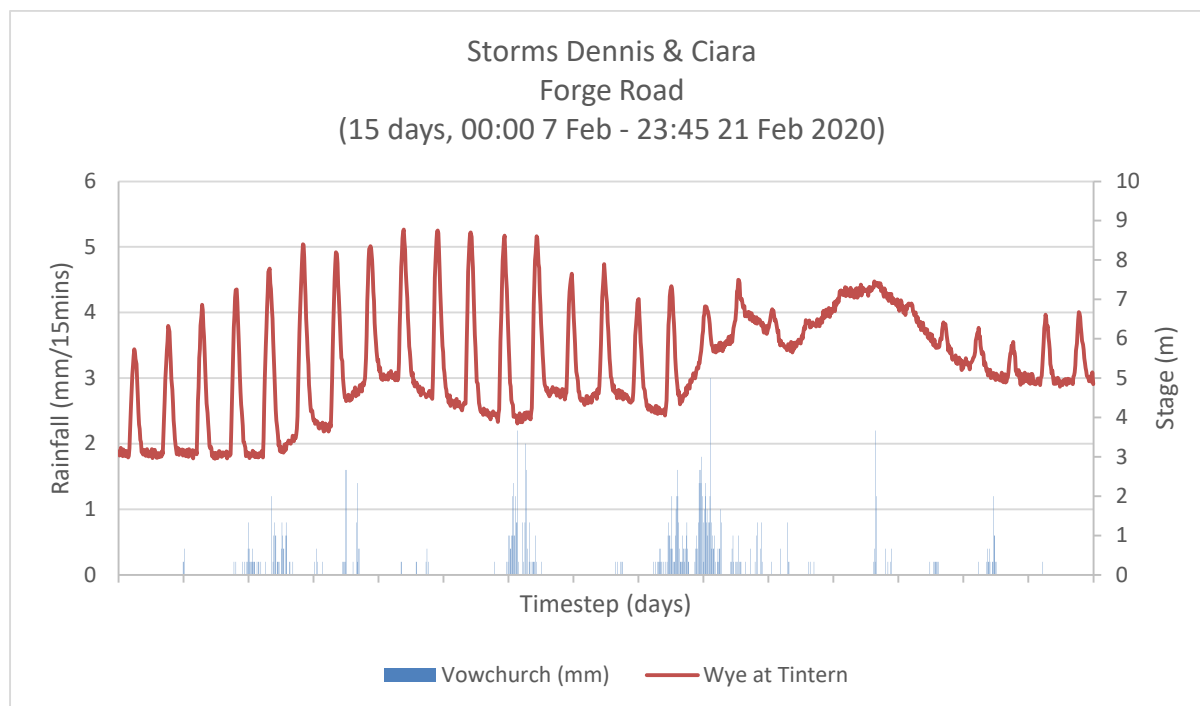
Figure 0-8. Storm Dennis - Tidal levels for the Wye at Tintern Abbey for the 15-day period 7 to 21 February 2020
