## **Landscape Character and Visual Impact Assessment of Proposed Development at Rockfield Road, Monmouth**

**Text, Plans, Photographs & Appendices**

**Prepared for Morspan Pension Scheme**

**TDA/2629/LC&VIA/RhC/08.21**

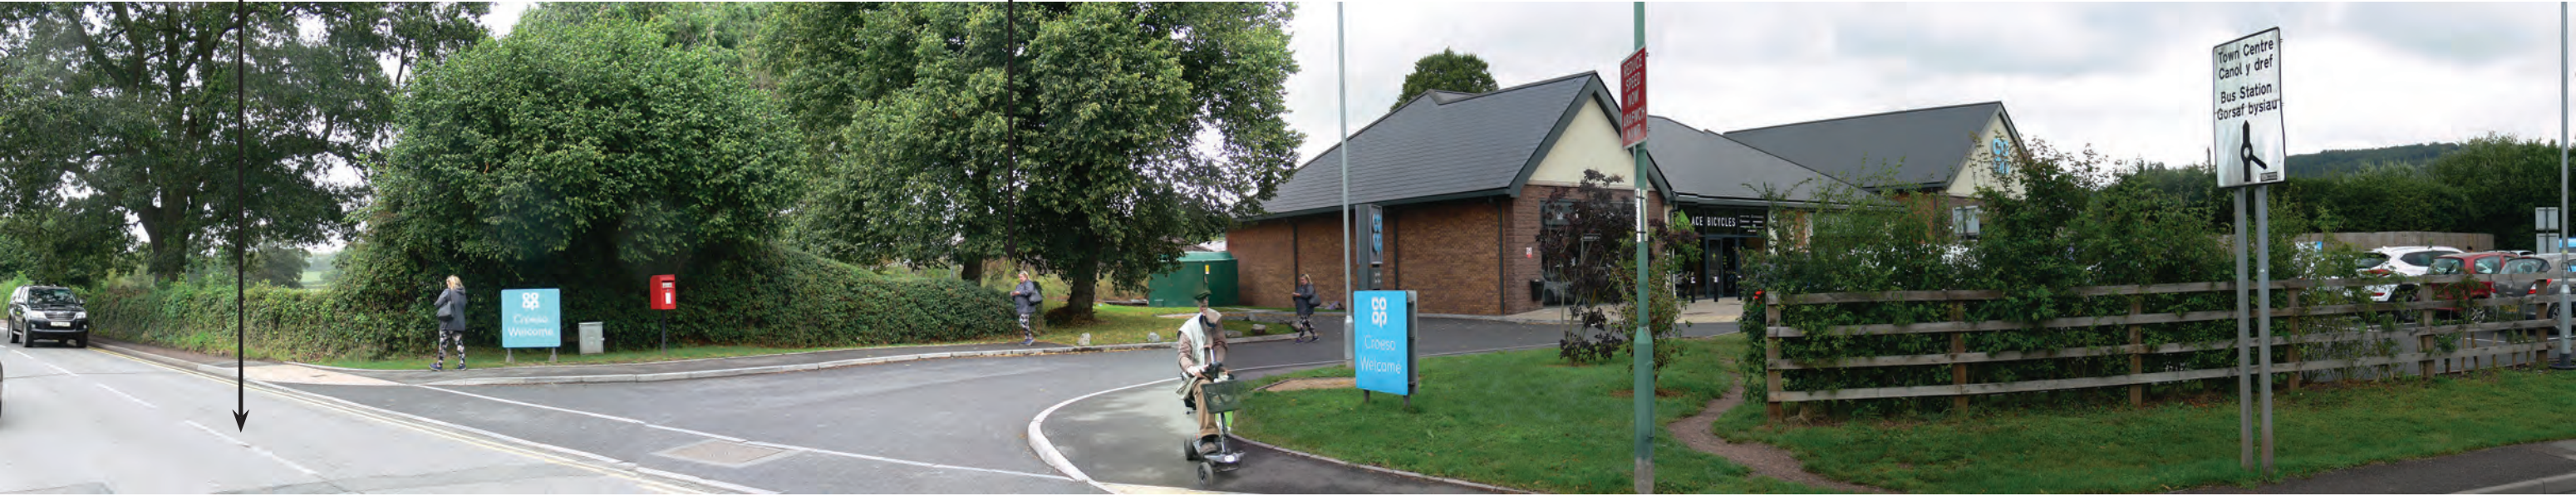
Photo Viewpoint 1: Short-range view looking north from Rockfield Road

Rockfield Road

The site (predominantly screened)

- 4.9 **Photo Viewpoint 1** is a short-range view looking north from Rockfield Road. The site is predominantly screened by the existing retail development and adjacent trees and hedgerow.

**Development's visual impact: slight adverse impact**
- 4.10 **Photo Viewpoint 2** is a short-range view looking east from Rockfield Road. The is screened by field boundary hedgerow and associated hedgerow trees.

- 6.6 With regards to Photo Viewpoint 1, it was noted that the viewpoint is immediately adjacent to the site boundaries, as such any visual impact is highly localised. Furthermore, only small glimpses of the development will be available.

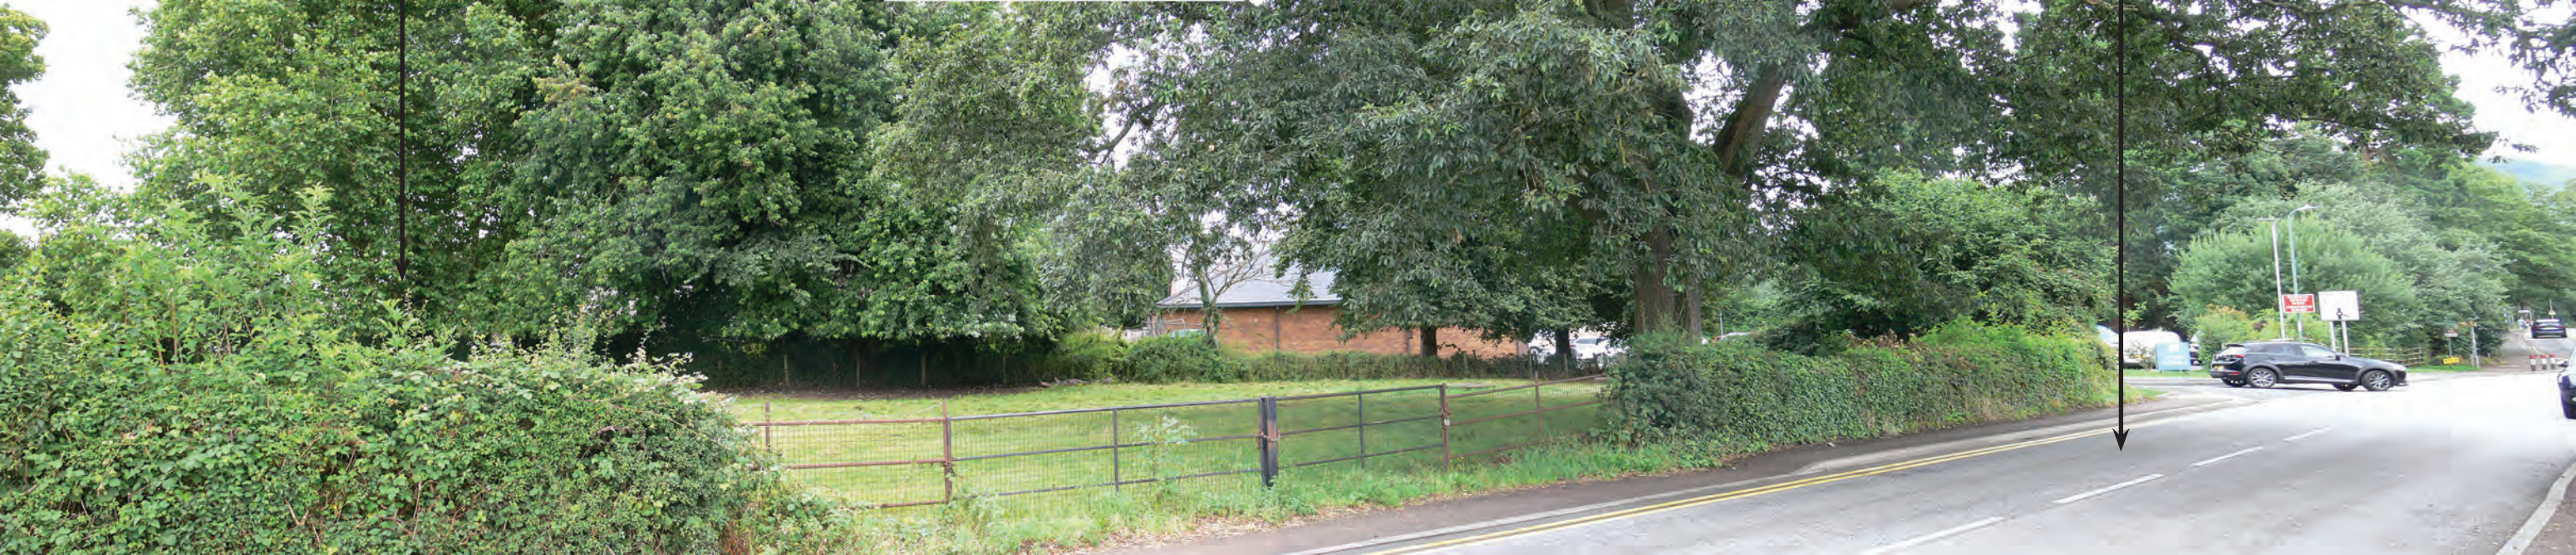
Photo Viewpoint 2: Short-range view looking east from Rockfield Road

The site (screened)

Rockfield Road

**Development's visual impact: no change**
- 4.11 **Photo Viewpoint 3** is a short-range view looking south-east from Rockfield Road. The site is screened by existing residential properties.

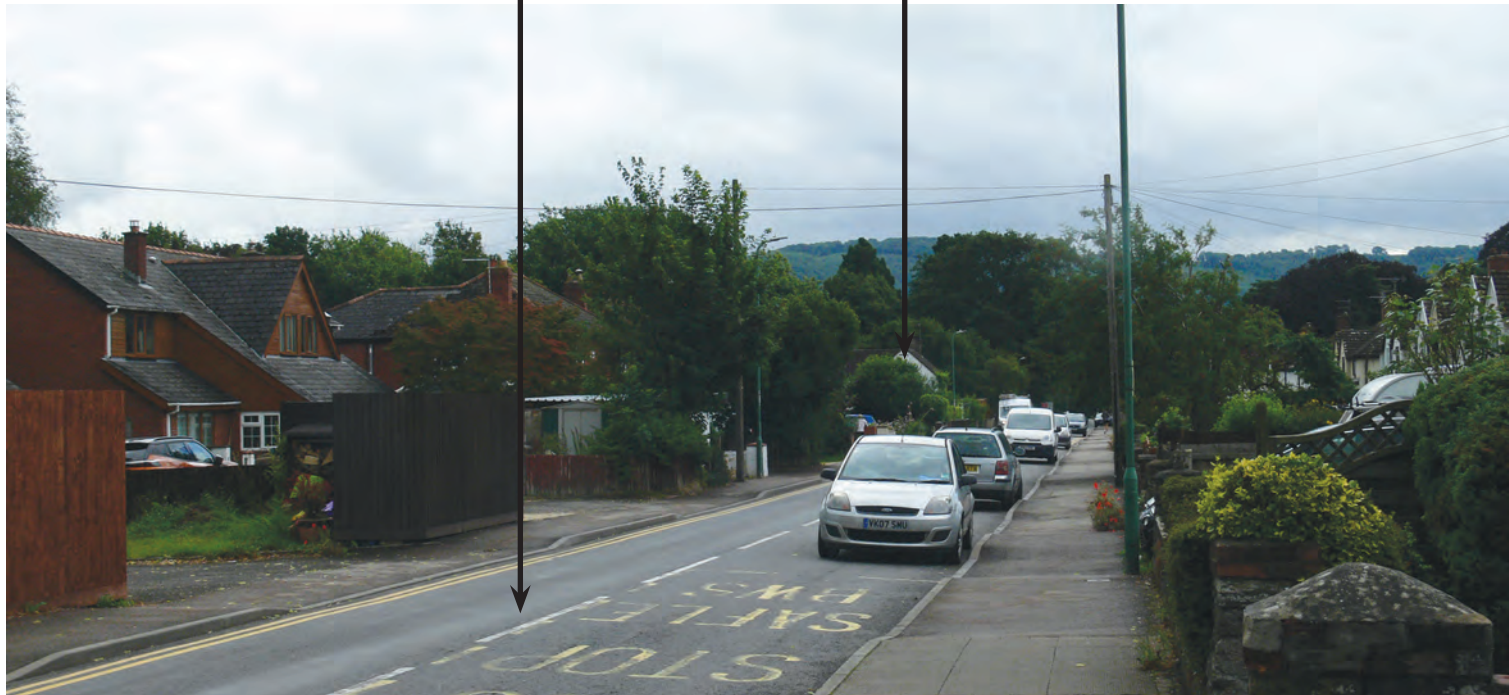
Photo Viewpoint 3: Short-range view looking south-east from Rockfield Road

Rockfield Road

Approximate location  
of site (screened)

**Development's visual impact: no change**
- 4.12 **Photo Viewpoint 4** is a mid-range view looking south east from a public footpath off Rockfield Road. The site is screened by field boundary hedgerow and associated hedgerow trees.

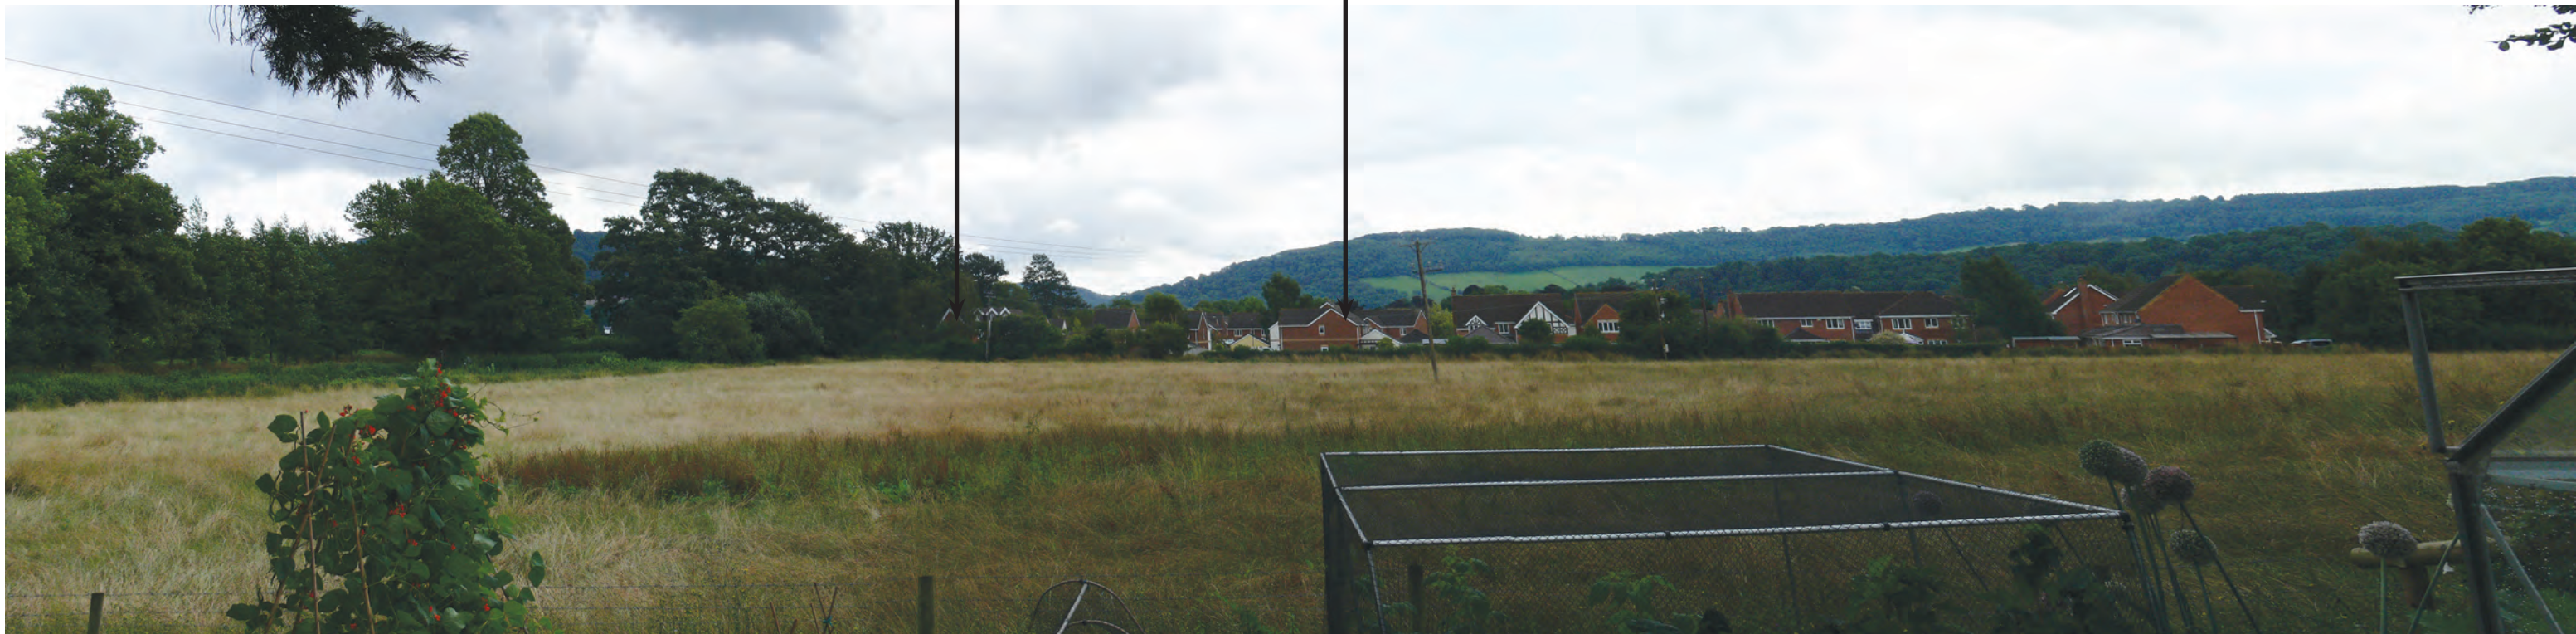
Photo Viewpoint 4: Mid-range view looking south east from a public footpath off Rockfield Road

Approximate location  
of site (screened)

Properties on Hamilton Way

**Development's visual impact: no change.**
- 4.13 **Photo Viewpoint 5** is a mid-range view looking south east from Ancrehill Lane. The site is screened by field boundary hedgerow and associated hedgerow trees.

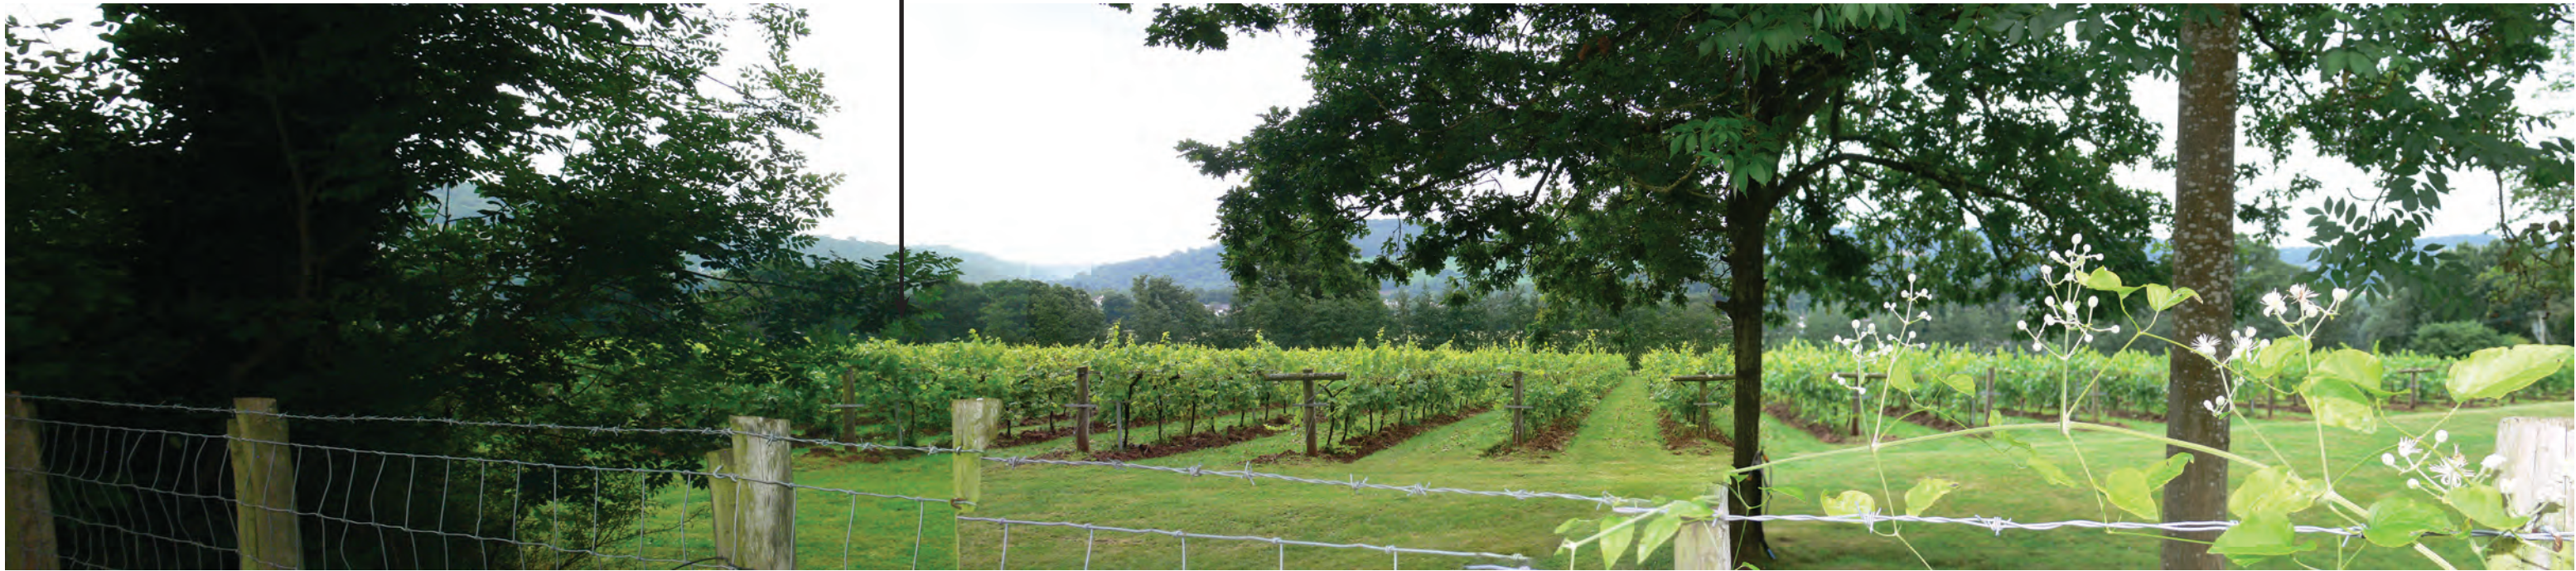
Photo Viewpoint 5: Mid-range view looking south east from Ancrehill Lane

Approximate location  
of site (screened)

**Development's visual impact: no change.**
- 4.14 **Photo Viewpoint 6** is mid-range view looking south from a public footpath linking Ancrehill Lane and Rockfield Road. The site is screened by field boundary hedgerow and associated hedgerow trees.

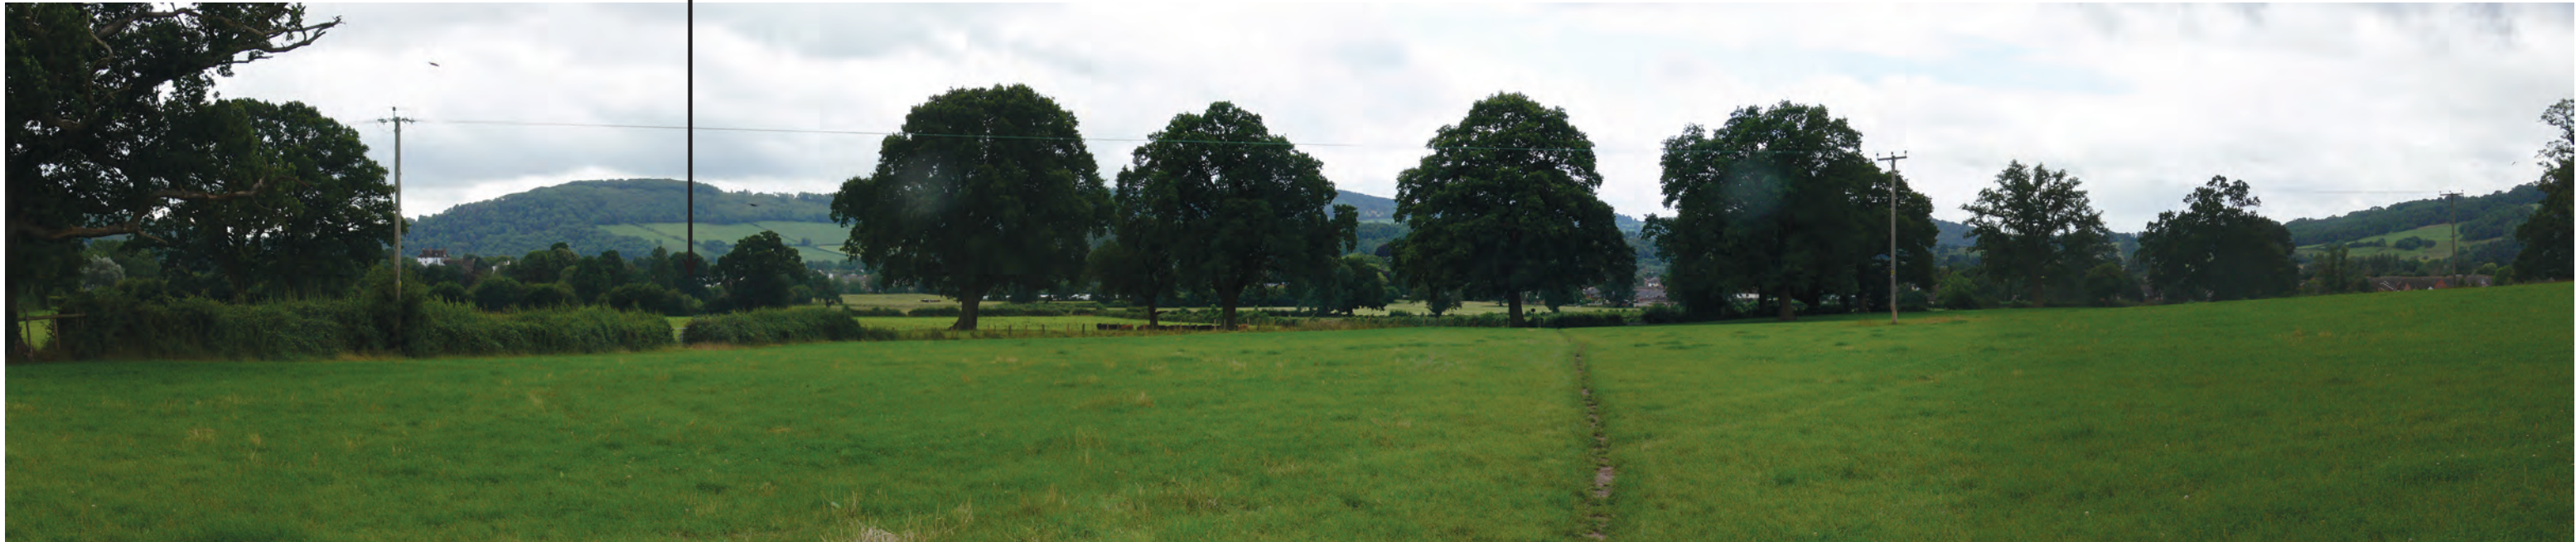
Photo Viewpoint 6: Mid-range view looking south from a public footpath linking Ancrehill Lane and Rockfield Road

Approximate location  
of site (screened)

**Development's visual impact: no change.**
- 4.15 **Photo Viewpoint 7** is short-range view looking north west from a public footpath off Rockfield Road. The site is screened by the existing retail development.

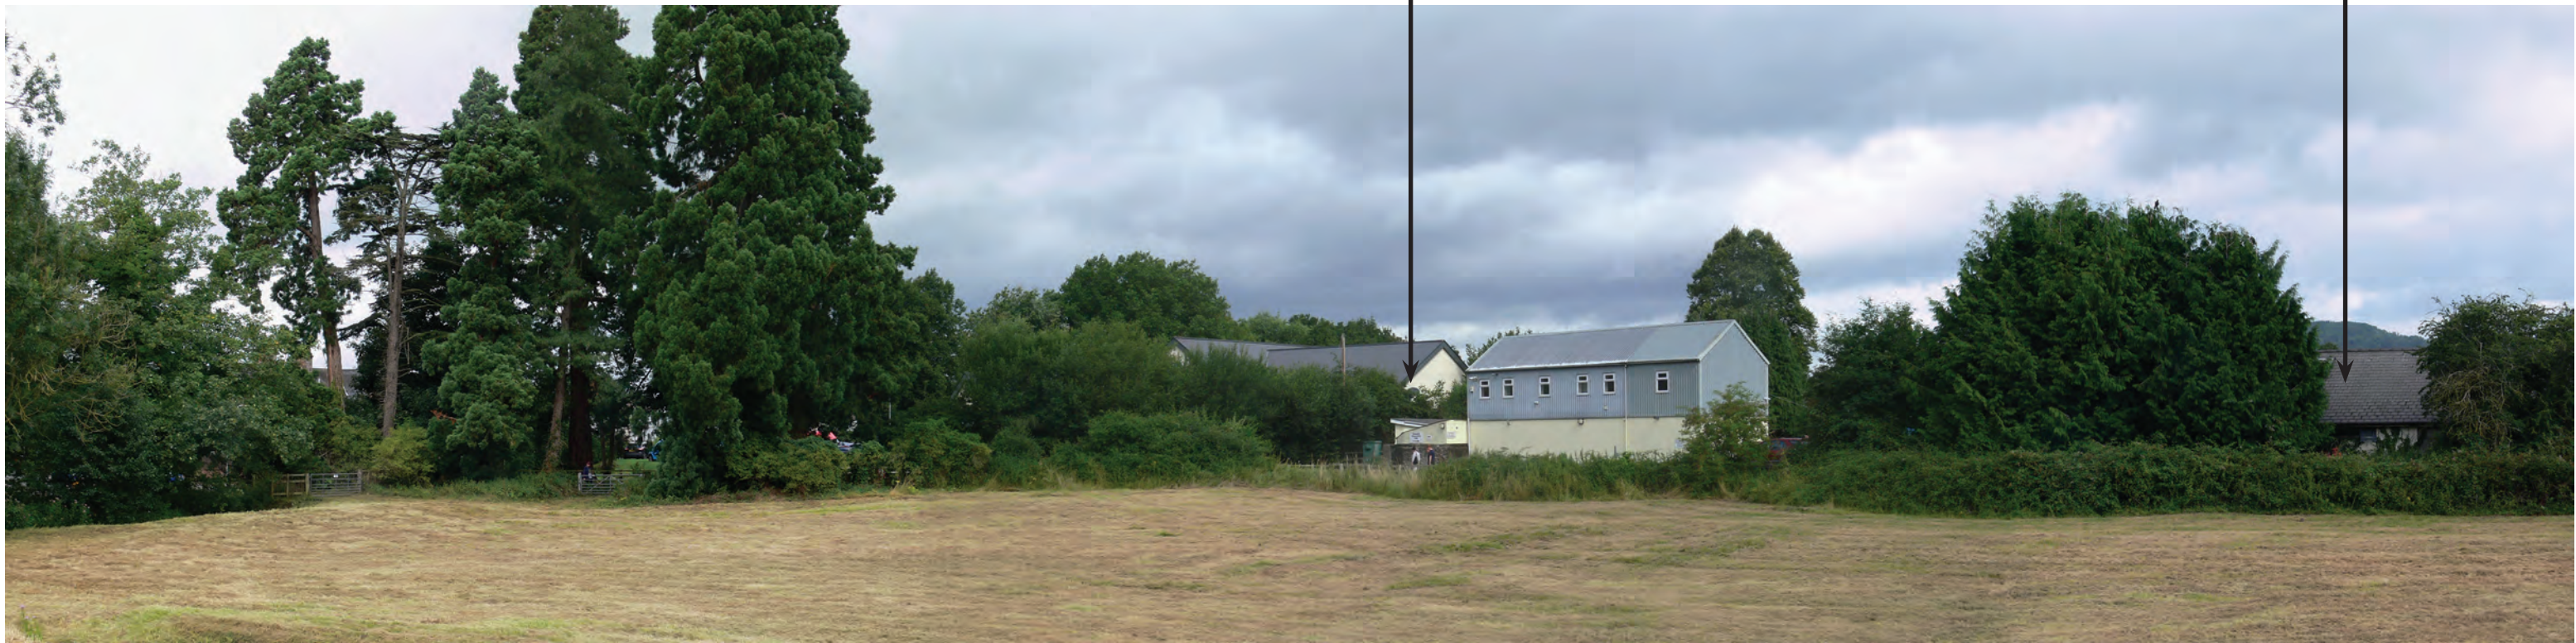
Photo Viewpoint 7: Short-range view looking north west from a public footpath off Rockfield Road

The site (screened)

Monmouth Caravan Park

**Development's visual impact: no change.**
- 4.16 **Photo Viewpoint 8** is short-range view looking west from a public footpath linking Ancrehill Lane and Rockfield Road. The site is screened by field boundary hedgerow.

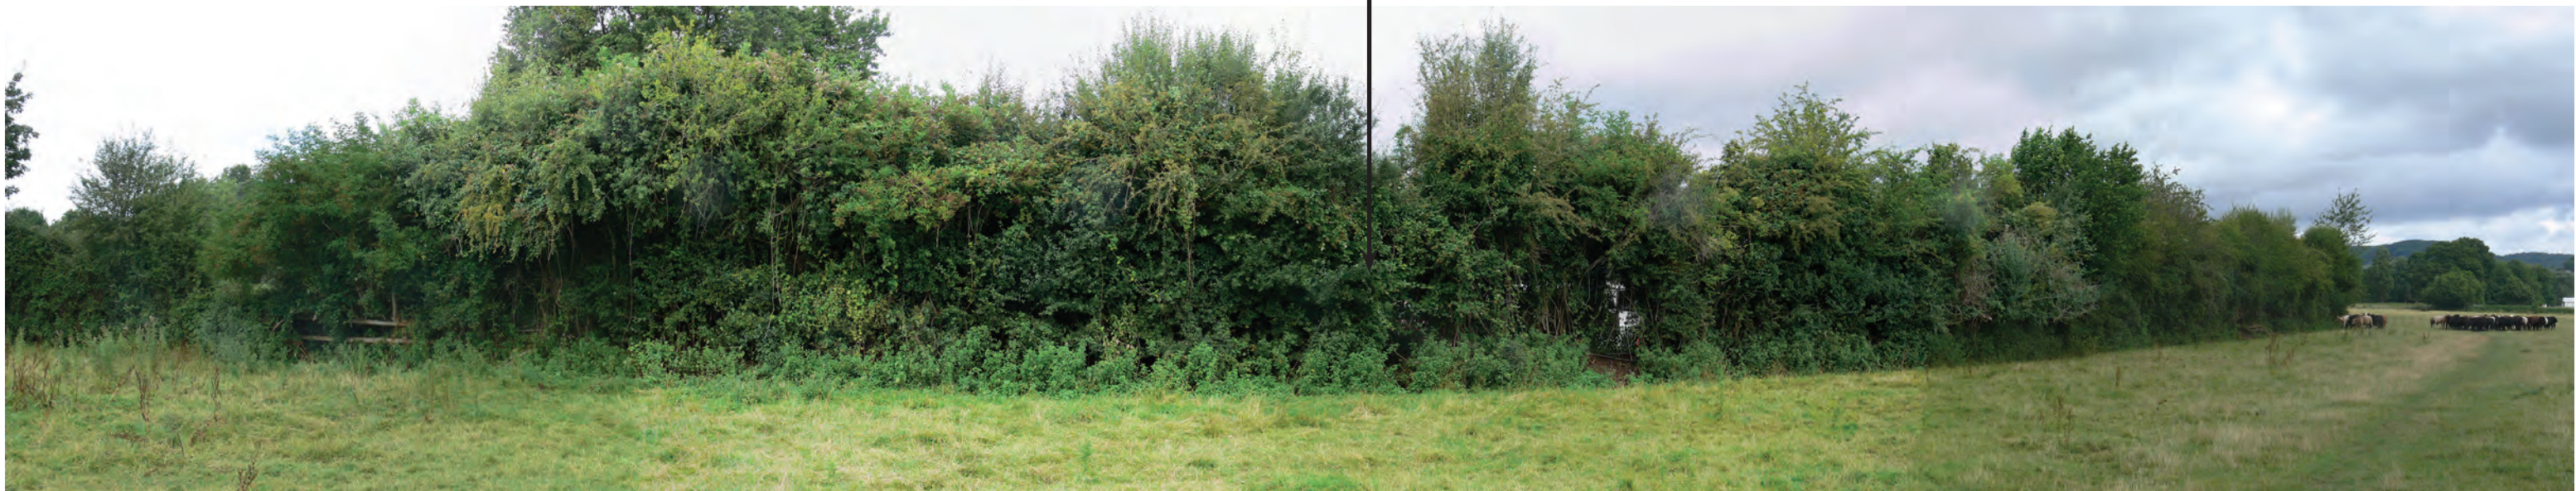
Photo Viewpoint 8: Short-range view looking west from a public footpath linking Ancrehill Lane and Rockfield Road

Approximate location  
of site (screened)

**Development's visual impact: no change.**
- 4.17 **Photo Viewpoint 9** is a mid-range view looking west from Monmouth Castle. The site is screened by trees and vegetation surrounding Monmouth Castle.

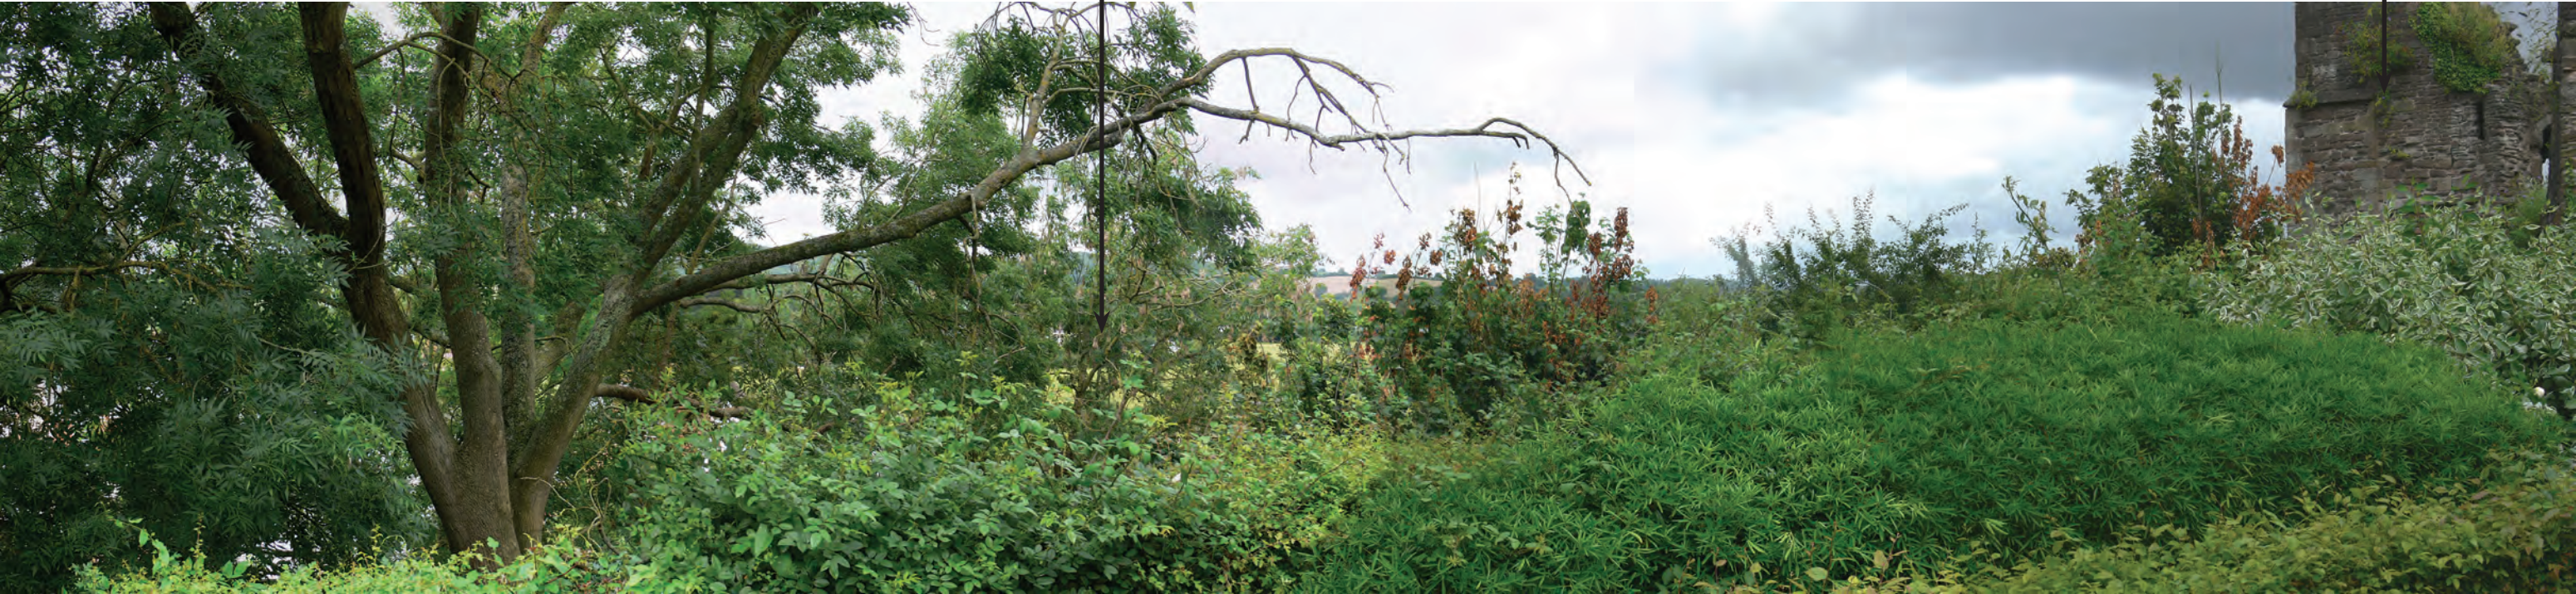
Photo Viewpoint 9: Mid-range view looking west from Monmouth Castle

Approximate location  
of site (screened)

Monmouth Castle

**Development's visual impact: no change.**
