Date: 18th January 2024  
Our ref: 18012024\_CC-1187\_CS\_MB

### **Re: Mounton Road, Chepstow - Infiltration Assessment**

On behalf of Barwood Development Securities Ltd (the 'client'), T&P Regeneration Ltd (T&P) is pleased to provide the results of a ground investigation undertaken at Mounton Road, Chepstow (the Site).

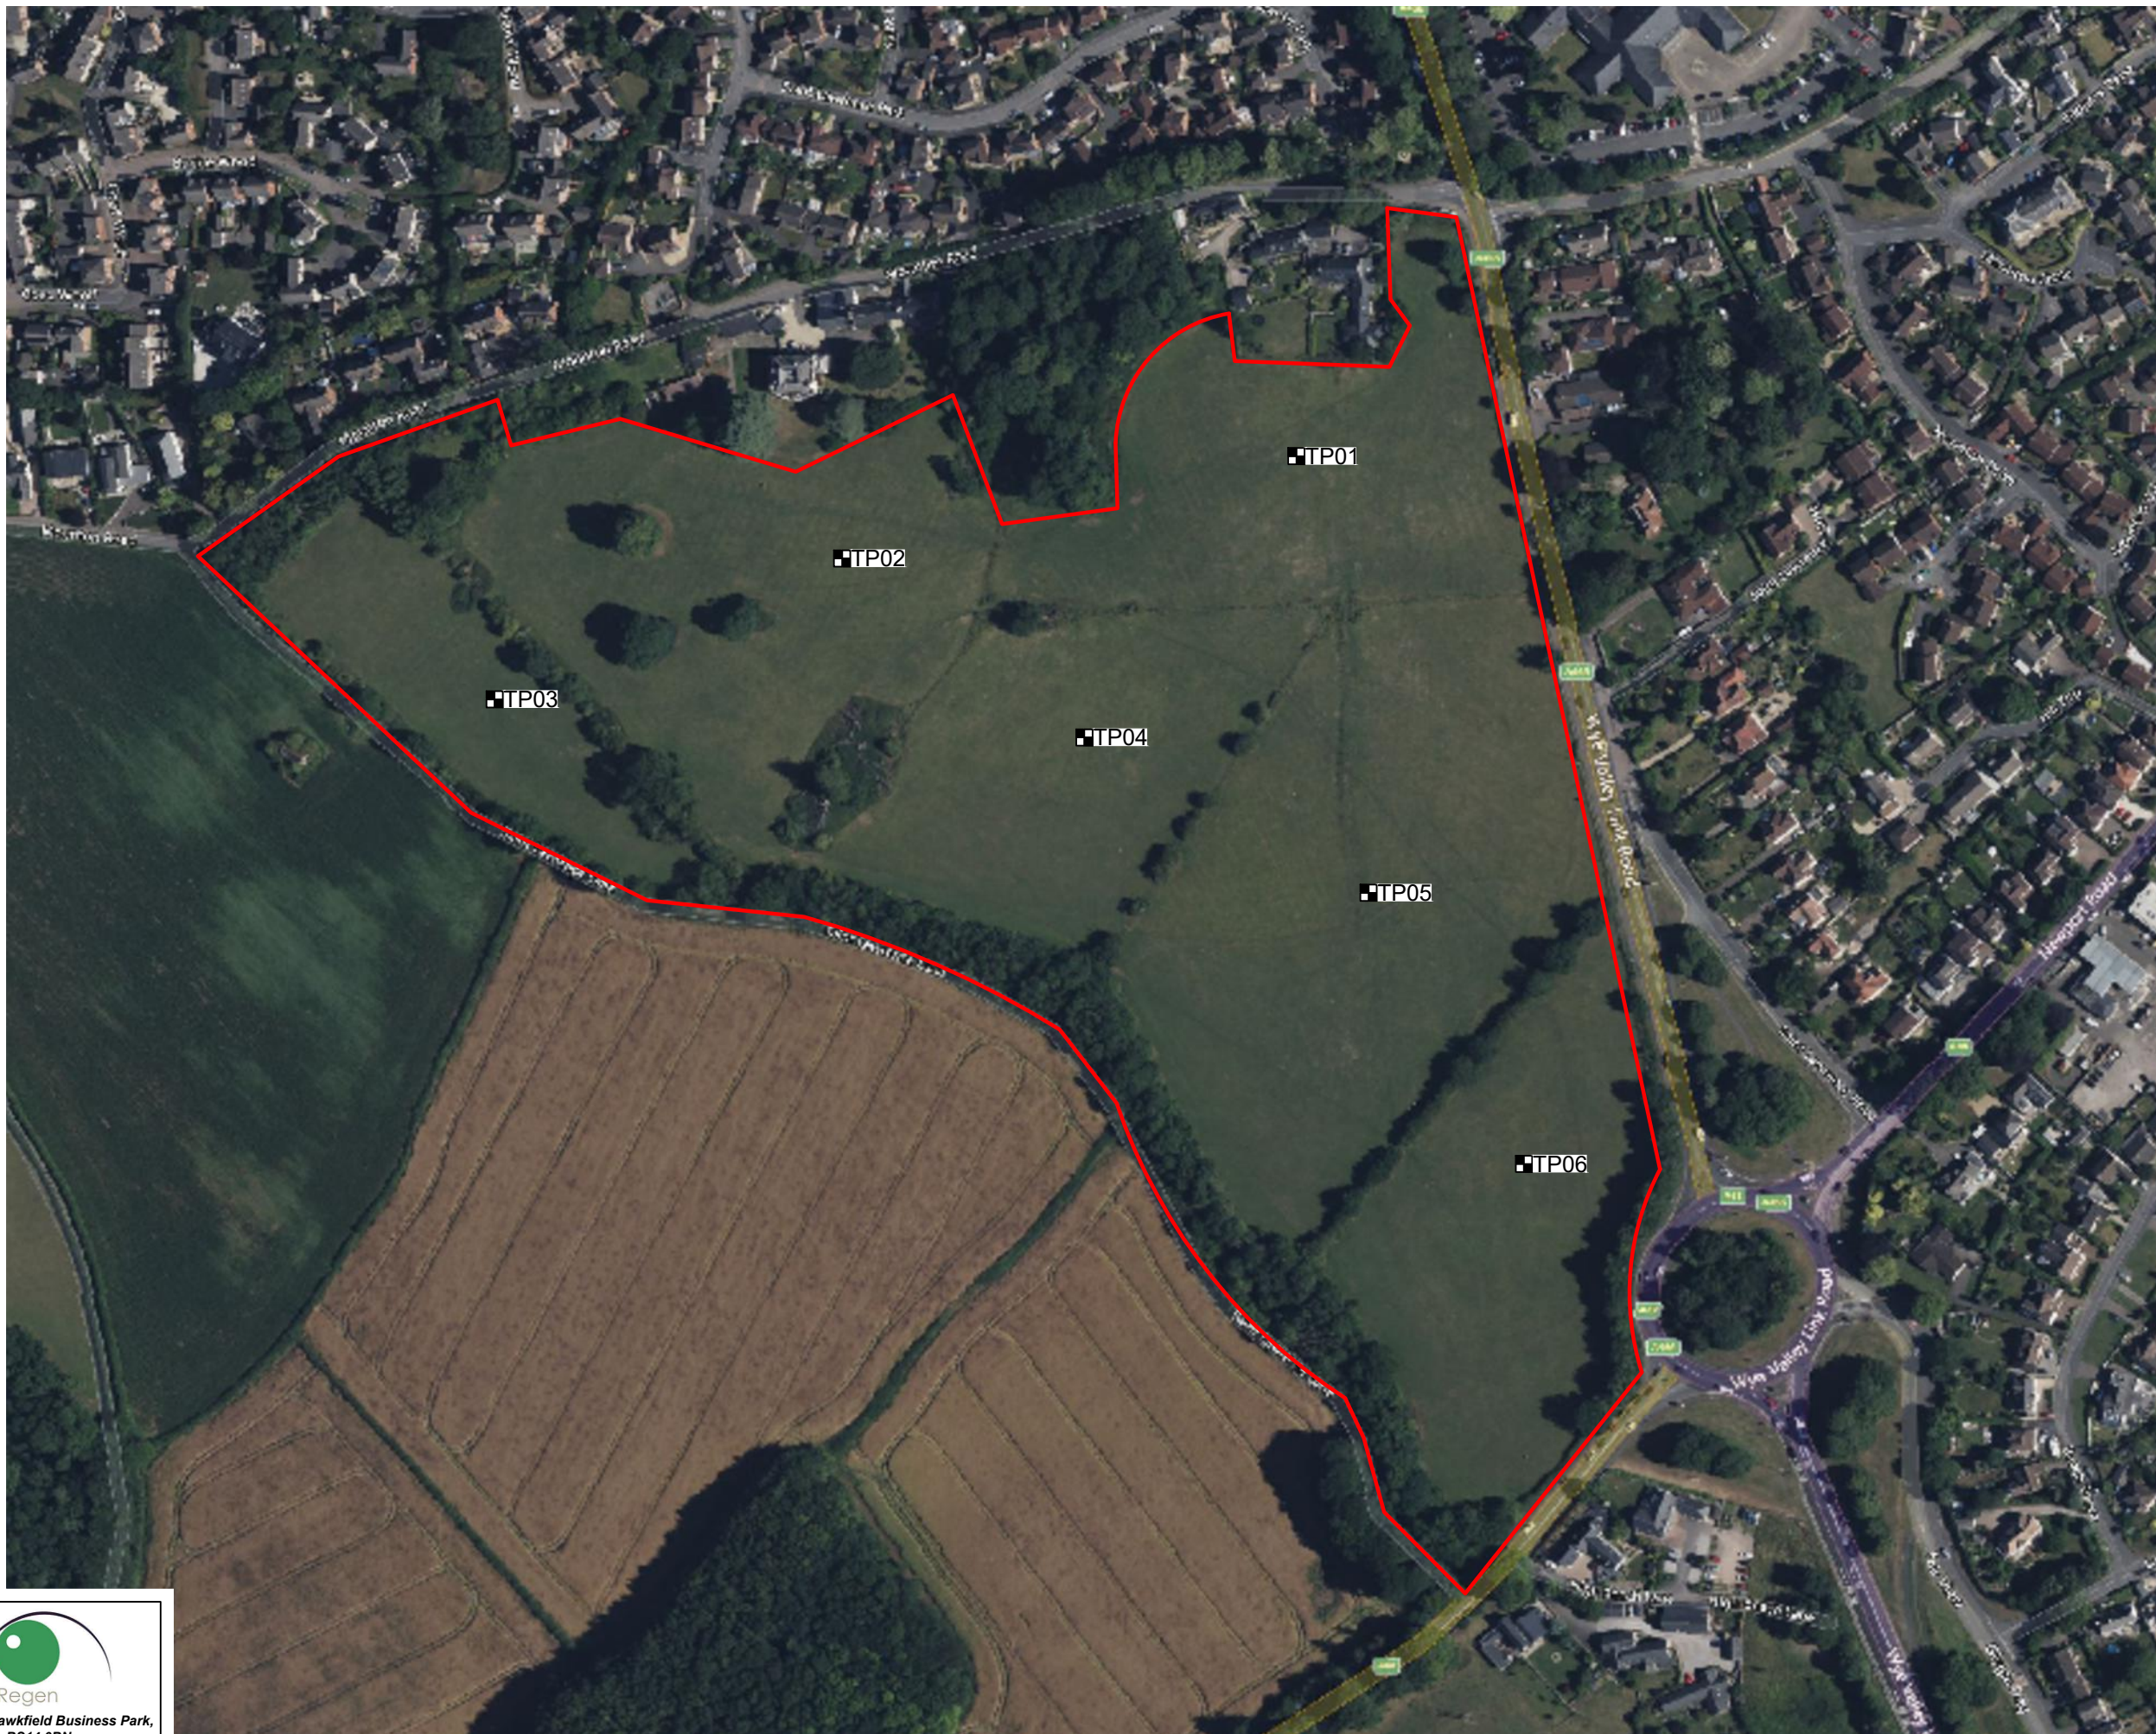
Drawn	Checked	Amendment	Date	Rev.
Barwood Development Securities Ltd				Client
Mounton Road, Chepstow				Project
Exploratory Hole Location Plan				Title
Scale	Date	Drawn by	Check by	Rev.
1:2500@A3	15/01/24	HL	CS	-

An exploratory hole location plan is included within Appendix A, a selection of photographs from the ground investigation are included within Appendix B with exploratory hole logs in Appendix C.

■ Trial Pit Locations  
(TP01 - TP06)

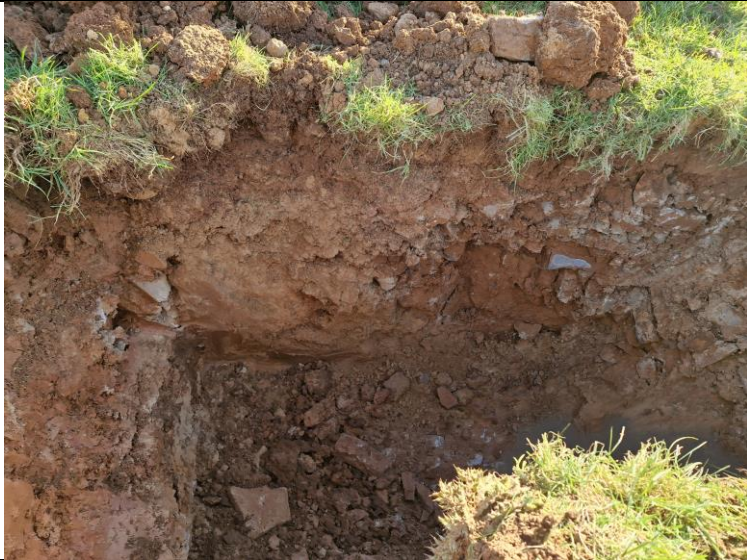
**PLATE 01 – Trial Pit Excavation – TP01.**

Firm brown mottled grey slightly sandy slightly gravelly CLAY with a low cobble content. Gravel is subangular fine to coarse of limestone. Cobbles are subangular of limestone. (BLACK ROCK LIMESTONE SUBGROUP)		
				(0.80)

Extremely weak light grey LIMESTONE. Recovered as slightly clayey angular fine to coarse limestone GRAVEL with a high cobble content. Cobbles are angular of limestone. (BLACK ROCK LIMESTONE SUBGROUP)	1	
			92.02	1.20

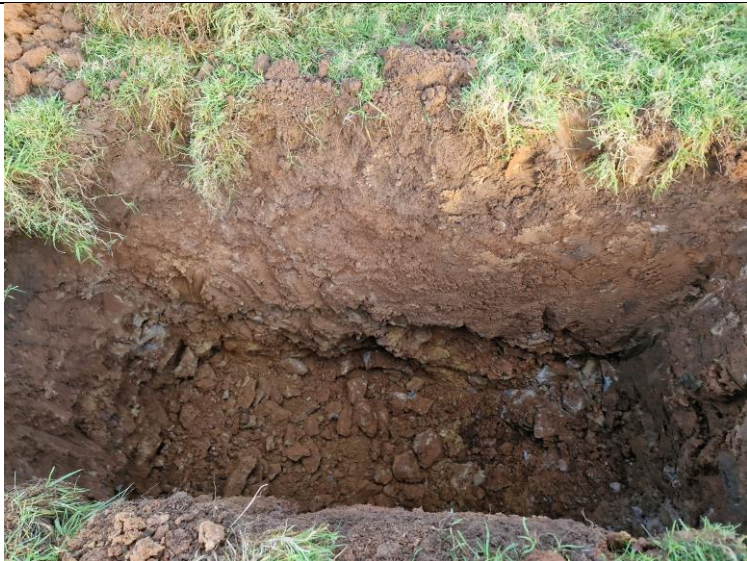
**PLATE 03 – Trial Pit Excavation – TP02.**

Extremely weak light grey LIMESTONE. Recovered as slightly clayey slightly sandy angular fine to coarse limestone GRAVEL and COBBLES. Cobbles are angular of limestone. (BLACK ROCK LIMESTONE SUBGROUP)		
			92.26	1.00		End of Trial Pit at 1.00m	1	
							2	
							3	
							4	
							5

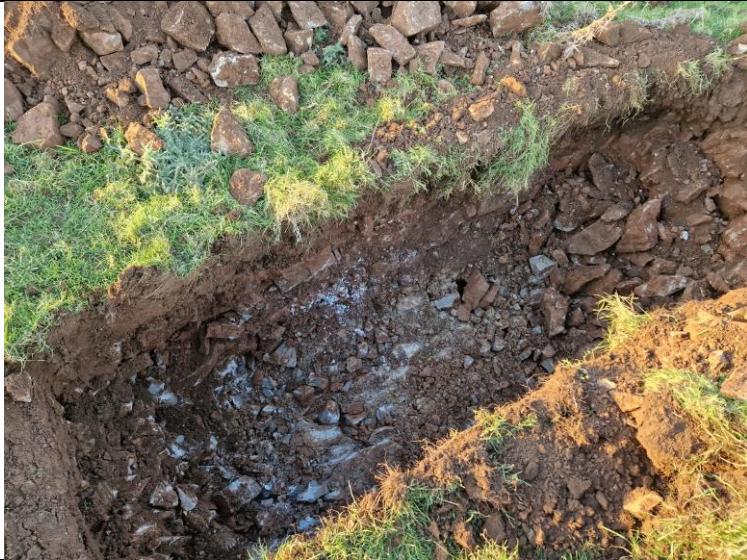
**PLATE 05 – Trial Pit Excavation – TP03.**

Soft reddish brown silty friable CLAY. (BLACK ROCK LIMESTONE SUBGROUP)		
			83.76	0.90

Extremely weak light grey LIMESTONE. Recovered as slightly clayey slightly sandy angular fine to coarse limestone GRAVEL and COBBLES. Cobbles are angular of limestone. (BLACK ROCK LIMESTONE SUBGROUP)	1	
			83.06	1.60		End of Trial Pit at 1.60m		
							2	
							3	
							4	
							5

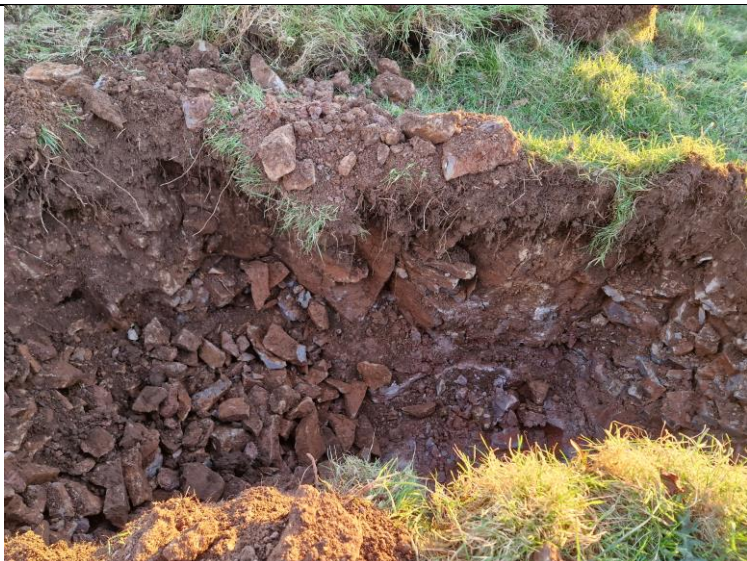
**PLATE 07 – Trial Pit Excavation – TP04.**

Extremely weak light grey LIMESTONE. Recovered as slightly clayey slightly sandy angular fine to coarse limestone GRAVEL and COBBLES. Cobbles are angular of limestone. (BLACK ROCK LIMESTONE SUBGROUP)		
			86.97	0.90

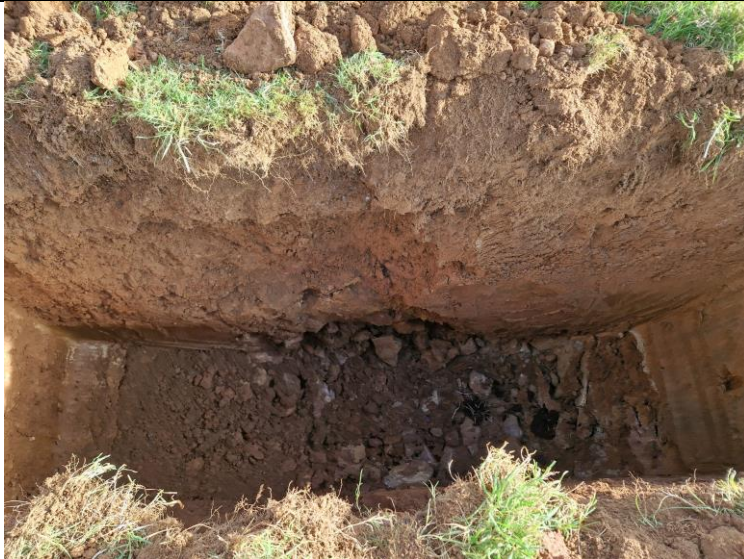
PLATE 09 – Trial Pit Excavation – TP05.

Soft reddish brown silty friable CLAY. (BLACK ROCK LIMESTONE SUBGROUP)  <i>At 0.70mbgl: Becomes firm.</i>	1	
			82.20	1.50

Extremely weak light grey LIMESTONE. Recovered as slightly clayey slightly sandy angular fine to coarse limestone GRAVEL with a medium cobble content. Cobbles are angular of limestone. (BLACK ROCK LIMESTONE SUBGROUP)		
			81.90	1.80		End of Trial Pit at 1.80m	2	
							3	
							4	
							5

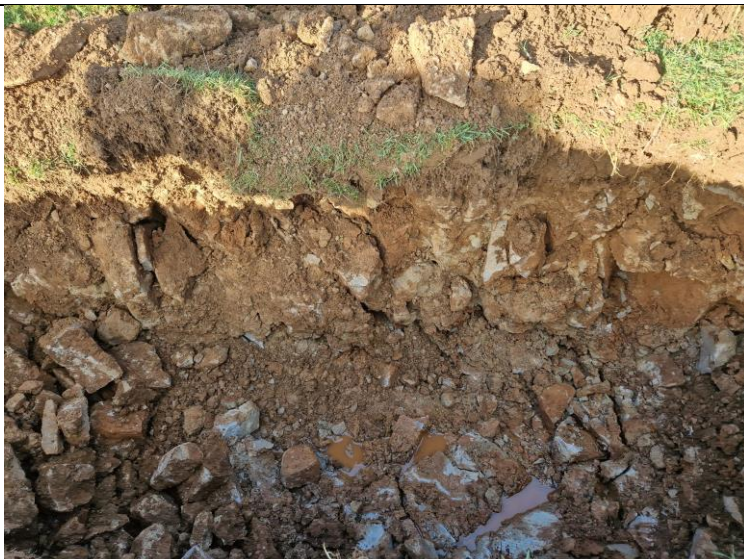
PLATE 11 – Trial Pit Excavation – TP06.

Extremely weak light grey LIMESTONE. Recovered as slightly clayey slightly sandy angular fine to coarse limestone GRAVEL and COBBLES. Cobbles are angular of limestone. (BLACK ROCK LIMESTONE SUBGROUP)		
			78.03	1.00		End of Trial Pit at 1.00m	1	▼
							2	
							3	
							4	
							5

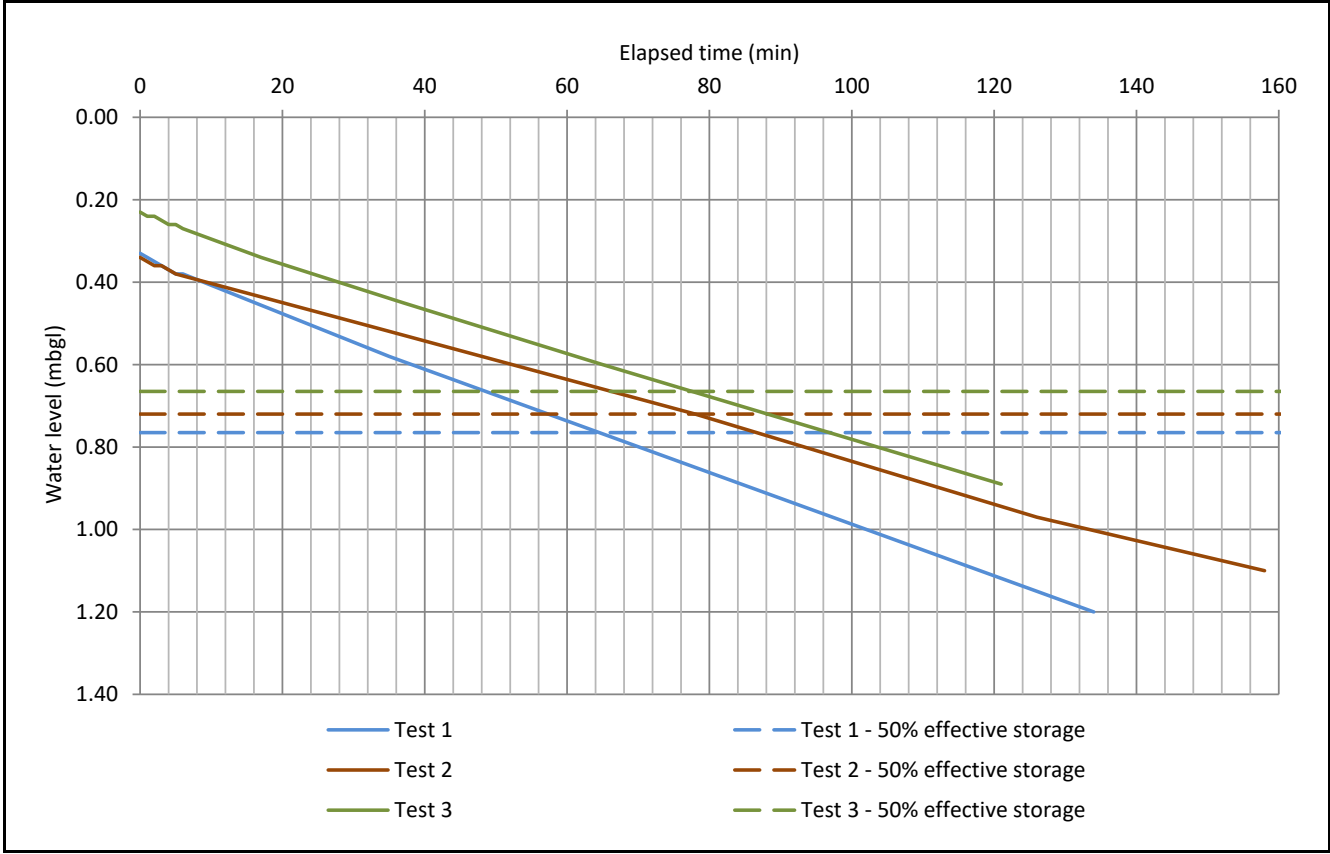
Project Name: Land off Mounton Road, Chepstow						Project ID: P1058					
Client: Barwood Development Securities Ltd											
Hole ID: TP01			Test Date: 10/01/2024		Logged: CS	Checked: JD					
Test 1		Test 2		Test 3		Soakaway Dimensions:					
Length (m)	1.60										
Width (m)	0.70										
Test 1 - Depth (m)	1.20										
Time (mins)	Depth (m)	Time (mins)	Depth (m)	Time (mins)	Depth (m)	Test 2 - Depth (m)	1.10				
0	0.33	0	0.34	0	0.23	Test 3 - Depth (m)	1.10				
1	0.34	1	0.35	1	0.24		Test 1	Test 2	Test 3		
2	0.35	2	0.36	2	0.24		Depth to water at start of test (m)	0.33	0.34	0.23	
3	0.36	3	0.36	3	0.25		Depth to water at end of test (m)	1.20	1.10	0.89	
4	0.37	4	0.37	4	0.26		Total head drop (m)	0.87	0.76	0.66	
5	0.38	5	0.38	5	0.26		Depth to water at 75% level (m)	0.55	0.53	0.45	
6	0.38	33	0.51	6	0.27		Depth to water at 50% level (m)	0.77	0.72	0.67	
35	0.58	78	0.72	17	0.34		Depth to water at 25% level (m)	0.98	0.91	0.88

134	1.20	126	0.97	37	0.45						
		158	1.10	65	0.60						
				121	0.89		Base area of pit (m <sup>2</sup> )	1.12	1.12	1.12	
							Computed Internal Surface Area A <sub>p50</sub> (m <sup>2</sup> )	3.12	2.87	3.12	
							Effective Storage Volume V <sub>p75-25</sub> (m <sup>3</sup> )	0.49	0.43	0.49	
							Elapsed time at 75% level (mins)	30	37	37	
							Elapsed time at 25% level (mins)	99	114	120	
							Total discharge during test	100%	100%	76%	
							50% discharge in 24 Hours	Yes	Yes	Yes	
							Soil infiltration rate <i>f</i> (m/s)	3.76E-05	3.20E-05	3.13E-05	
							<b>Design soil infiltration rate <i>f</i> (m/s)</b>	<b>3.13E-05</b>

Graphical representations of the data are contained within Appendix D.

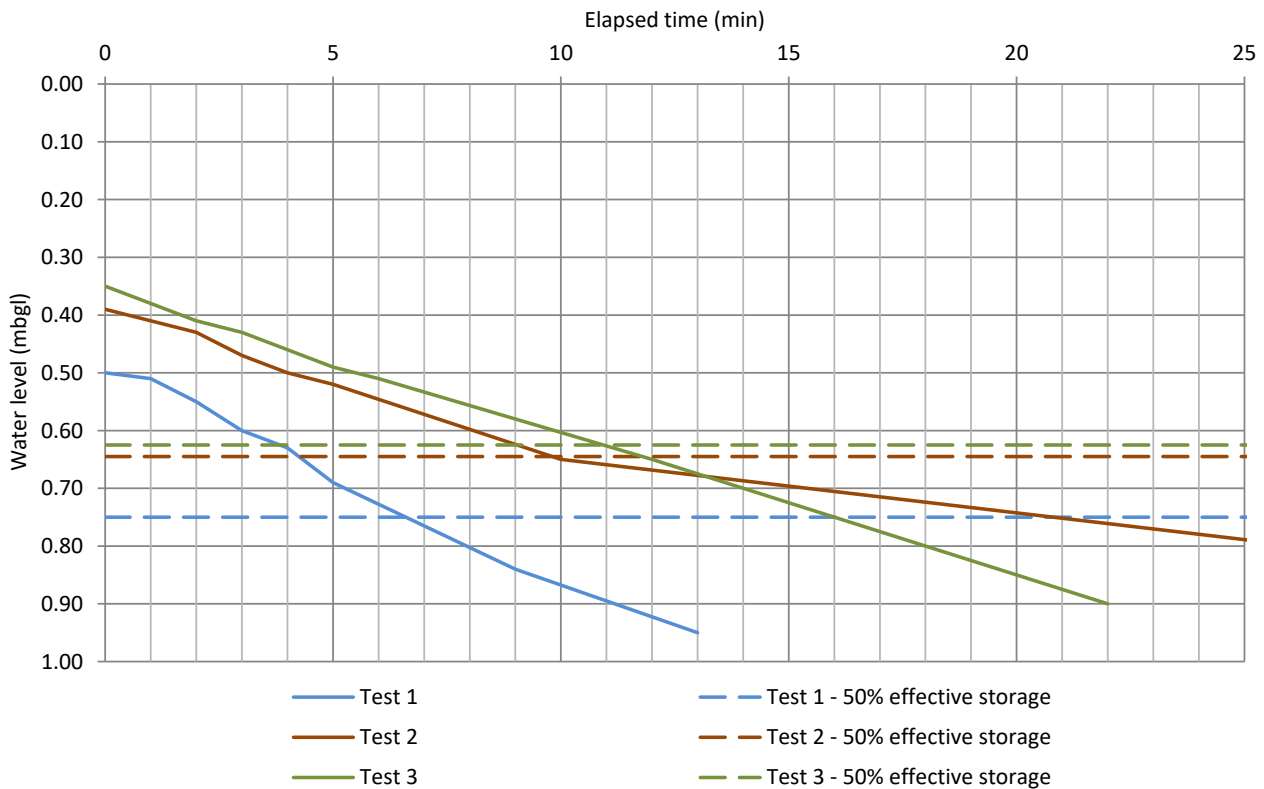
Project Name: Land off Mounton Road, Chepstow						Project ID: P1058			
Client: Barwood Development Securities Ltd									
Hole ID: TP02			Test Date: 10/01/2024		Logged: CS	Checked: JD			
Test 1		Test 2		Test 3		Soakaway Dimensions:			
Time (mins)	Depth (m)	Time (mins)	Depth (m)	Time (mins)	Depth (m)				Length (m)
0	0.50	0	0.39	0	0.35	Width (m)	0.70		
1	0.51	1	0.41	1	0.38	Test 1 - Depth (m)	1.00		
2	0.55	2	0.43	2	0.41	Test 2 - Depth (m)	0.90		
3	0.60	3	0.47	3	0.43	Test 3 - Depth (m)	0.90		
4	0.63	4	0.50	4	0.46	Test 1	Test 2	Test 3	
5	0.69	5	0.52	5	0.49	Depth to water at start of test (m)	0.50	0.39	0.35
9	0.84	10	0.65	6	0.51	Depth to water at end of test (m)	0.95	0.90	0.90
13	0.95	37	0.90	12	0.65	Total head drop (m)	0.45	0.51	0.55
				22	0.90	Depth to water at 75% level (m)	0.63	0.52	0.49
						Depth to water at 50% level (m)	0.75	0.65	0.63
						Depth to water at 25% level (m)	0.88	0.77	0.76
						Base area of pit (m <sup>2</sup> )	1.26	1.26	1.26

Computed Internal Surface Area A <sub>p50</sub> (m <sup>2</sup> )	2.51	2.54	2.64
						Effective Storage Volume V <sub>p75-25</sub> (m <sup>3</sup> )	0.32	0.32	0.35
						Elapsed time at 75% level (mins)	4	5	5
						Elapsed time at 25% level (mins)	10	23	16
						Total discharge during test	90%	100%	100%
						50% discharge in 24 Hours	Yes	Yes	Yes
						Soil infiltration rate <i>f</i> (m/s)	3.25E-04	1.15E-04	1.89E-04
						<b>Design soil infiltration rate <i>f</i> (m/s)</b>	<b>1.15E-04</b>

Due to the relatively quick infiltration rates observed while filling the trial pits using a 1000l ICB, TP02 and TP03 in particular were unable to fill completely before starting the test.

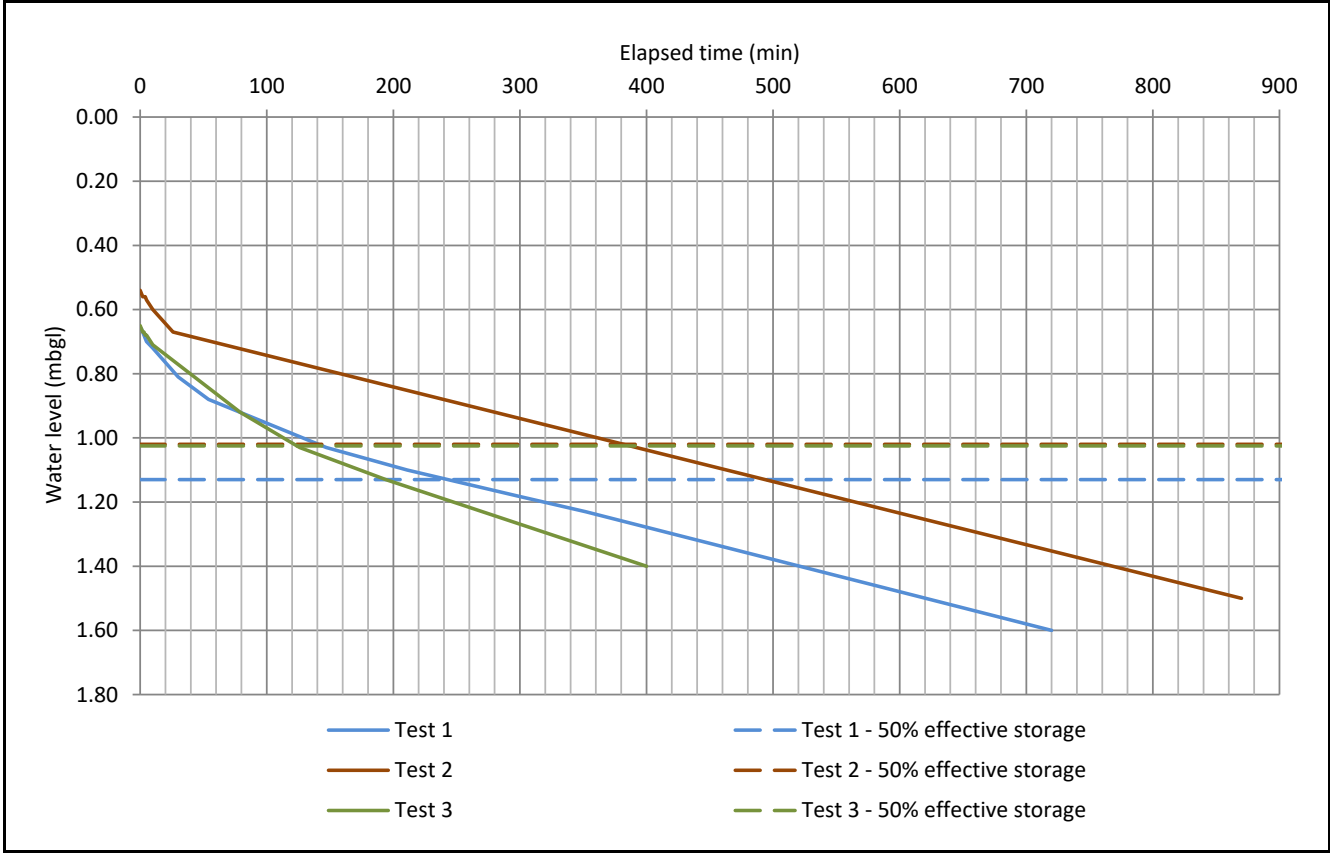
Project Name: Land off Mounton Road, Chepstow						Project ID: P1058					
Client: Barwood Development Securities Ltd											
Hole ID: TP03			Test Date: 10/01/2024		Logged: CS	Checked: JD					
Test 1		Test 2		Test 3		Soakaway Dimensions:					
Length (m)	1.70										
Width (m)	0.60										
Test 1 - Depth (m)	1.60										
Time (mins)	Depth (m)	Time (mins)	Depth (m)	Time (mins)	Depth (m)	Test 2 - Depth (m)	1.50				
0	0.66	0	0.54	0	0.65	Test 3 - Depth (m)	1.40				
1	0.66	1	0.55	1	0.66						
2	0.67	2	0.56	2	0.67	Test 1	Test 2	Test 3			
3	0.68	3	0.56	3	0.67	Depth to water at start of test (m)	0.66	0.54	0.65		
4	0.69	4	0.56	4	0.68	Depth to water at end of test (m)	1.60	1.50	1.40		
5	0.70	5	0.57	5	0.68	Total head drop (m)	0.94	0.96	0.75		
10	0.72	10	0.60	10	0.71	Depth to water at 75% level (m)	0.90	0.78	0.84		
30	0.81	26	0.67	79	0.92	Depth to water at 50% level (m)	1.13	1.02	1.03		
54	0.88	870	1.50	126	1.03	Depth to water at 25% level (m)	1.37	1.26	1.21

147	1.03			194	1.13						
211	1.10			400	1.40	Base area of pit (m <sup>2</sup> )	1.02	1.02	1.02		
297	1.18					Computed Internal Surface Area A <sub>p50</sub> (m <sup>2</sup> )	3.18	3.23	2.75		
352	1.23					Effective Storage Volume V <sub>p75-25</sub> (m <sup>3</sup> )	0.48	0.49	0.38		
720	1.60										
						Elapsed time at 75% level (mins)	63	138	52		
						Elapsed time at 25% level (mins)	486	626	257		
						Total discharge during test	100%	100%	100%		
						50% discharge in 24 Hours	Yes	Yes	Yes		
						Soil infiltration rate f (m/s)	5.94E-06	5.18E-06	1.13E-05		
						<b>Design soil infiltration rate f (m/s)</b>	<b>5.18E-06</b>

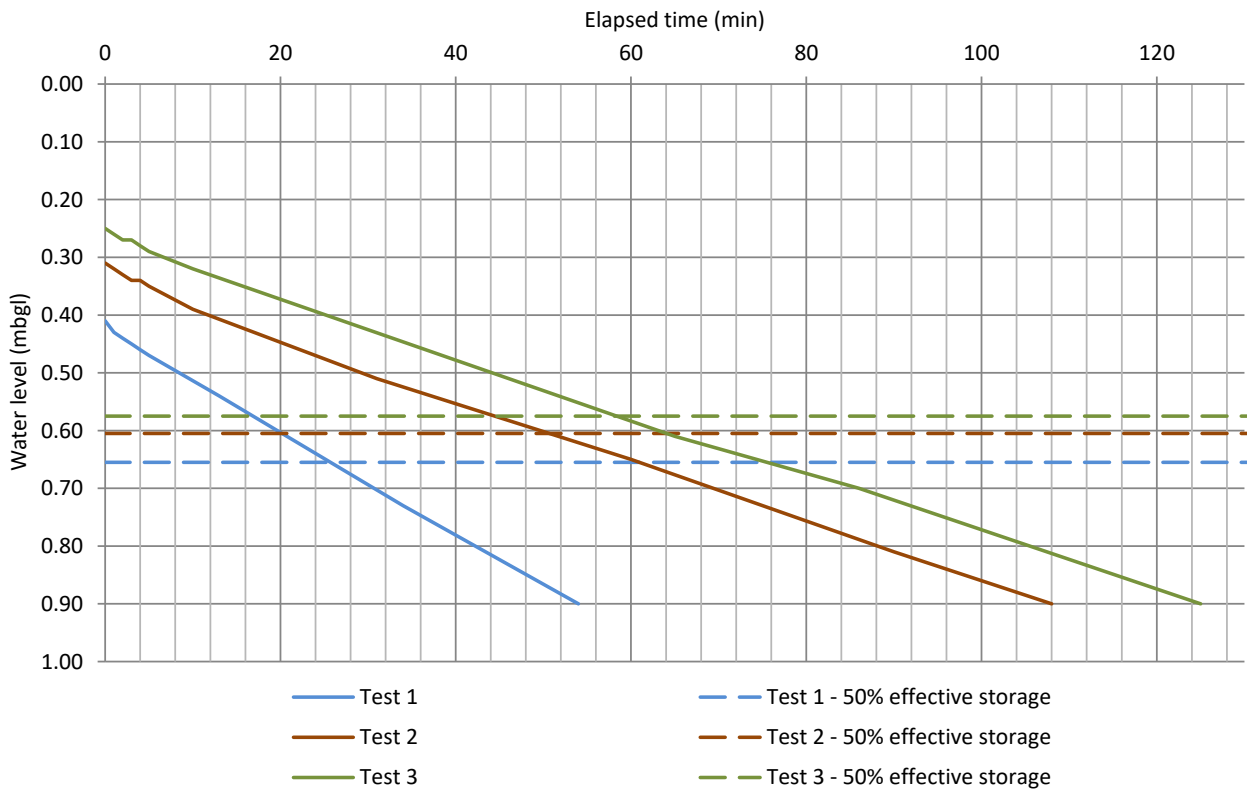
Project Name: Land off Mounton Road, Chepstow						Project ID: P1058					
Client: Barwood Development Securities Ltd											
Hole ID: TP04			Test Date: 10/01/2024		Logged: CS	Checked: JD					
Test 1		Test 2		Test 3		Soakaway Dimensions:					
Time (mins)	Depth (m)	Time (mins)	Depth (m)	Time (mins)	Depth (m)				Length (m)	2.20	
0	0.41	0	0.31	0	0.25				Width (m)	0.70	
1	0.43	1	0.32	1	0.26				Test 1 - Depth (m)	0.90	
2	0.44	2	0.33	2	0.27	Test 2 - Depth (m)	0.90				
3	0.45	3	0.34	3	0.27	Test 3 - Depth (m)	0.90				
4	0.46	4	0.34	4	0.28	Test 1	Test 2	Test 3			
5	0.47	5	0.35	5	0.29	Depth to water at start of test (m)	0.41	0.31	0.25		
13	0.54	10	0.39	10	0.32	Depth to water at end of test (m)	0.90	0.90	0.90		
34	0.73	31	0.51	29	0.42	Total head drop (m)	0.49	0.59	0.65		
54	0.90	60	0.65	65	0.61	Depth to water at 75% level (m)	0.53	0.46	0.41		
		90	0.81	86	0.70	Depth to water at 50% level (m)	0.66	0.61	0.58		
		108	0.90	125	0.90	Depth to water at 25% level (m)	0.78	0.75	0.74

Base area of pit (m <sup>2</sup> )							1.54	1.54	1.54		
Computed Internal Surface Area A <sub>p50</sub> (m <sup>2</sup> )							2.96	3.25	3.43		
Effective Storage Volume V <sub>p75-25</sub> (m <sup>3</sup> )							0.38	0.45	0.50		
Elapsed time at 75% level (mins)							12	22	28		
Elapsed time at 25% level (mins)							40	79	93		
Total discharge during test							100%	100%	100%		
50% discharge in 24 Hours							Yes	Yes	Yes		
Soil infiltration rate <i>f</i> (m/s)							7.74E-05	4.06E-05	3.70E-05		
<b>Design soil infiltration rate <i>f</i> (m/s)</b>							<b>3.70E-05</b>

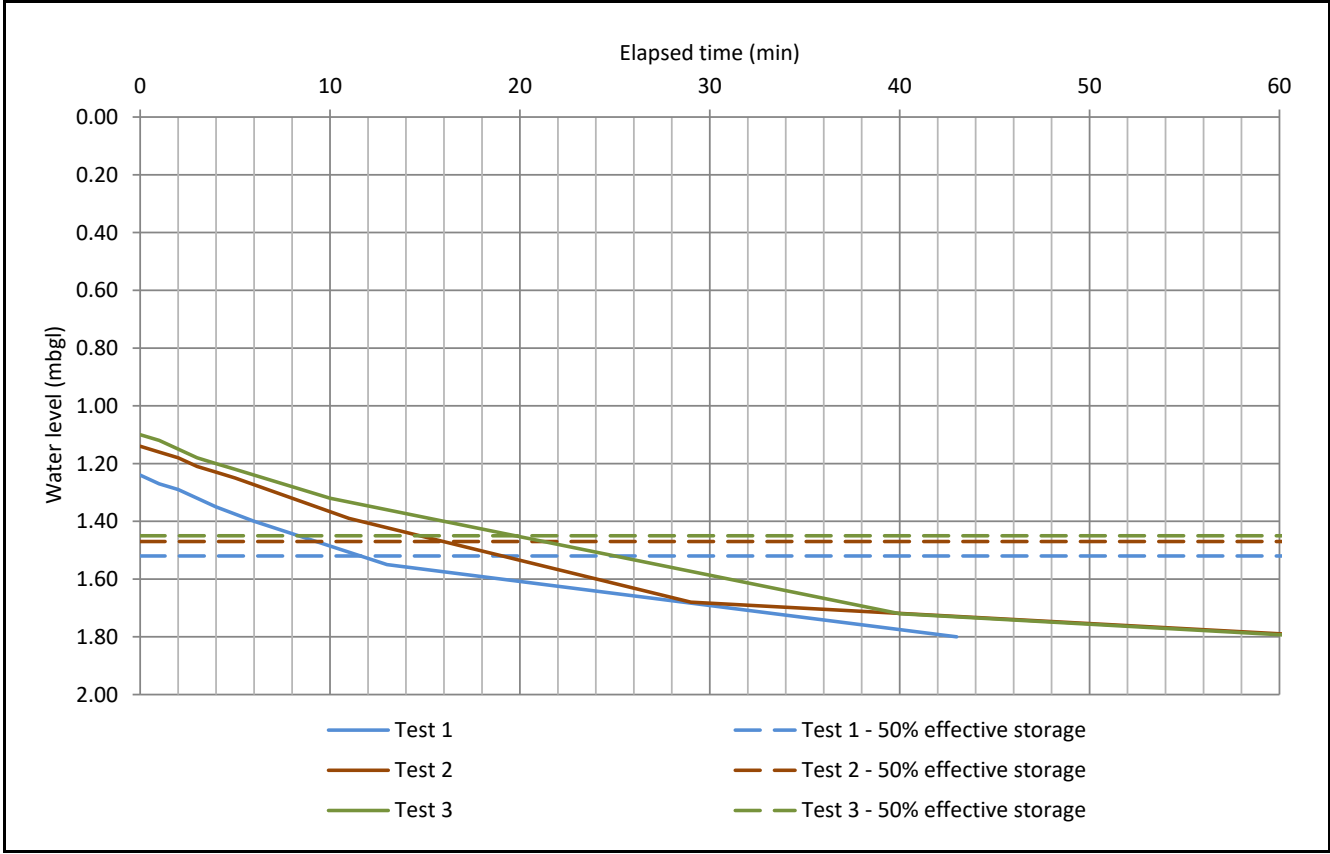
Project Name: Land off Mounton Road, Chepstow						Project ID: P1058					
Client: Barwood Development Securities Ltd											
Hole ID: TP05			Test Date: 10/01/2024		Logged: CS	Checked: JD					
Test 1		Test 2		Test 3		Soakaway Dimensions:					
Time (mins)	Depth (m)	Time (mins)	Depth (m)	Time (mins)	Depth (m)				Length (m)	2.30	
0	1.24	0	1.14	0	1.10				Width (m)	0.60	
1	1.27	1	1.16	1	1.12				Test 1 - Depth (m)	1.80	
2	1.29	2	1.18	2	1.15	Test 2 - Depth (m)	1.80				
3	1.32	3	1.21	3	1.18	Test 3 - Depth (m)	1.80				
4	1.35	4	1.23	4	1.20	Test 1	Test 2	Test 3			
6	1.40	5	1.25	5	1.22	Depth to water at start of test (m)	1.24	1.14	1.10		
13	1.55	11	1.39	10	1.32	Depth to water at end of test (m)	1.80	1.80	1.80		
43	1.80	29	1.68	40	1.72	Total head drop (m)	0.56	0.66	0.70		
		63	1.80	62	1.80	Depth to water at 75% level (m)	1.38	1.31	1.28		
						Depth to water at 50% level (m)	1.52	1.47	1.45		
						Depth to water at 25% level (m)	1.66	1.64	1.63

Base area of pit (m <sup>2</sup> )	1.38	1.38	1.38		
						Computed Internal Surface Area A <sub>p50</sub> (m <sup>2</sup> )	3.00	3.29	3.41		
						Effective Storage Volume V <sub>p75-25</sub> (m <sup>3</sup> )	0.39	0.46	0.48		
						Elapsed time at 75% level (mins)	5	7	8		
						Elapsed time at 25% level (mins)	26	26	33		
						Total discharge during test	100%	100%	100%		
						50% discharge in 24 Hours	Yes	Yes	Yes		
						Soil infiltration rate <i>f</i> (m/s)	1.02E-04	1.22E-04	9.40E-05		
						<b>Design soil infiltration rate <i>f</i> (m/s)</b>	<b>9.40E-05</b>

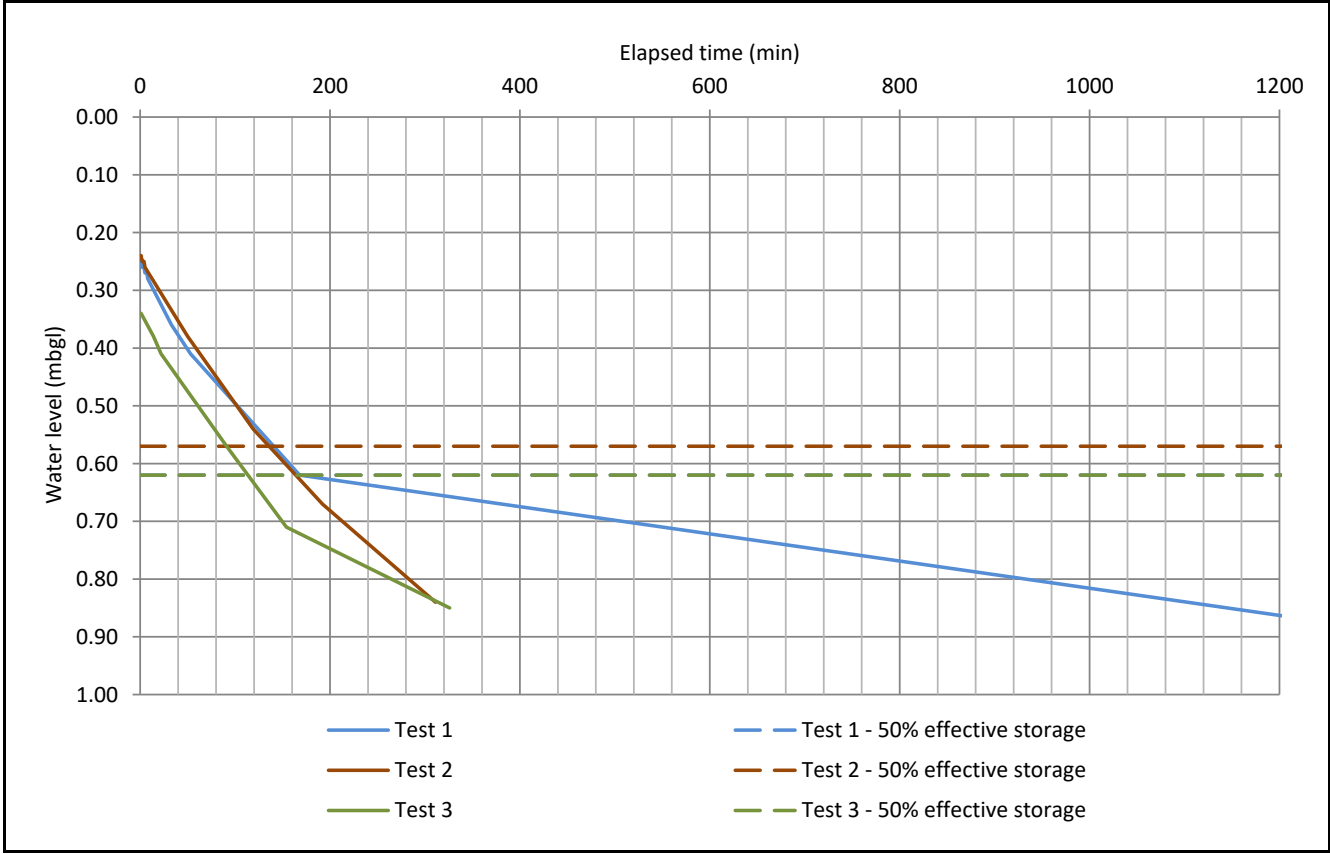
Project Name: Land off Mounton Road, Chepstow						Project ID: P1058					
Client: Barwood Development Securities Ltd											
Hole ID: TP06				Test Date: 10/01/2024		Logged: CS	Checked: JD				
Test 1		Test 2		Test 3		Soakaway Dimensions:					
Time (mins)	Depth (m)	Time (mins)	Depth (m)	Time (mins)	Depth (m)				Length (m)	1.50	
0	0.24	0	0.24	0	0.34				Width (m)	0.60	
1	0.25	1	0.24	1	0.34	Test 1 - Depth (m)	1.00				
2	0.26	2	0.25	14	0.38	Test 2 - Depth (m)	0.90				
3	0.26	3	0.25	22	0.41	Test 3 - Depth (m)	0.90				
4	0.26	4	0.25	91	0.57	Test 1	Test 2	Test 3			
5	0.27	5	0.26	154	0.71	Depth to water at start of test (m)	0.24	0.24	0.34		
6	0.27	50	0.38	326	0.85	Depth to water at end of test (m)	0.87	0.84	0.85		
7	0.27	119	0.54			Total head drop (m)	0.63	0.60	0.51		
8	0.28	192	0.67			Depth to water at 75% level (m)	0.43	0.41	0.48		
33	0.36	311	0.84			Depth to water at 50% level (m)	0.62	0.57	0.62		
53	0.41					Depth to water at 25% level (m)	0.81	0.74	0.76

168	0.62					Base area of pit (m <sup>2</sup> )	0.90	0.90	0.90		
1230	0.87					Computed Internal Surface Area A <sub>p50</sub> (m <sup>2</sup> )	2.50	2.29	2.08		
						Effective Storage Volume V <sub>p75-25</sub> (m <sup>3</sup> )	0.34	0.30	0.25		
						Elapsed time at 75% level (mins)	64	61	52		
						Elapsed time at 25% level (mins)	975	238	215		
						Total discharge during test	83%	91%	91%		
						50% discharge in 24 Hours	Yes	Yes	Yes		
						Soil infiltration rate f (m/s)	2.51E-06	1.23E-05	1.24E-05		
						<b>Design soil infiltration rate f (m/s)</b>	<b>2.51E-06</b>
