# **Flood and Water Management Act 2010**

## **Section 19 Flood Investigation Report**

**River Monnow Catchment: Storm Claudia,  
November 2025**

**Prepared for  
Monmouthshire County  
Council**

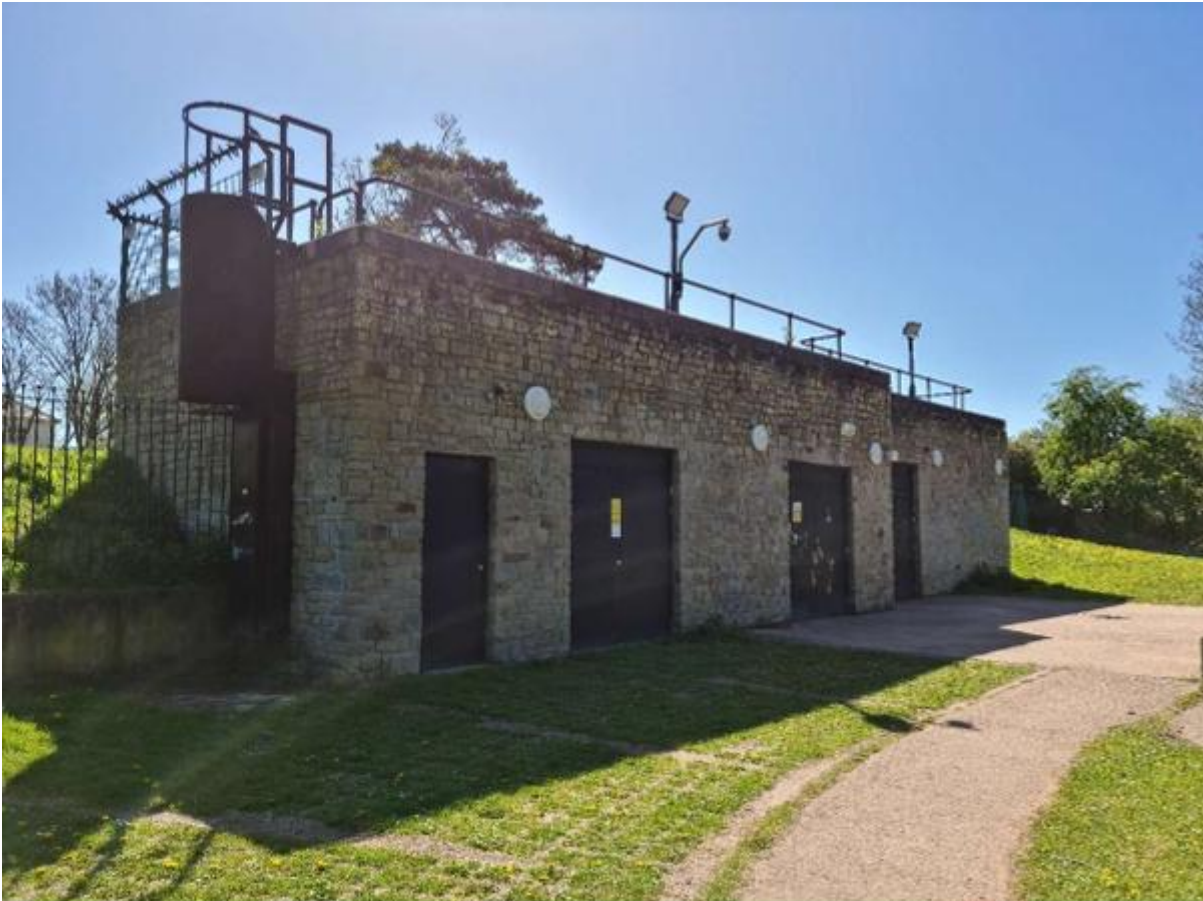
Figure 3-2 Wonastow Road Flood Alleviation Scheme pumping station

The Wonastow Brook flows towards the River Monnow, overflowing to Drybridge Community Pond when capacity within the ordinary watercourse is exceeded. Drybridge Community Pond acts as flow attenuation and flood storage in periods of high rainfall. When levels on the River Monnow result in hydraulic locking of the Wonastow Brook, a pumping station draws water from Drybridge Community Pond and pumps it over the NRW maintained embankment into the River Monnow. The pumping station is shown in Figure 3-2.

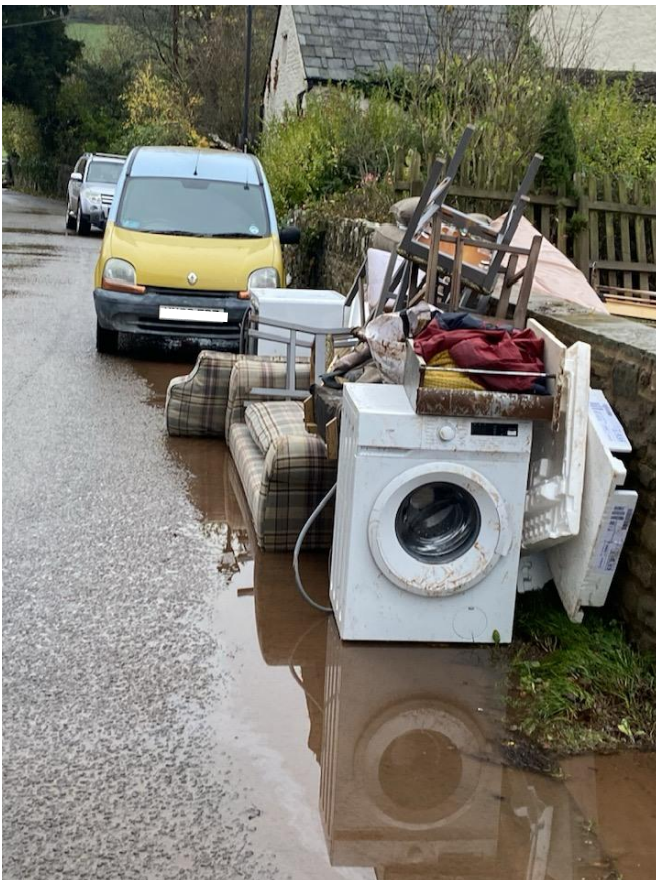
Figure 5-1 Damage from internal flooding in Skenfrith

Overall, flooding in Skenfrith was characterised by extreme river levels, backwater effects, and combined influences from multiple watercourses, resulting in deep, prolonged and internally extensive flooding. Feedback from residents indicates a strong desire for the implementation of improved flood defences to reduce future flood risk, with some residents noting the potential detrimental impact to surface water flows and potential to impact third parties from such flood defence works which needs to be carefully considered.

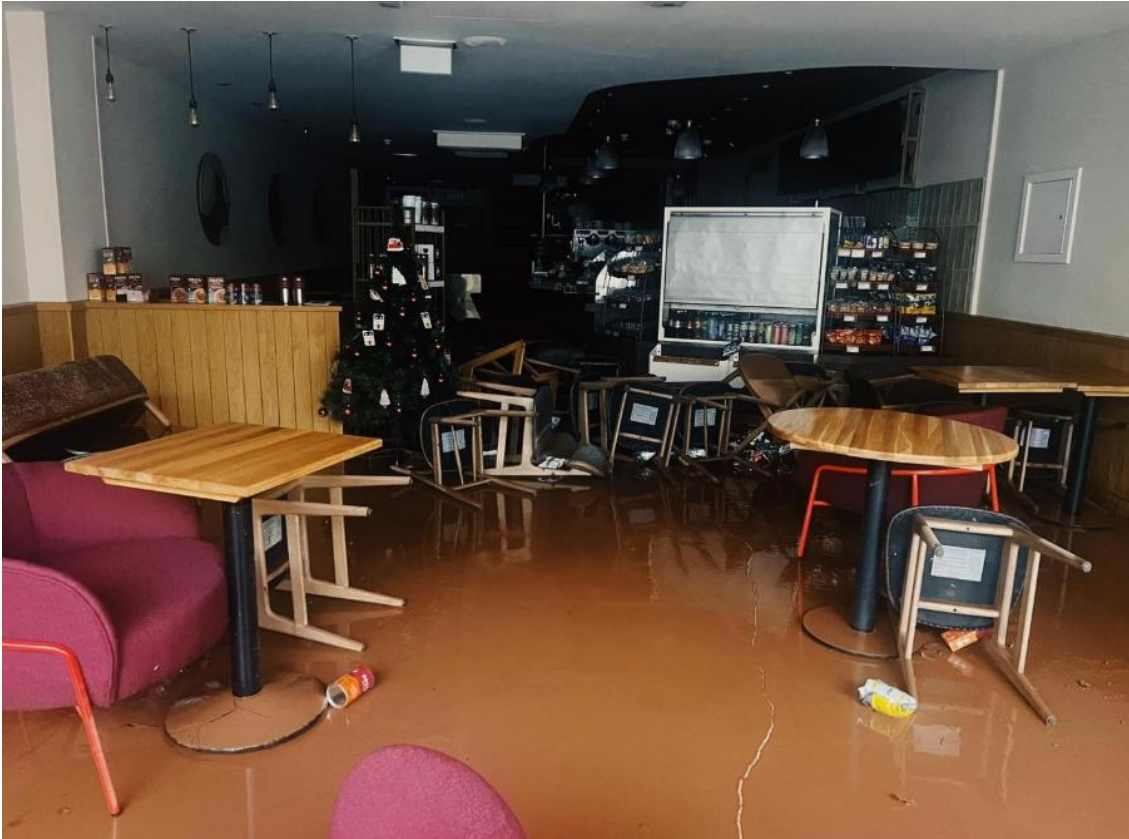
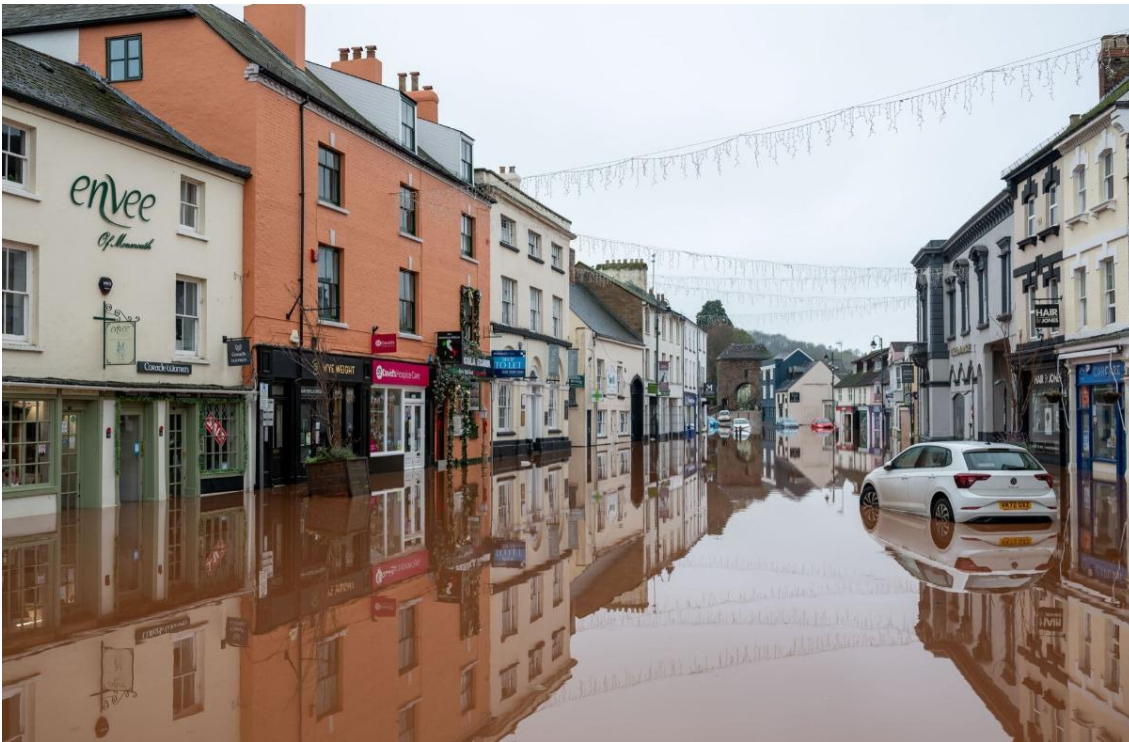
Figures 8-2 and 8-3 illustrate internal and external flooding along Monnow Street, where maximum flood depths were reported to exceed 1m.

Figure 8-2 Internal flooding in Costa Coffee, Monnow Street (Image from Social Media)

Figure 8-3 Flooding on Monnow Street (Image from Social Media/News Reports)

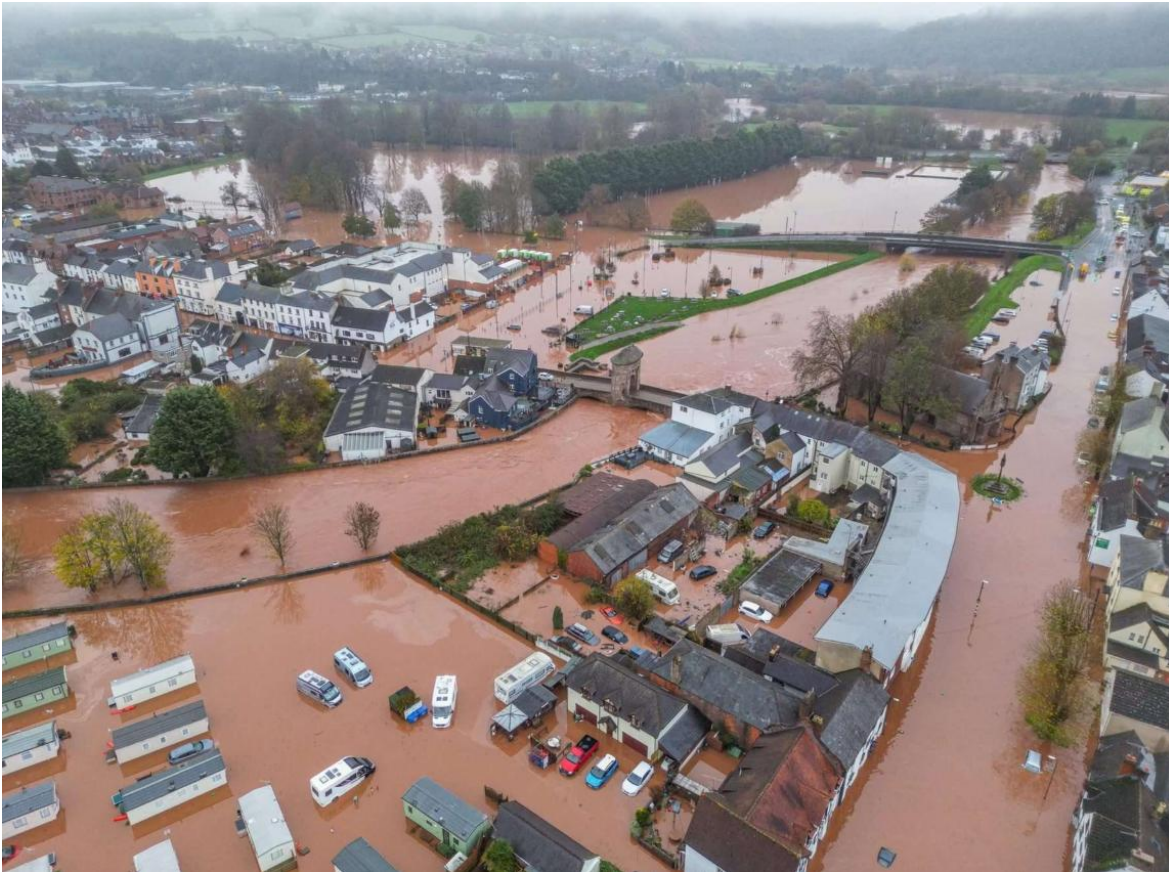
Figure 8-4 Drone Imagery of Storm Claudia across the East of Monnow Study Area

Flows are conveyed from Chippenham Fields via a culvert under the A40. This culvert is flap-valved to prevent backflow in the event of high-water levels and / or flooding associated with the River Wye. The outfall is located within a coarse grid size 'cage' to prevent access to the outfall by the general public. It is understood that during the Storm Claudia event, the flap valve was unable to open to 100% capacity due to the cage preventing full opening. However, flows were still able to be conveyed for the duration of the event. During the event, the cage was removed from the outfall allowing the flap valve to fully open. It is not envisaged that this partial opening of the flap valve would have greatly impacted the flood mechanisms, extent, depth or duration of the event seen across the 'East of the River Monnow' area.

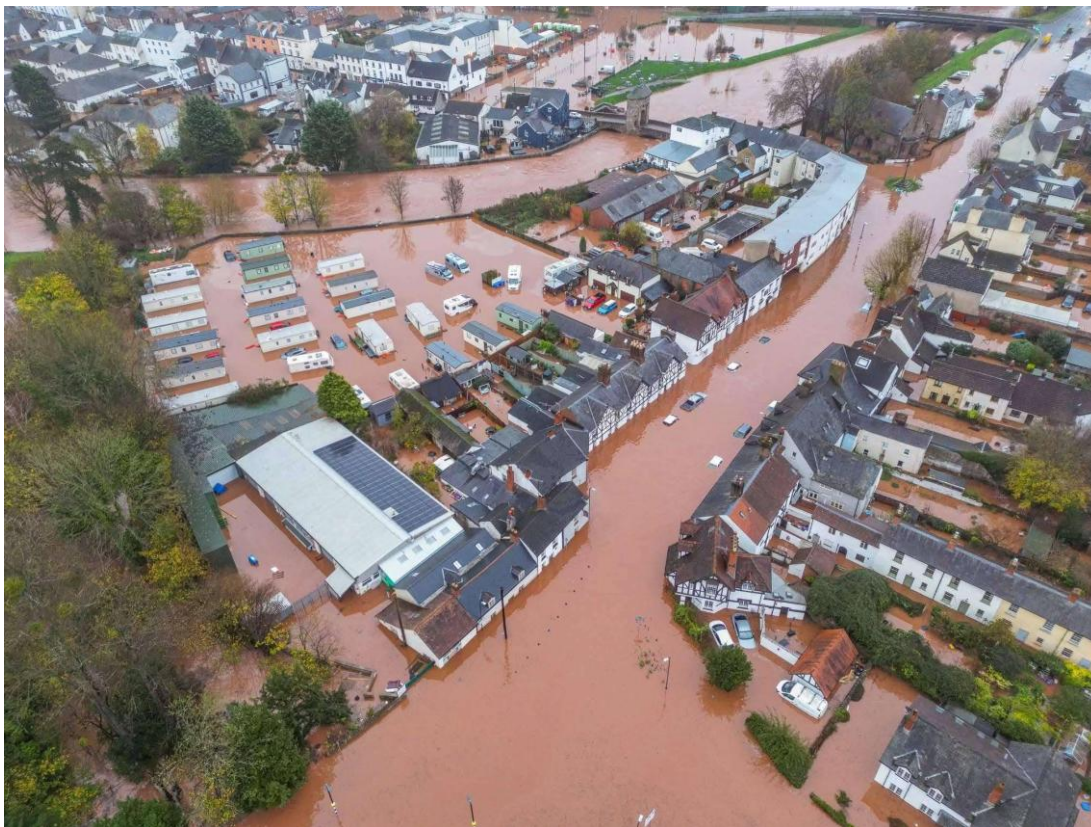
Figure 8-5 Drone Image of Flooding Across West of Monnow Study Area

Reports indicate that flooding occurred along Cinderhill Street at approximately 02:00, with water depths reaching up to knee height (approximately 0.6 m). Several properties experienced significant impacts, including the complete inundation of cellars. Floodwaters are reported to have persisted for an estimated 24 to 36 hours before receding.

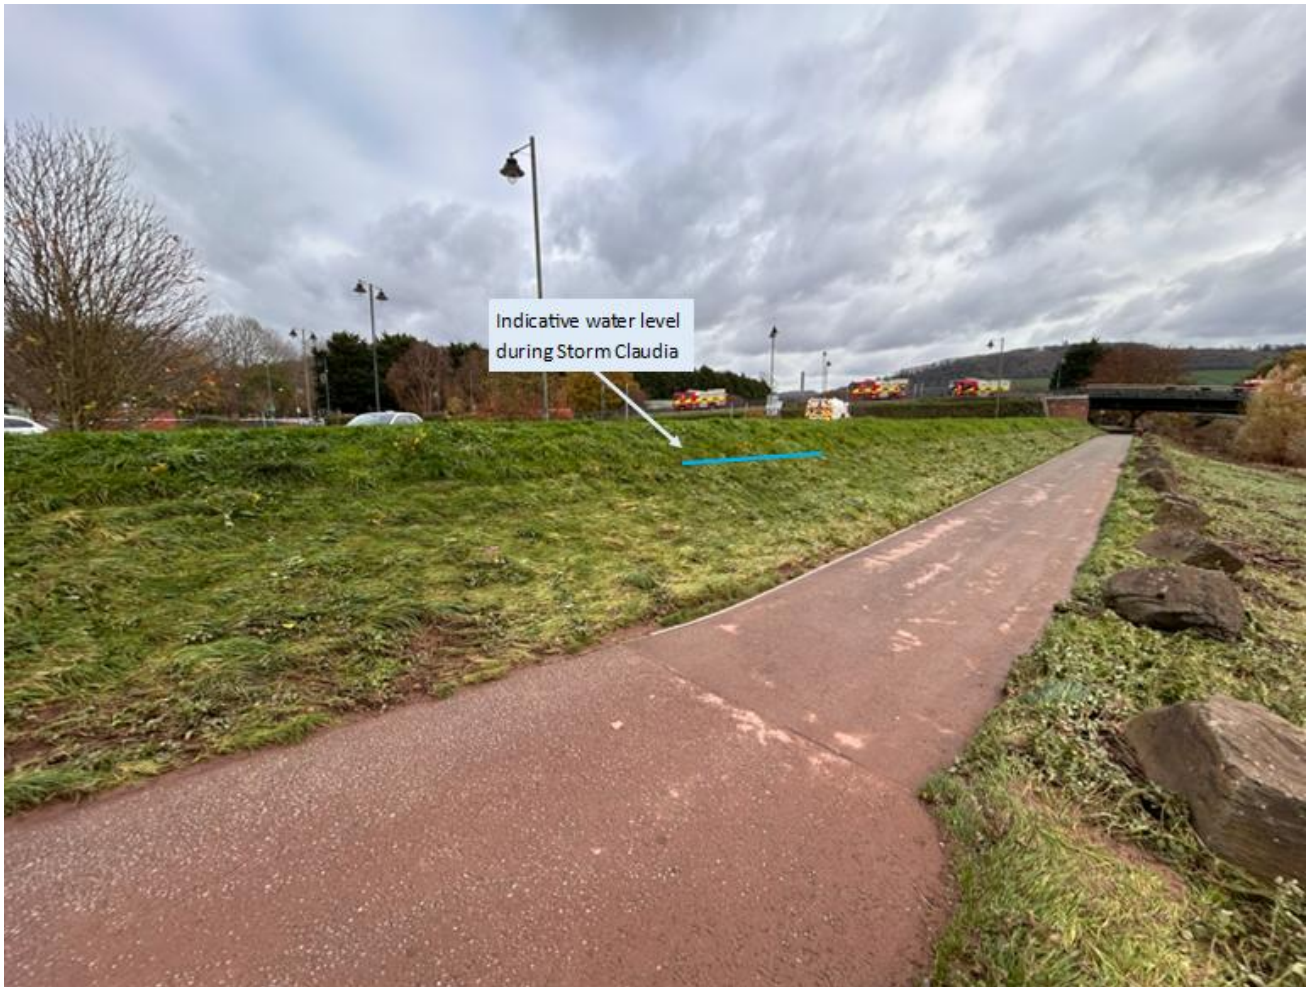
Figure 8-8 Evidence of Water Level Downstream of Monnow Bridge

Primary fluvial flood routing resulted from overtopping of the River Monnow upstream of Monnow Bridge, within the 'West of the River Monnow' area. Fluvial flows tracked in a westerly direction towards Rockfield Road and beyond, tracking approximately 600m along Wonastow Road and subsequently flowing in a primarily southerly direction to wider residential areas. It is understood that the River Monnow did not overtop defences between Monnow Bridge and the A40, with water remaining in channel for this stretch of the Main River. Figure 8-8 shows evidence of the water level on the left-hand embankment of the River Monnow along this stretch of the watercourse. The River Monnow is on the right-hand side of the image.

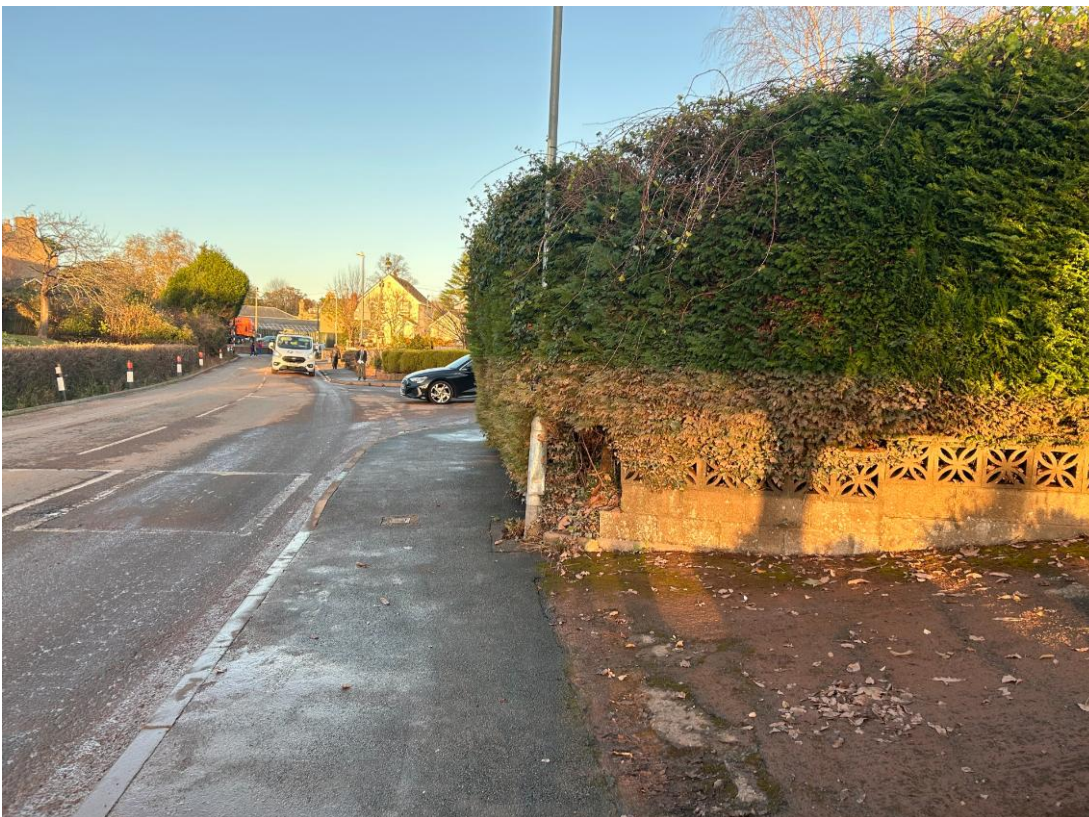
Figure 8-10 Flood Level along Wonastow Road

Properties along Wonastow Road, west of its junction with Fitzroy Close, did not generally experience internal flooding, due to raised property thresholds (approximately 1 metre above road level), although floodwater depths on the highway were sufficient to approach property curtilages, as shown in Figures 8-10, 8-11 and 8-12. It is recognised that 8 residential properties within this reach did report internal property flooding.

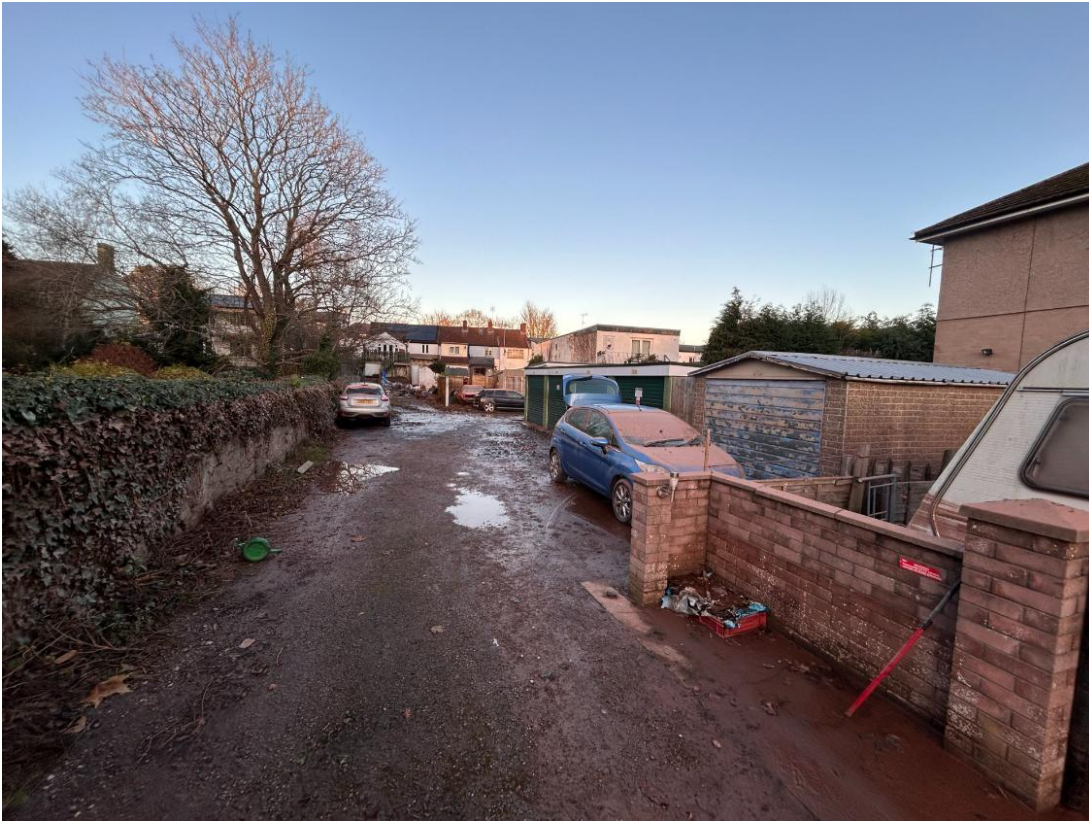
Figure 8-14 Significant Flood Levels across Land adjacent to Goldwire Lane

Ground levels across the Wonastow Road area vary greatly resulting in a range of flood depths reported through the property survey. Generally, ground levels are lowest east of Old Town Ditch and west of Cinderhill Street. Consequently, flood depths of over 2m were reported adjacent to Goldwire Lane where ground levels surrounding Homeforge House and Cappers Place are significantly lower than adjacent land. As shown in Figure 8-13, an electricity substation within this area was significantly inundated, and flood levels of approximately 2m are evidenced to this area, as shown in Figure 8-14.

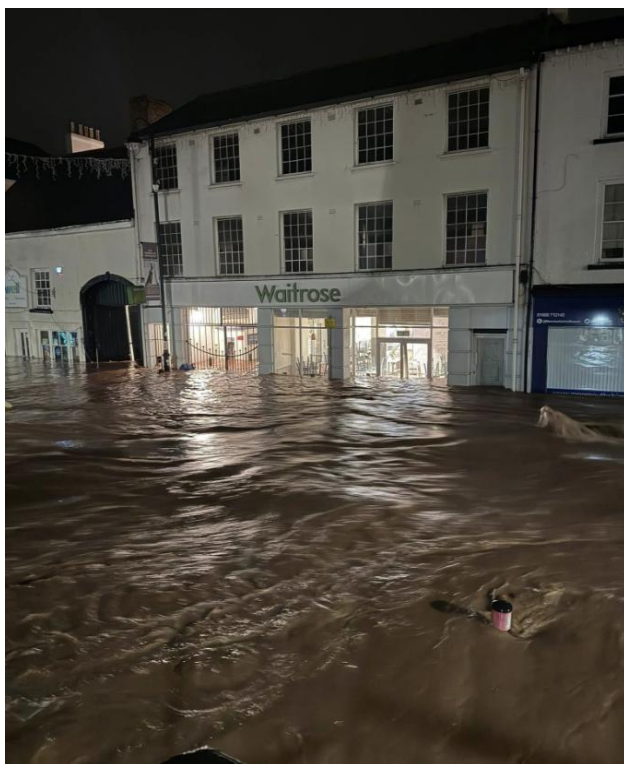
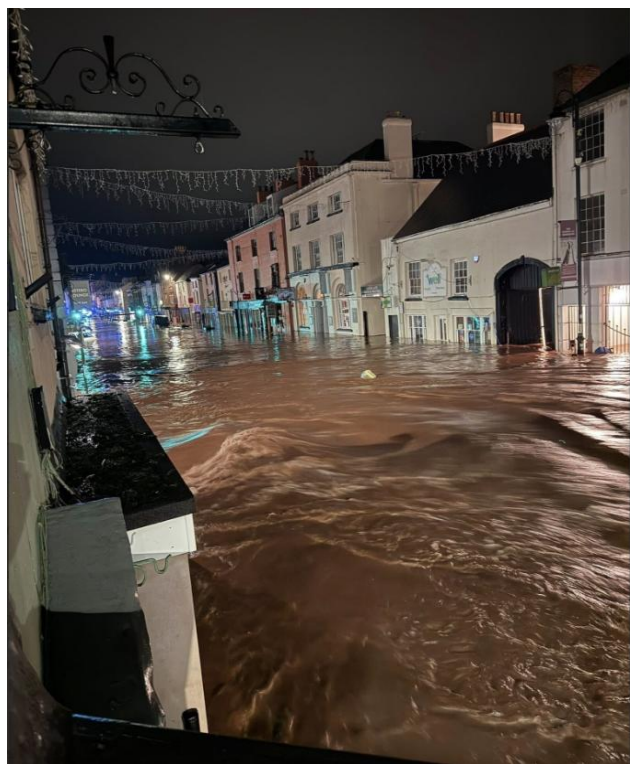
Figure 9-1 Flooding on Monnow Street (sourced from social media images)

Figure 9-1 offers a small representation of the scale of the flooding and the impacts it had on properties.

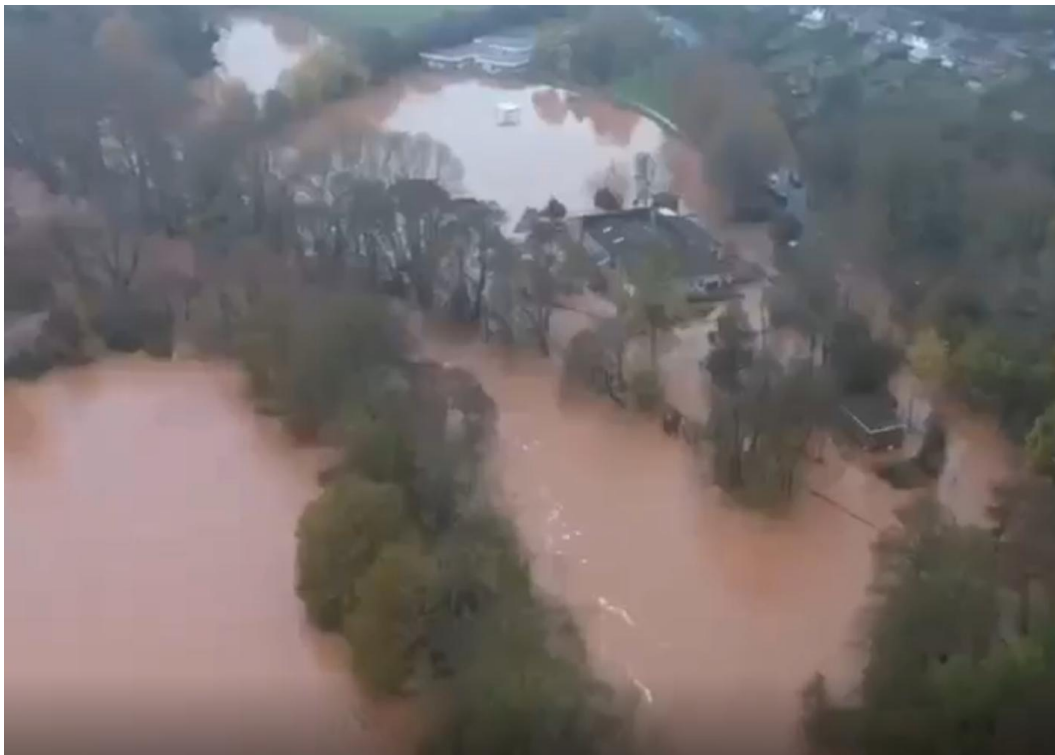
Figure 9-2 Drone Footage of Flooding across Osbaston Primary Schools

Wider infrastructure across Monmouthshire was also impacted as a direct consequence of the Storm Claudia event which includes flooding of main A and B highways restricting access to towns and villages, including Rockfield and Skenfrith. Emergency Services, including assistance from SARA, was required in some instances to facilitate evacuation procedures and check-in on residents choosing to stay in their properties for the duration of the flood event. As detailed in Section 7.1, two primary schools were also impacted by the event, with one school shut for 4 weeks before reopening to accommodate pupils and learning. Full recovery took longer than this four-week period. Figure 9-2 displays drone footage of flooding across the two primary school sites, with Figure 9-3 displaying an image of the clear water level against Osbaston Primary Lower School.

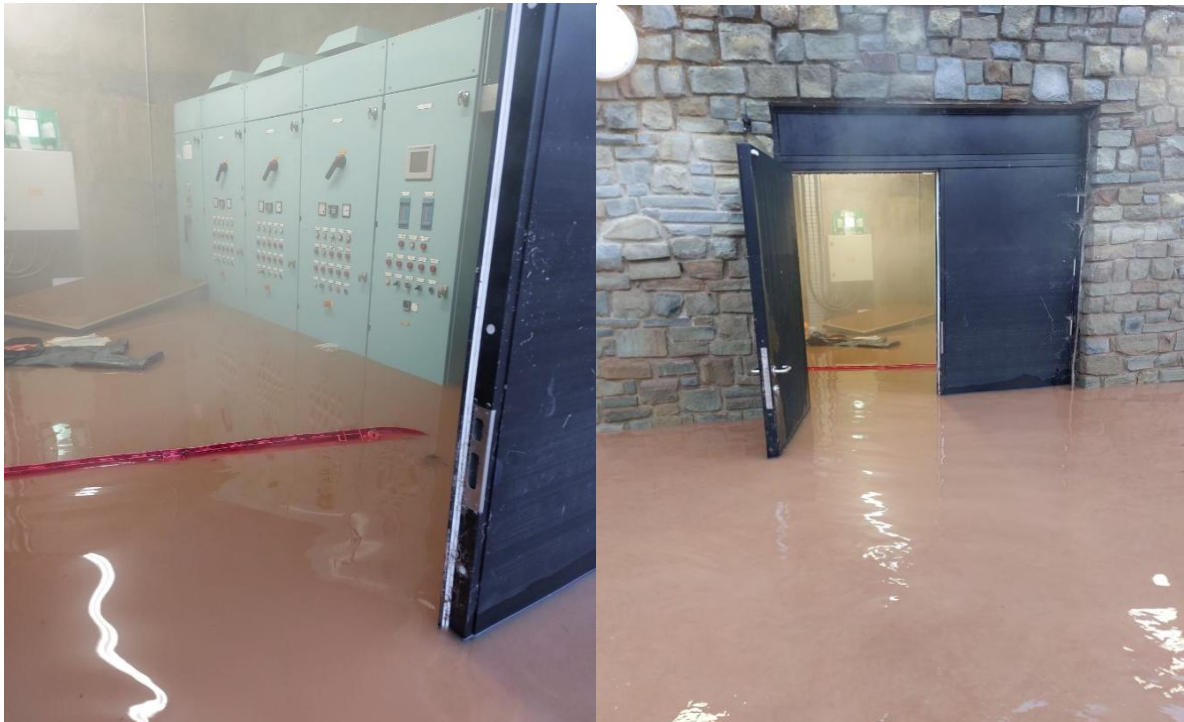
Figure 9-4 Wonastow Road Pumping Station

Post-event, whilst the pumps were not operational, Monmouthshire County Council brought in hired pumps in case of further heavy rainfall and flooding. The repair costs to the pumping station and surrounding infrastructure are estimated to be in the region of £180,000.

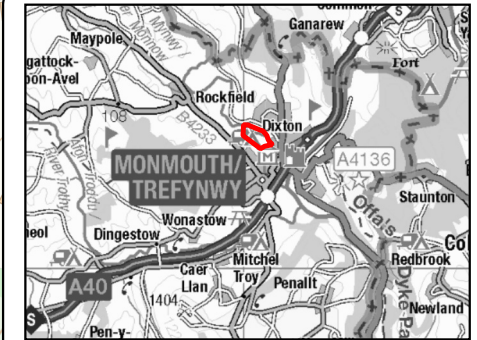
Note- The indicative flood extent is shown for the study area only, and it is acknowledged that flooding occurred across the catchment. The flood extent shown is an estimate only, based on the data provided to inform the S19 report analysis to July 2026.

### Forge Road, Osbaston- Flood Mechanisms and Extent

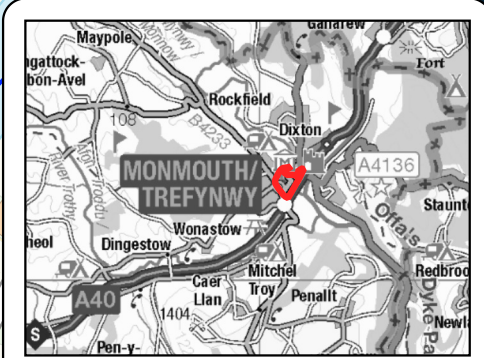
Note- The indicative flood extent is shown for the study area only, and it is acknowledged that flooding occurred across the catchment. The flood extent shown is an estimate only, based on the data provided to inform the S19 report analysis to July 2026.

### East of the River Monnow - Flood Mechanisms and Extent

- East of the River Monnow- Study area
- Monmouth Town Study Area
- River Monnow
- Flood Defences
- Indication of flood extent within study area boundary
- Primary Flow Route
- Secondary Flow Route
