### **Section 19 Flood Investigation Report**

# Woodside, Usk

### February 2020

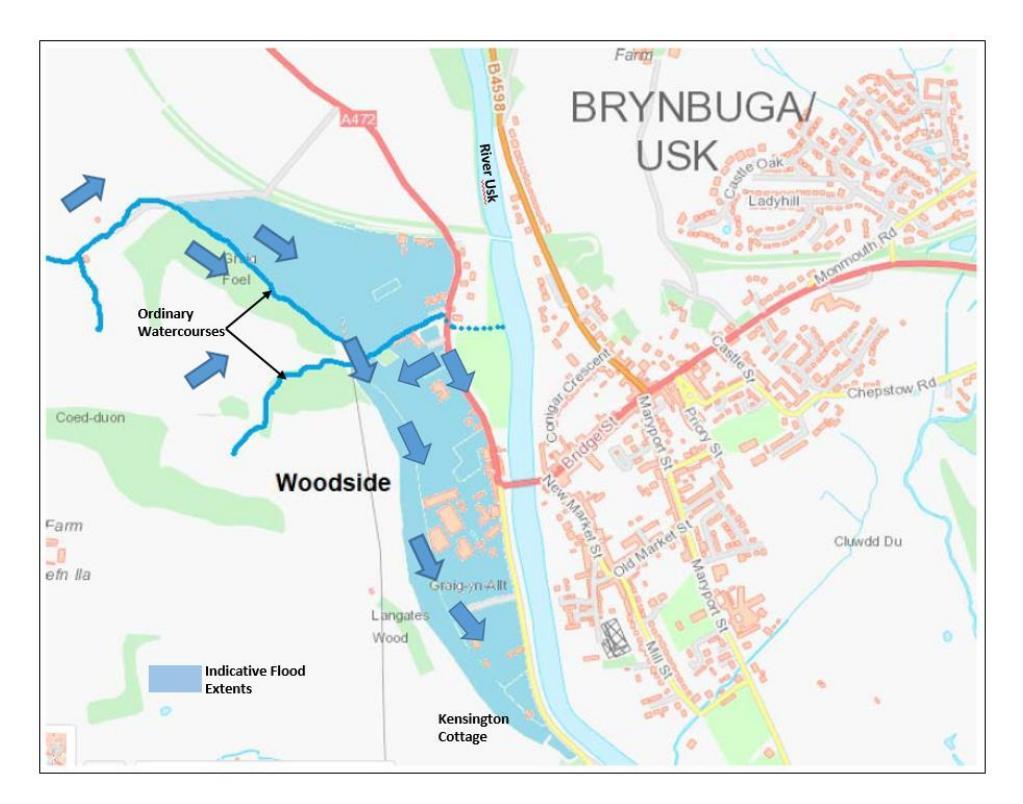
### Figure 1: Location Plan Showing the Flood Area (Indicative) and the Ordinary Watercourse

The area of the investigation runs from the disused railway line in the north, to Kensington Cottage in the south. The topography is relatively flat with a shallow gradient to the south following the fall of the River Usk. To the west the ground rises quite steeply to Graig Foel and Coed-duon hill. The River Usk flows from north to south through Usk town and separates Woodside from the main town.

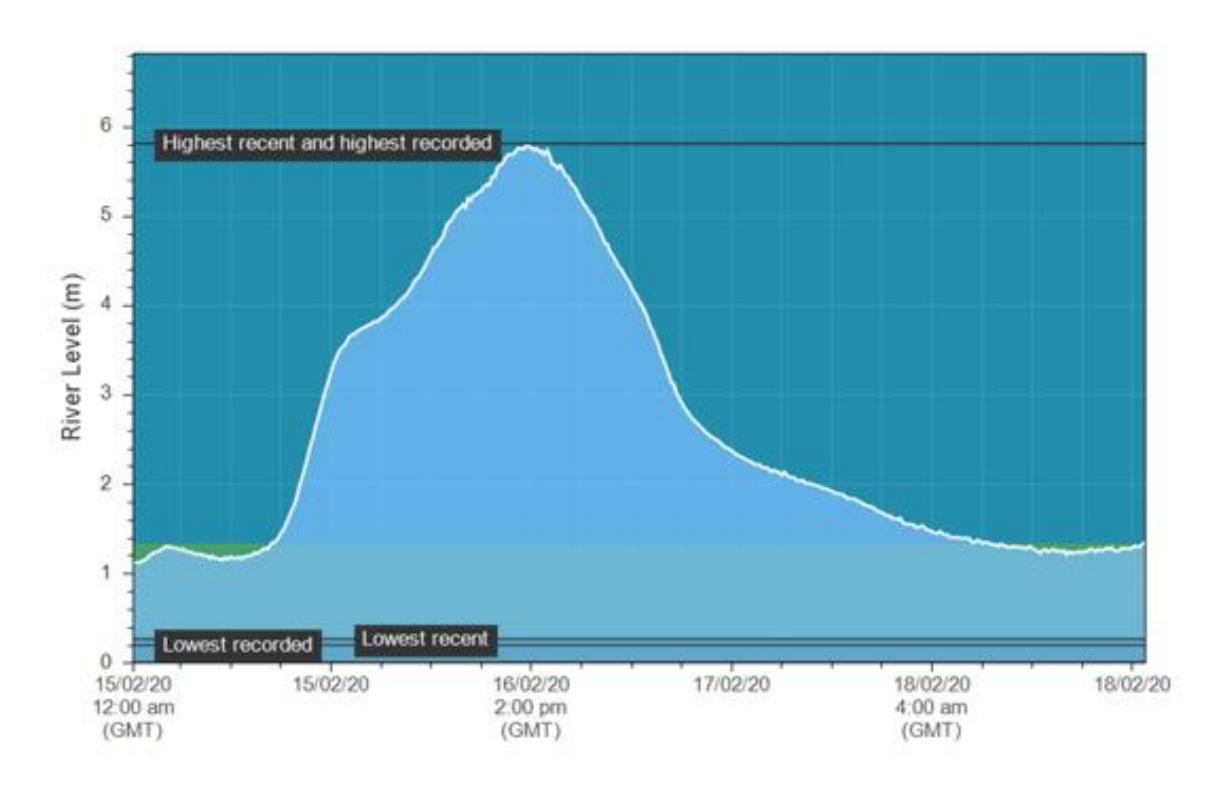
Figure 3: The Flood Levels in the River Usk 15th to 18th February 2020

Following this persistent period of heavy rain, levels in the River Usk rose rapidly during Saturday and increased significantly overnight and during Sunday morning. The River Usk reached its peak around 2.00pm on the Sunday and then steadily fell back to a more normal level on Monday the 17<sup>th</sup>. Partial flood locking on the unnamed stream commenced around 8.30pm on Friday the 15<sup>th</sup> with full flood locking some four hours later. This continued through to around 2.30am on the 17<sup>th</sup> and then became fully open for discharge by 5am on Monday the 17<sup>th</sup>. This created a flood lock period of some 27 to 35 hours.
