Monmouthshire County Council

Section 19 Flood Investigation Report

Llanwenarth

February 2020

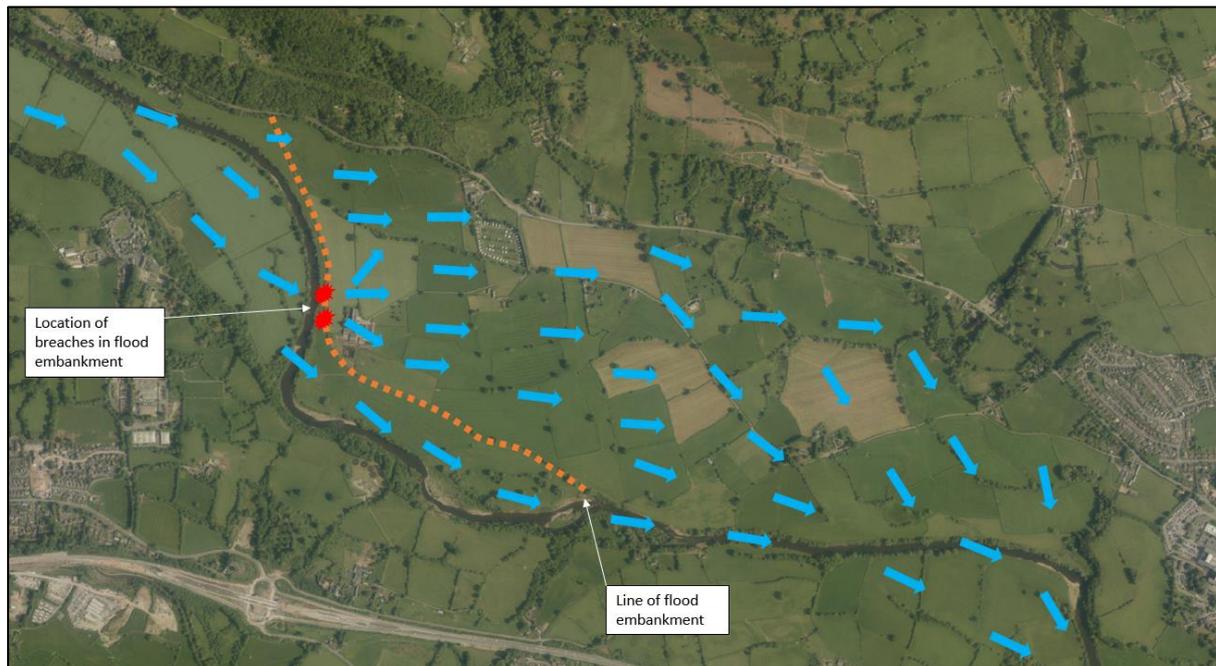
Residents of Mardy Farm in the west of Llanwenarth report that around 03:00 on 16th February houses in the west of Llanwenarth were swiftly inundated by flood water which reached a depth of 2 feet in the farmhouse. This time is likely to coincide with overtopping and subsequent breaching of the flood embankment (which is situated 75 m to the west). The embankment was breached in two main locations, both close to Mardy Farm.

Figure 7: Indicative overland flow path based on evidence obtained by the LLFA. This diagram is highly conjectural as no modelling taking into account the flood embankment has been undertaken.
