Monmouthshire County Council

Section 19 Flood Investigation Report

Llanbadoc, Usk

February 2020

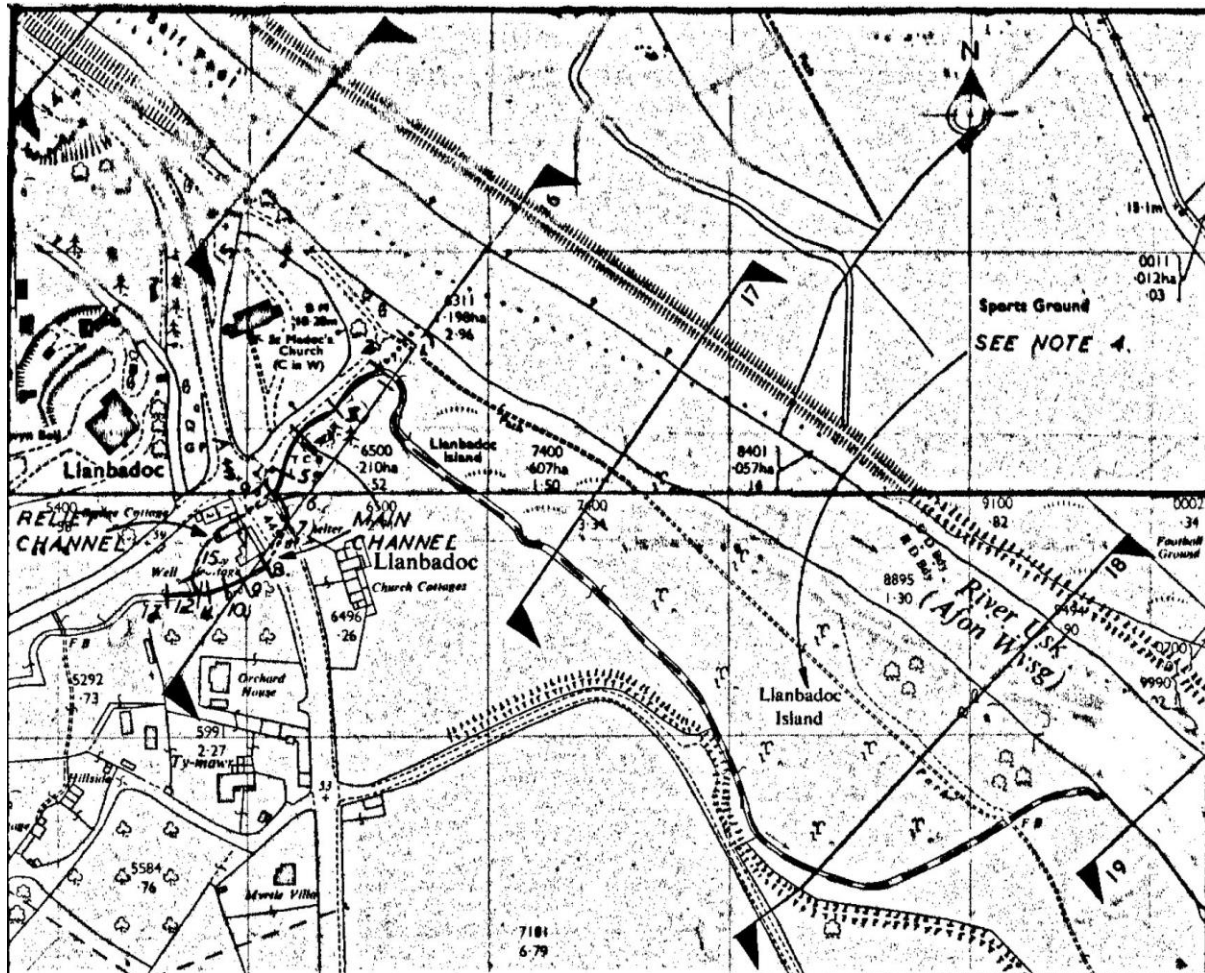
Figure 21 - Extract from Scheme Drawing showing historic alignment of Brook & Main Channel – Works undertaken during Usk Town Scheme – Drawing Source: Llanbadoc Brook Improvements - Welsh Water Authority, Usk Division 1981

Historically this watercourse had a different alignment downstream of the R106 and once flowed parallel to the River Usk, discharging further downstream to its current location which is at 90 degrees to the main river. It is unclear as to the intended purpose or benefit of this realignment which was undertaken by NRW's predecessor in 1982.

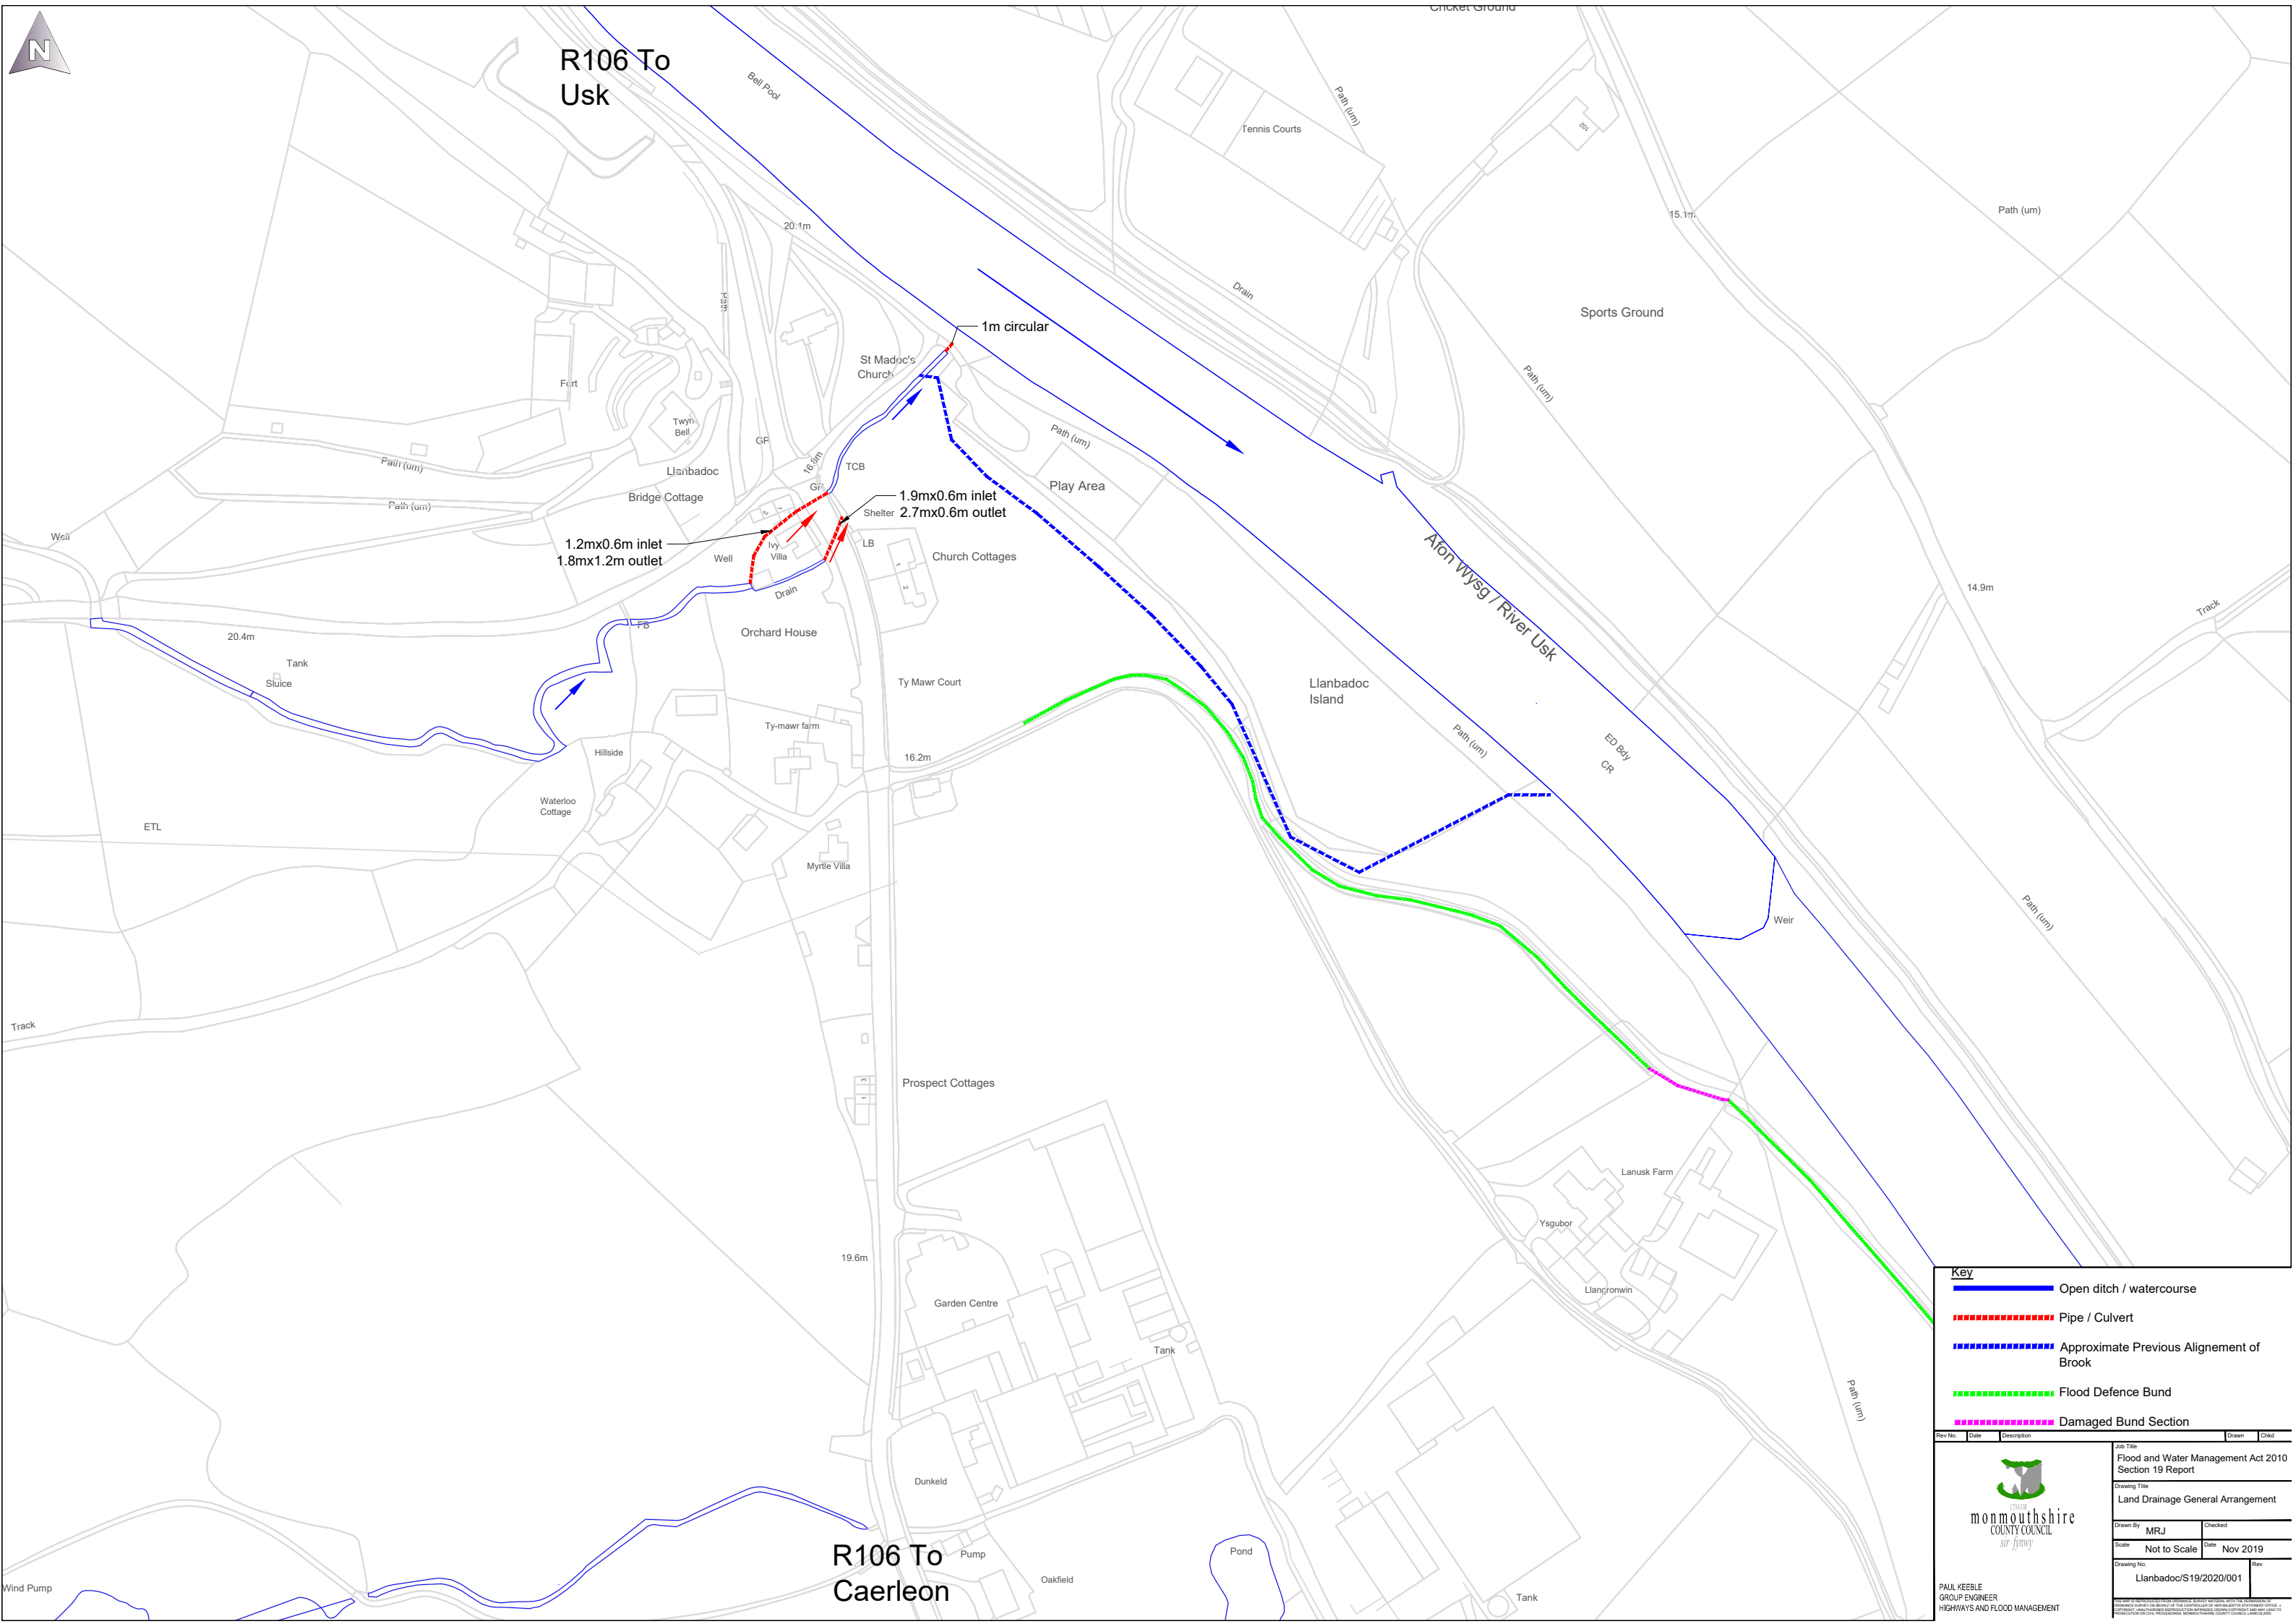
Appendix B – Land Drainage General Arrangement

Residents at Lanusk Farm described water as starting to spill over the primary flood defence (See plan in Appendix B) adjacent to the river and pooling between that and a lower bund within the garden. This overtopping caused significant damage to the back of the raised defences. Once the water level in the main channel rose significantly above the defences, the 9 properties, businesses and agricultural barns were inundated quickly to a maximum depth of about three feet throughout. When trying to evacuate the resident also explained about water flowing through a hedgerow between the access driveway (see plan in Appendix B) and the higher field to the rear of Llanbadoc Island Car Park confirming that flow was coming over the top of the River Usk banks at Llanbadoc Island Car Park.

In addition, water was noted to be flowing over the defences (previously perceived to be private defences) adjacent to Lanusk Farm causing damage to them. Any further erosion or damage to these defences could have created a serious risk to life.

LB6	NRW to consider future maintenance requirements of existing defences and/or provide specialist advice to riparian owners covering repair and maintenance of the existing flood defence assets	NRW
