Flood and Water Management Act 2010

Section 19 Flood Investigation Report

Caldicot

February 2020

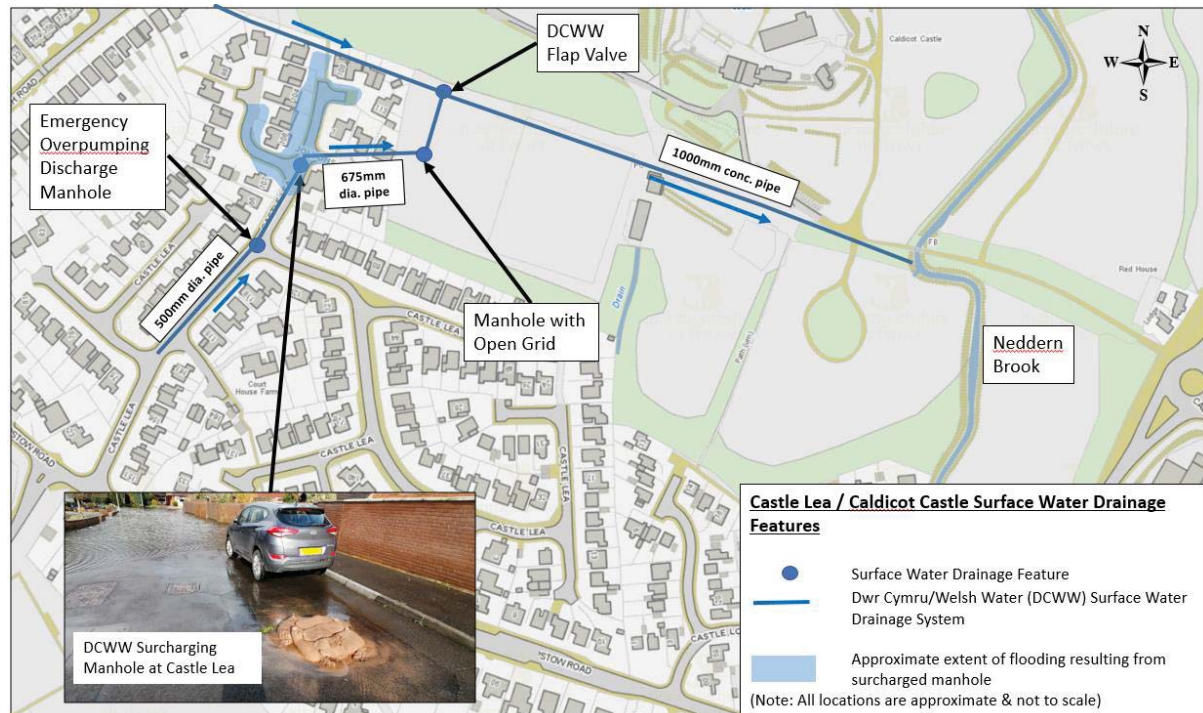
c) residents affected by the flooding had called the Fire Brigade and they had set up to pump the water away by discharging the water into the drainage system, but in error had connected to the foul drainage system. This had caused an overload at the sewage pumping station, leading to backing up and surcharging the system causing foul sewage to mix with the flood water and aggravating the situation.

Figure 8: Surface Water Plan Showing Location of Manhole for Pumping

Welsh Water subsequently identified a particular manhole that the fire brigade could safely use in any future events and also agreed to carry out annual cleansing of the local system to minimise further backups.

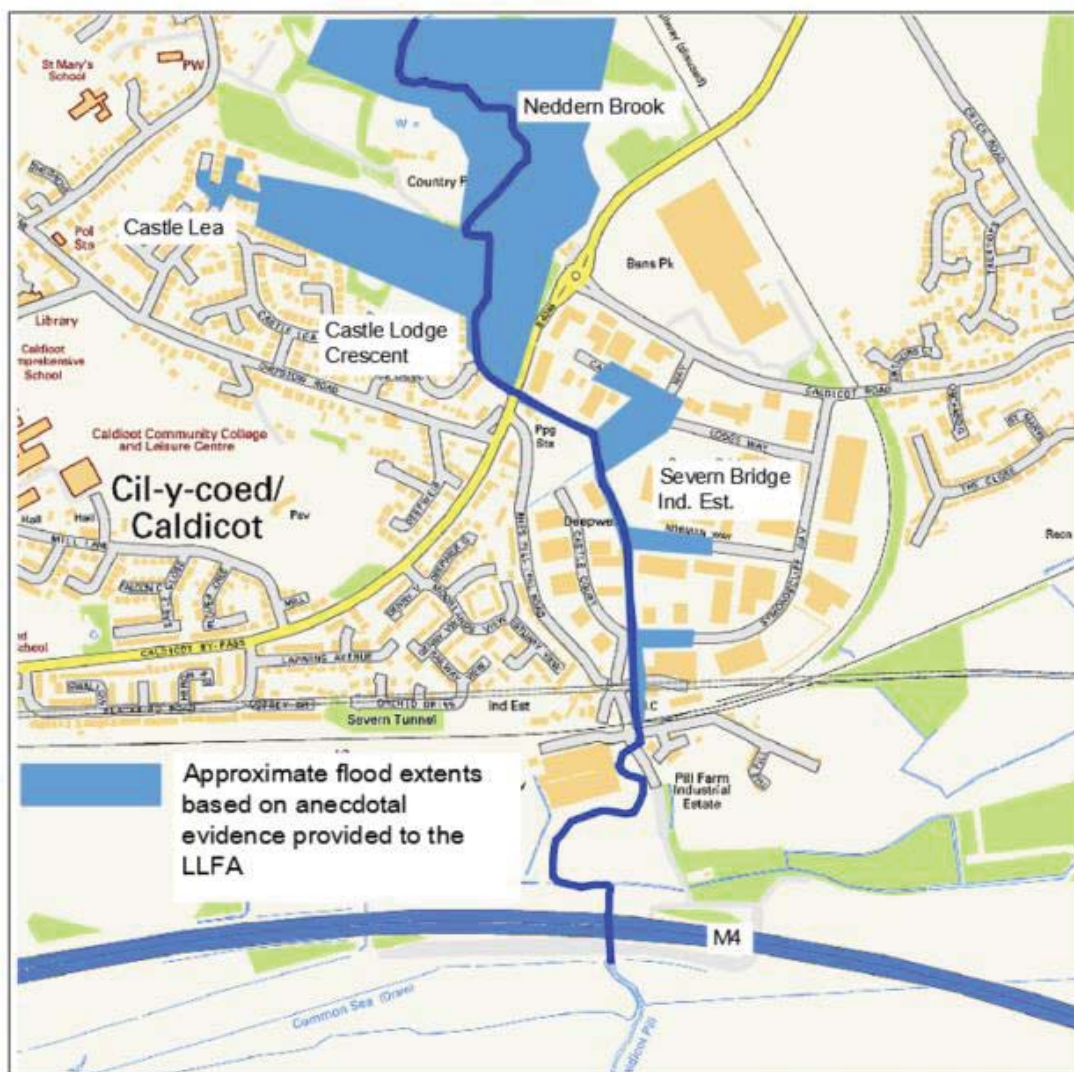
Figure 9: Approximate flood extents based information provided to the LLFA

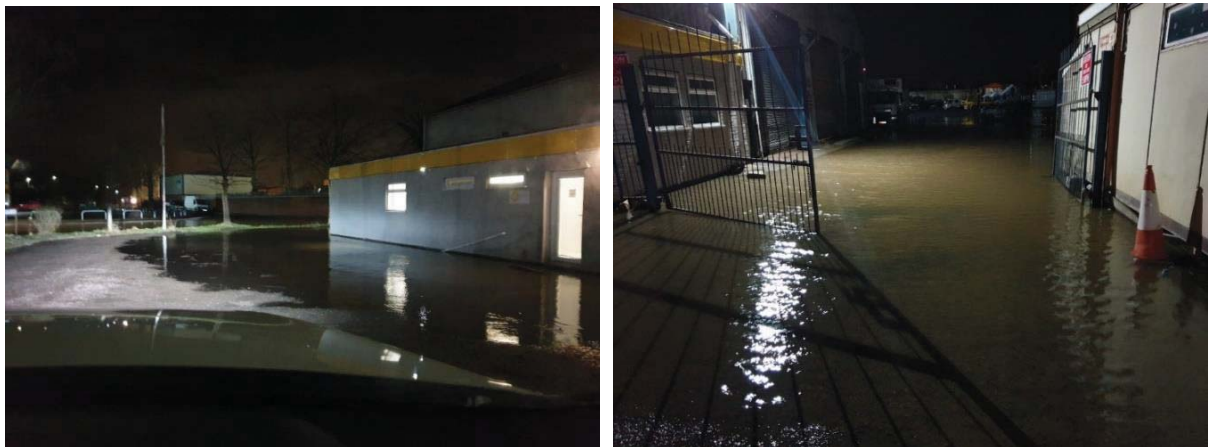
Photo 5: (Left) Shows Some of the Flooding in the Commercial Area on the Evening of 29th February 2020
Photo 6: (Right) Shows the Flooding in the Commercial Area on the Evening of 29th February 2020 Courtesy of Caldicot Recovery

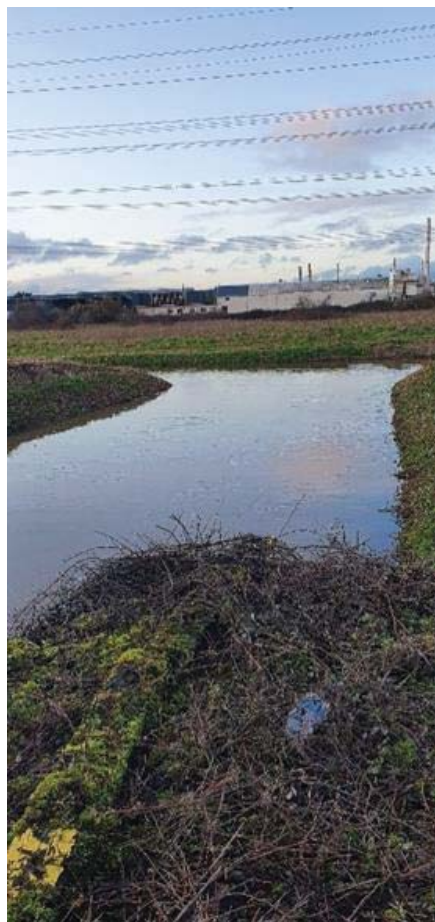
Photo 12: Showing the flooded Neddern Brook looking North from near the Culvert under the M4.

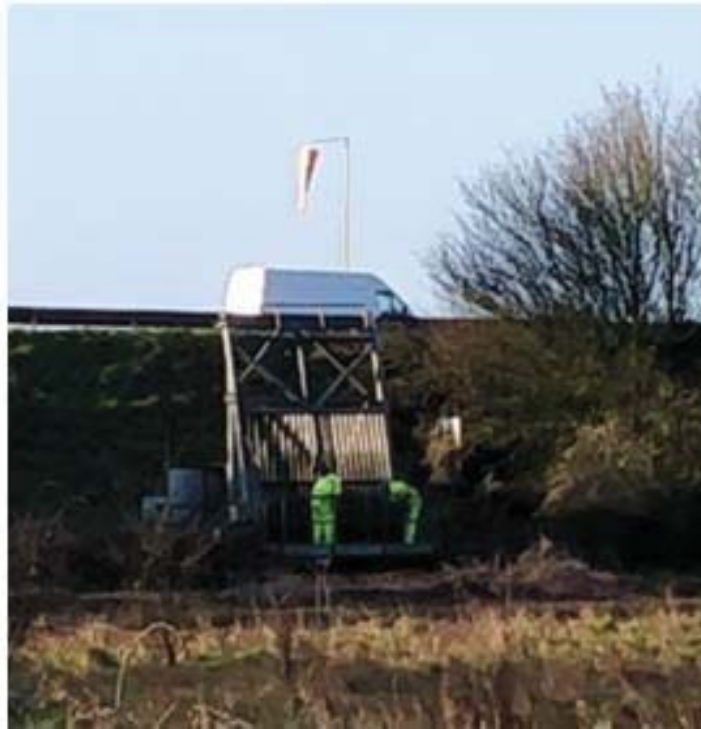
Natural Resources Wales attended the site from around 10.15am on Sunday the 1st March and identified that the trash screen at the entrance to the culvert under the M4 Motorway was clogged with debris. They called Highways England at around 10.45am to attend to deal with the clogged trash screen. The trash screen, culvert and sea door are the responsibility of Highways England as they are associated with the Severn Second Crossing. Highways England (HE) report they received a call at around 11am and their Senior Operations Manager arrived at the site at midday, noting the screen was blocked by debris, mostly with reeds. He considered that the water in the reed was nothing out of the ordinary for this time of year but arranged for a team to attend and then left the site. No records of this team attending have been provided.

The Senior Operations Manager HE returned at 4pm and explained to several local representatives that were now on site that they were unable to lift the screen for clearing due to the water pressure on the flooded screen. They would need to wait for the next high tide to balance water pressures. Nonetheless the Senior Operations Manager called out a Chargehand / Rigger from HE to join him and they attempted to clear some of the debris manually to relieve the water pressure. An attempt to lift the screen at around 6.30pm failed as the power to the motor cut out. An Electrician from HE attended and restored power but could still not lift the screen and manual clearing continued to around 10pm. The HE staff on site then brought some manual pull lifts from their depot and around 1am on Monday 2nd March they were finally able to lift the screen and flood water dropped significantly. Having cleared the screen of debris it was put back in place. The screen again caught debris and the screen was lifted again, this time by motor about 1.30am on Monday 2nd March and cleared of debris.

Photo 18: Shows The Screen at the Entrance to the Culvert under the M4 Motorway, south of the Commercial Areas, taken Sunday 1st March 2020

It is with reasonable confidence to conclude that the blockage of the trash screen on the M4 culvert, along with possible restrictions to flow along the channel of the Neddern Brook were the primary causes of the flooding. This led to flooding parts of the Severn Bridge Industrial Estate, the Country Park and adjacent playing field areas. The surface water systems in the Castle Lea area, mostly within Welsh Water's responsibility discharge into the Neddern Brook, but as the water levels in the brook rose the discharges became unable to flow and became tide locked. This then created surcharging at various points in the surface water system, including a gridded manhole in the Playing field area of the Country Park. Most evident was a manhole within the Castle Lea estate near its junction with Jolyons Court which caused internal flooding to four adjacent residential properties. Further downstream the brook broke its banks causing internal flooding to a property in Castle Lodge Crescent and six commercial properties in the Severn Bridge Industrial Estate. Parts of the highways at Castle Lea, Castle Lodge Crescent, Norman Way, Castle Way, Lodge Way and Symondscliffe way were also flooded.

Whilst the groundwater element and surface water discharges to the Neddern Brook added to the flooding, the relative rapidity of the flood level reductions once the trash screen was lifted and cleared reinforce the conclusion that the clogged trash screen had a significant impact on the upstream levels. It is noted that there are no reported HE visits made between the 3rd February and the 1st March during which time there had been three major storms, with little doubt that each generated substantial debris which would have been caught by the trash screen.

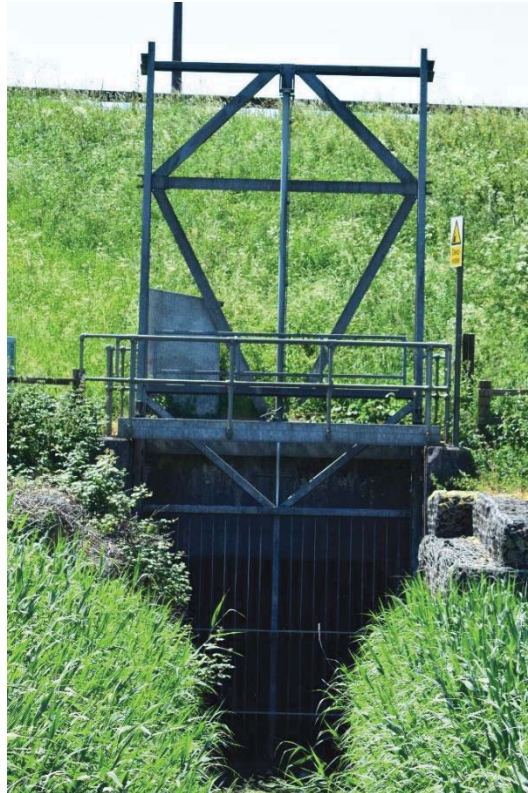
Photo 21: Shows the Screen on the Neddern Brook Culvert under the M4 Motorway taken June 2020

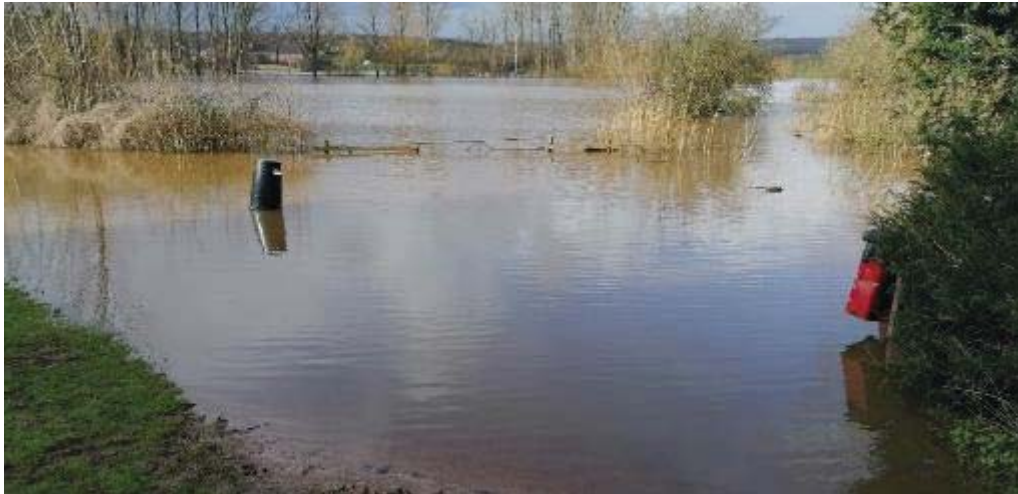
Photo 23: Showing the Flood Levels in the Country Park, taken on 1st March 2020

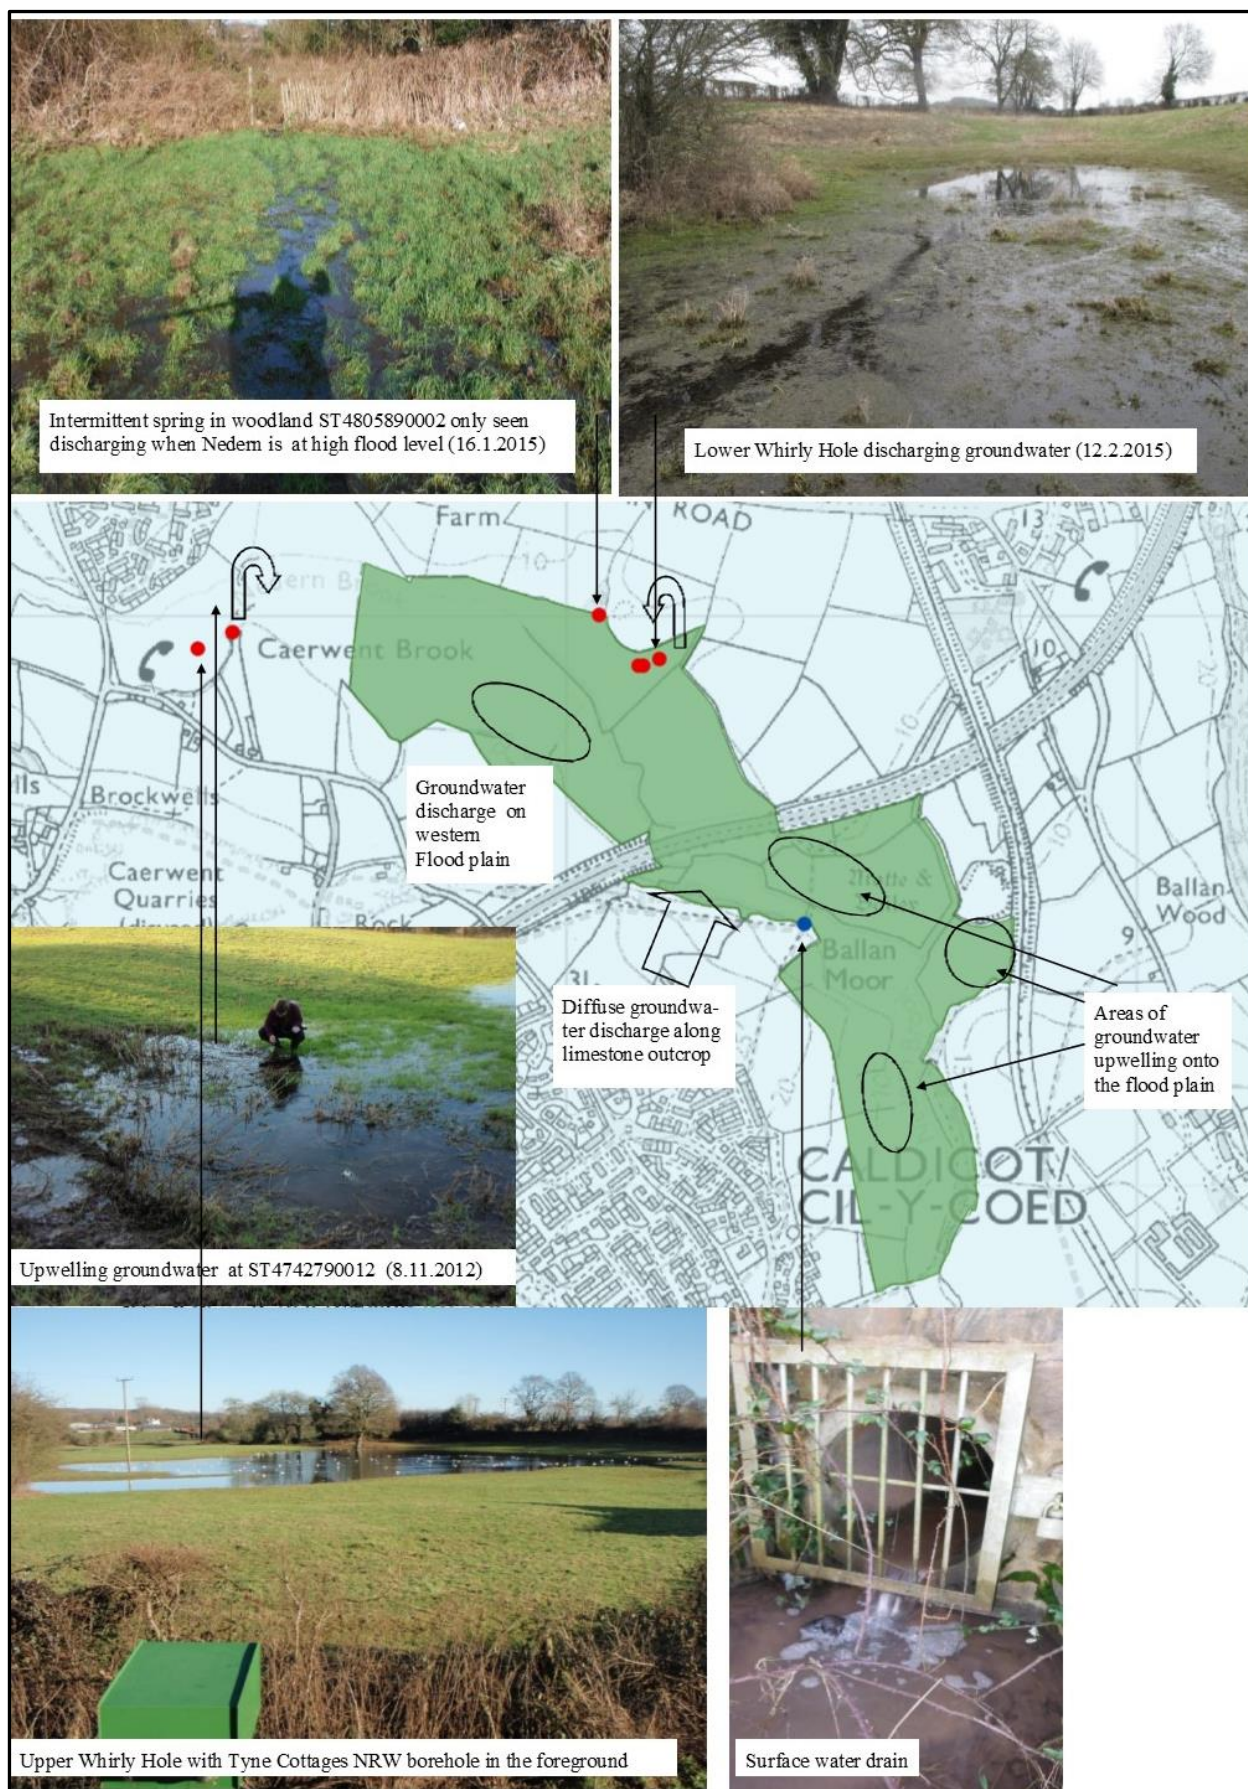
Figure 5 Key groundwater and surface water discharges in the Nedern SSSI (P502171, P915237, P915234, P915243). © BGS NERC.

During the walk over surveys it was possible to observe areas where groundwater was discharging into the wetland, the key areas are illustrated on Figure 5. The Lower Whirly Hole was actively discharging groundwater for most of the monitoring period and during recession other small seepages and springs appeared nearby. The electrical conductivity of the spring water was 580 - 670 $\mu\text{S}/\text{cm}$, indicative of groundwater. A large spring head/seepage area can be found in a woodland area just to the north of the Lower Whirly Hole however it was only actively discharging water during very high flood levels, remaining dry for the majority of the monitoring period.

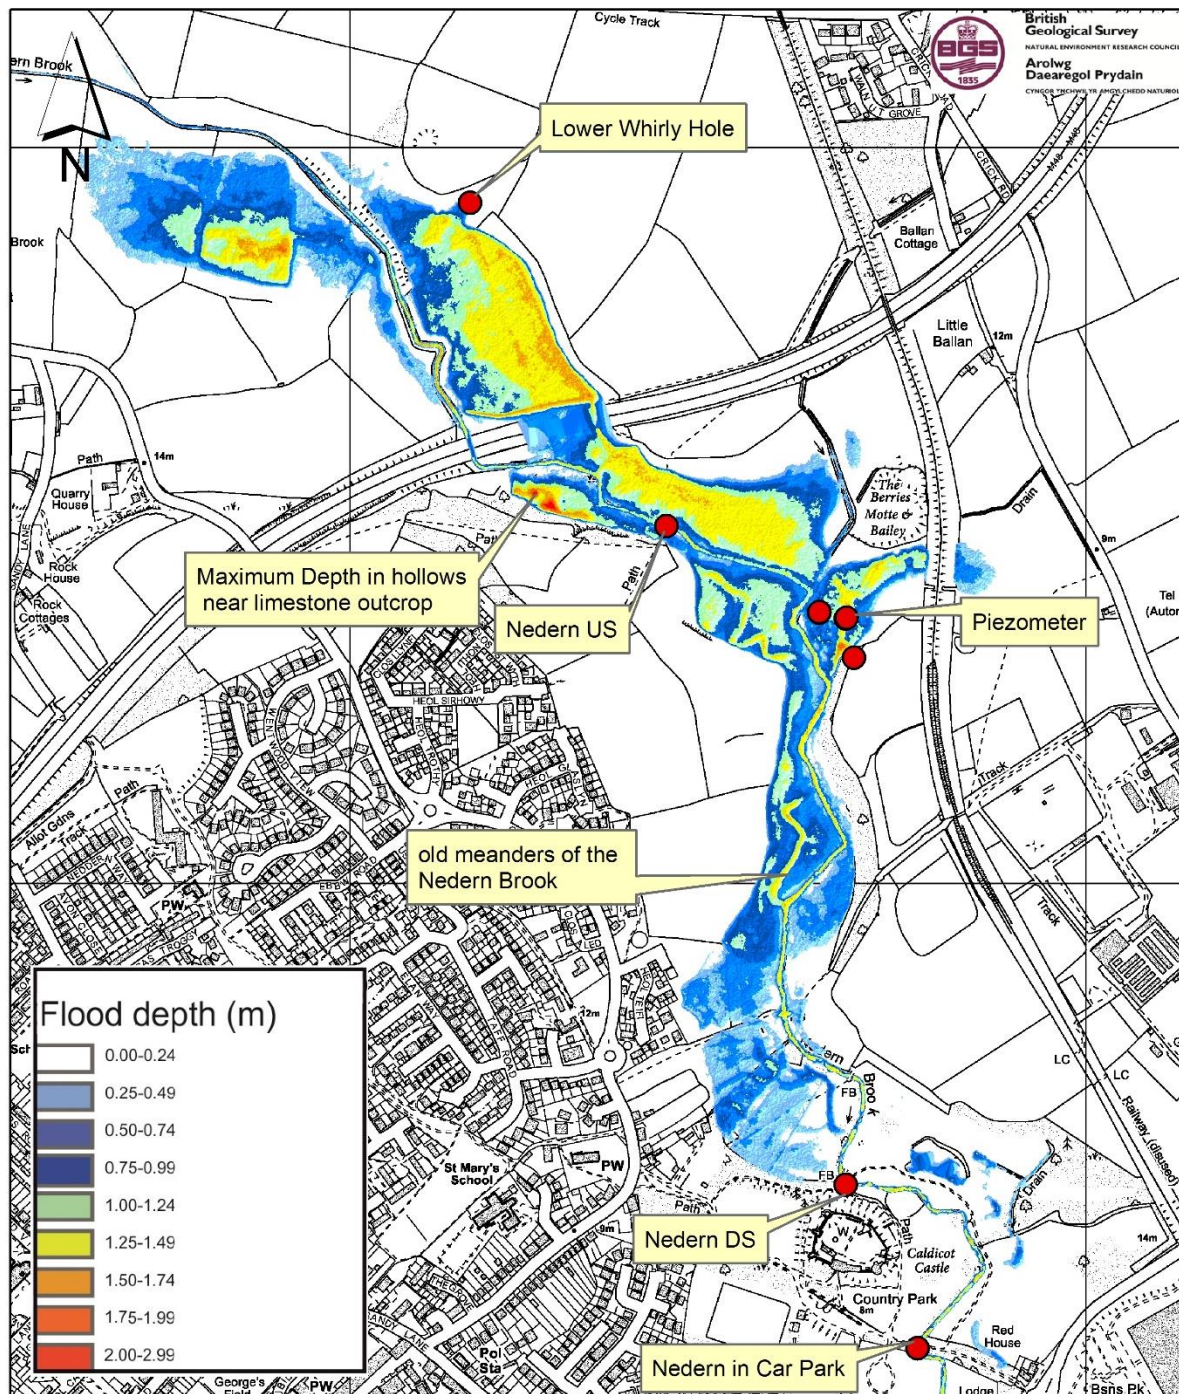
Figure 9 Maximum Flood levels based on 5.92maOD elevation of maximum flood depth between 30/09/2014 and 1/05/2015

The following flood depth maps were produced to illustrate the maximum and mean flood depths during the monitoring period (Figure 9; Figure 10). The existing and historic meanders of the Nedern Brook are clearly visible, the deeper areas tend to be those that flood first and retain water longest.

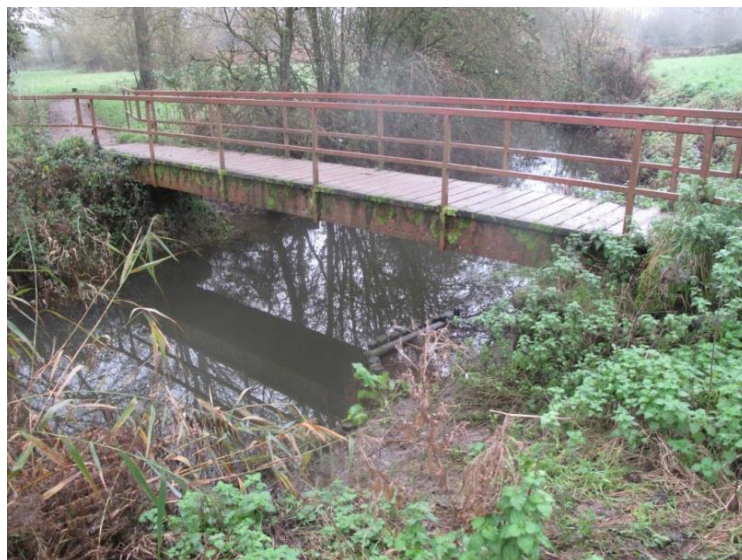
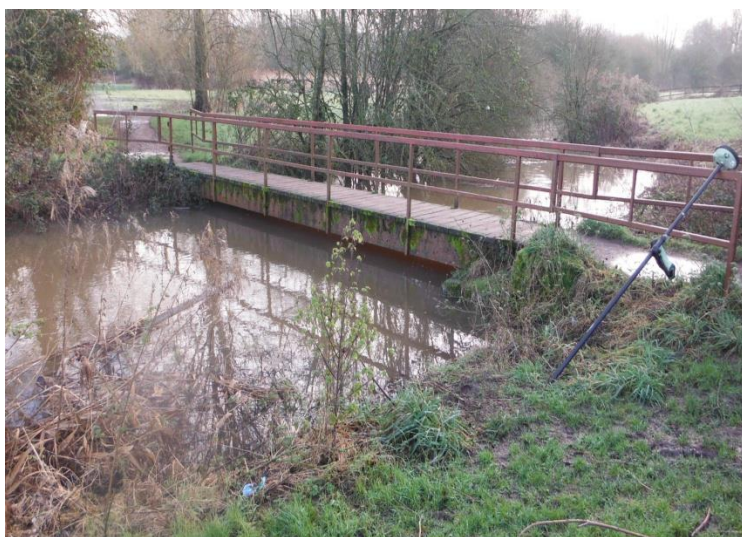
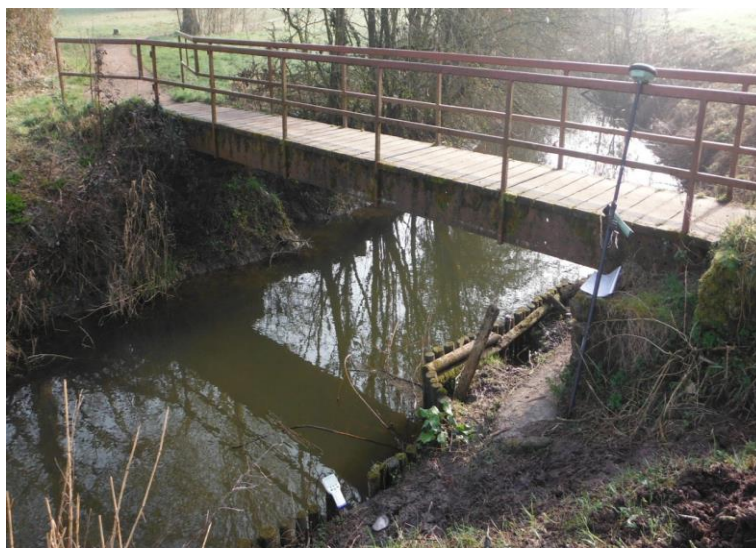
Figure 14 Nedern Brook DS Monitoring Point under variable flow conditions © BGS NERC.

27.11.2014 (top), 16.1.2015(middle) & 18.3.2015 (bottom)

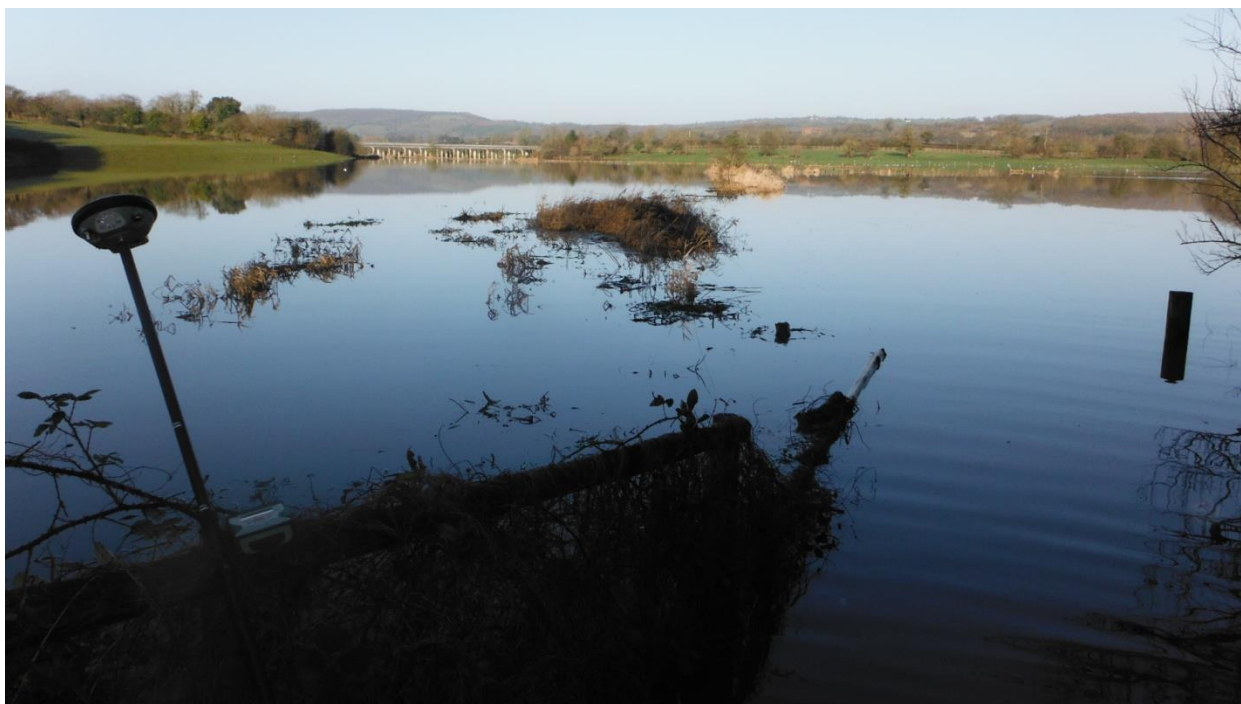
Figure 16 Dipwells and Piezometers (P3) in dry and flood conditions © BGS NERC.

30.09.2014 (top: dry install and survey view north towards M48) and 16.01.2015 (bottom: wet similar view)

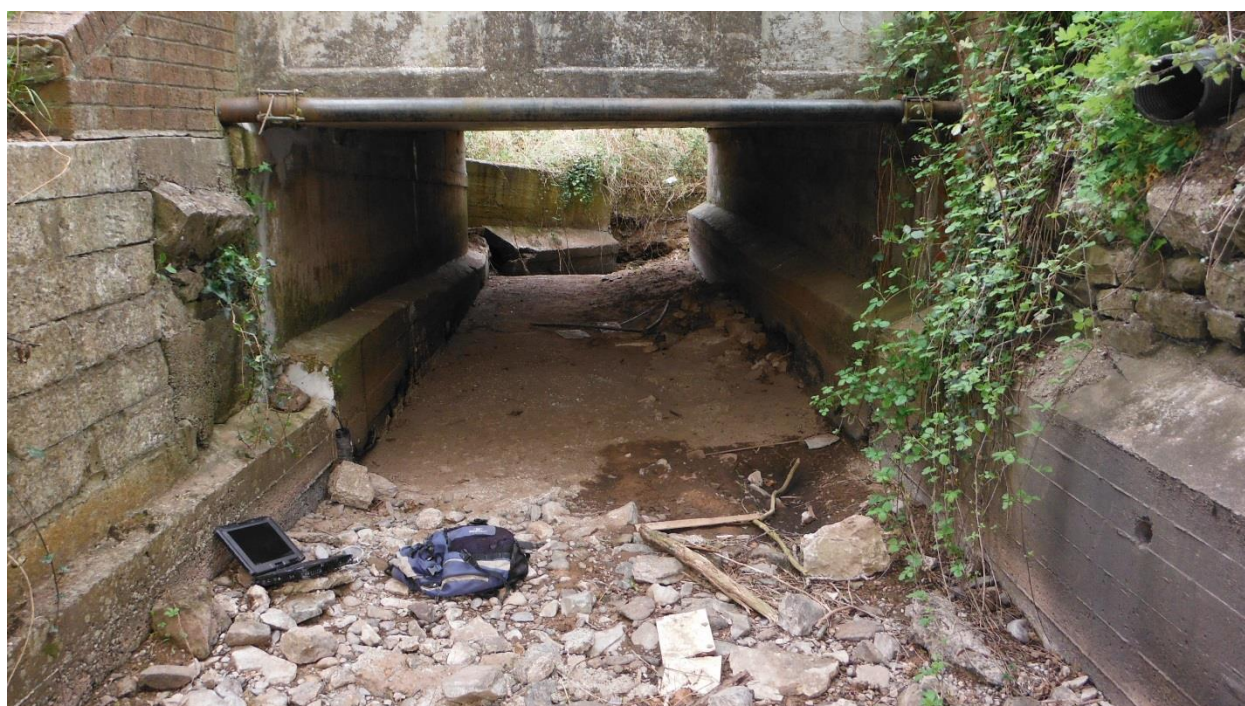
Figure 18 Nedern Brook at Tyne Cottages in variable flow conditions © BGS NERC.

27.11.2014 (top) and 1.05.2015 (below)
