Cyngor Sir Fynwy

### Adroddiad Ymchwilio Llifogydd Adran 19

# Cil-y-coed

Chwefror 2020

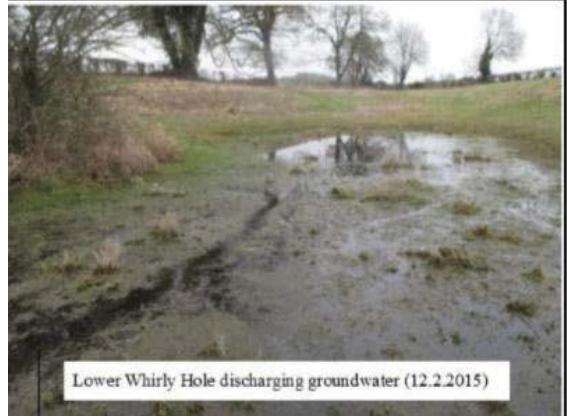
Dynodwyd dau lyncdwll, y ddu ar hyd ymyl gogleddol yr SSSI. yr OSGR ar eu cyfer yw 348163/189925 a 347354/189943. Dangosir ffotograff o un islaw, diolch i Arolwg Ddaearegol Brydeinig. Mae adroddiad eu hastudiaeth o aef 2014/15 ar gael yn Atodiad D. Mae dau ran o'r adroddiad o ddiddordeb yma:

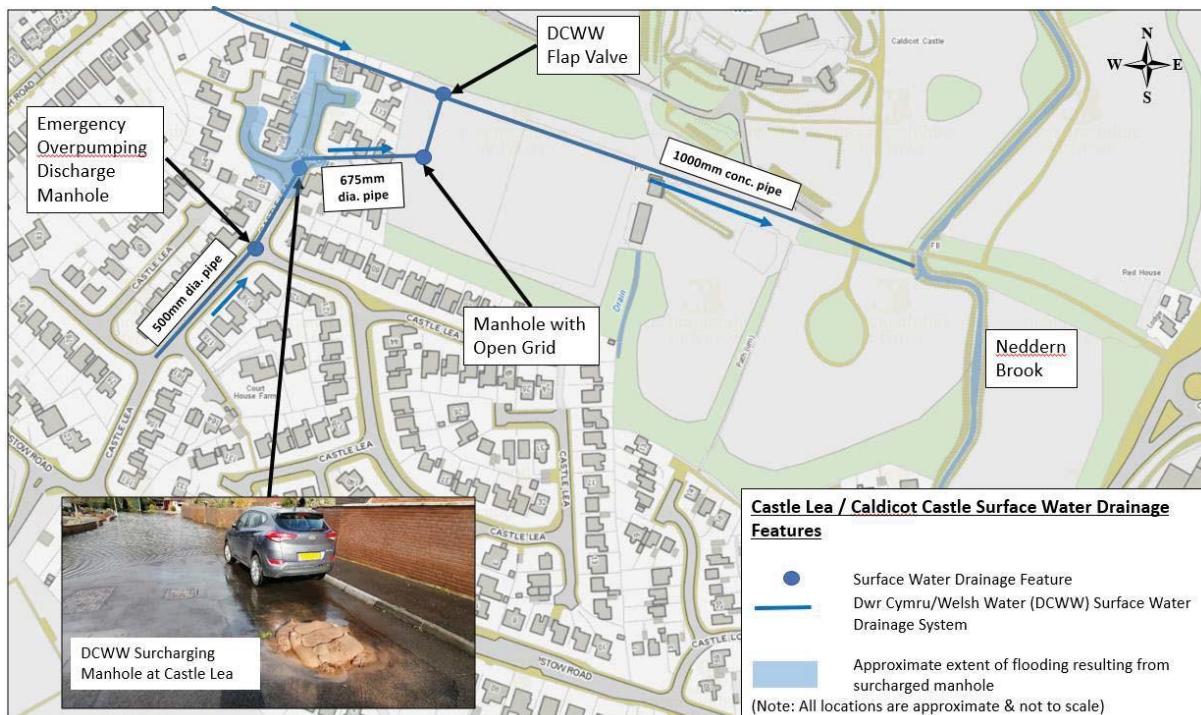
c) roedd preswylwyr yr effeithiodd y llifogydd arnynt wedi galw'r Frigâd Dân oedd wedi mynd ati i bwmpio'r dŵr i ffwrdd drwy arllwys y dŵr i'r system ddraeniad ond mewn camgymeriad wedi cysylltu gyda'r system draeniad aflan. Roedd hyn wedi achosi gorlwytho yn yr orsaф bwmpio carthffosiaeth, gan arwain at gronni a gorlenwi'r system gan achosi i garthffosiaeth aflan gymysgu gyda'r dŵr llifogydd a gwaethygu'r sefyllfa.

Ffigur 6: Cynllun dŵr wyneb yn dangos lleoliad twll gwaith ar gyfer pwmpio

Ar ôl hynny dynododd Dŵr Cymru dwll gwaith neilltuol y byddai'n ddiogel i'r frigâd dân ei ddefnyddio mewn unrhyw ddigwyddiadau yn y dyfodol a chytuno hefyd i lanhau'r system leol yn flynyddol i leihau unrhyw gronni pellach.

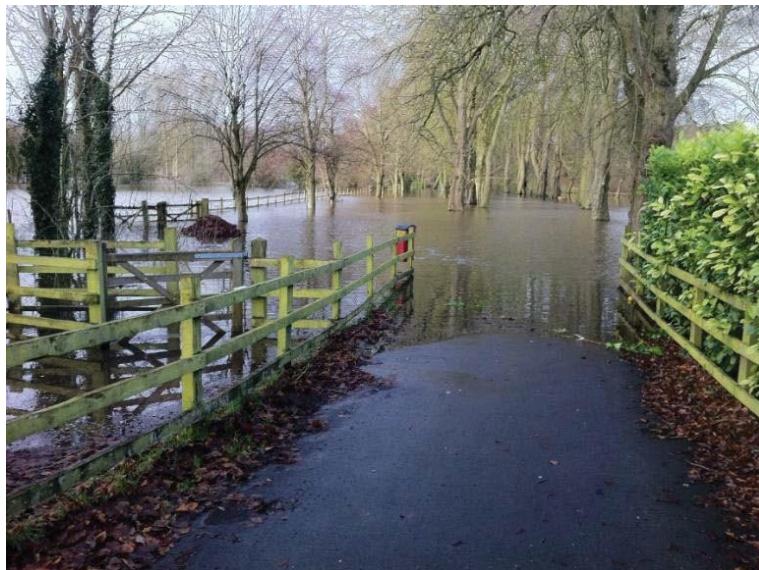
Roedd digwyddiad sylweddol arall ym mis Rhagfyr 2012 yn effeithio ar rannau o Castle Lea a'r rhan fwyaf o'r Parc Gwledig o amgylch y Castell – gweler Ffotograff 1 islaw. Deellir bod y llifogydd yn Castle Lea i'r gerddi ac adeiladau allanol ac nid yn fewnol. Yn lleol dywedwyd fod yr achos yn gysylltiedig â drws y môr – sef bod gollyngfa Nant Nedern i Fôr Hafren naill ai ddim yn agor yn iawn neu wedi tagu gan greu croniad sylweddol o lifogydd dŵr mewn ardaloedd uwchben, ond ni cafodd hyn erioed ei wirio.

Ffotograff 1: Yn dangos maint y llifogydd yn y Parc Gwledig Rhagfyr 2012

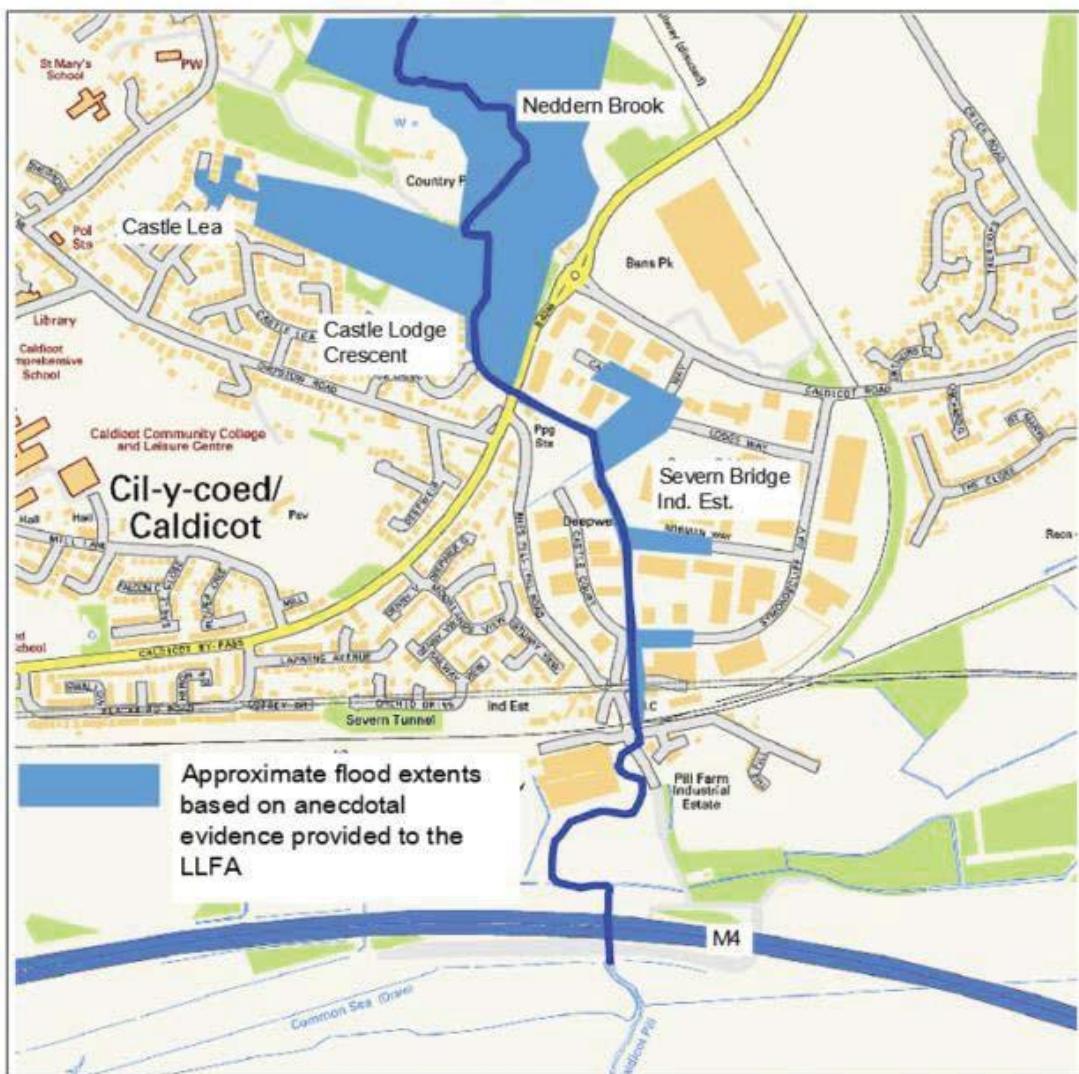
Ffigur 9: Amcan o faint y llifogydd, seiliedig ar wybodaeth a roddwyd i'r Awdurdod Llifogydd Lleol Arweiniol

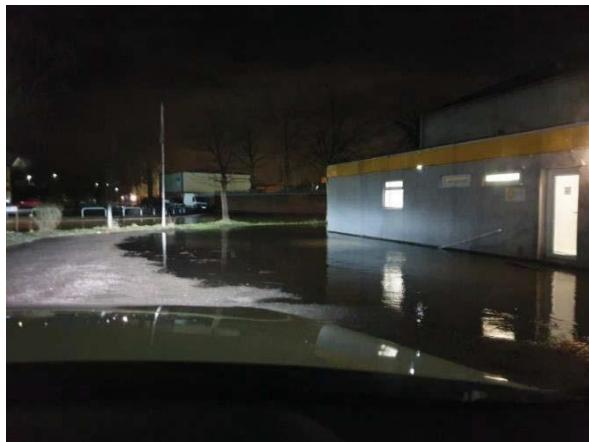
Fotograff 5 (ar y chwith) yn dangos peth o'r llifogydd yn yr ardal fasnachol ar noswaith 29 Chwefror 2020

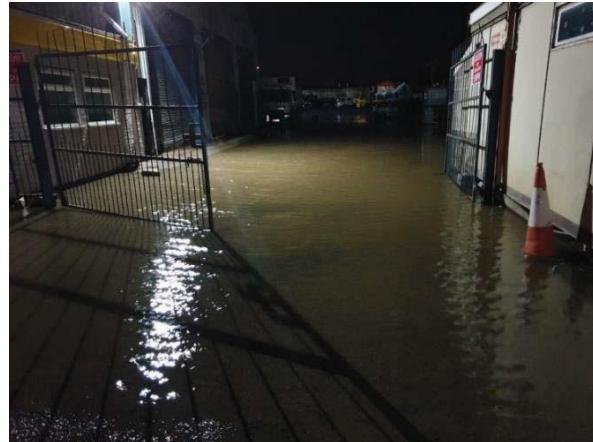
Fotograff 6 (ar y dde) yn dangos y llifogydd yn yr ardal fasnachol ar noswaith 29 Chwefror 2020 Diolch i Adferiad Cil-y-coed

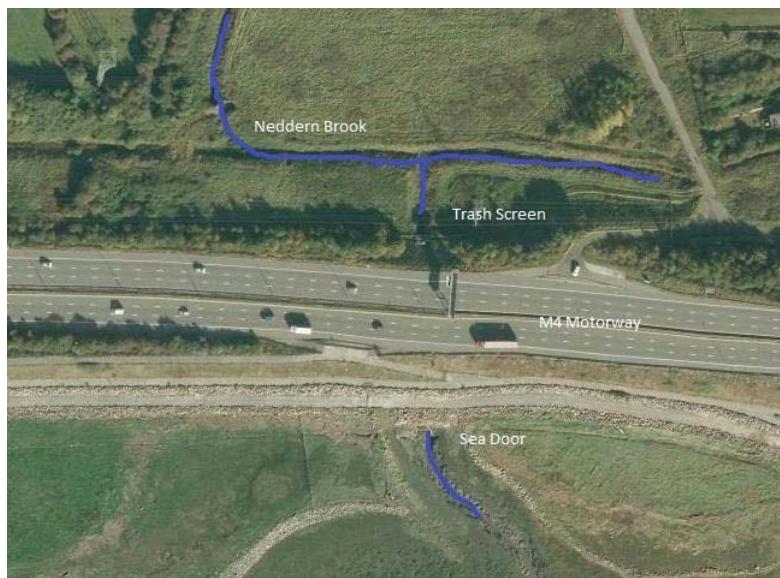
Roedd Cyfoeth Naturiol Cymru ar y safle o tua 10.15am ddydd Sul 1 Mawrth a dynodi bod y sgrin frigau wrth y fynediad i'r cwl fert dan Draffordd yr M4 yn llawn malurion. Fe wnaethant ffonio Highways England tua 10.45am i ofyn iddynt drin y sgrin frigau orlawn. Mae'r sgrin frigau, y cwl fert a'r drws môr yn gyfrifoldeb Highways England gan eu bod yn gysylltiedig gydag Ail Groesfan yr Hafren. Dywedodd Highways England iddynt dderbyn galwad tua 11am ac i'w Huwch Reolwr Gweithrediadau gyrraedd y safle am ganol-dydd, ac iddo nodi fod y sgrin wedi ei blocio gan ysgyrion, yn bennaf gan frwyn. Ystyriodd nad oedd y dŵr yn y ffos ddraenio yn ddim byd allan o'r cyffredin ar yr adeg honno o'r flwyddyn ond trefnodd i dîm fynychu ac yna gadawodd y safle. Ni chafwyd unrhyw gofnodion y bu'r tîm hwn ar y safle.

Ffurig 10: Ffotograff o'r awyr (2010) o'r cwl fert dan draffordd yr M4

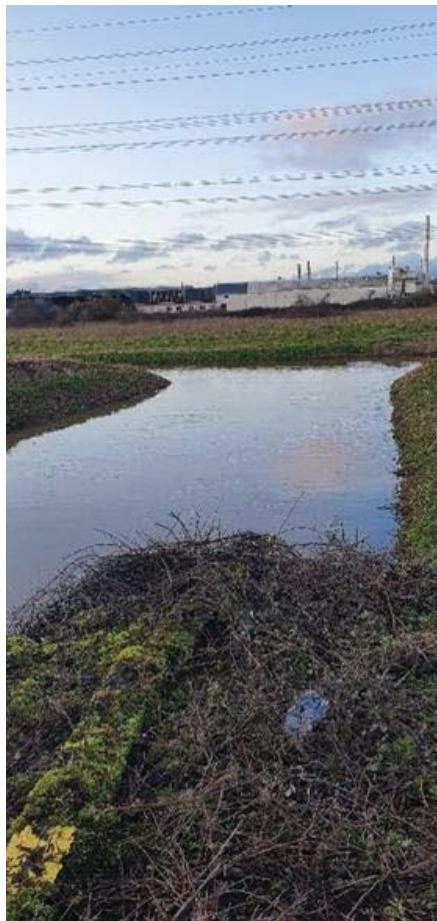
**Ffotograff 12:** Yn dangos y llifogydd yn Nant Nedern yn edrych i'r gogledd ger y cwl fert dan yr M4.

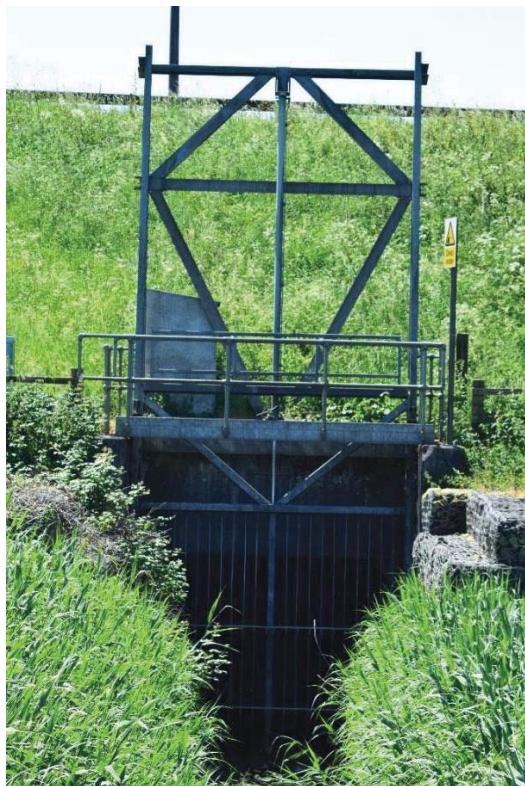
Dychwelodd Uwch Reolwr Gweithrediadau Highways England am 4pm ac esbonio wrth nifer o gynrychiolwyr safle oedd bellach ar y safle na fedrent godi'r sgrin ar gyfer clirio oherwydd y pwysau dŵr ar y sgrin. Byddai angen iddynt aros am y llanw uchel nesaf er mwyn cydbwys o pwysedd dŵr, Serch hynny, galwodd yr Uwch Reolwr Gweithrediadau am i Weithiwr mewn Gofal/Rigiwr o Highways England ymuno ag ef a gwnaethant ymgais i glirio rhai o'r malurion gyda llaw er mwyn llacio'r pwysedd dŵr. Methodd ymgais i godi'r sgrin tua 6.30pm wrth i'r pŵer i'r modur gael ei dorri. Bu Trydanwr o Highways England yn bresennol ac adfer y pŵer ond roeddent yn dal i fethu codi'r sgrin a pharhaodd clirio â llaw tan tua 10pm. Yna daeth staff Highways England oedd ar y safle gyda rhai liffiau tynnu â llaw o'u depot a tua 1am ddydd Llun 2 Mawrth gallasant yn y diwedd godi'r sgrin a bu gostyngiad sylweddol yn y dŵr. Ar ôl clirio'r malurion o'r sgrin cafodd ei rhoi yn ôl yn ei lle. Fe wnaeth y sgrin unwaith eto ddal malurion a chodwyd y sgrin eto, y tro hwn gyda modur tua 1.30am ddydd Mawrth 2 Mawrth a chliriwyd y malurion.

Ffotograff 21: Yn dangos y sgrin ar gwlfert Nant Nedern dan draffordd yr M4, tynnwyd Mehefin 2020

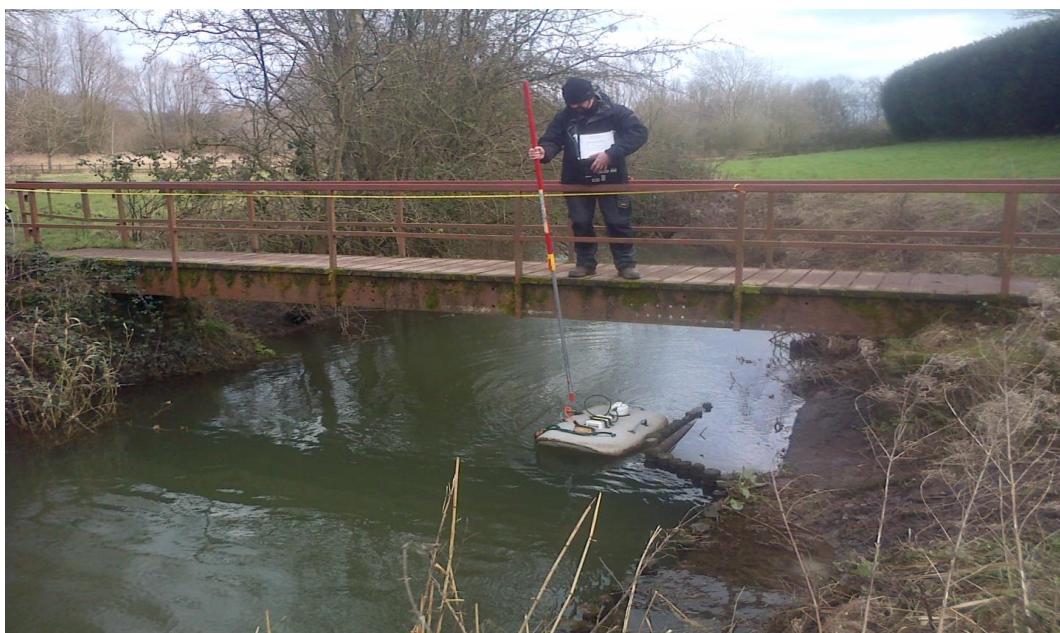
**Figure 1 Flow gauging at ‘Nedern DS’ using a Sontek M9 ADCP view south (Photograph with permission of Hydrometry & Telemetry Team South East Wales, Natural Resources Wales)**

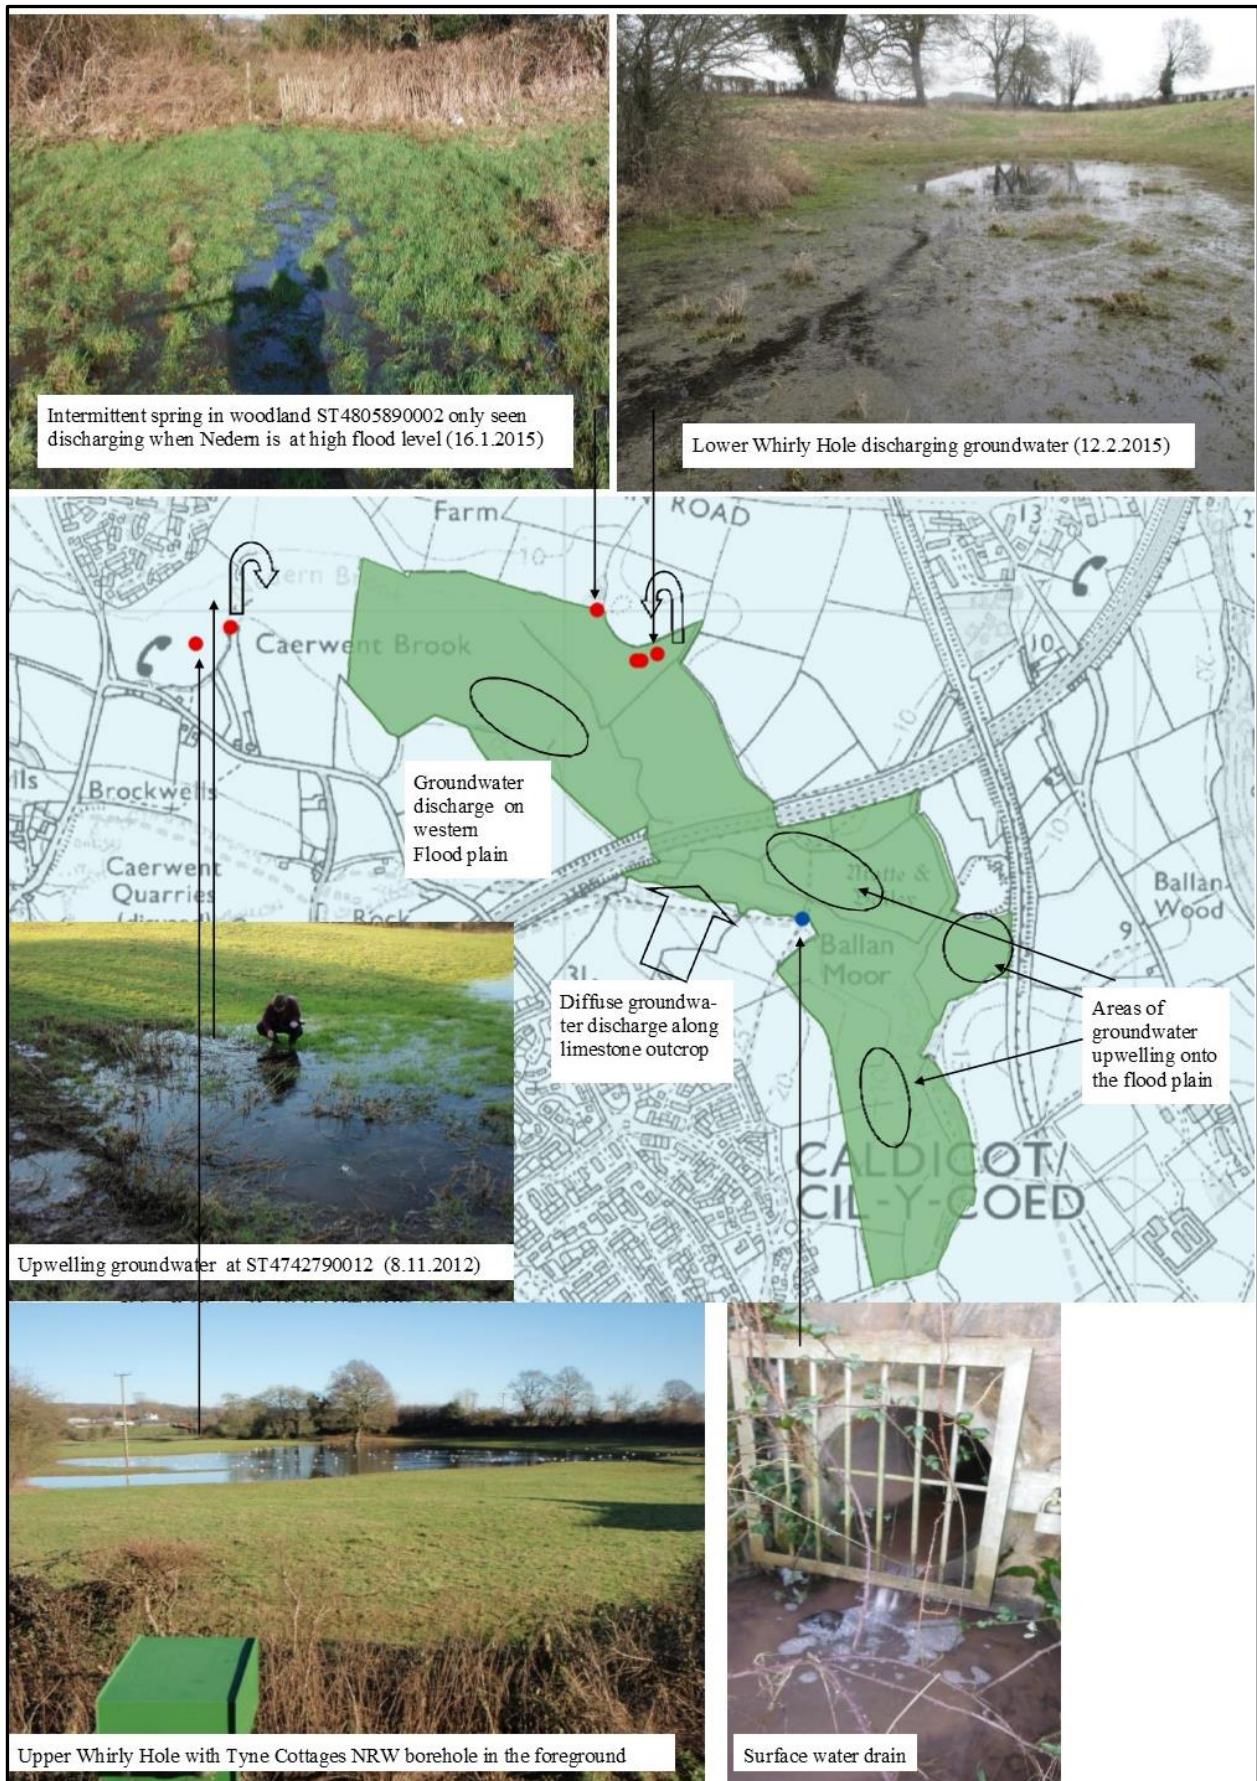
During the walk over surveys it was possible to observe areas where groundwater was discharging into the wetland, the key areas are illustrated on Figure 5. The Lower Whirly Hole was actively discharging groundwater for most of the monitoring period and during recession other small seepages and springs appeared nearby. The electrical conductivity of the spring water was 580 - 670  $\mu\text{s}/\text{cm}$ , indicative of groundwater. A large spring head/seepage area can be found in a woodland area just to the north of the Lower Whirly Hole however it was only actively discharging water during very high flood levels, remaining dry for the majority of the monitoring period.

**Figure 5 Key groundwater and surface water discharges in the Nedern SSSI (P502171, P915237, P915234, P915243). © BGS NERC.**

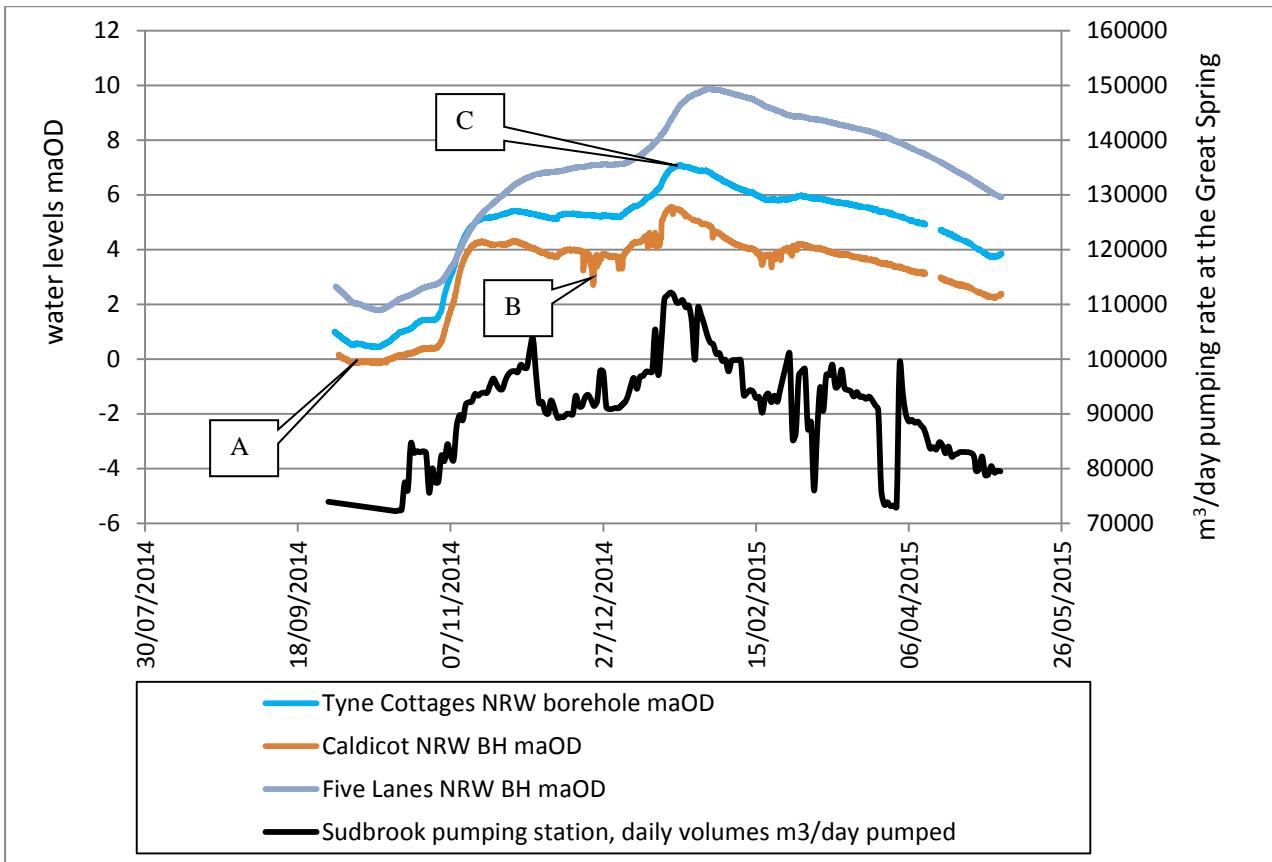
Groundwater in the underlying Carboniferous Limestone aquifer is monitored by NRW as part of routine monitoring within the Great Spring Source Protection Zone (SPZ). The general overall trend of groundwater levels (Figure 6) within the limestone aquifer is very similar. There is a significant groundwater abstraction at the ‘Great Spring’, located about 2 km to the south east. The Great Spring is a dewatering operation to keep the Severn Tunnel from flooding. It is monitored by Network Rail (Figure 6). Pumping at the Great Spring has to respond to increasing groundwater levels in order to maintain groundwater at a set level within the tunnel and thus also shows a similar trend to the groundwater hydrographs. Figure 6-A illustrates groundwater levels in the Caldicot Country Park borehole, during September when groundwater levels are <0 maOD. Groundwater levels would not normally be <0 maOD under natural conditions and it is prosed this is a dewatering effect of the Great Spring. Small changes in the same hydrograph (Figure 6-B) are also possible responses to pumping at the Great Spring. The Tyne Cottages borehole, Figure 6 C, is geographically closest to the wetland and has a range of nearly 6 m.

**Figure 6 Groundwater levels in the Carboniferous Limestone aquifer compared to pumping rates at the Great Spring**

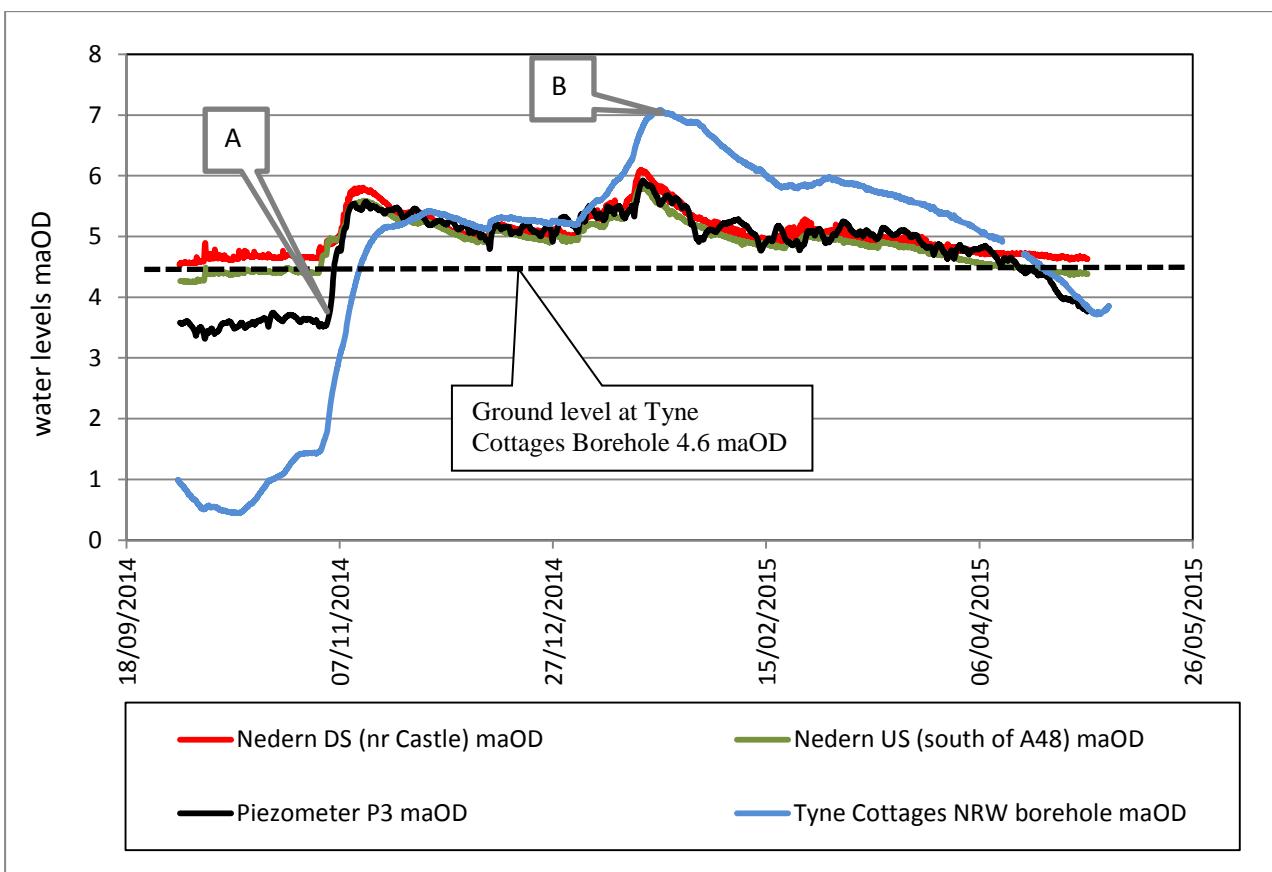
**Figure 7 Groundwater and surface water levels in the wetland.**

Groundwater levels recorded from a piezometer ‘P3’ located within the wetland are plotted against surface water levels collected from the stilling wells on the Nedern Brook and groundwater levels from the NRW Tyne Cottages borehole(Figure 7). Tyne Cottages is the closet bedrock borehole to the wetland that monitors the underlying Carboniferous Limestone aquifer (Figure 7). The ground level near the dipwells and piezometers, approximately 4.6 maOD, is marked by the black dashed line (Figure 7 and Figure 8). The rapid rise in groundwater levels within the limestone aquifer, in response to precipitation, is reflected by a rise in Piezometer P3 (Figure 7 A) and also the stage readings within the Nedern Brook US and DS monitoring points. During the flooding period the piezometric head in the limestone aquifer (Tyne Cottages borehole) is lower than that of the flood water in the wetland suggesting that there is a limited vertical movement of groundwater from the limestone during the initial flooding period. This could highlight that springs and seepage from shallower sources such as the River Terrace Gravels (which are not instrumented) are in part responsible for initial flooding within the wetland. However in late November the piezometric head in the limestone aquifer reaches 7 maOD (Figure 7 B), higher than the ground level within the wetland and greater than the flood waters within the wetland, suggesting that vertical flow of water upwards into the wetland might be possible if a low permeability pathway (such as a sand or gravel horizon) exists. The flood depth reaches about 1.5 m in the vicinity of the dipwell and piezometer nests and covers an area of over 30 ha (see Appendix 5 field maps for the 1<sup>st</sup> January 2015).

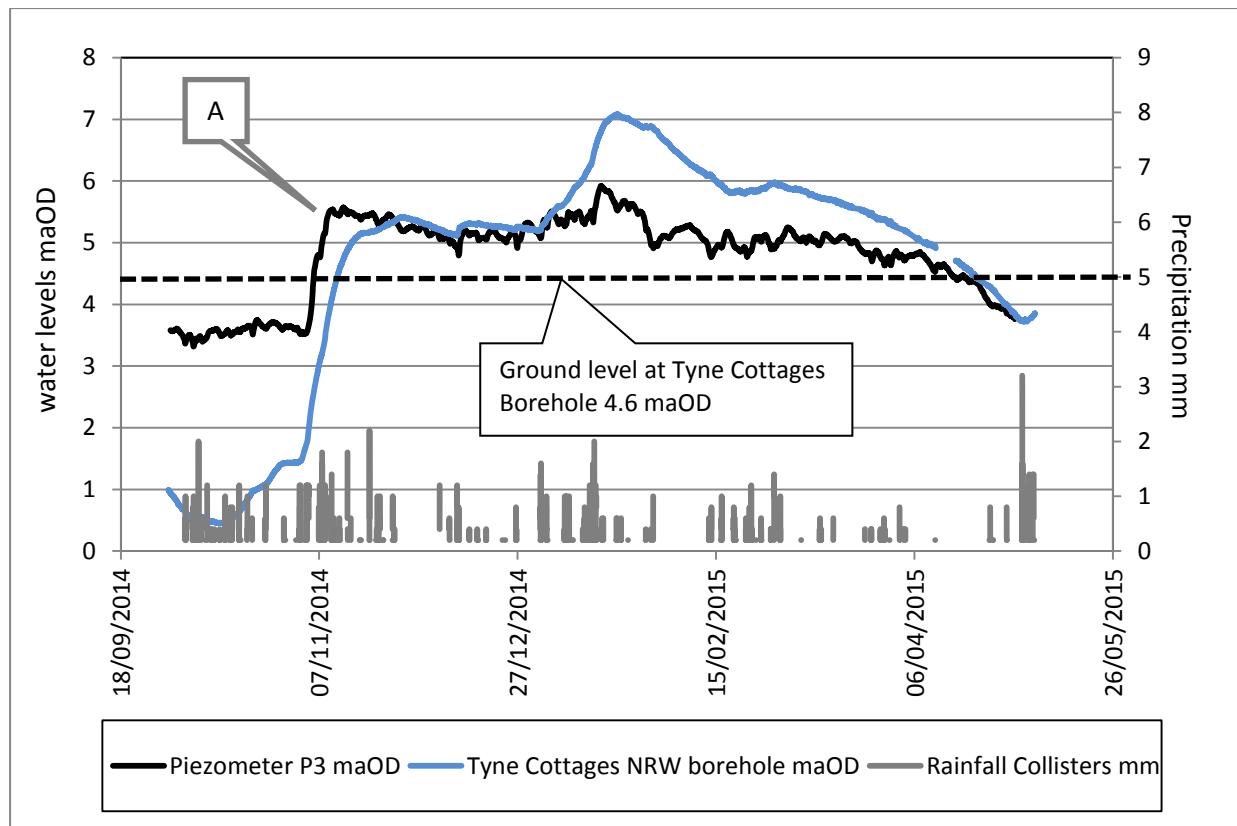
Precipitation at Collister Pill gauging station is compared to groundwater levels in the Carboniferous Limestone (Tyne Cottages Borehole) and flood levels in the Nedern wetland, Piezometer P3 (Figure 8). The black dashed line represents ground level within the wetland next to the peizometer, and not at the Tyne Cottage borehole. It is clear that flooding in the Nedern Wetland occurs before the piezometric head in the limestone aquifer is great enough to cause surface flooding (Figure 8 A), suggesting either an input from another source such as the overlying river terrace gravels or impediment of downwards flow by low permeability infill within the Nedern Brook Wetland.

**Figure 8 Rainfall compared to flood depth in the wetland (P3) and groundwater levels in the Carboniferous Limestone (Tyne Cottages).**

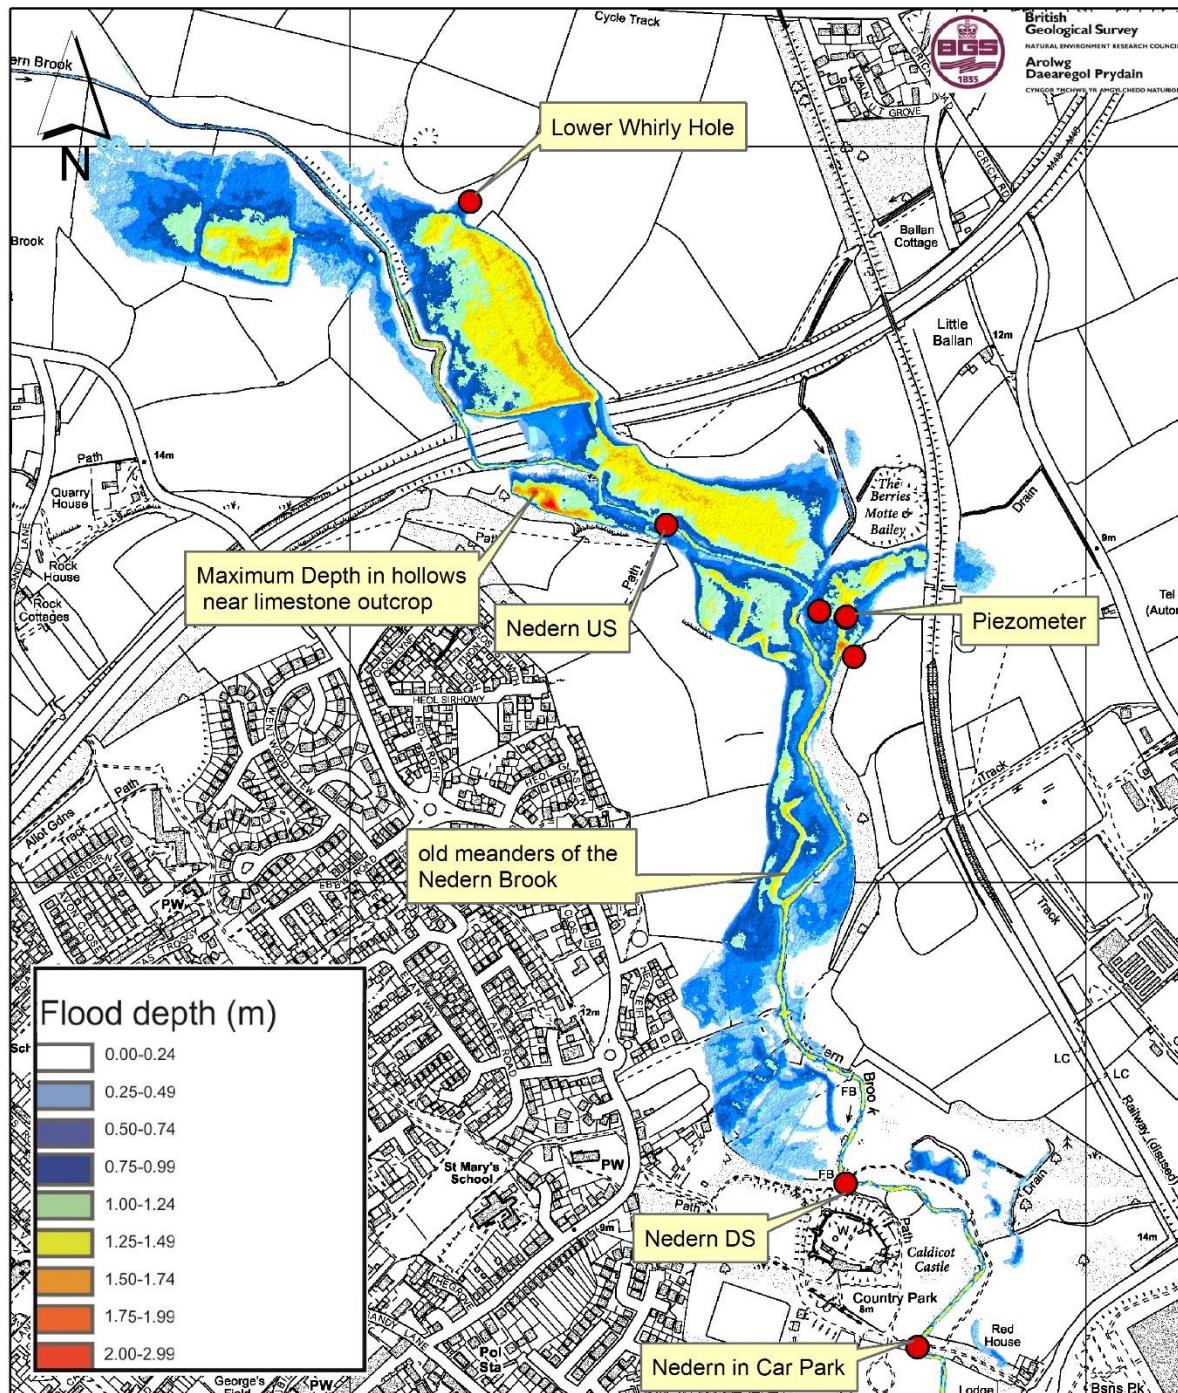
The following flood depth maps were produced to illustrate the maximum and mean flood depths during the monitoring period (Figure 9; Figure 10). The existing and historic meanders of the Nedern Brook are clearly visible, the deeper areas tend to be those that flood first and retain water longest.

**Figure 9 Maximum Flood levels based on 5.92maOD elevation of maximum flood depth between 30/09/2014 and 1/05/2015**

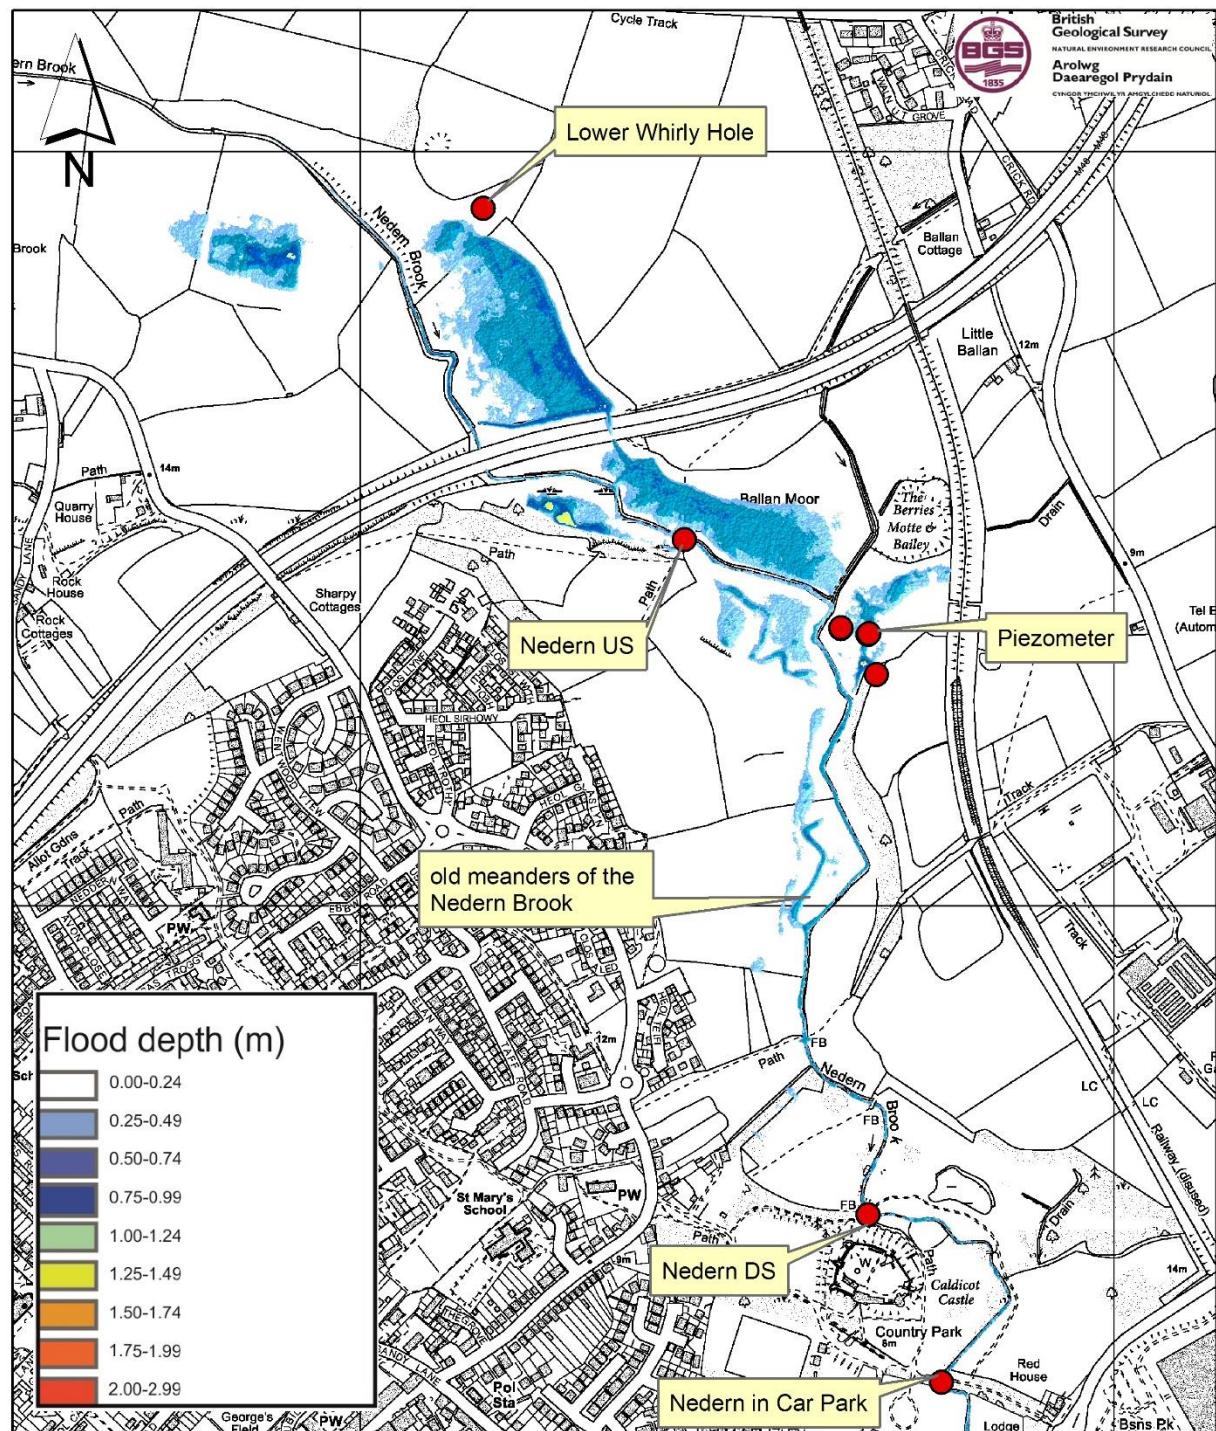
**Figure 10 Mean flood depth, based on 5.15maOD elevation of average flood during between 30/09/2014 and 1/05/2015**

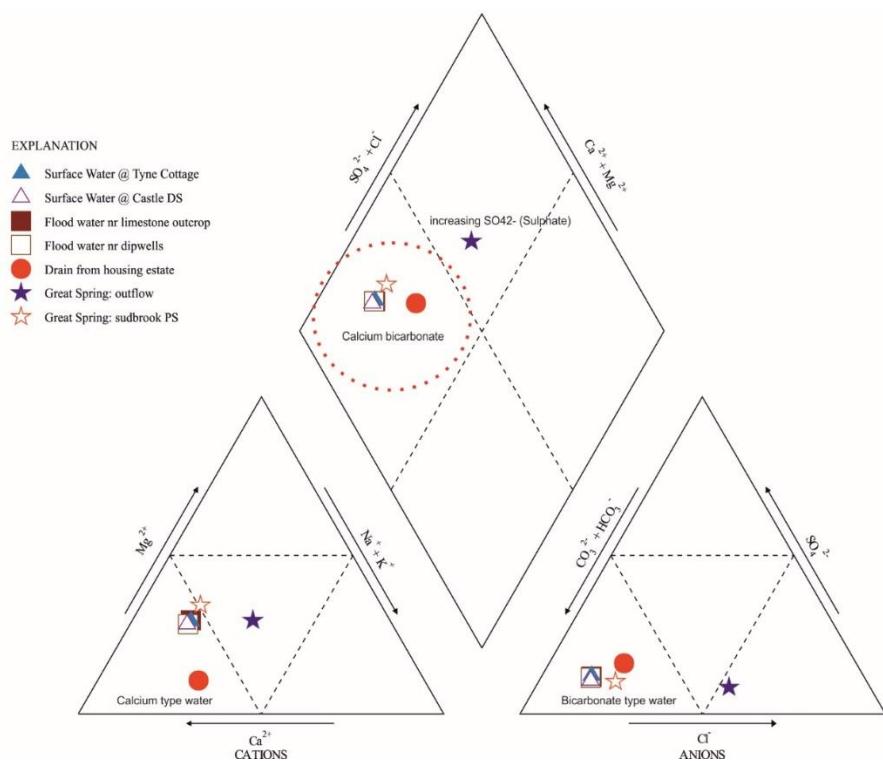
Calcium bicarbonate dominates the water types, however the Great Spring outflow, that represent groundwater from the Carboniferous Limestone aquifer, has higher levels of sulphate especially when sampled at the outflow to the River Severn. The groundwater from the Great Spring is more mineralised than the waters in the Nedern Brook and the wetland, however this could be representative of a longer residence time of groundwater within the Carboniferous Limestone aquifer before it reaches the Great Spring. In the upper part of the Nedern Brook (nr Caldicot Castle) nitrate (5.45mg/l) concentrations reflect that of local groundwater in the Great Spring (5.61mg/l), which may reflect the high amount of baseflow that the upper course of the brook receives from the underlying limestone aquifer. The effects of dilution, from direct precipitation or from groundwater from the river terrace gravels are not understood.

**Figure 11 Major ions of water samples taken from Table 1, shown in a ‘Piper Trilinear Diagram’. Most samples are of  $\text{CaHCO}_3$  type as highlighted by the red dashed circle in the upper triangle.**

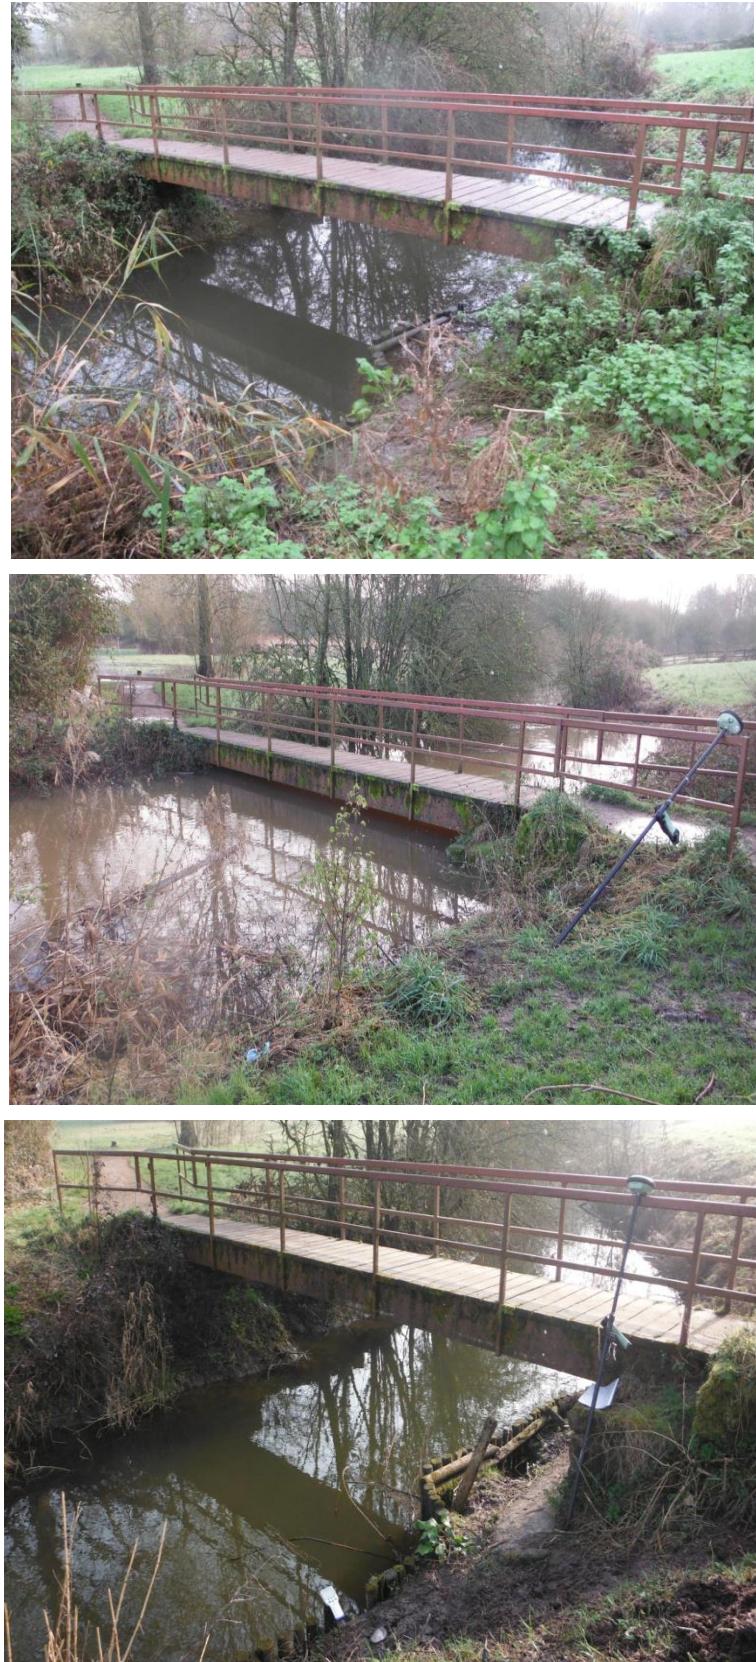
**Figure 14 Nedern Brook DS Monitoring Point under variable flow conditions © BGS NERC.**

27.11.2014 (top), 16.1.2015(middle) & 18.3.2015 (bottom)

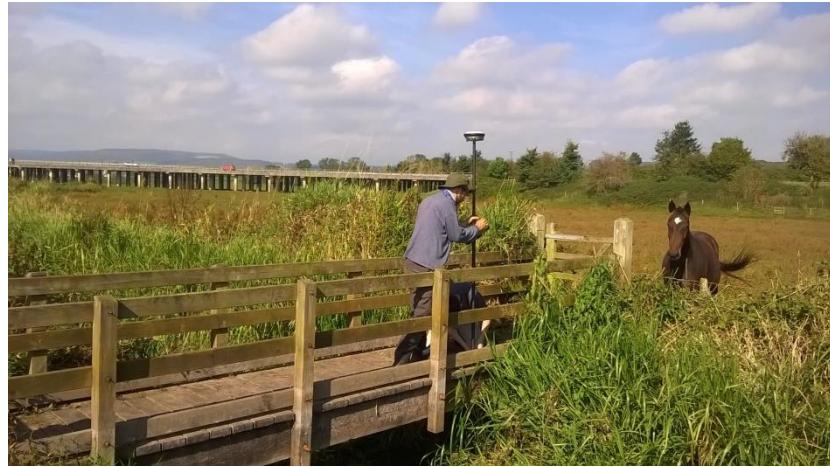
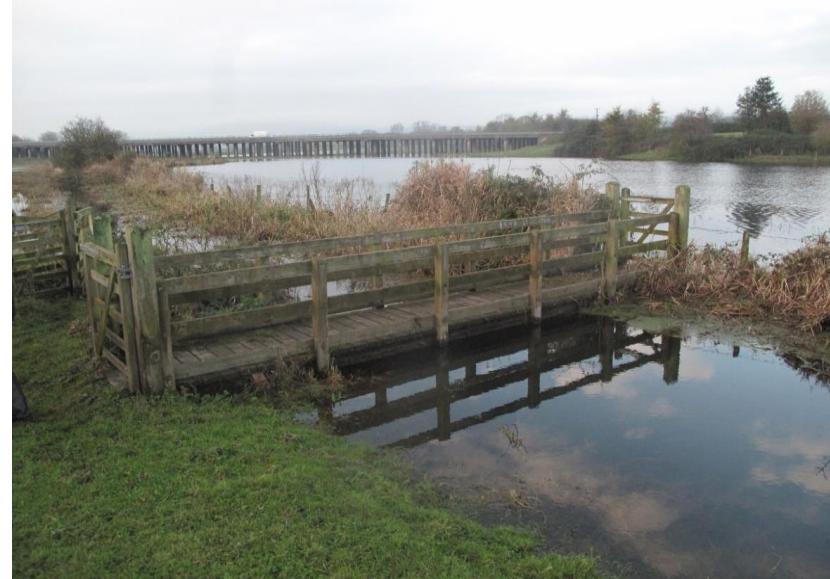
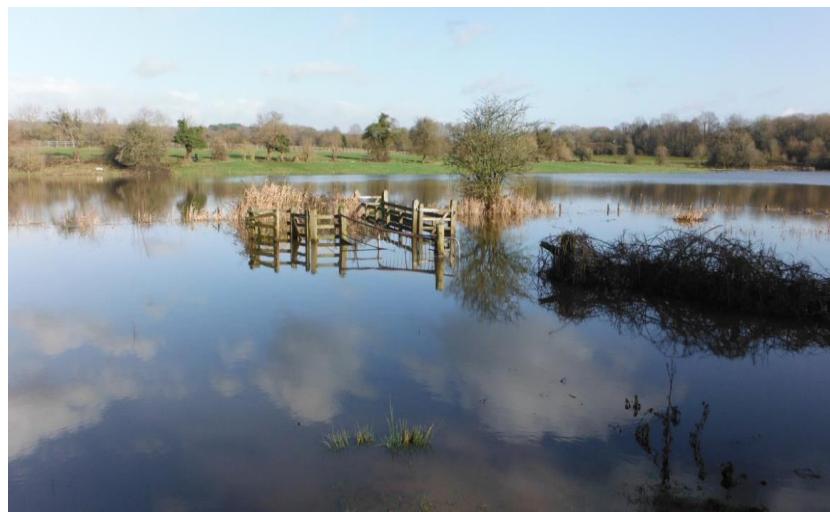
**Figure 15 Nedern Brook US Monitoring Point under variable flow conditions © BGS NERC.**

30.09.2014 (top: dry), 27.11.14 (middle: dry view north towards the road bridge), 16.1.15 (bottom: wet view east).

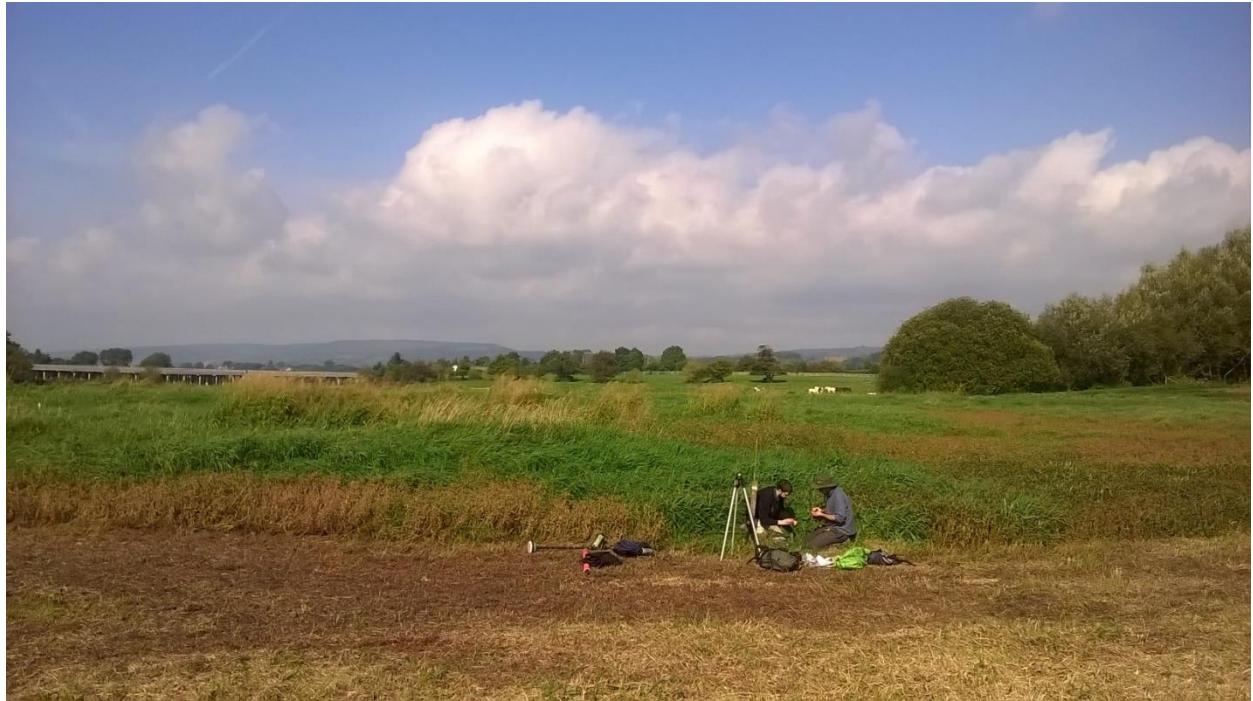
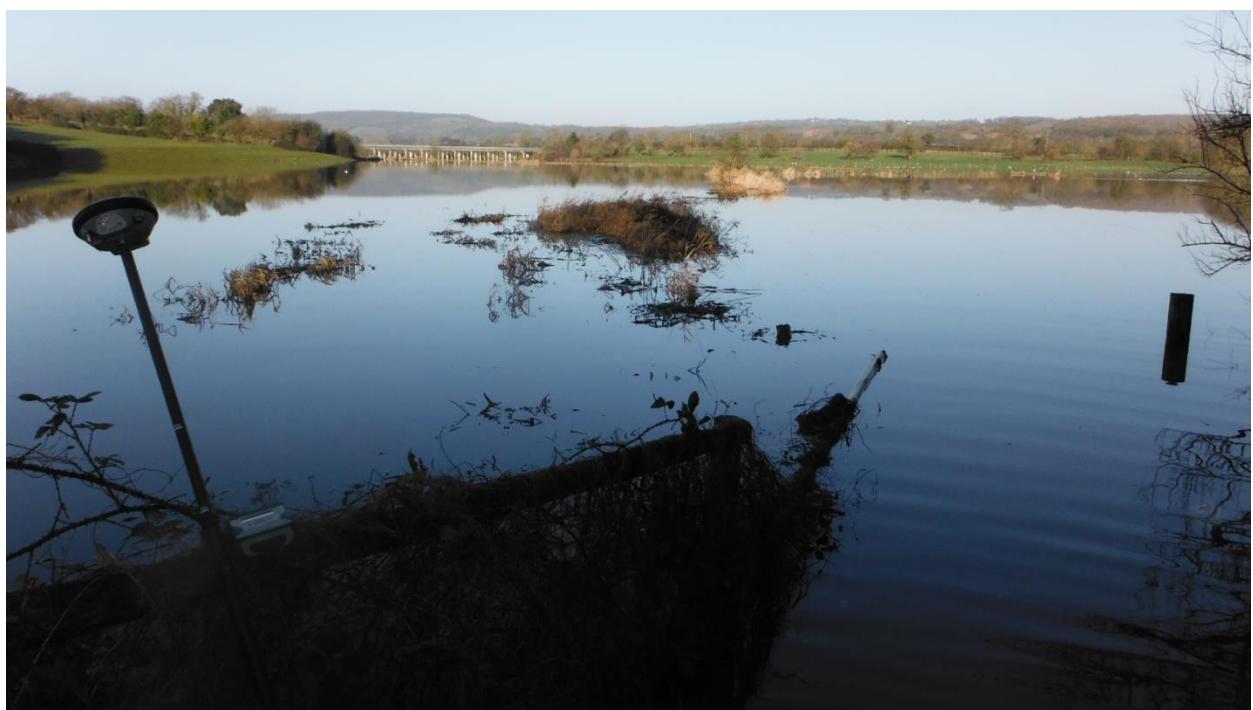
**Figure 16 Dipwells and Piezometers (P3) in dry and flood conditions © BGS NERC.**

30.09.2014 (top: dry install and survey view north towards M48) and 16.01.2015 (bottom: wet similar view)
