Cyngor Sir Fynwy

### Adroddiad Ymchwilio Llifogydd Adran 19

# Cil-y-coed

Chwefror 2020

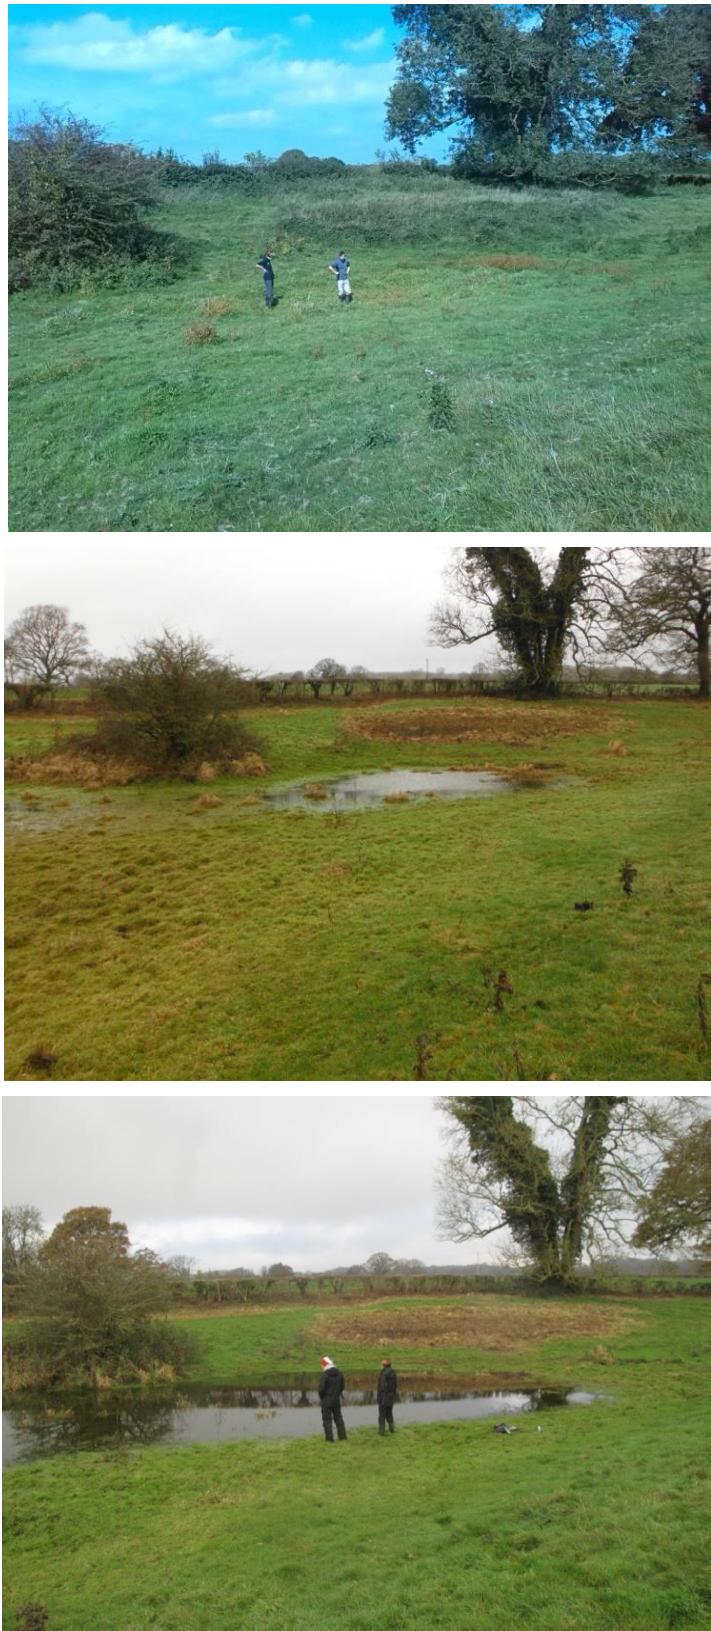
**Figure 17 Lower Whirly Hole in variable flood conditions © BGS NERC.**

30.09.2014 (top), 18.12.2014 (middle), 27.11.2014 (bottom)

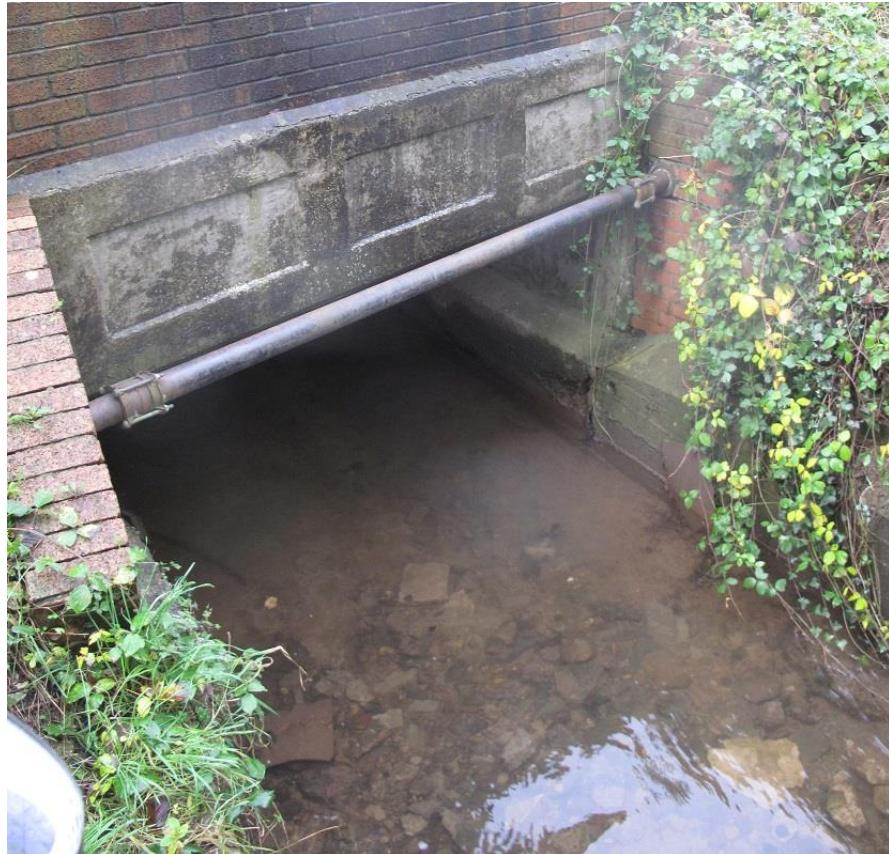
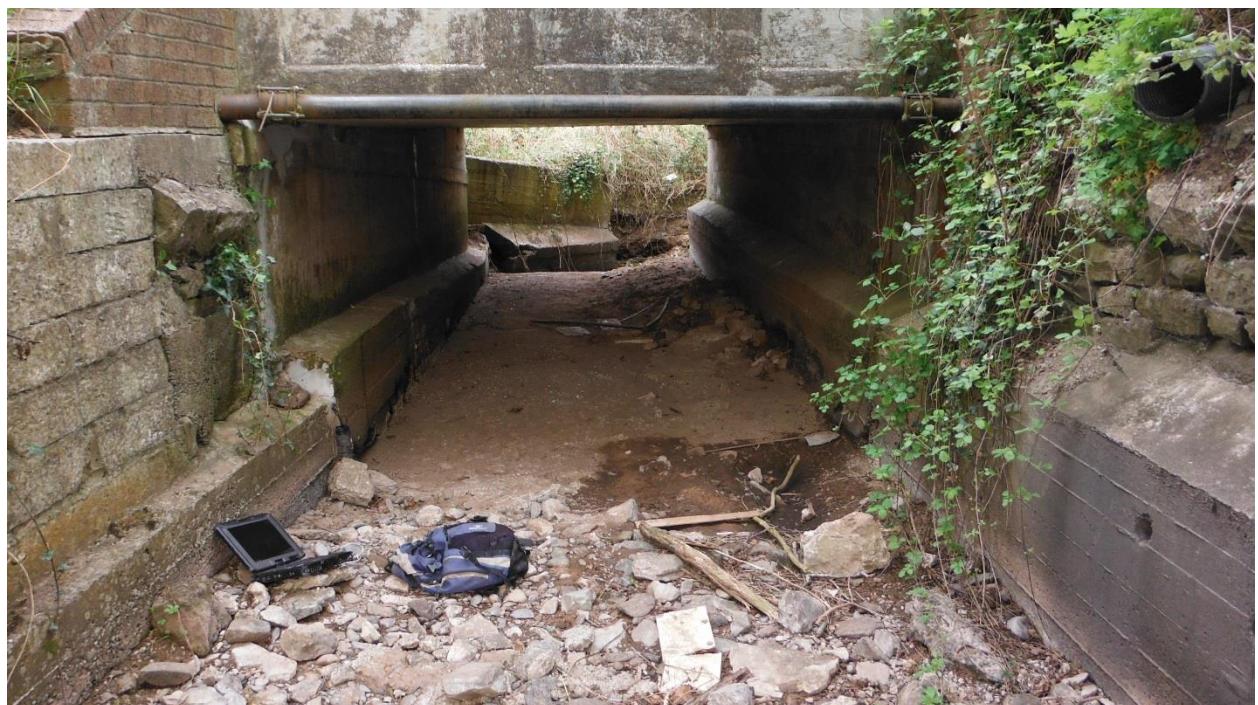
**Figure 18 Nedern Brook at Tyne Cottages in variable flow conditions © BGS NERC.**

27.11.2014 (top) and 1.05.2015 (below)
