# OLD WYE BRIDGE – COMPLETE CLOSURE UPDATE

PRESENTATION TO MONMOUTHSHIRE COUNTY COUNCIL

Presented to MCC | 31<sup>st</sup> March 2026

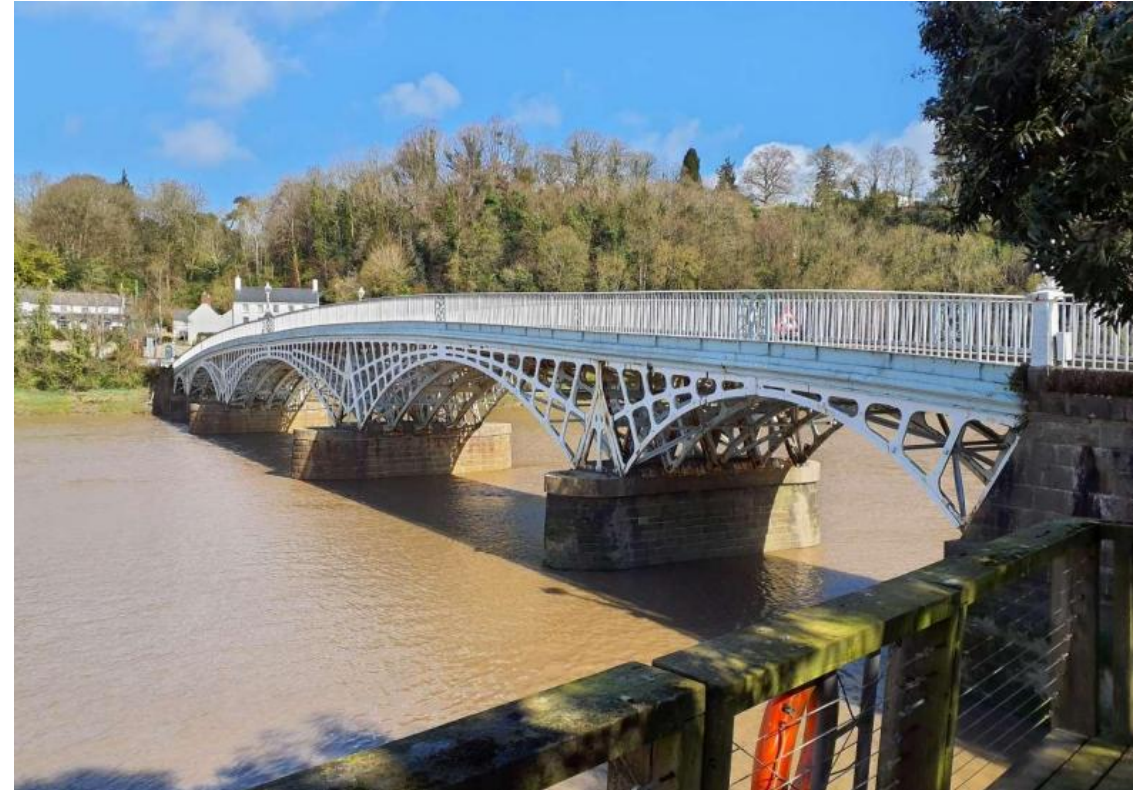
- Special Inspection undertaken by Up&Under on the week commencing 23-Mar-26
- New defects found in Pier 2 on the 24-Mar-26
- New defects found on Pier 4 on the 25-Mar-26
- Analysis and review of the defects undertaken on the 25-Mar-26
- Decision to close the bridge to pedestrians on the 26-Mar-26

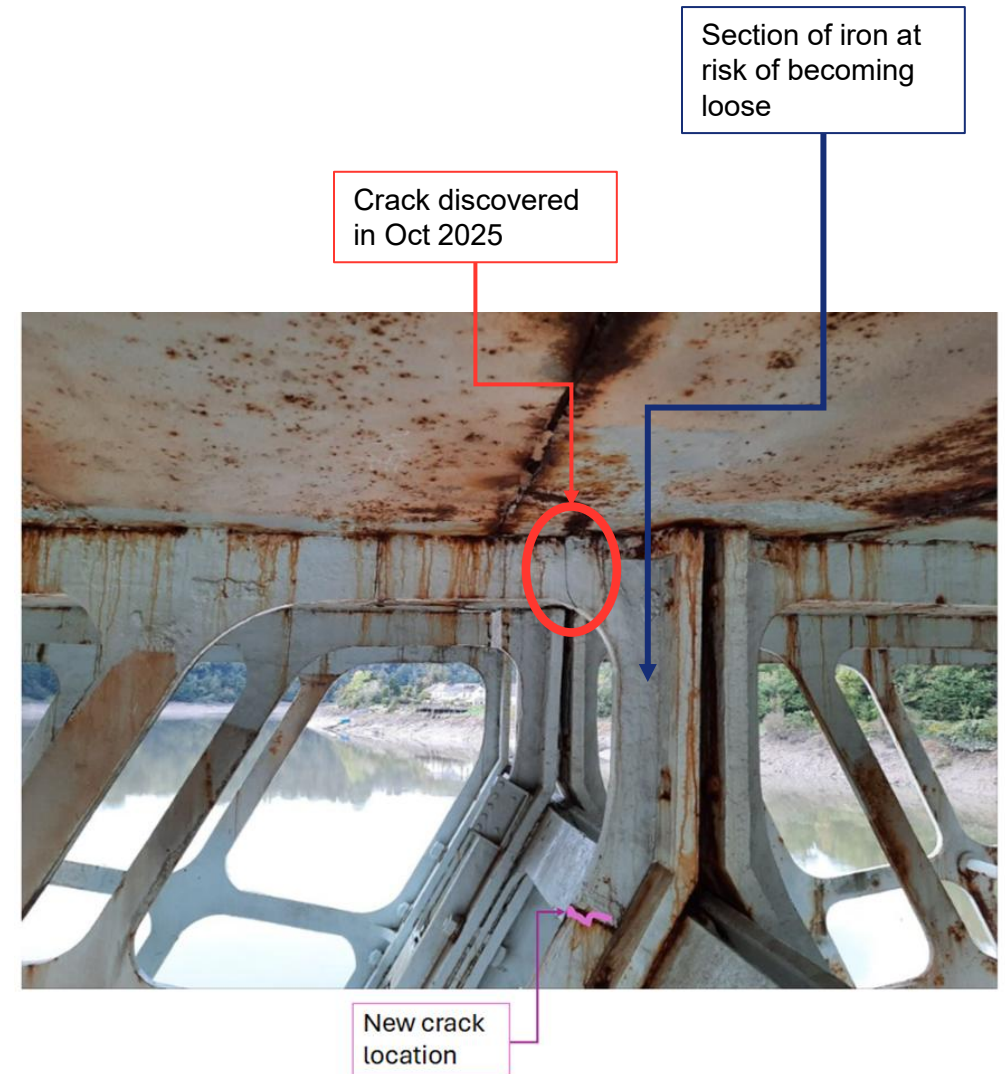
# Reason for pedestrian closure

- New cracks are most likely to have occurred as the bridge contracted during cold weather over the winter, with the cracks discovered in Oct 2025 due to expansion in hot weather over the summer.

- Cast iron is susceptible to fatigue, so cycles of load/stress from temperature changes and vehicle loads will have accumulated damage in the metal. This means that cracking can occur even at loads that the bridge has previously supported without cracking.

- Provisional calculations have shown that cracks that have occurred do not significantly affect the ability of the bridge to carry its own weight, or those of pedestrians. However, if there is further cracking of several additional members, this could begin to reduce the capacity of the bridge.

- The new cracks at Piers 2 and 4 leave a section of the cast iron structure that is disconnected from the bridge by cracks. These sections support cast iron deckplates, that in turn support the road and footways. This results in a loss of support to the deck plates and there is a concern that three of the deck plates in the area over Pier 2 and two deck plates near Pier 4 have a loss of support and that therefore the road/footway in these regions doesn't have adequate support.
