Former Community Centre School Lane Gilwern Monmouthshire

An Ecological Survey Report by:

November 2017

Client	Monmouthshire County Council			
Project Name	Former Community Cent	re, School Lane, Gilweri	n, Monmouthshire	
Report Title	An Ecological Survey Report			
File Reference	BAT4417			
Status	Signed	Name	Position	Date
Author	Dollary	Grace Dooley BSc (Hons) MSc	Assistant Ecologist	10 November 2017
Reviewer	Re	Diane J Morgan BA (Hons) ACIEEM	Senior Ecologist	20 November 2017

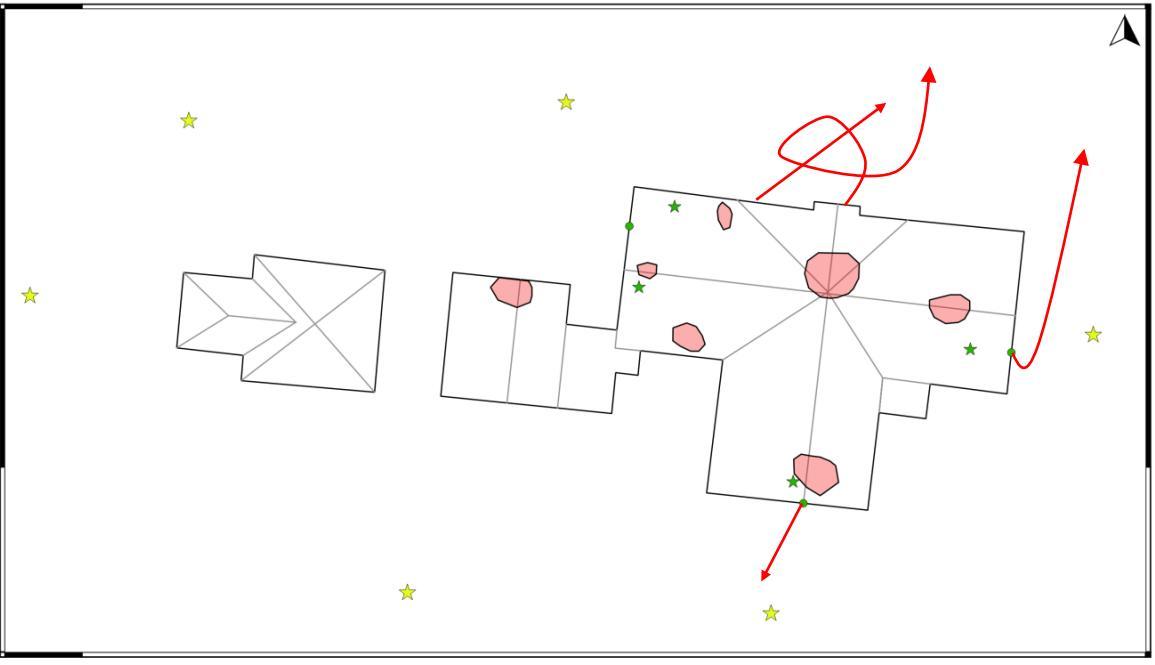
Figure 3: Plan of buildings showing evidence of bats and exit points

Actual and potential bat access points:	Former community centre and the stonework; gap b beneath tiled ridge tiles cracked tiles. Single-storey extension: northern gable end; gaps eastern and western eleva Annexe: gap between bit entire structure.	e: gaps around the whole structure between the soffit eneath terminal ridge tile on eastern gable end; gaps along western ridge line; gaps due to slipped and gap between barge boards and wall plate along at eaves between wall plate and bitumen lining along ations. tumen lining and decorative timber cladding around
Actual and potential bat roosting sites:	Former community centre sarking; behind soffit and brickwork on brick suppor coverings and at the tops Single-storey extension: g	e: gaps between ridge coverings and internal timber d fascias; crevices in stone walls at the wall plate, rts within loft void: between roof timbers and the roof of walls. laps between roof coverings and bitumen lining

Species and number recorded:	Soprano pipistrelle: (1) fro Common pipistrelle: (1) fro Pipistrelle: (1) fro Common pipistrelle (1) fro	om north elevation main building 21 st August 2017 om south gable main building on 21 st August 2017 om east gable main building 17 th September 2017 om north elevation main building17 th September 2017
Droppings recorded:	Former community centre Single-storey extension: te	: total approximately 315+ otal approximately 115+

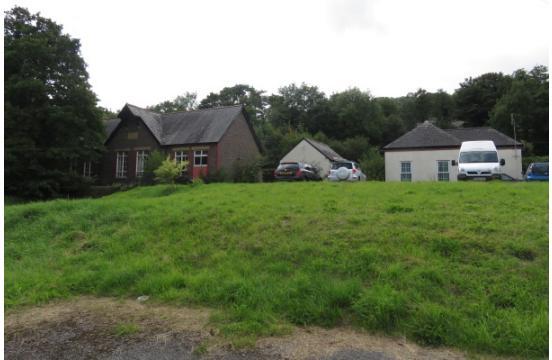
Plate 9: Gaps at ridge

- 9.3 Within the main building, historic alterations in the timber sarking were noted at the ridge, close to the four gable ends, where it is considered air vents were historically positioned. It was possible to view the ridge tiles in these locations. Below these features were small quantities of droppings, which were considered to have fallen through into the loft as a result of bats roosting around the ridge area.

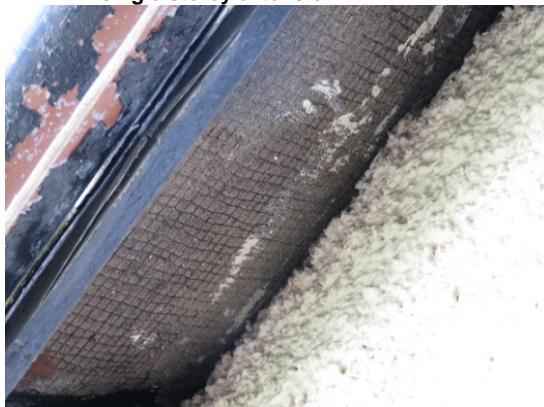
Plate 13: Loft of former community centre

- 8.5 Inside the main building of the former community centre, no live bats were seen, although evidence of the presence of bats was immediately noted. As well as a general scattering of bat droppings, small concentrations of bat droppings were noted in several places. Modifications to the roof were present at the ridge apex, close to each gable end, where it is considered that an air vent was historically sited. Beneath these capped features were accumulations of pipistrelle (*Pipistrellus sp.*) type bat droppings, in aggregations (ranging between 50+ and 150+). Additional bat droppings were noted on the brick support pillars, which appear to correspond to crevices in the brickwork of the pillars themselves. The droppings recorded within the loft were small, and mostly old, with some fresher and recent examples. A large and inactive wasp (*Vespula vulgaris*) nest was noted at the east gable wall plate, near the north-east corner.

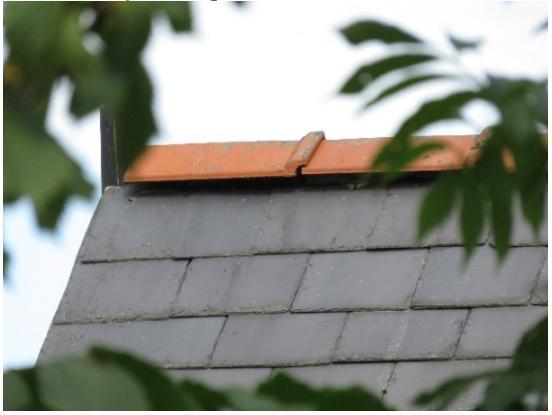
Plate 12: Gap beneath lead flashing on porch

- 8.2 The daytime assessment in August 2017 commenced with the external features of the former community centre, which revealed no evidence of bats such as bat droppings, staining or anything to indicate the presence of a bat roost. However, potential access points that bats and birds might exploit were identified. A gap was noted between the soffit and the stonework that runs around the entire structure at eaves height. Along the western and southern ridge lines, the ridge tiles were noted to be positioned off-centre, and at a tilt, with a significant gap beneath the tiles was observed on one aspect. At the eastern gable end, a gap was also noted underneath the terminal ridge tile. Additional gaps were present along the eastern ridge, where tiles on the top course have slipped and created gaps leading to the ridge line itself. Along the northern elevation, in the western valley of the projecting gable, there are additional slipped tiles, as well as broken slates, making way for a larger hole. Lead flashing present on the flat-roofed porch structure, to the south-east, was also noted to have lifted, creating a small gap.

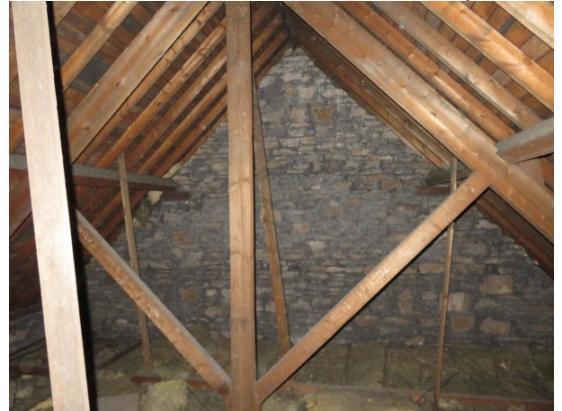
Plate 16: Bird remains in loft of main building

- 8.8 Evidence of nesting birds was also considered, and no active nests were found. However, the survey visit was conducted outside the main bird nesting season. Several old and inactive nests were seen within the main loft space of the main former community centre. Grassy nests are located at the eastern, western, and southern gable end walls, with nesting material also located directly below each nest. Further evidence of bird nesting activity was noted at the eastern gable end wall, where a nest comprising mainly twigs was recorded at the eastern gable end wall. A total of seven dead juvenile birds were encountered on the floor of the loft space, close to each of the gable end walls. Evidence by way of white droppings indicate that birds are perching atop the wall plates at eaves level in all areas of the loft space. The birds thought likely to make use of the features of this building are pigeon (*Columba livia*), starling (*Sturnus vulgaris*), and house sparrow (*Passer domesticus*).

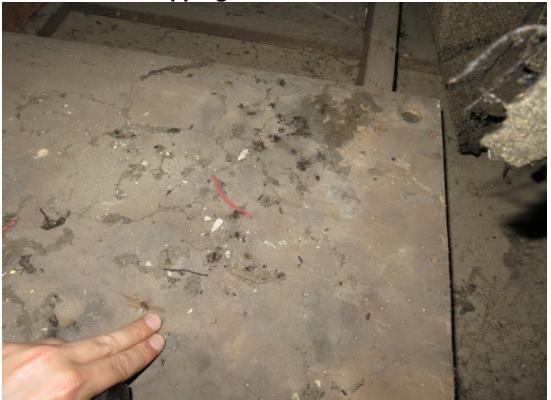
Plate 20: Loft of annexe

- 8.7 Within the interior of the annexe building, no evidence of bats was noted. Two small old wasp
