Section 19 Flood Investigation Report

Llanvihangel Gobion and Kemeys Commander

Storm Dennis February 2020

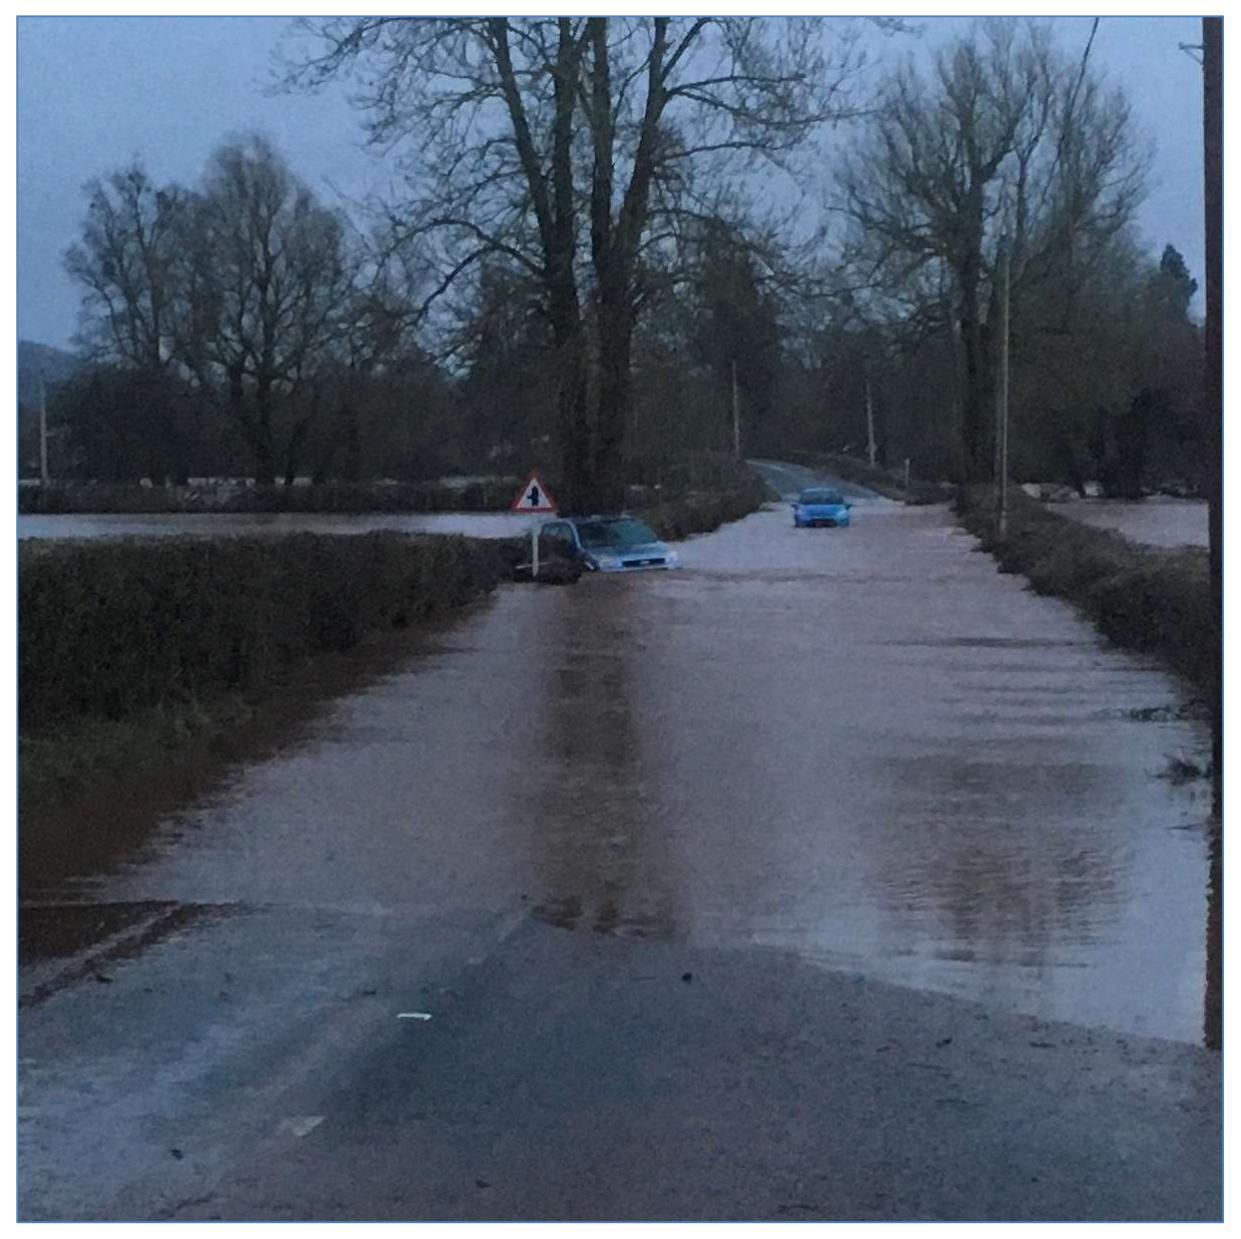
Figure 2-7. The B4598 flooding north of Pant-Y-Goitre Bridge, Storm Dennis flood event, photo taken at 17:00hrs 16 February 2020, from Steel Horse Café, Llanvihangel Gobion.

LK2020/09	Internal residential property flooding on 15 and 16 February, possibly 17 February 2020. Property was accessible by 07:00hrs on 17 February. Downstairs had flooded to approximately 0.2m, utility room and garage flooded to approximately 0.25m. The garden, approximately 3 to 3.66m from the house has previously flooded in January/February 2015 and October 2019. The river is at the bottom of the garden, and there is usually a 3 to 3.66m drop down to the river. Residents asked other locals about the flooding and they said the house had not flooded in living memory. Figure 2-7 is a photo of the B4598 flooding during the flood event.

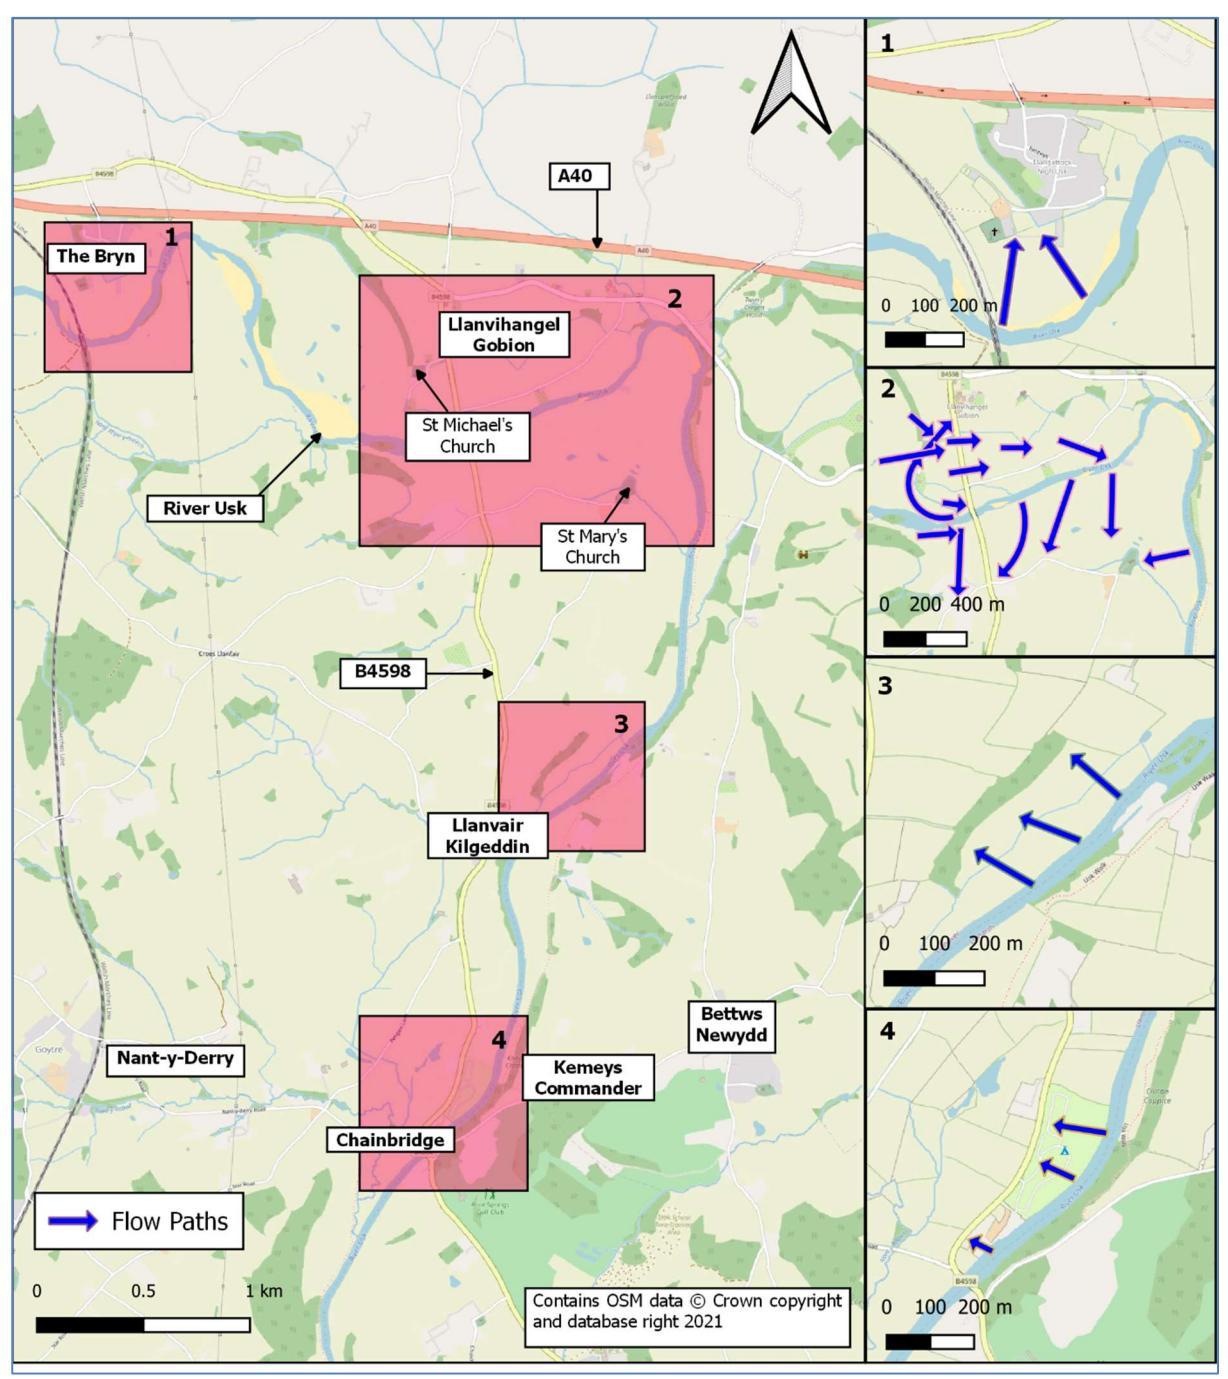
Figure 3-1. Flood flow paths from anecdotal evidence

Flood flow paths from anecdotal reports are shown in Figure 3-1.

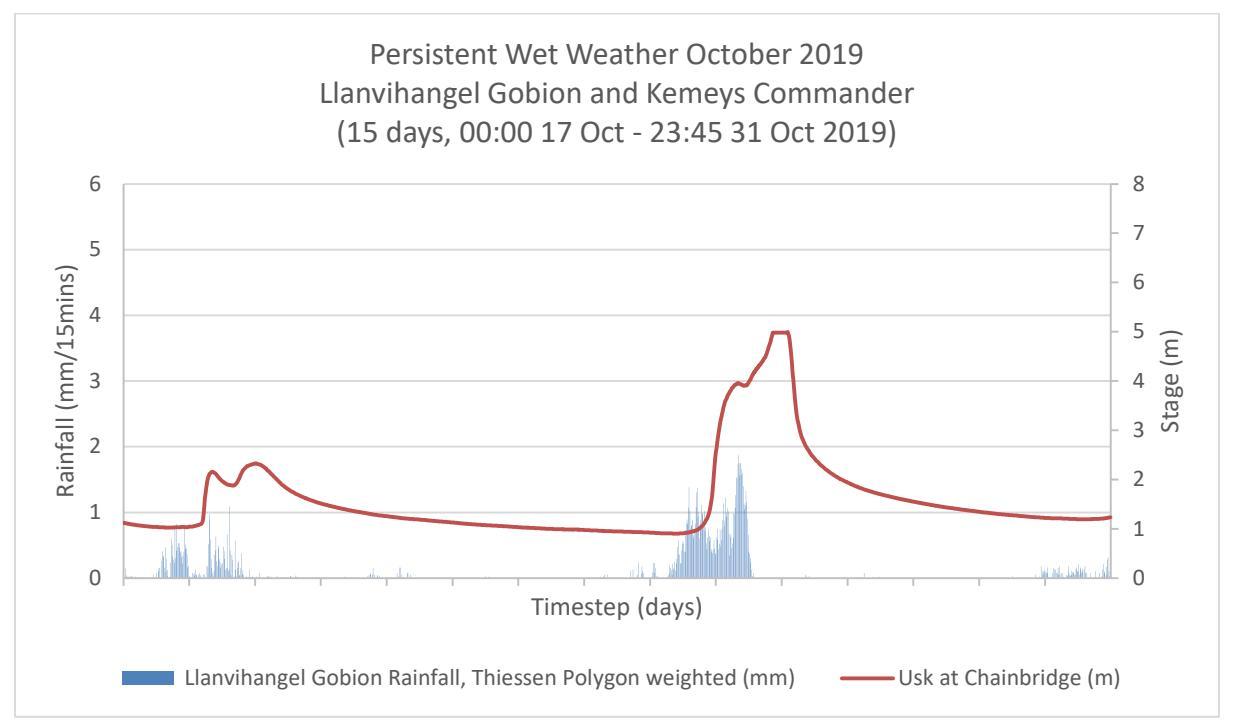
Figure 3-7. Persistent Wet Weather October 2019 - Rainfall and river levels for the Usk at Chainbridge for the 15day period 17 to 31 October 2019

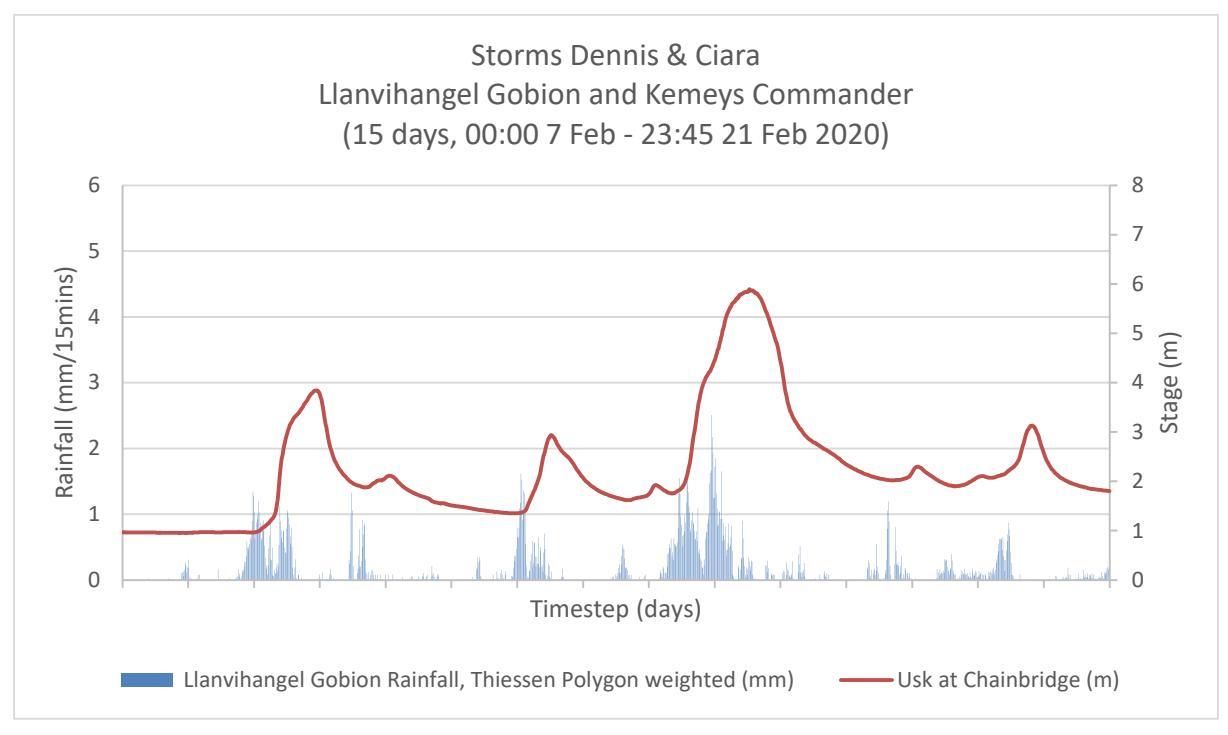
Figure 3-8. Storm Dennis - Rainfall and river levels for the Usk at Chainbridge for the 15-day period 7 to 21 February 2020

The peaks in the hydrographs on the Usk are used by flood risk authorities as triggers for flood warnings, and to action emergency flood responses. Lead times are important in emergency flood situations; the earlier the warning, the longer property owners have to evacuate and protect their property, and the longer emergency services have to respond.

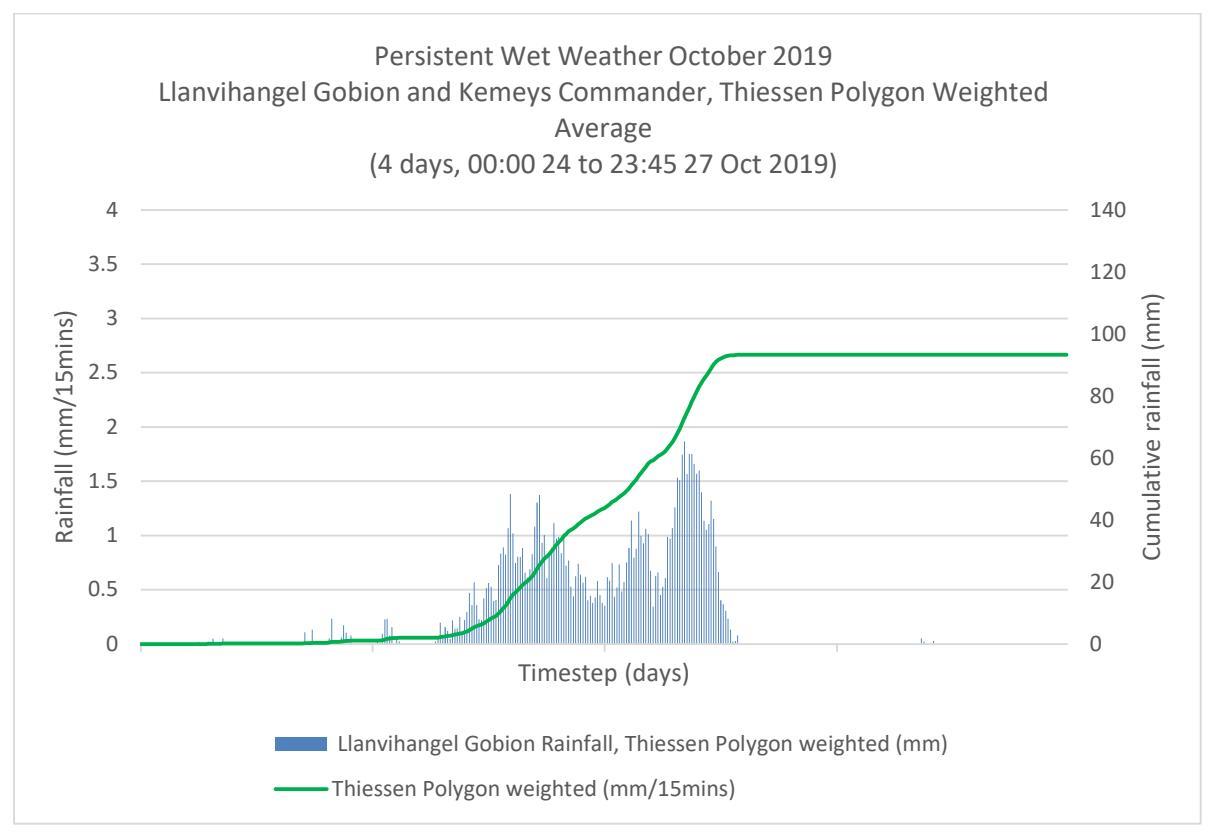
Figure 3-9. Persistent Wet Weather October 2019 - Rainfall totals (mm/15mins) and cumulative rainfall (mm) for the 4-day period 24 to 27 October 2019

The graphs in Figure 3-9 and Figure 3-10 show cumulative rainfall totals for the 4-day period with the storms beginning on day 2 for Thiessen Polygon weighted rainfall of the 5 gauges included in the assessment. The individual cumulative rainfall graphs for the 5 gauges can be found in Appendix B. The cumulative totals are presented in Table 3-5:

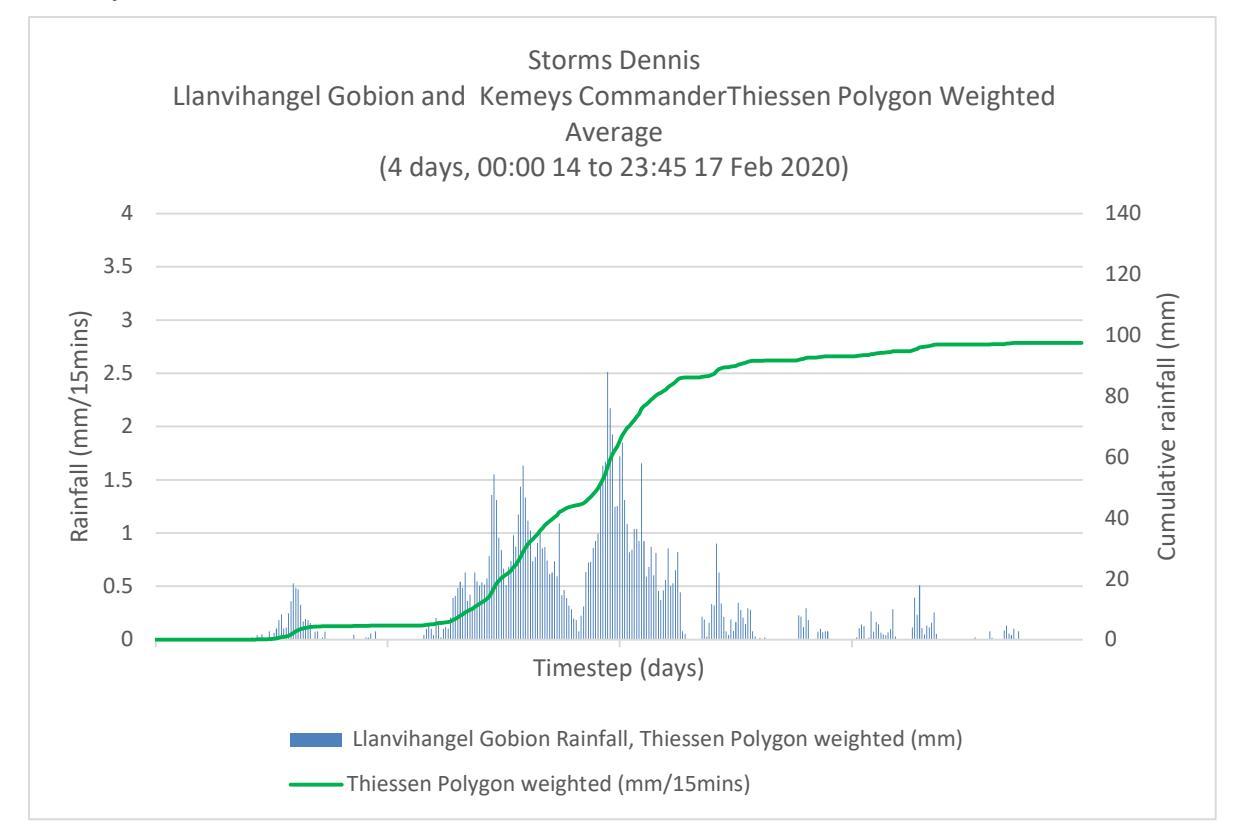
Figure 3-10. Storm Dennis - Rainfall totals (mm/15mins) and cumulative rainfall (mm) for the 4-day period 14 to 17 February 2020

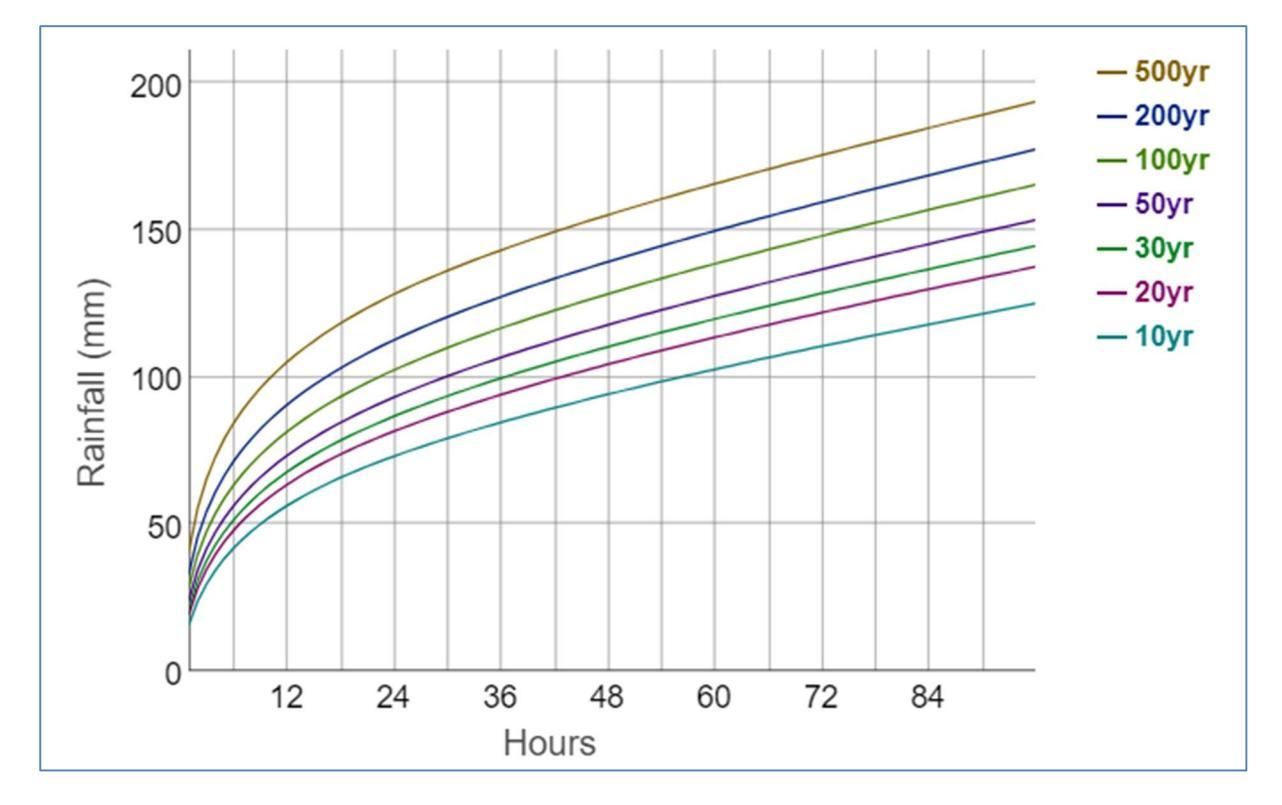
The Depth Duration Frequency curves in Figure 3-11 show the relationship between rainfall depth and storm duration for set return periods for the Usk's catchment at point 334600, 205550. Between 0 and approximately 48-hours, rainfall depths increase at a decreasing rate, and for storms of approximately 48-hour duration and greater, the relationship between storm duration and rainfall depth is linear.

Figure 3-11. FEH Depth Duration Frequency, Usk Catchment, point 334600, 205550.

Whilst Storm Dennis has the lower return period, river levels were already high at Chainbridge at the onset of Storm Dennis, and the catchment was already saturated due to Storm Ciara and an unnamed rainfall event on 12 and 13 February 2020 generating very fast runoff to the rivers and a high peak in the hydrograph; these were major contributing factors to the flooding. See section 3.4 for further details on antecedent conditions and factors contributing to flooding.

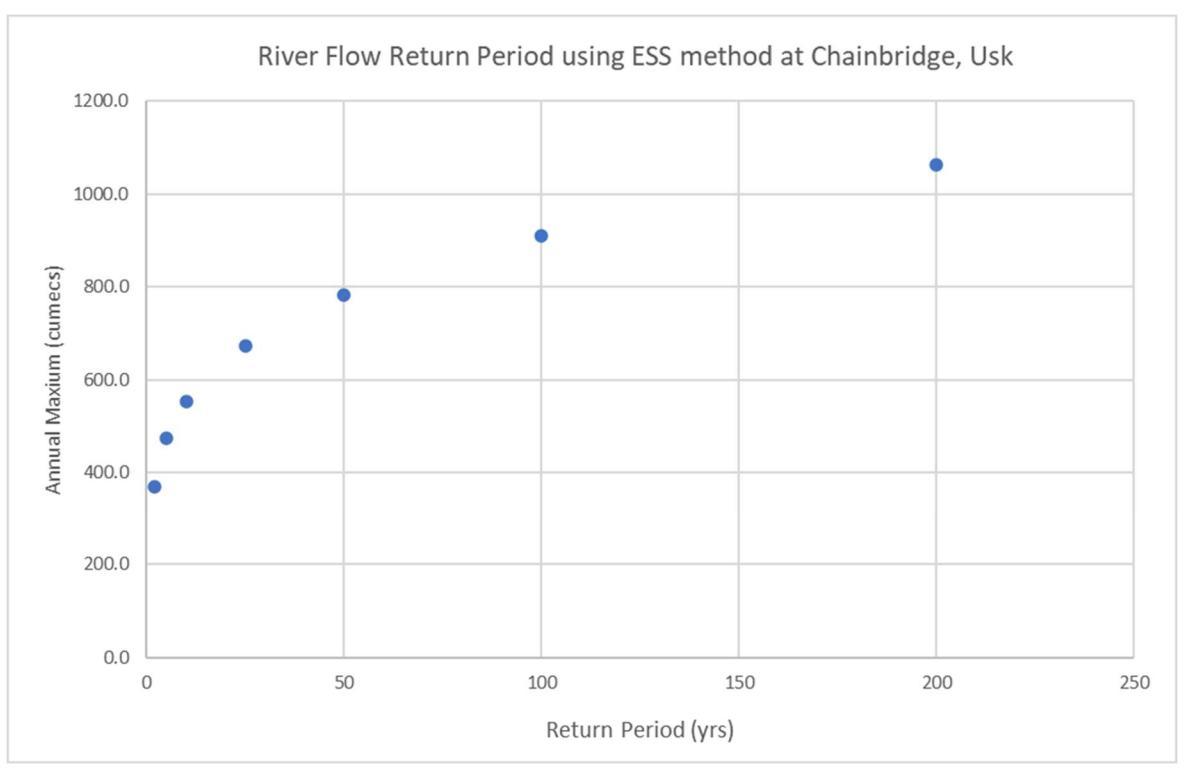
For ESS the index flood is QMED, this is the median flow, and is derived from a long historical record of annual maximum (AMAX) flood data. The growth curve is generated by multiplying observed flows by QMED, and provides a scale for higher and lower return period events. AMAX for the water year 2019/2020 was reached during the Storm Dennis flood event with the Usk discharging at 718m³/s, at 13:30hrs on 16 February 2020. Using the flood frequency curve this puts the river flow return period at around a 1 in 40-year event, see Figure 3-12.

Figure 3-12. Flood frequency curve for the Usk at Chainbridge

Using WINFAP software, and peak flow data at Chainbridge from the National River Flow Archive (NRFA), the flood growth curve was calculated indicating the river flow return period.

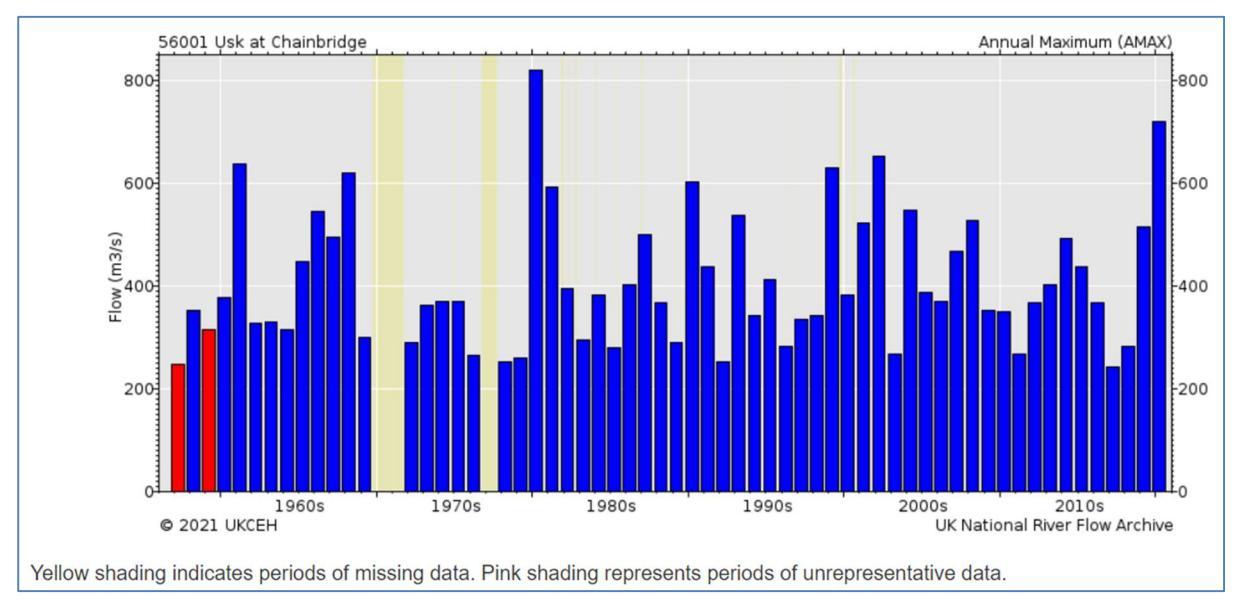
The NRFA records show that the greatest flow event in the gauge's history was 819.6³/s on 27 December 1979, see Figure 3-13, Storm Dennis is the last bar in the graph and has the second greatest flow since 1957.

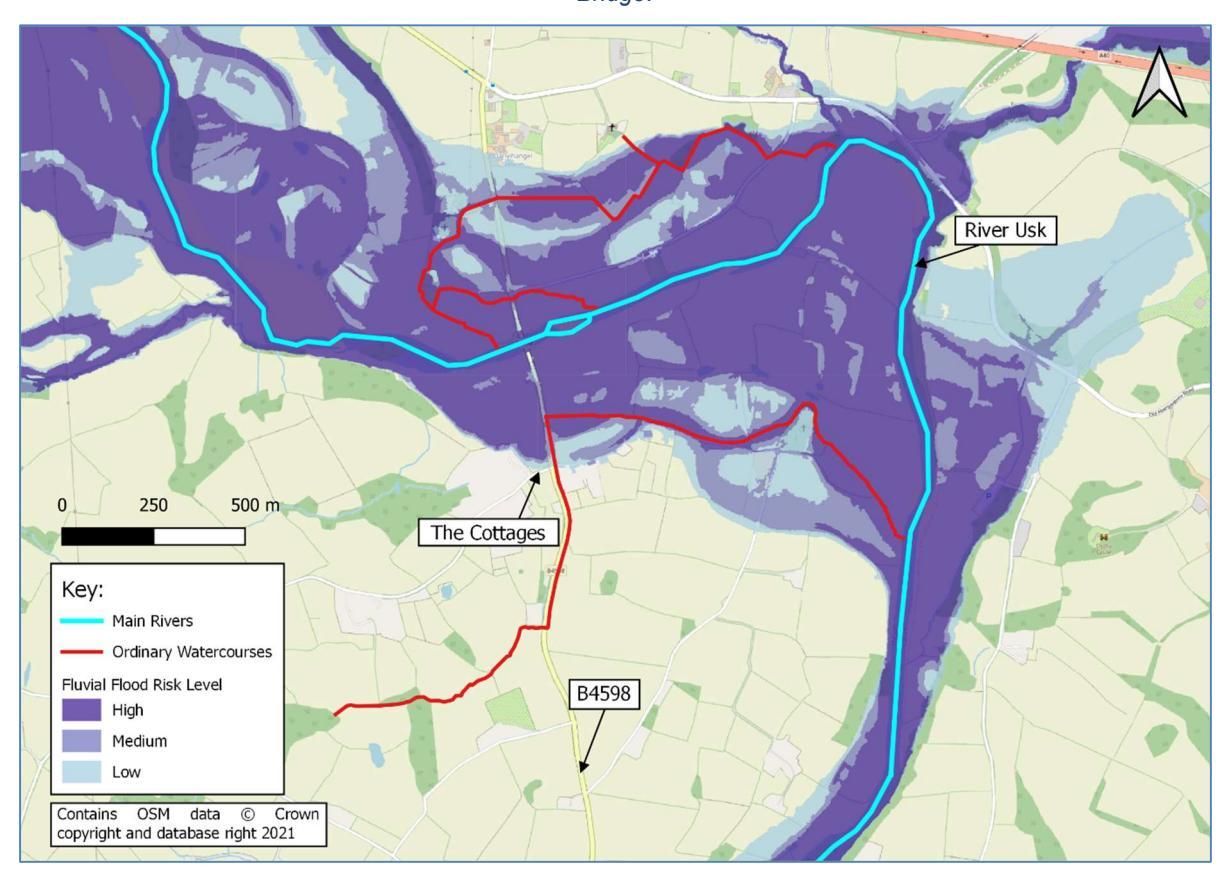
The River Usk overtopped in multiple locations along its course from The Bryn to Chainbridge, and flood water extended across the Usk's floodplain. Figure 4-1 shows the course of the river Usk and its floodplain in blue, and ordinary watercourses in red. There are anecdotal reports of 5 residential properties flooding in Llanvihangel Gobion, 4 in Kemeys Commander, and further properties in between. Some properties in the flood investigation area are surrounded by earth bunds, one of the residents of these properties reported that during the flood event one of the bunds leaked.

Figure 4-1. Path of the River Usk and ordinary watercourses in Llanvihangel Gobion and south of Pant-Y-Goitre Bridge.

Additionally, there are ordinary watercourses in Llanvihangel Gobion and south of Pant-Y-Goitre Bridge as described in section 4.1 and shown in Figure 4-1.

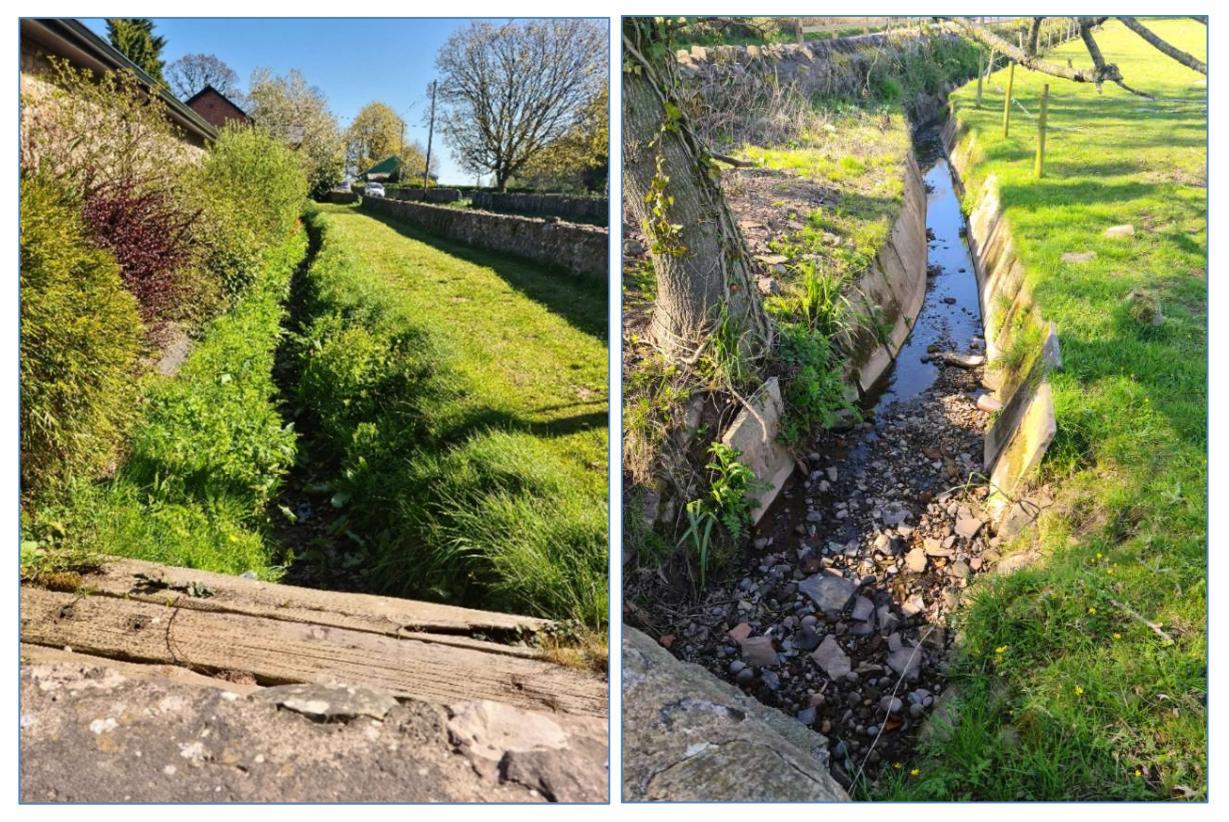
Figure 4-2. Ordinary watercourse near Pant-Y-Goitre Bridge south of the Usk, culvert under The Cottages, left the inlet, right the outlet, site visit April 2021.

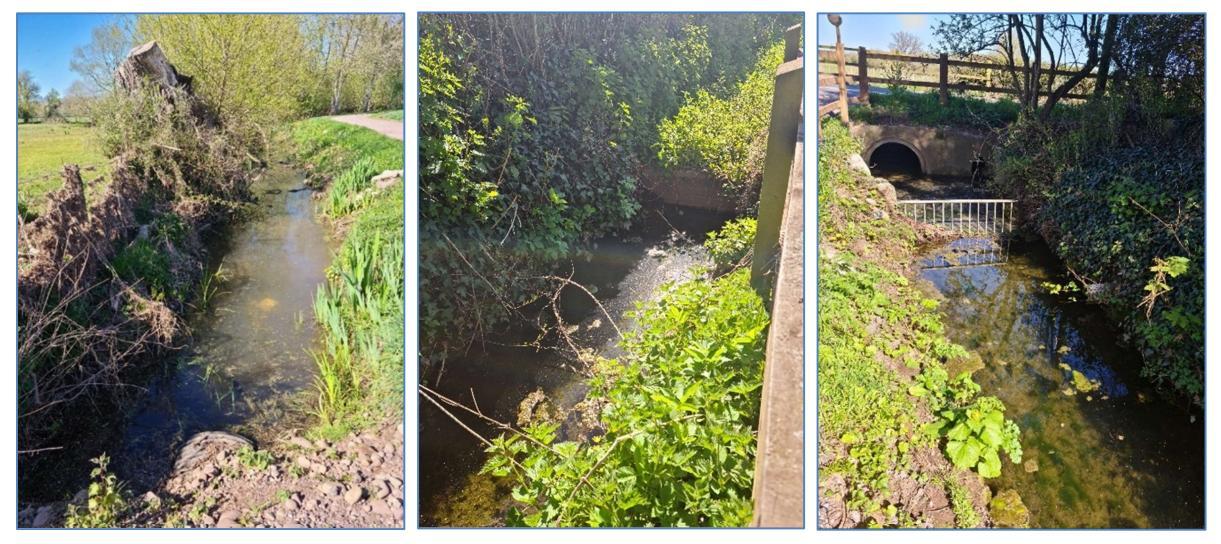
Figure 4-3. Ordinary watercourse in Llanvihangel Gobion, left near St Michael's Church, centre and right the inlet and outlet of the culvert under the B4598, site visit April 2021

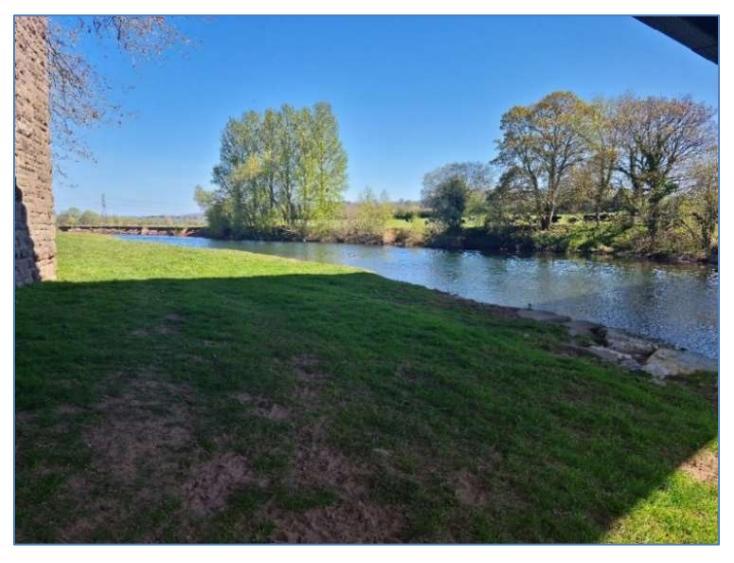
Figure 4-4. The River Usk and floodplain at The Bryn, site visit April 2021.

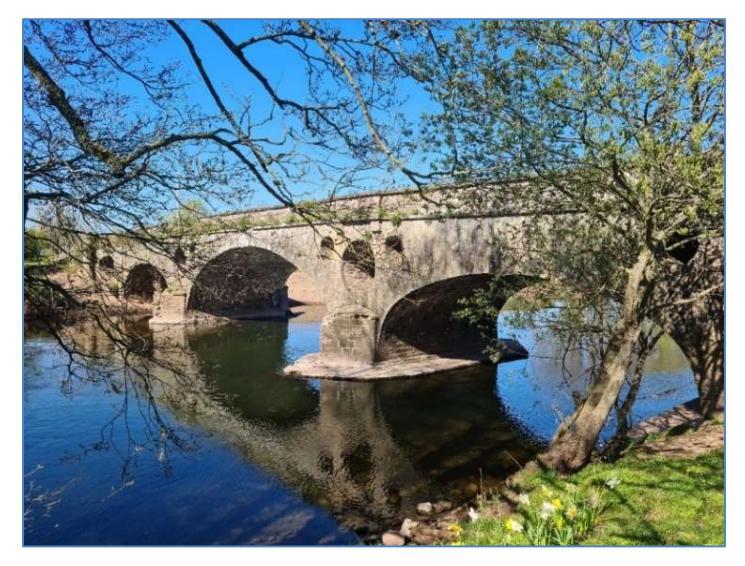
Figure 4-5. Pant Y Goitre Bridge carrying the B4598 over the River Usk, south bank, site visit April 2021.

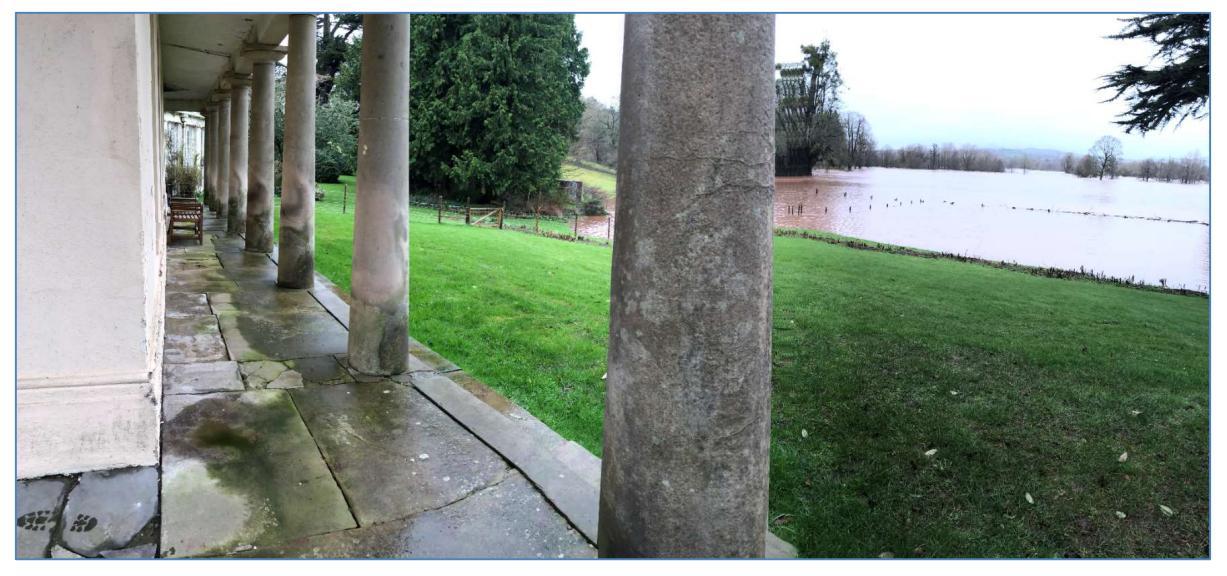
Figure 4-6. Photo showing flood extent to land adjacent to the Usk, Storm Dennis February 2020

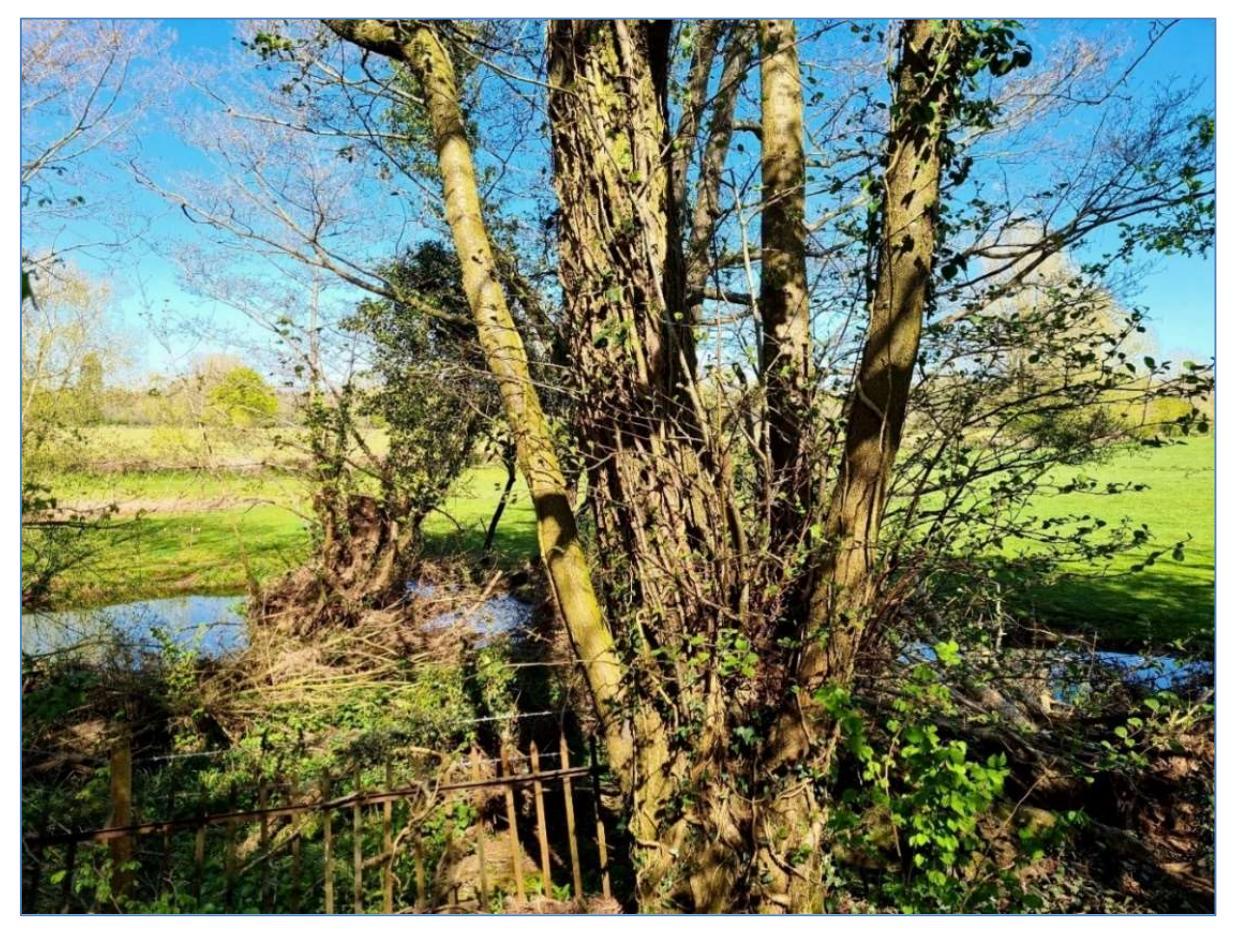
Figure 4-7. Ordinary watercourse flowing around the Church of St Mary, site visit April 2021

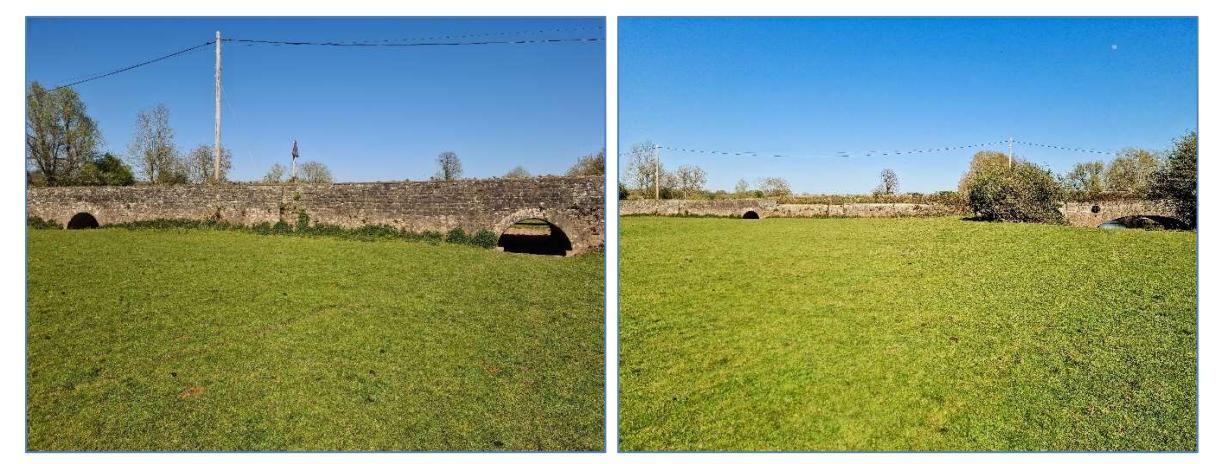
Figure 4-8. Land drainage under the B4598 on the banks of the River Usk. Pant Y Goitre Bridge can be seen in the right photo, Llanvihangel Gobion, site visit April 2021

There are land drainage arches in Llanvihangel Gobion on the banks of the River Usk under the B4598, as shown in Figure 4-8.
