Raglan

Conservation Area Appraisal & Management Proposals

Report Title: Raglan Conservation Area Appraisal & Management Proposals
Client: Monmouthshire County Council
Project Number: 2009/089

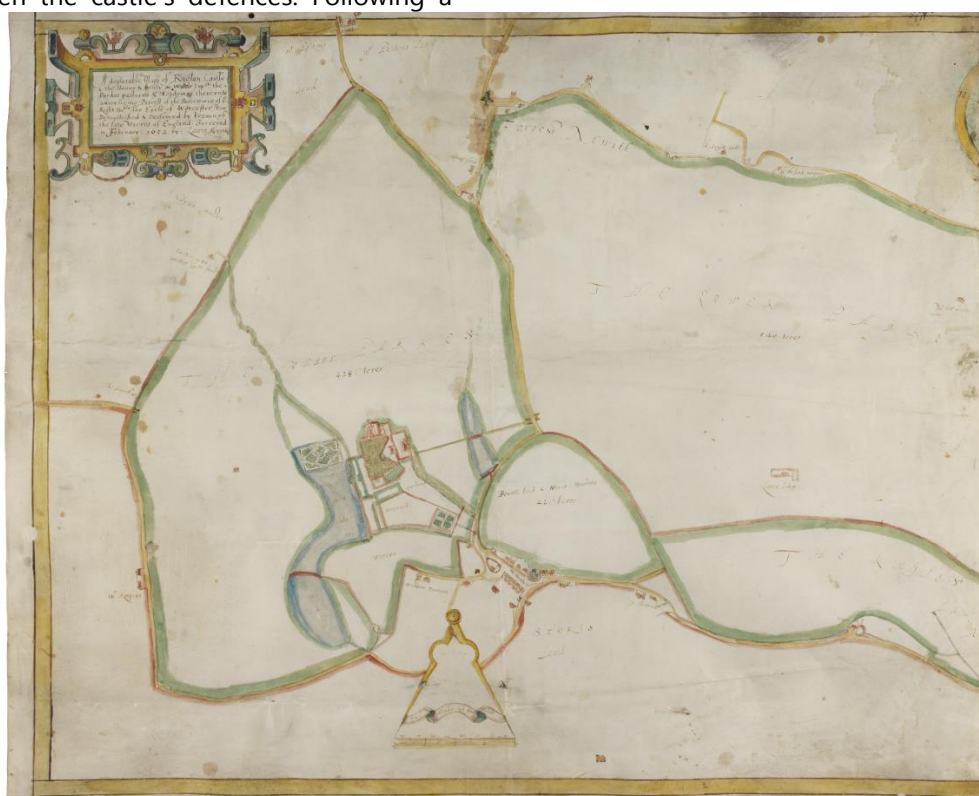
Fig.3 1652 Plan by Lauren Smyth (The National Library of Wales)

6.1.7 William Somerset, third Earl of Worcester (buried in St Cadoc's Church) rebuilt some of the inner courts of the castle, redesigning the great hall and introducing a long gallery in the mid-16th century. The gardens were extended in Renaissance style. A plan of 1652 (**Fig.3** next page) depicts a series of walled terraces, knot garden, fountain court, a huge lake to the west and other water features to the east. These gardens were developed by the fourth Earl of Worcester adding a large formal water garden at the northern end of the great lake and a moat around the Great Tower (Kenyon, 2003).

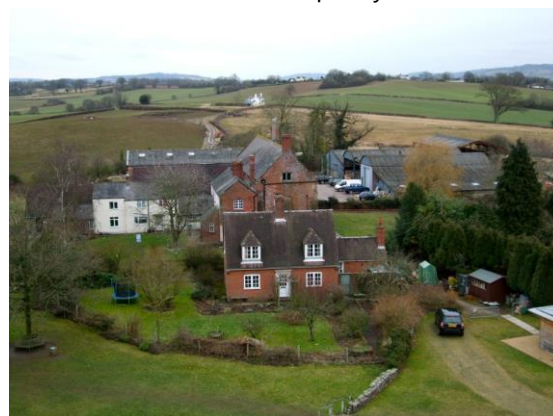
Fig.10 View to the 17th century Castle Farm from the Great Tower

7.3.5 To the east of the castle lies Castle Farm; with its two-and-a-half-storey 17th century farmhouse, marking an important early use of brick in the county (perhaps built to serve the castle in the 1640s) with its regular courtyard plan, traditional farmstead and modern steel framed agricultural buildings to the south-east of the farmhouse (**Fig.10**). Between the farmhouse and castle is a small one-and-a-half-storey red brick cottage, built at right angles to the farmhouse. To the south is the visitor centre/gift shop erected in 2008, a well-conceived design partially built into and hidden by the remains of the White Gate (**Fig.11**). The historic buildings within the farmhouse complex, including the later inserted cottage and the castle, form an historic group of some considerable architectural and historic quality.

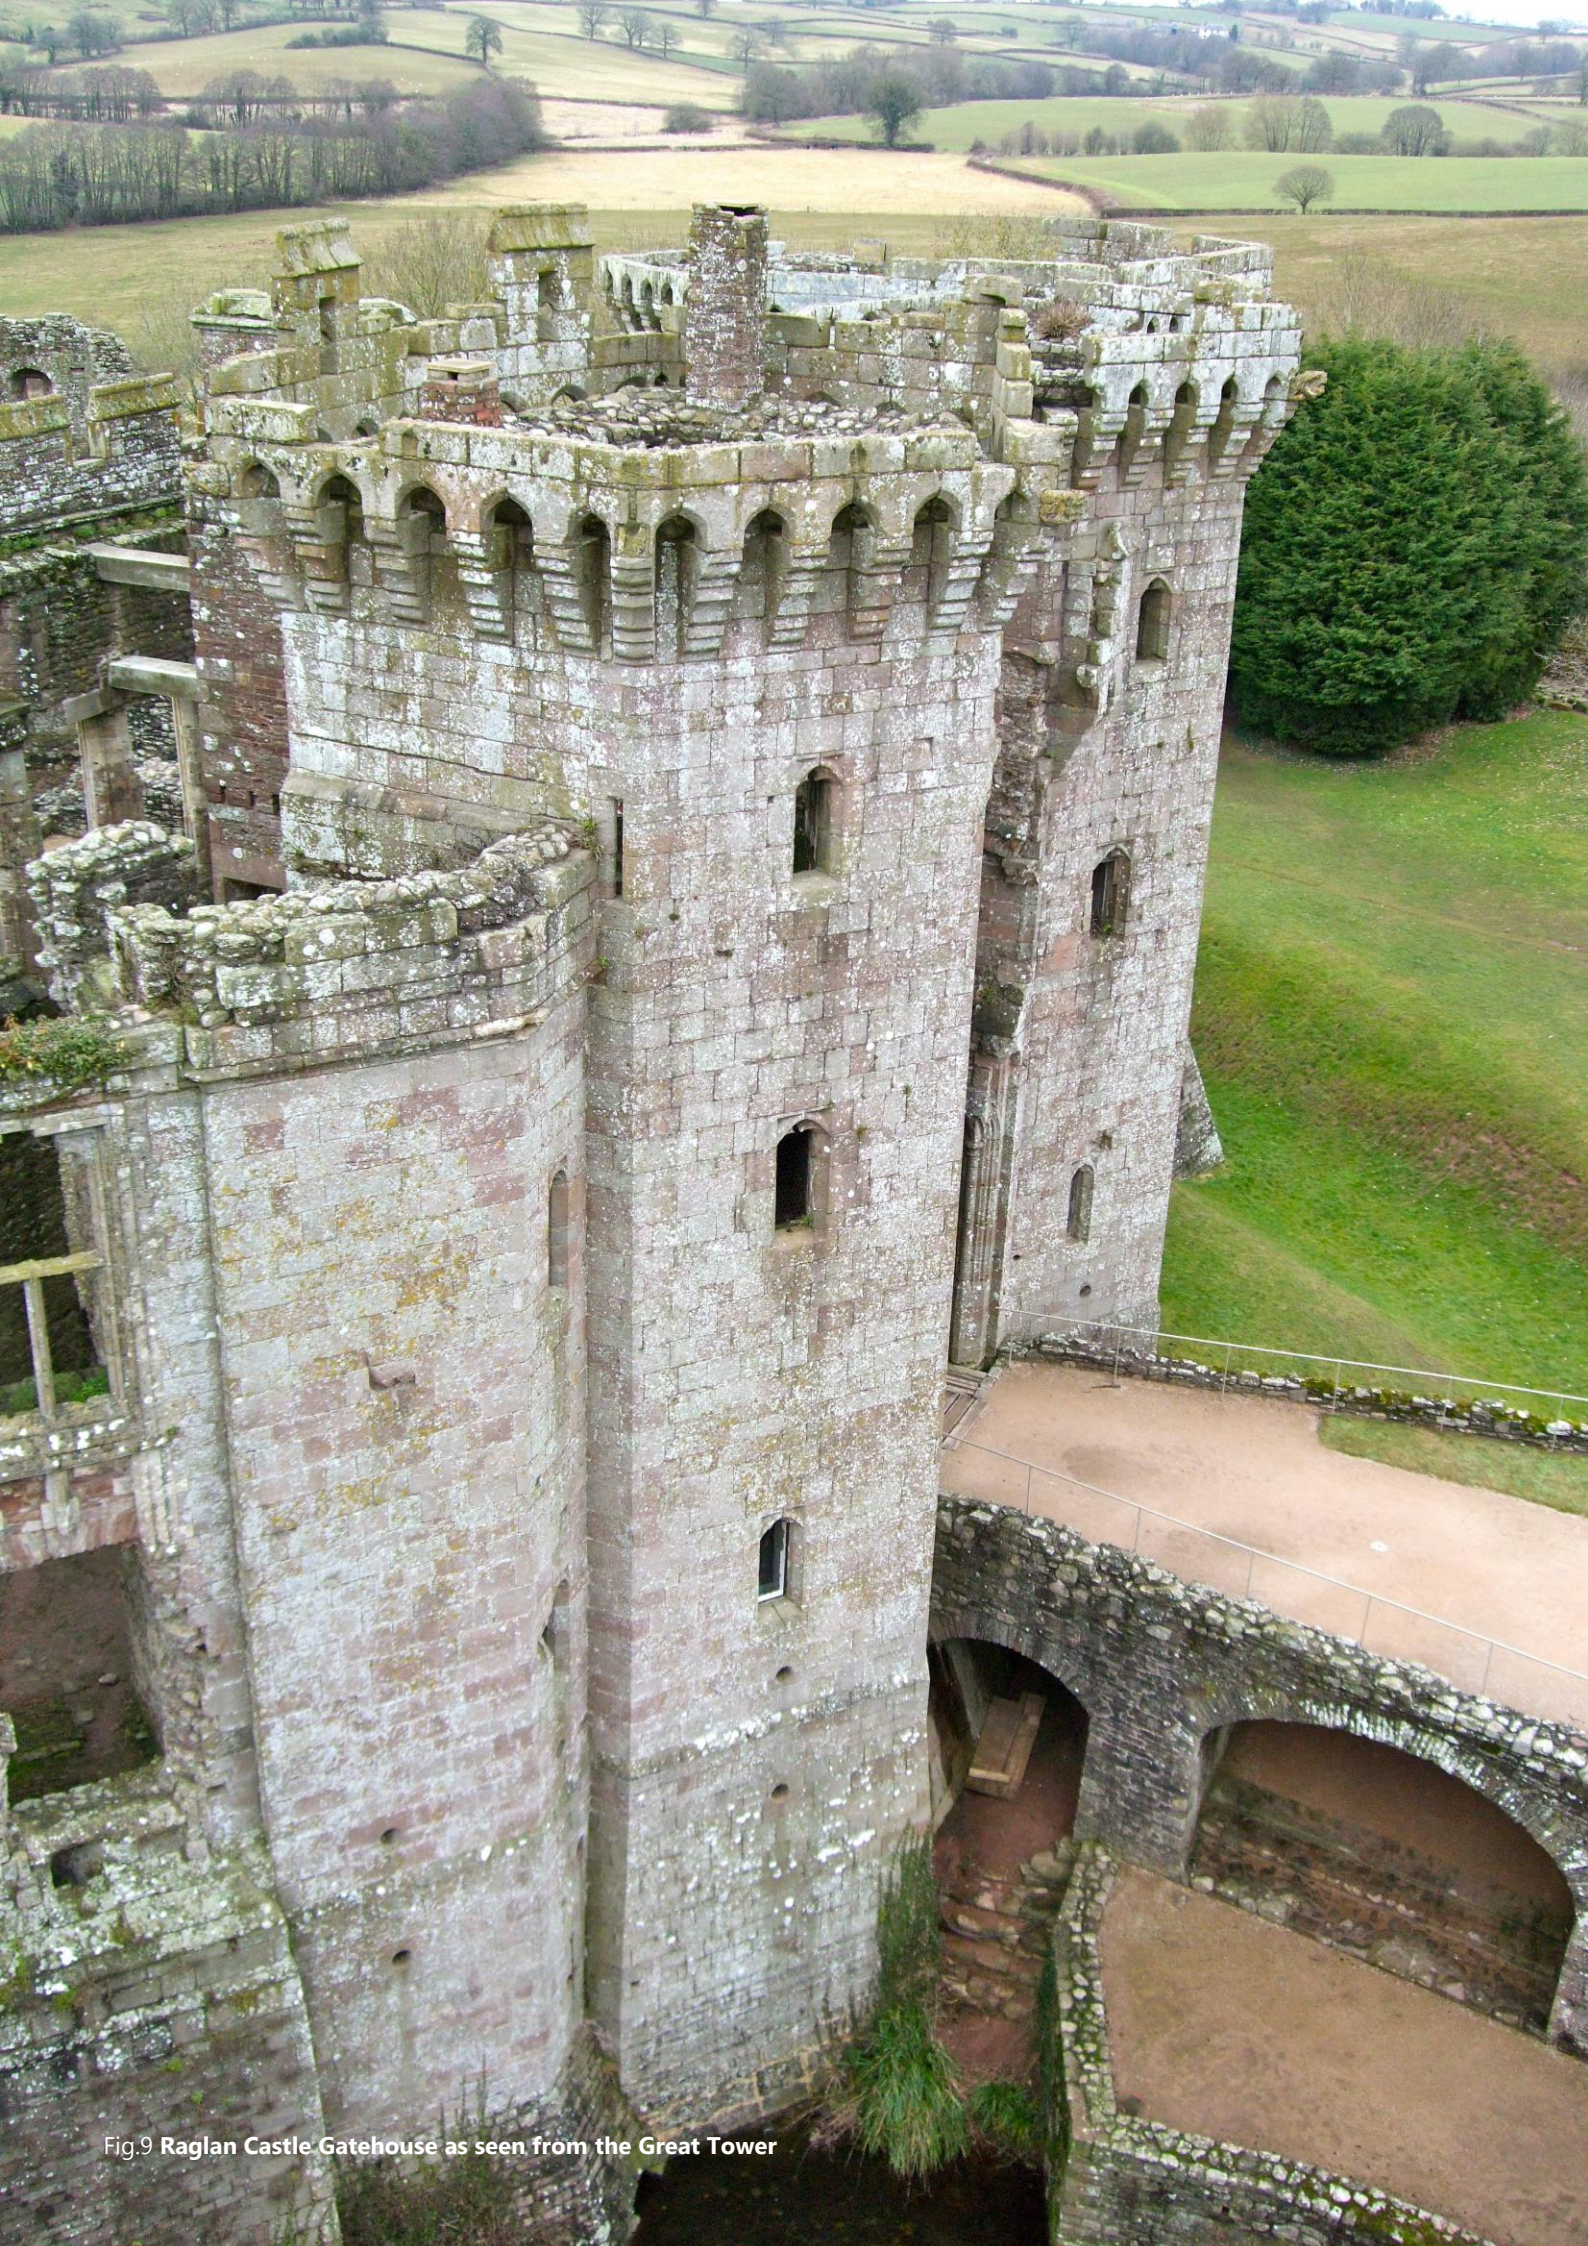
Fig.9 Raglan Castle Gatehouse as seen from the Great Tower

courtyards which are divided by the 16th century hall with its impressive oriel window (**Fig.9** next page).

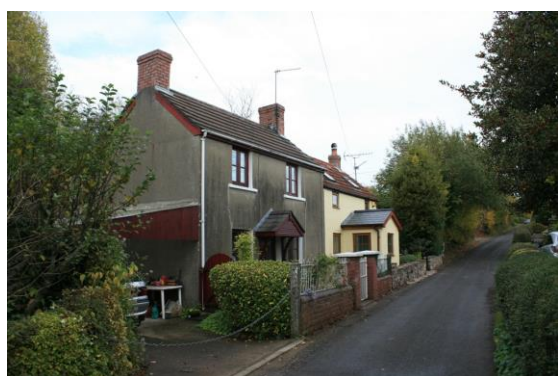
Fig.13 Castle Road: Houses with a well-defined building line positioned just back from the roadside behind low boundary walls and railings

7.3.9 The scale and building line varies within the character area. Houses on Monmouth Road face the road, set back behind front gardens/driveways with beech and conifer hedges. Those on the south side of Castle Road are positioned almost immediately to the roadside (**Fig.13**). Ty-Hir and Hill House are set back in their own grounds (the new Horatia House set in the grounds of Hill House with a further new house recently given planning permission) whilst the modern housing development on Barton Bridge Close and Barton Bridge Rise follow the curve of the roads, with driveways and small suburban front gardens. The wide pavements, clipped conifer trees and street lighting give the close a coherent 20th century suburban character of some dignity. Traditional buildings are of a modest domestic scale, mainly two-storey, those on Barton Bridge Close and Barton Bridge Rise, are a modern one-and-a-half-storey, chalet house style (**Fig.14**).

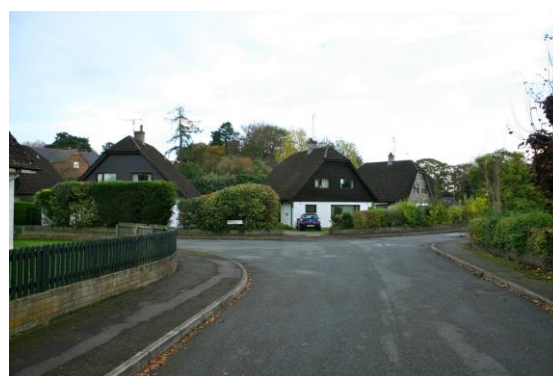
Fig.14 The suburban Barton Bridge Close with the building line of houses following the wide curving roads

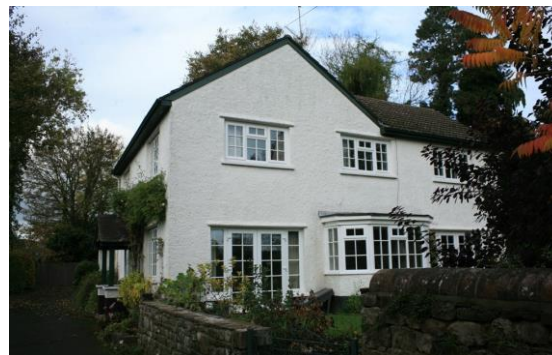
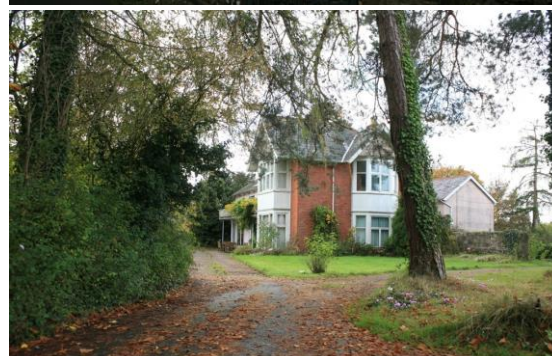
Fig.15 Ty-Hir and Hill House are buildings which make a positive contribution to the character and appearance of the conservation area

7.3.10 Good historic groups of traditional buildings are limited to Ty-Hir, set back off the roadside in mature garden and the plain red brick Hill House to the east set back and reached by an enclosed tree-lined driveway. (Fig.15)

7.3.13 Important locally distinctive features include the stone and brick walls (in English garden wall bond) to Ty-Hir and Hill House.

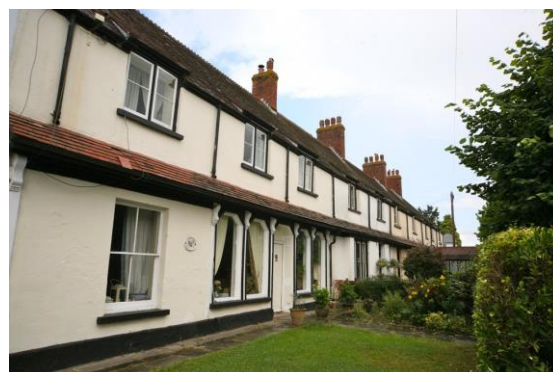
Fig.18 The architecturally distinctive terrace of Castell Coch, Exmoor & The Malt House set off the roadside behind pollarded trees

Travelling north on the west side of the street Beaufort House (public WC in front) and the terrace of Castell Coch, Exmoor and The Malt House (with its repetition of openings, continuous porch and rhythm of tall brick chimney stacks) share a well-defined building line. Built form is set slightly back from the roadside behind small front gardens with a series of pollarded trees alongside (**Fig.18**). An unusually elongated front porch extends out towards the pavement on The Malt House. Further north into Castle Hill, the houses are much more dispersed, positioned in larger plots and occasionally offset from the line of the road. The east side of Castle Street has a continuous building line, with houses set on the roadside, from the junction with Monmouth Road in the south to opposite the junction with Primrose Green in the north (**Fig.19**).

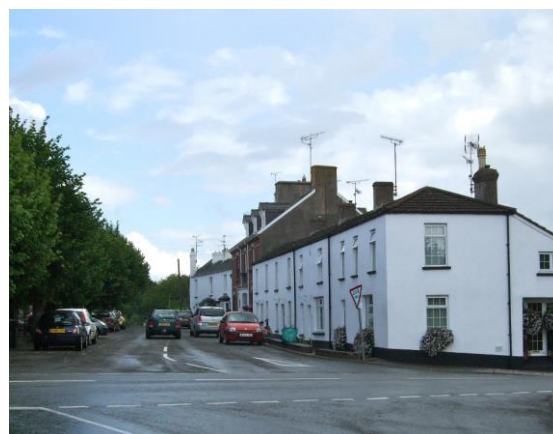
Fig.19 Well-defined building line on the east side of Castle Street

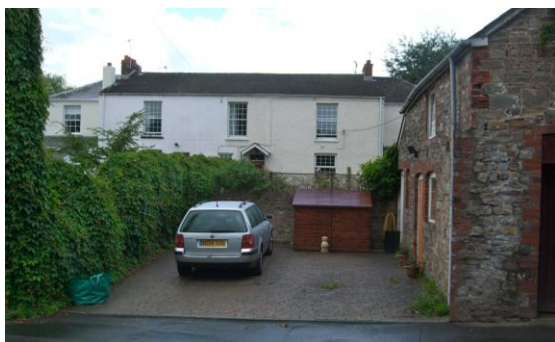
Fig.20 Chepstow Road: with a terrace of houses set back off the roadside, differing in character to that of Castle Street

7.3.16 Chepstow Road is much more informal with large 20th century houses set back on top of the earth bank at the corner with stone retaining walls, behind Beaufort Square. There is a terrace of three substantial 19th century houses (Church House, Waterloo House and The Birches) to the west of the road with driveways replacing front garden areas and former stables/outbuildings now used as garages facing the roadside (**Fig.20**). The old school building (now a community centre) encloses the road on the east side below the church (**Fig.21**). The conservation area moves to the west side of the road, excluding the modern primary school. From here the road opens out with a builder's yard, the Jehovah's Witness Kingdom Hall and two cottages on the roadside forming an intimate group. Outside the conservation area to the south, leading to

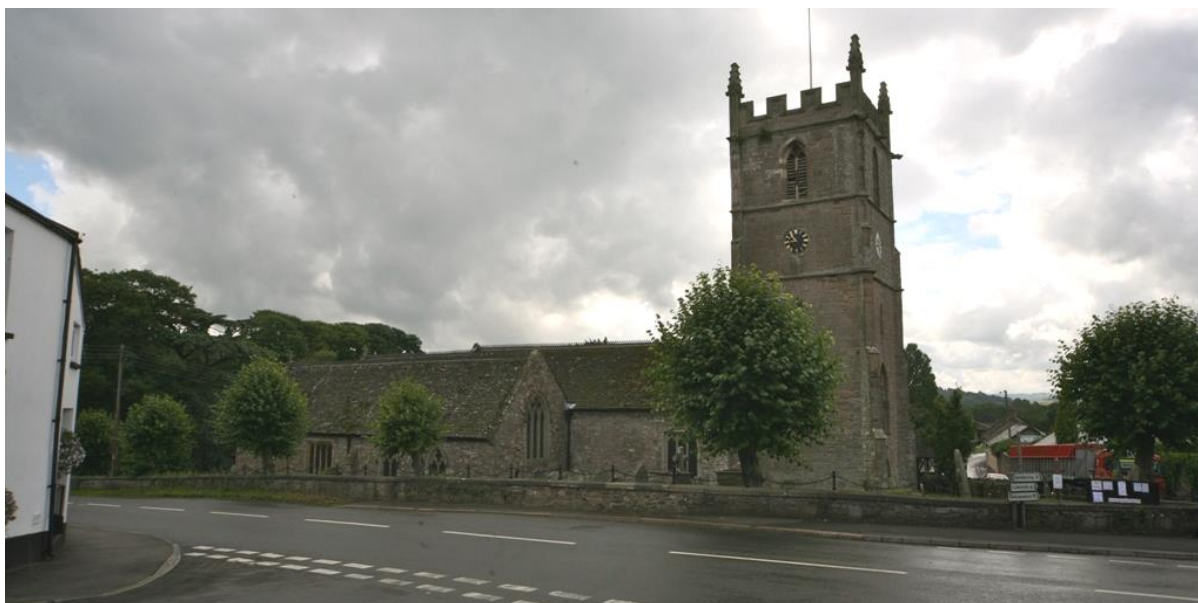
Fig.22 The landmark church, located on its prominent corner site surrounded by a low boundary wall and pollarded trees

7.3.17 The church, with its landmark tower, sits in an attractive churchyard surrounded by a low stone wall (brick in the north-east) topped with iron chains. A lych gate is positioned in the west wall, with a restored churchyard cross next to a large yew to the east and a series of pollarded trees along its north boundary (**Fig.22**). The church, lych gate, boundary walls and trees together with a number of significant memorials form a group of considerable architectural and historic interest and townscape quality.

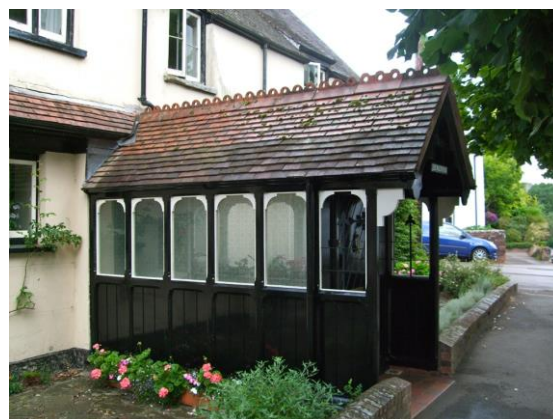
Fig.23 The Malt House's unusual 6-bay porch

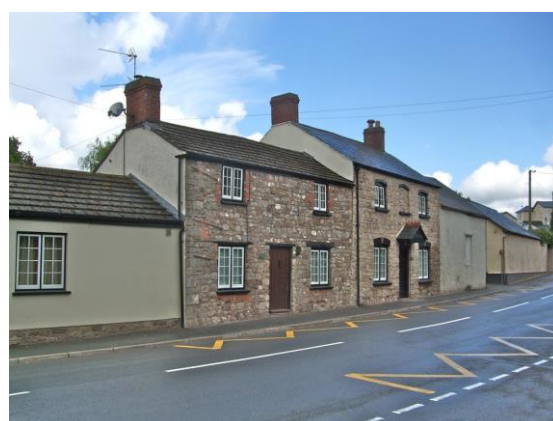
Fig.25 Elm Cottages, Elmcote and attached barn on Chepstow Road form a group making a positive contribution to the character and appearance of the conservation area

7.3.18 Other groups of buildings, in addition to the church group, making a positive contribution towards the character and appearance of the conservation area include, Castell Coch, Exmoor and The Malt House. The Malt House is a terrace of three houses on the west side of Castle Street in 19th century Domestic Revival style with small casement windows, clay tiled roofs and tiled pentice roof projecting over the ground floor and red brick stacks. Upper windows subtly break the eaves with catslide roofs. The Malt House stands out with its long 6-bay timber-framed passage porch coming out to the pavement line (**Fig.23**). The white painted rendered terrace opposite (Nos. 1-4 with datestone; 1817) has retained much of its architectural and historic character, but unfortunately most of the original six over six sash windows have been replaced with uPVC windows. To the north is Dan Y Castell and Rose Cottage, followed, on Primrose Lane, by stone gate piers leading to Blue Door Cottage opposite which is a stone boundary wall, a significant feature in the streetscape. (**Fig.24**). On Chepstow Road the old school has considerable architectural and townscape character as does the stone built No. 1 Elm Cottages with natural slate roof, red brick end stacks, small pane casement windows and central door with gabled timber hood. It forms a group with Elmcote and the attached stone barn with timber mullion window and corrugated iron roof (**Fig.25**).

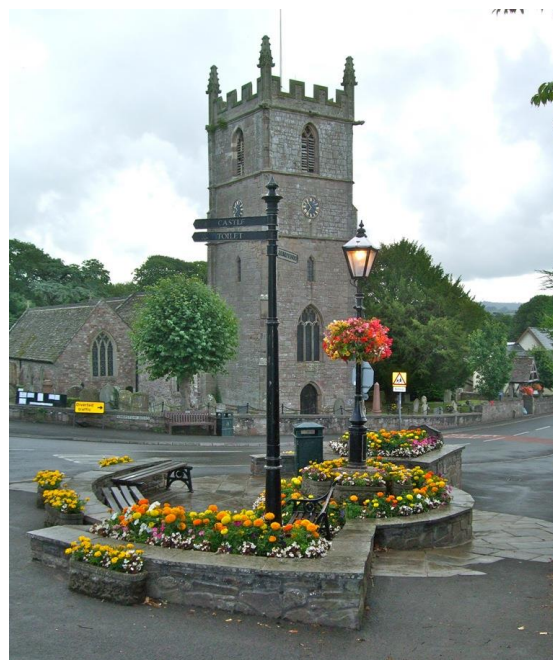
Fig.29 Beaufort Square seating area and planting scheme obscures the original market cross base

7.3.21 The area of Beaufort Square is marked by a rather municipal raised seating area with planters, although the use of natural stone is a positive enhancement to the conservation area. The old market cross is a key feature in this area. Only its base survives and it is topped by a 'traditional style' streetlight that unfortunately does little to enhance the site, masking the presence of the old cross base to the passer-by (**Fig.29**). The War Memorial (see **Fig.29**), commemorating those who died in the 1939-45 war from Raglan, Llandenny and Penyclawdd is also of considerable local importance. Stone walls are a feature on the south side of Primrose Green and west side of Castle Hill with an arched stone bridge crossing the stream to the north. Stone walls in front of Church House and The Birches, Chepstow Road, have red brick arched gateways (**Fig.30**). There are two very large mature oaks, one on the village side of the A40, opposite the road to the castle, the other on the west side of the road leading to the castle on the north side of the A40. These trees visually dominate their surroundings and are historic markers of the once important track that led from the village to the castle. There are significant survivals of traditional street surfaces on the east side of Castle Street with stone sets outside Nos. 7-9, red quarry tiles outside the red brick Nos. 5 & 6 with terracotta sets and stone flags outside Nos. 1-4 (**Fig.31**).

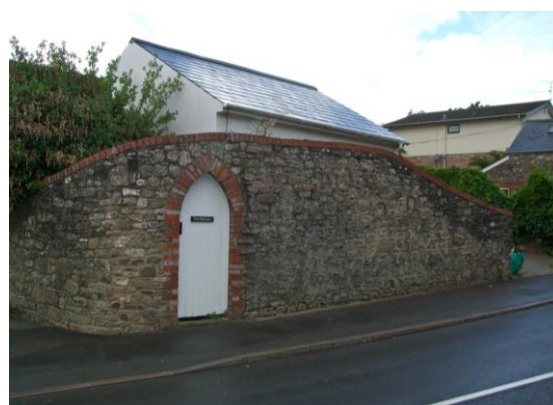
Fig.30 Red brick arched doorway set in the stone walls on Chepstow Road

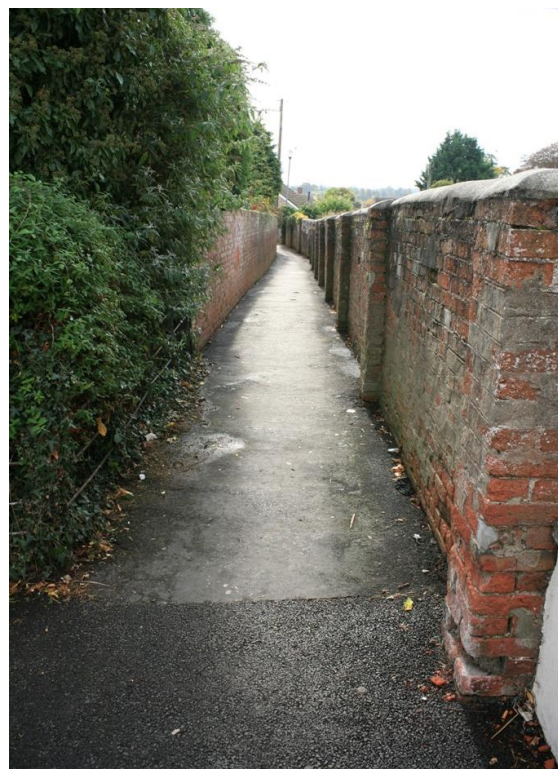
Fig.34 The narrow brick wall-lined alleyway leading south past Raglan House

7.3.24 On the south side of the High Street, next to the Post Office (Raglan House), a walled lane leads south and east to Orchard Close. Off the main High Street this area has a very different character with walls and outbuildings creating well-enclosed and intimate spaces. The Scout Hall encloses the lane on its north side, the wall opposite maintains enclosure and hides the two modern detached houses to the south. A narrow alleyway leading south past Raglan House is strongly defined by brick walls either side (**Fig.34**).

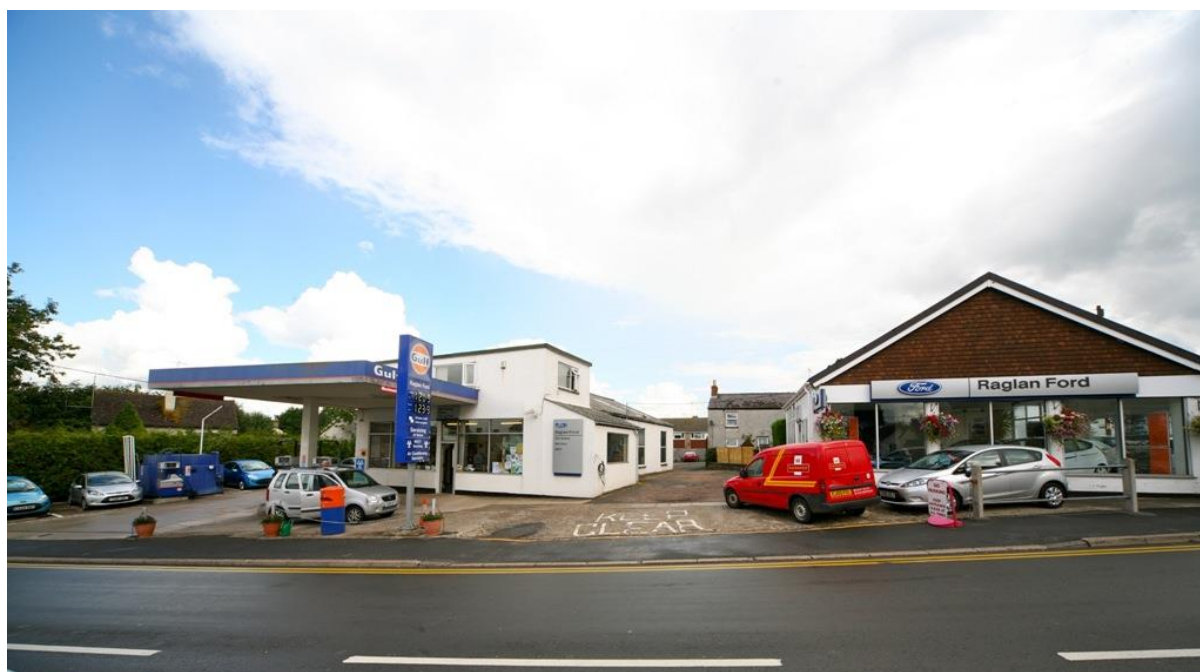
Fig.33 The garage forecourt disrupts the traditional street scene, breaking down the townscape on the north side of the High Street

7.3.23 On the south side of the High Street the buildings are positioned straight on the roadside facing north. The north side lacks this strong building line; instead buildings are set back, often at angles to the roadside. The 20th century garage lacks definition and the hard standing and forecourt creates a lack of enclosure to this side of the street (**Fig.33**). Further east is a group of buildings comprising the altered Ship Cottage (Fish and Chip take away) and the Ship Inn positioned at 45 degrees to the roadside, set back behind a stone cobbled seating area with well and hand pump.

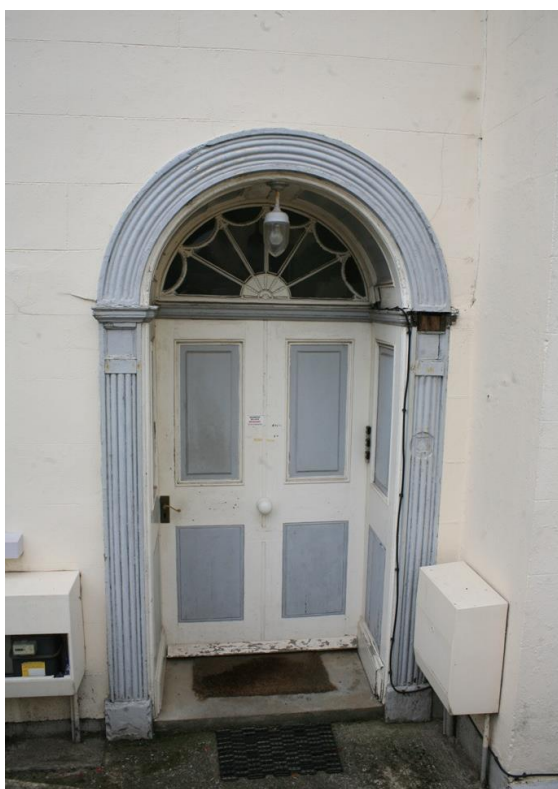
Fig.35 The fine classical doorcase at Raglan House

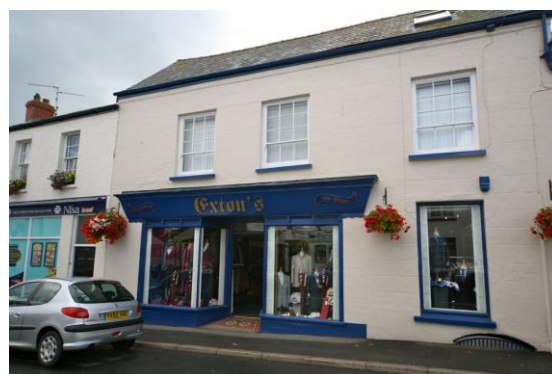
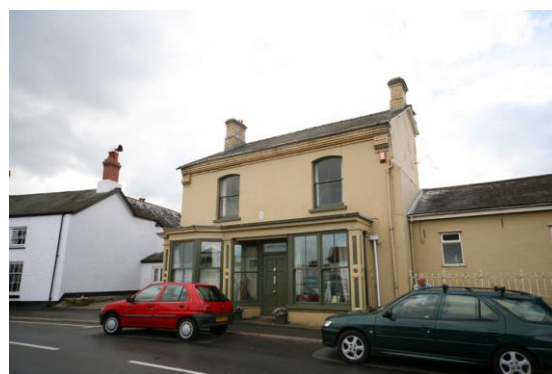
Fig.36 Two traditional shopfronts on the High Street at Extons & London House

7.3.29 Local features include the traditional shopfronts, for example, London House and Extons and the butcher's hooks outside No. 3 High Street. The stone cobbled surface outside the Ship Inn is a significant survival of traditional surface treatments within the conservation area.

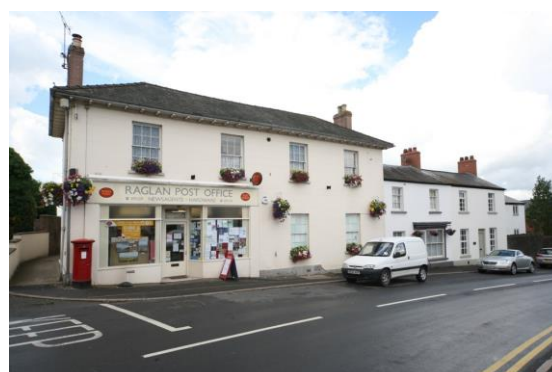
Fig.37 No. 3 High Street and the Post Office combine to create a group on High Street which make a positive contribution towards the character and appearance of the conservation area

7.3.26 Groups of buildings making a positive contribution towards the character and appearance of the Raglan conservation area include No. 3 High Street, Post Office (Raglan House) and London House, on the south side of the street (**Fig.37**). The Ship Inn and connecting buildings offset to the road provide a focal point for the north side of the street (**Fig.38**).

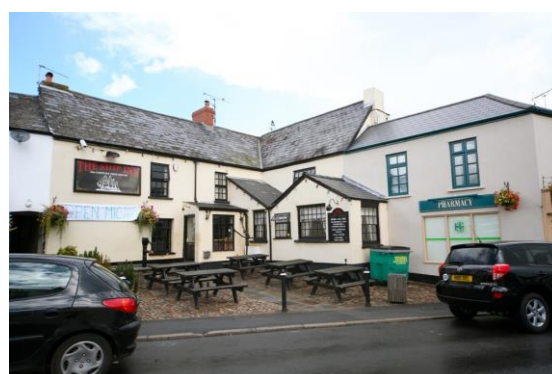
Fig.38 The Ship Inn of 16th century origins offset to the road (marking the site of the sheep markets) with its stone sett forecourt

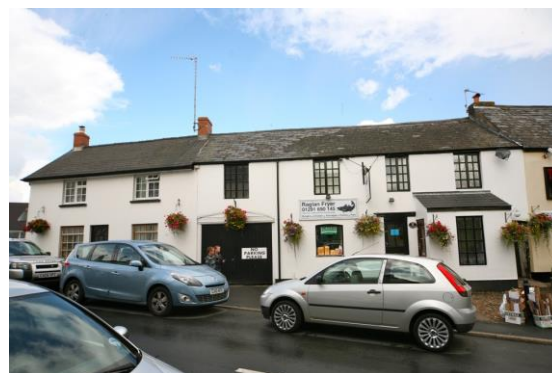
Fig.39 White painted rendered buildings with natural slate roofs predominate the High Street

7.3.27 The character area is dominated by white/cream painted rendered buildings with natural slate roofs and red brick stacks (**Fig.39**). Some, such as Raglan House, have incised lines to the render to mimic the use of ashlar stonework. There are stone cobbles to the area in front of the Ship Inn. There is a good survival of timber vertical sliding sash windows to this part of the conservation area, for example the 12 pane hornless sashes to Raglan House and 9 pane hornless sashes to No. 3 High Street.

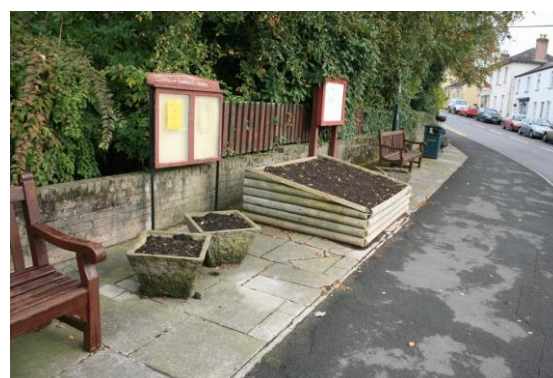
Fig.41 Dominant Planters could be improved to reflect the quality of the conservation area setting

7.3.31 The character area contains a variety of buildings from the high status residence of Willsbrook House with walled entrance, gravel driveway and monkey-puzzle tree, to the modern 20th century Castell House and Ty Pentre. A seating area with village notice boards has been introduced, and there is a further opportunity for enhancements (Fig.41).

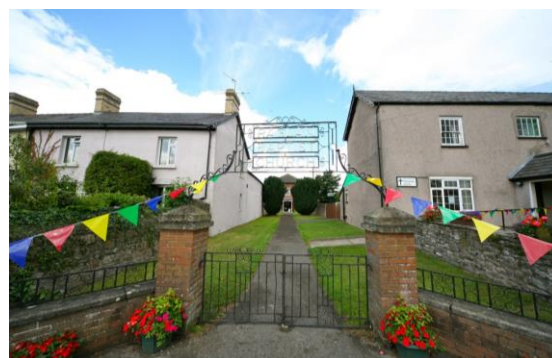
Fig.43 The Baptist Church set well behind houses fronting the roadside but is signalled in the street by its impressive entrance comprising brick piers and decorative wrought iron overthrow

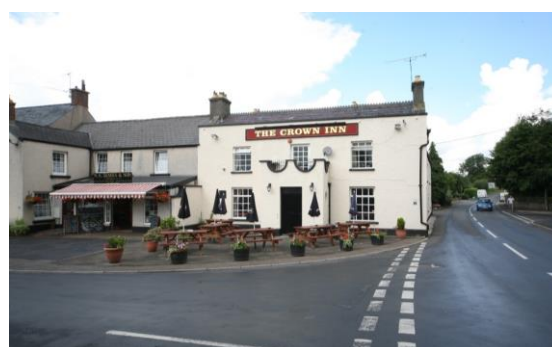
Fig.44 The Crown Inn, a prominent building set on a key corner in townscape terms

7.4.8 The relatively low, wide, two-storey three-bay, parapetted Crown Inn (**Fig.51**) is perhaps the most notable 18th century building in Raglan. It is rendered, with sash windows and a later porch with scalloped decorative battlements. The Crown partially terminates the view north along the High Street. It creates a semi-square at the junction of the High Street and Usk Road with its probably contemporary neighbour to its left which projects, creating a sense of enclosure. This latter building, with later projecting shopfront, retains most of its sash windows in good condition. The third building of this range, slightly higher but still having two storeys, retains some sashes. All are rendered and have slate roofs.

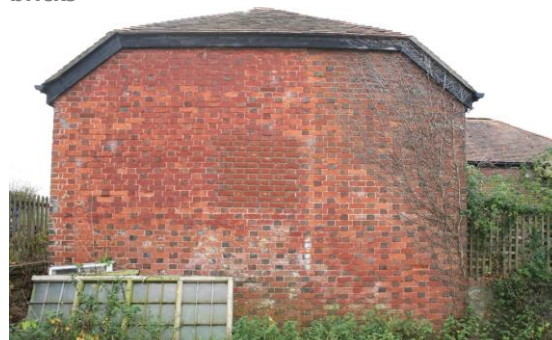
Fig.46 Chapel Cottage's distinctive brickwork, an unusual use of materials for this conservation area

7.7.4 Many traditional houses still retain natural slate. This is generally seen at low pitches to simple gabled roofs with brick ridge stacks. Plain clay tiles are seen occasionally, for example, to Chapel Cottage and clay pantiles on outbuildings opposite the Crown. Throughout the conservation area there has been some reversible loss of original roof coverings replaced with concrete tile or cement fibre slates.

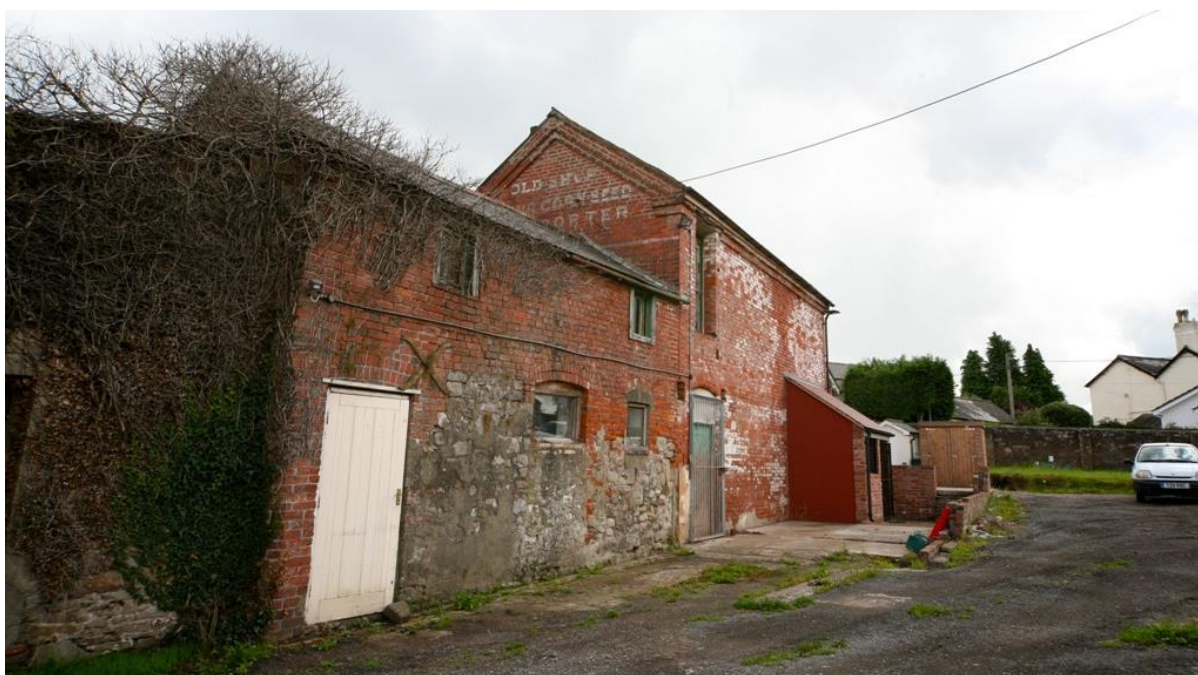
Fig.48 Attractive red brick outbuildings (listed) with historic painted signage are elements of significant local note

7.3.36 The gate piers and iron gates to Willsbrook House are of architectural and historic local significance. The brick and stone outbuildings and fading white painted advertisement/shop sign (flour, corn, seed, beer and porter stores) on the gable of the red brick building facing the car park area, behind No. 3 High Street are of local significance (**Fig.48**).

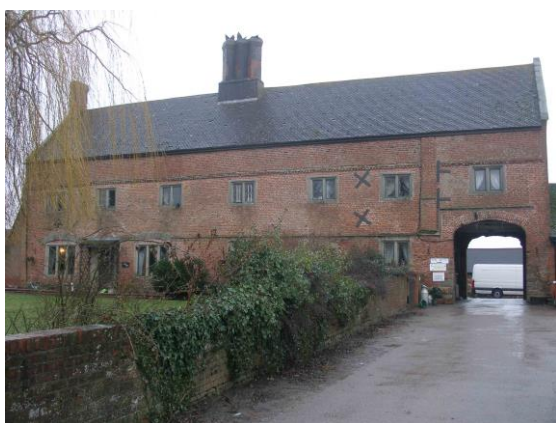
Fig.50 Castle Farm. Located in an exposed situation east of Raglan Castle, this substantial brick building was constructed just prior to the Civil War (1640s) Its style looks back to the Tudor or Jacobean period.

7.4.6 Castle Farm (Grade II listed, **Fig.50**) is the most complete surviving building of this period in Raglan. Built immediately prior to the Civil War, it stands east of the castle and is a simple massive red brick block with a long southern main façade, punctuated by a low cartway arch at its eastern end. It has two storeys and a loft under a pantile roof and massive chimney stacks. Late Tudor architectural features such as mullions, low arches and drip moulds predominate, and there is no hint of the Classical idioms infiltrating Britain in the 17th century.

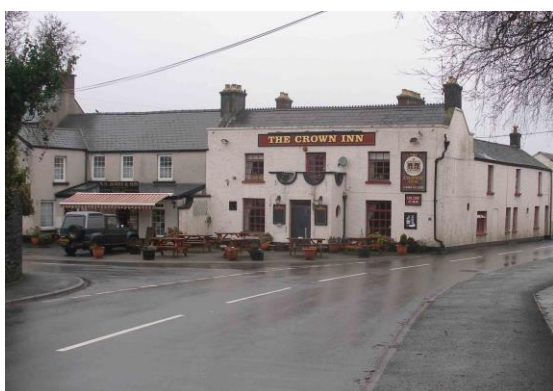
Fig.51 The Crown Inn. This symmetrical 18th century three bay building terminates the view down the High Street. The porch and some windows are later additions.

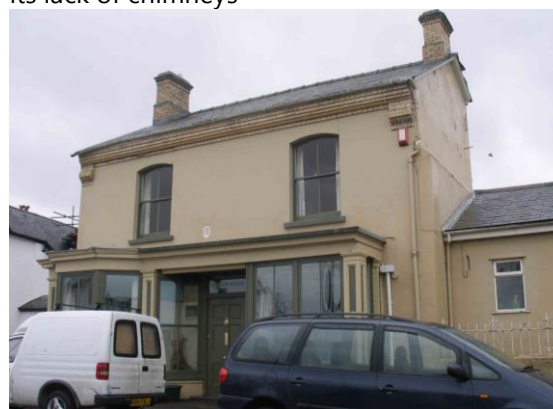
Fig. 53 London House from the mid 19th century with well detailed projecting shopfront .

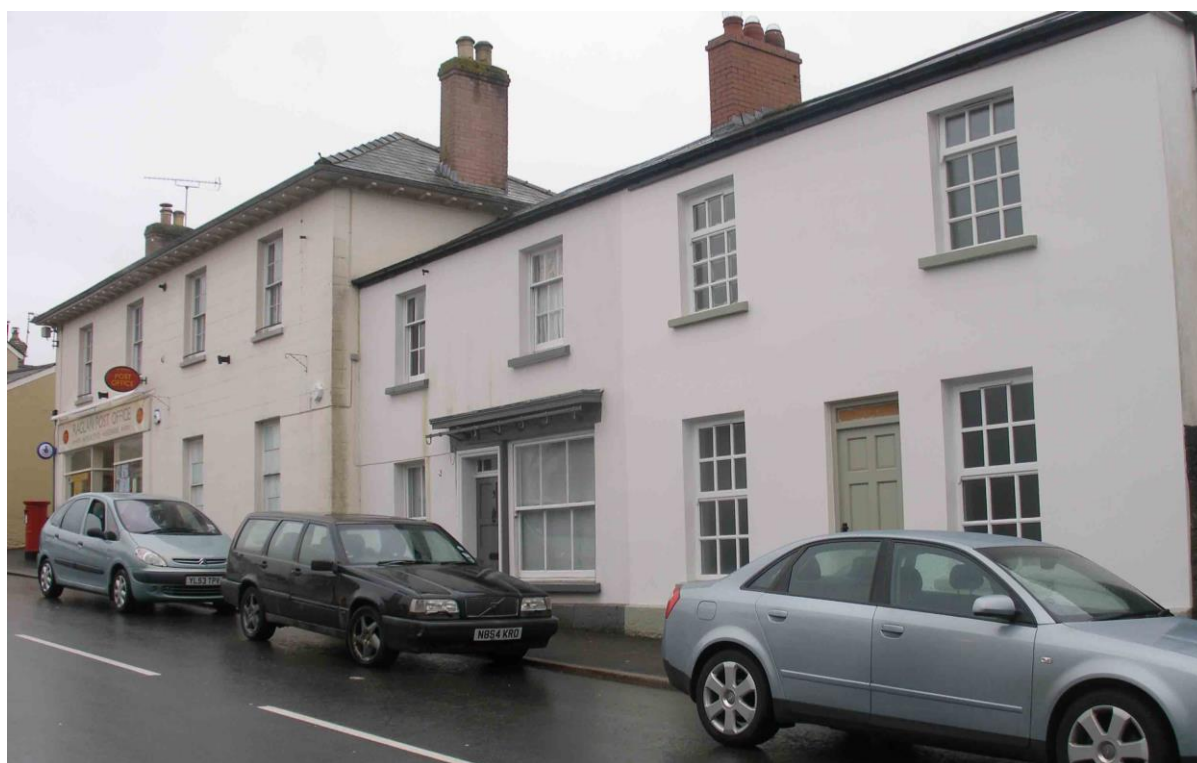
Fig. 52 Raglan House (to the left) dating from the early 19th century in the centre of the High Street has typical late classical features such as a low hipped roof with bracketed eaves. The shop front is a later addition.

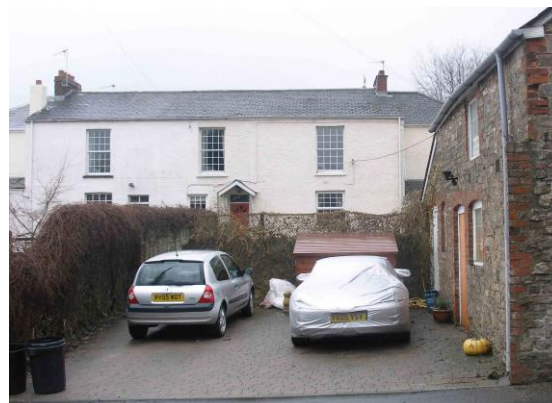
Fig. 54 **The Birches**, standing back from the Chepstow Road forms part of a terrace in a restrained stuccoed 19th century classical style.

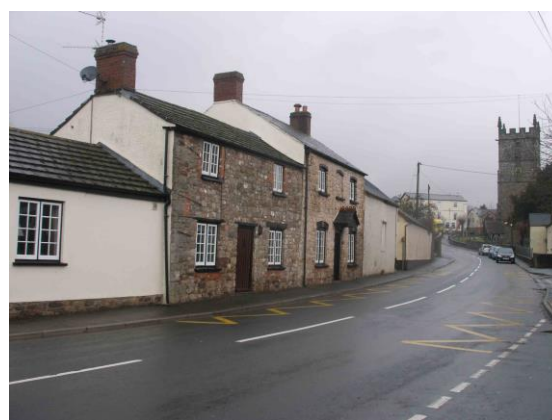
Fig. 55 **Elm Cottages**, also on the Chepstow Road, are more vernacular in character but have regularly proportioned front elevations in rubble walls. The Beaufort Arms and the tower of St Cadoc's church are in the background.

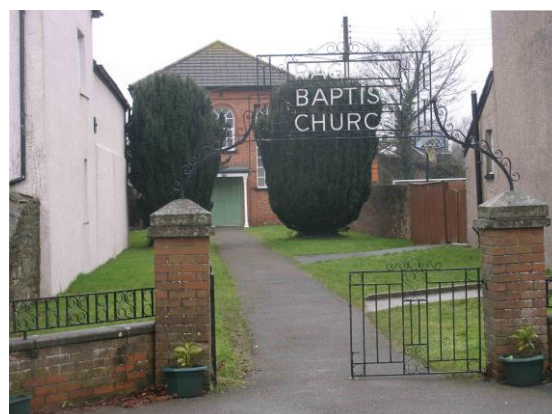
Fig. 56 **The Baptist Church** set well back from Usk Road, has the simple 'stripped' neo-classical characteristics of a mid 19th century non-conformist chapel.

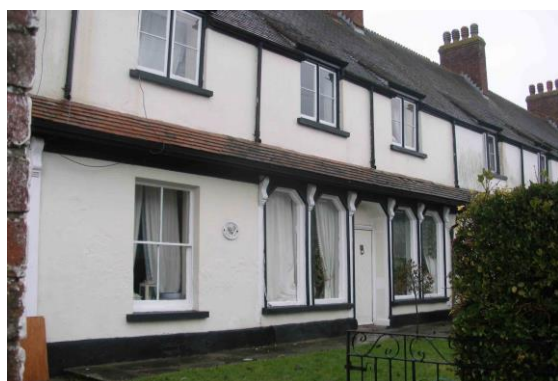
Fig. 57 Part of the terrace of three broad fronted Victorian houses on the west side of Castle Street. The chamfered window heads are an eye catching feature.

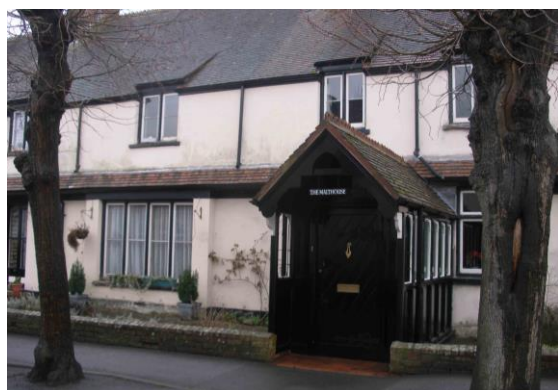
Fig. 58 The Malt House in the same terrace is distinguished by an unusual timber passage porch. The terrace is also unusual in having a continuous pentice roof to the ground floor

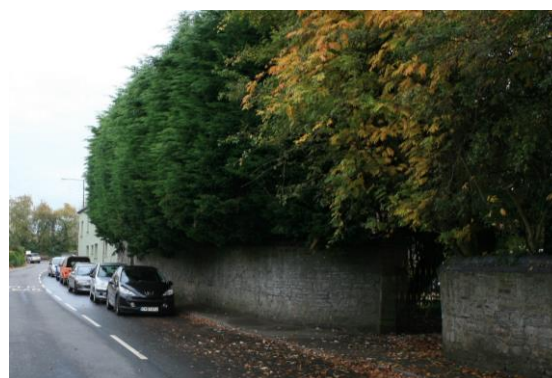
Fig.59 Rubblestone boundary wall

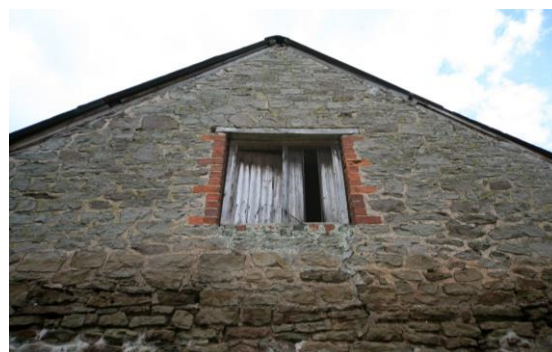
Fig.60 Typical rubblestone walling with red brick dressings as seen on an agricultural building on Chepstow Road

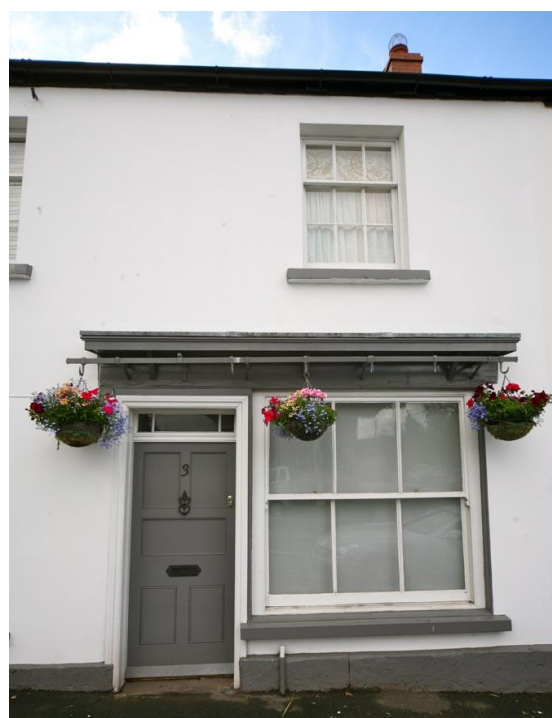
Fig.61 No.3 High Street: Good survival of traditional timber sliding sashes in the conservation area

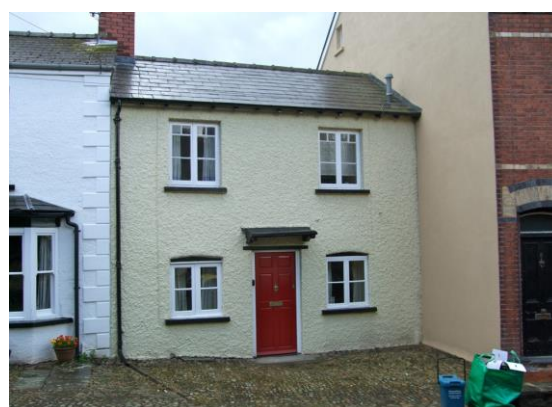
Fig.62 No.7 Castle Street displays typical features prevalent in Raglan, with rendered roughcast walls, slate roof, casement windows and stone setts or cobbles to forecourts

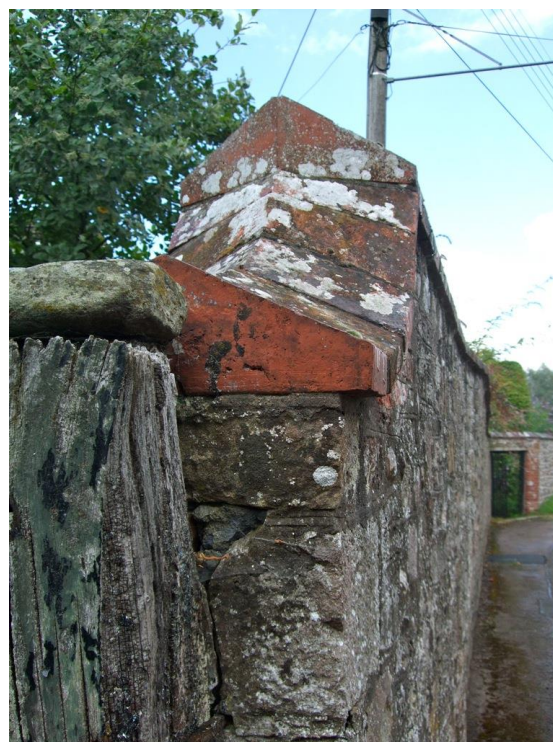
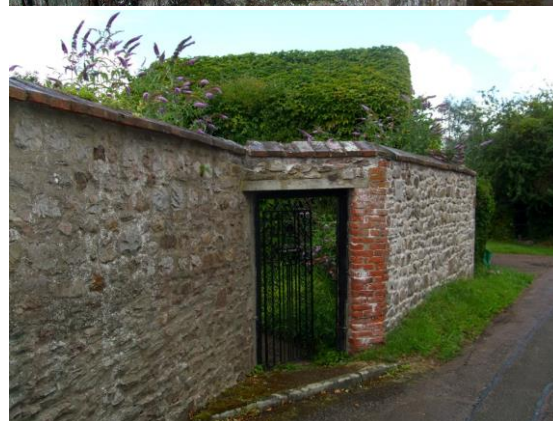
Fig.63 Stretches of rubblestone walling with brick cappings, along Primrose Lane

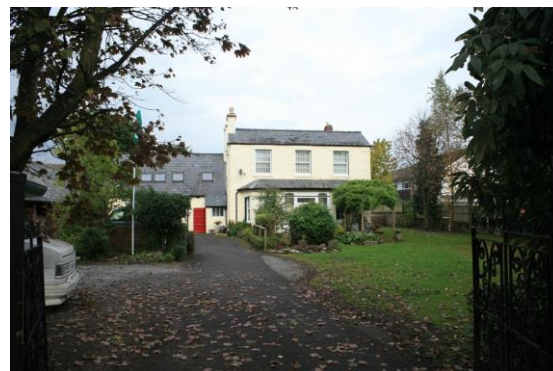
Orchard Lea (Fig.68)

11.2.1 Orchard Lea is on the north side of the High Street entering the village from the west. It is an attractive rendered residence with sash windows, quoins, slate roof, set in a garden with outbuilding with brick topped stone boundary wall. This building makes a positive contribution to the character and appearance of the conservation area and should therefore be included.

11.2.2 Orchard Lea, a double pile house, standing back from the northern end of the High Street, immediately adjoining the boundary of the conservation area probably has late 18th century origins. It is of three regular bays with original pattern sash windows and later bay windows linked by an enclosed porch. The rendered façade has rendered quoins with smaller scale quoins to the first floor windows.

Fig.68 Orchard Lea makes a positive contribution to the conservation area
